Inspection Photos

Operator: H & M PETROLEUM CORPORATION -
10032

Location ID: 458288

Inspection Doc. Number: 682504101

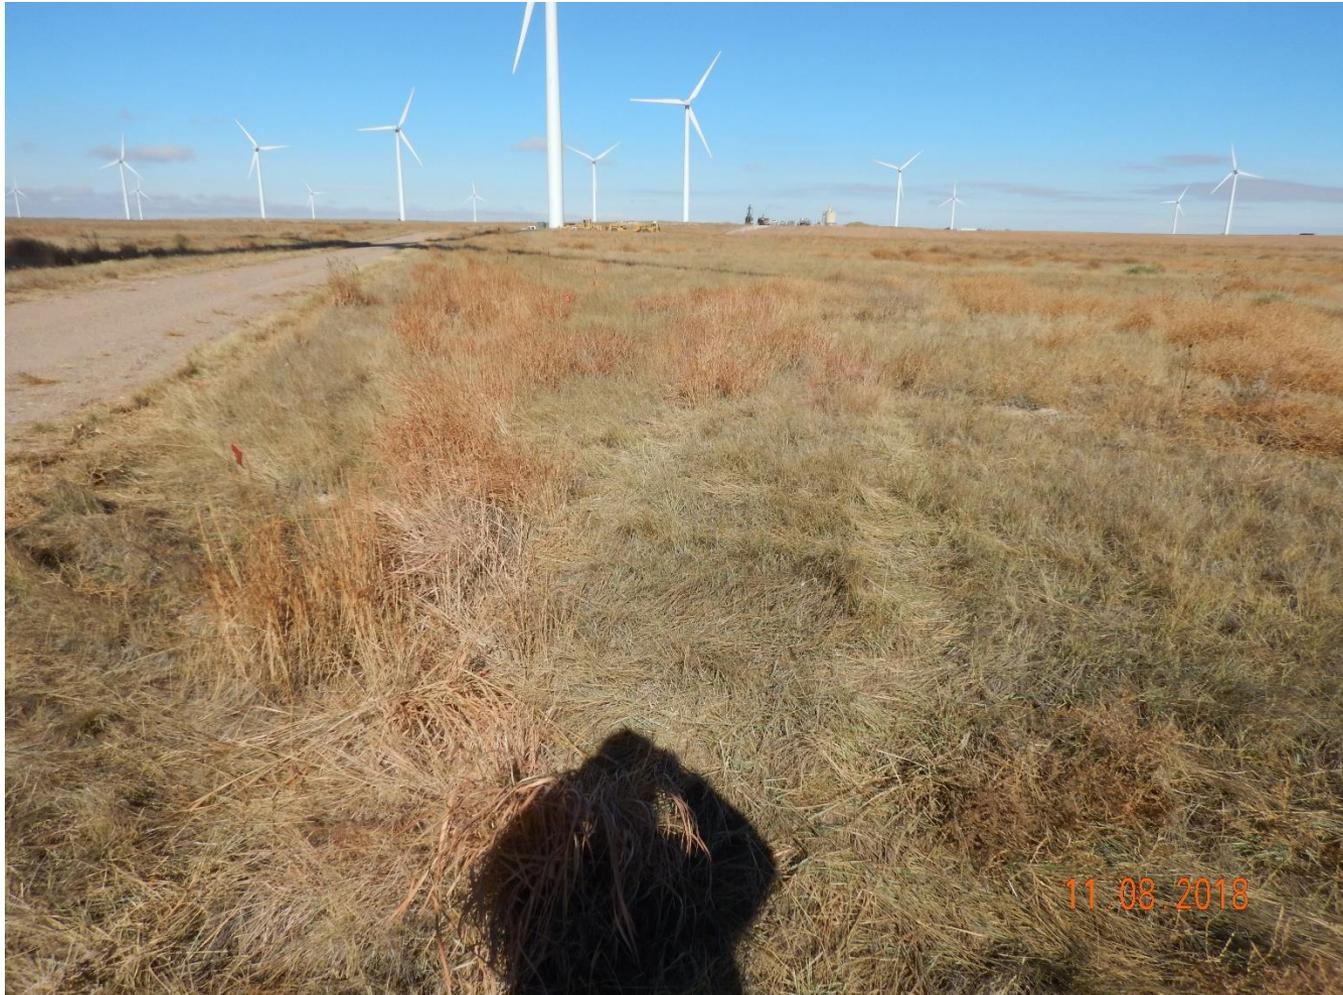
Photo 1: Photo taken from the west end of the location, facing north. No construction has begun on pad at time of the inspection. Photo shows vegetation of the location prior to disturbance activities.

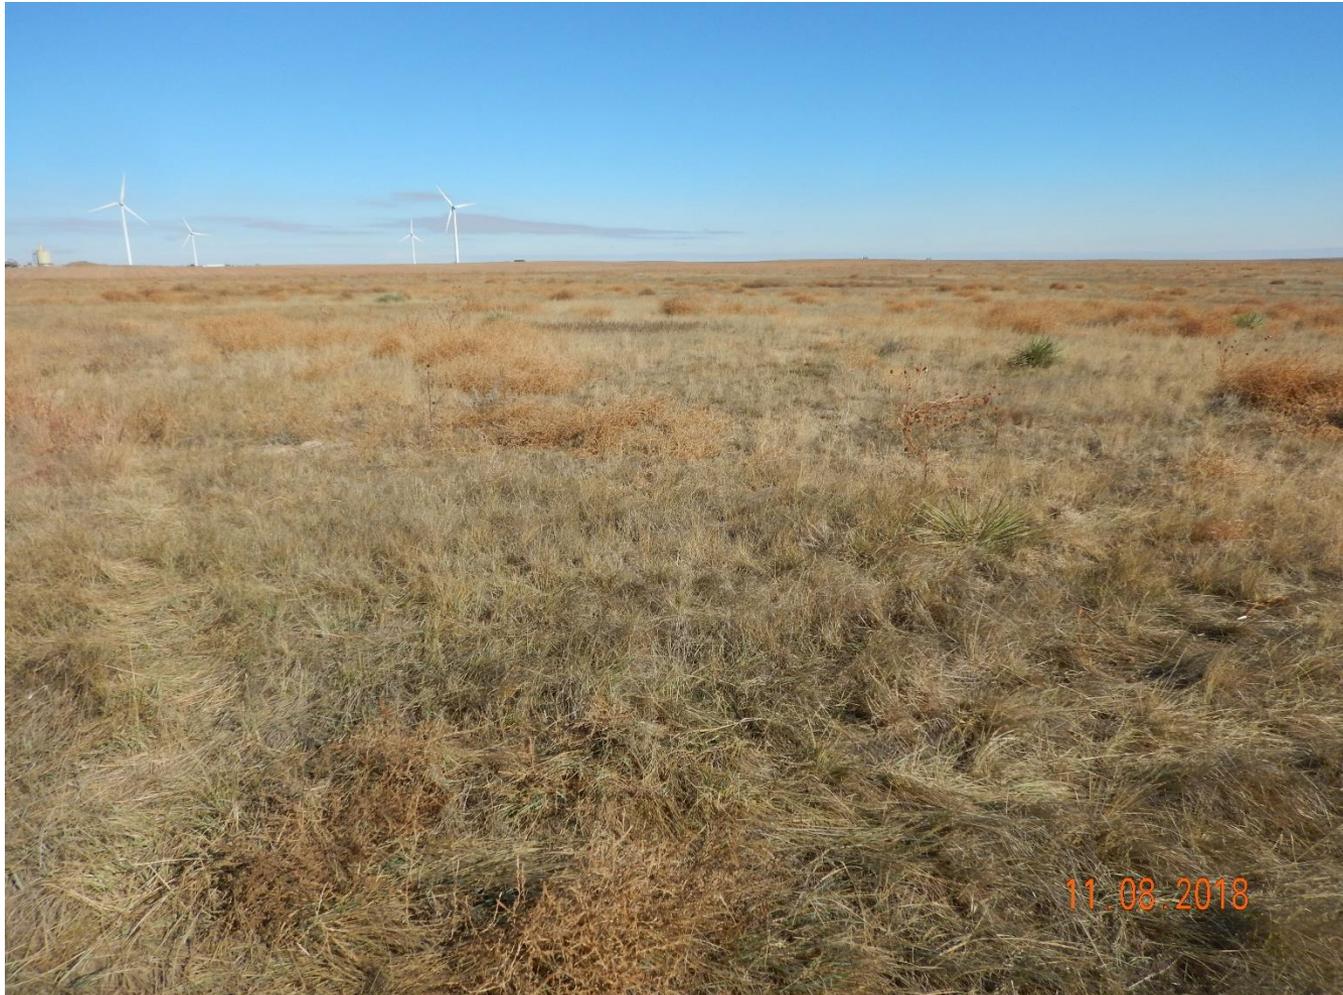
Photo 2: Photo taken from the west end of the location, facing northeast. No construction has begun on pad at time of the inspection. Photo shows vegetation of the location prior to disturbance activities.

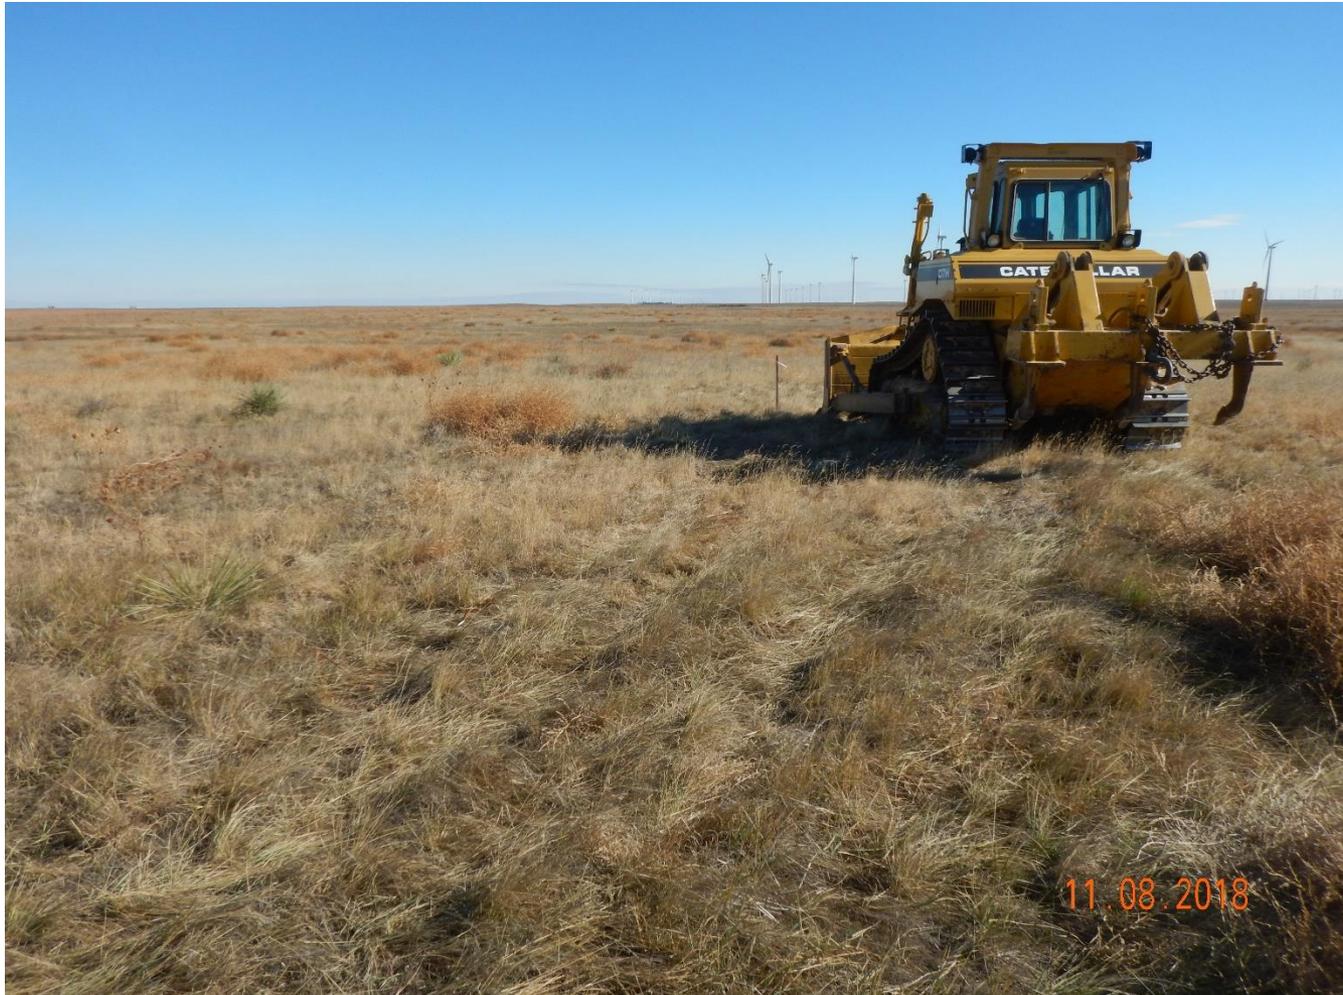
Photo 3: Photo taken from the west end of the location, facing east. No construction has begun on pad at time of the inspection. Photo shows vegetation of the location prior to disturbance activities.

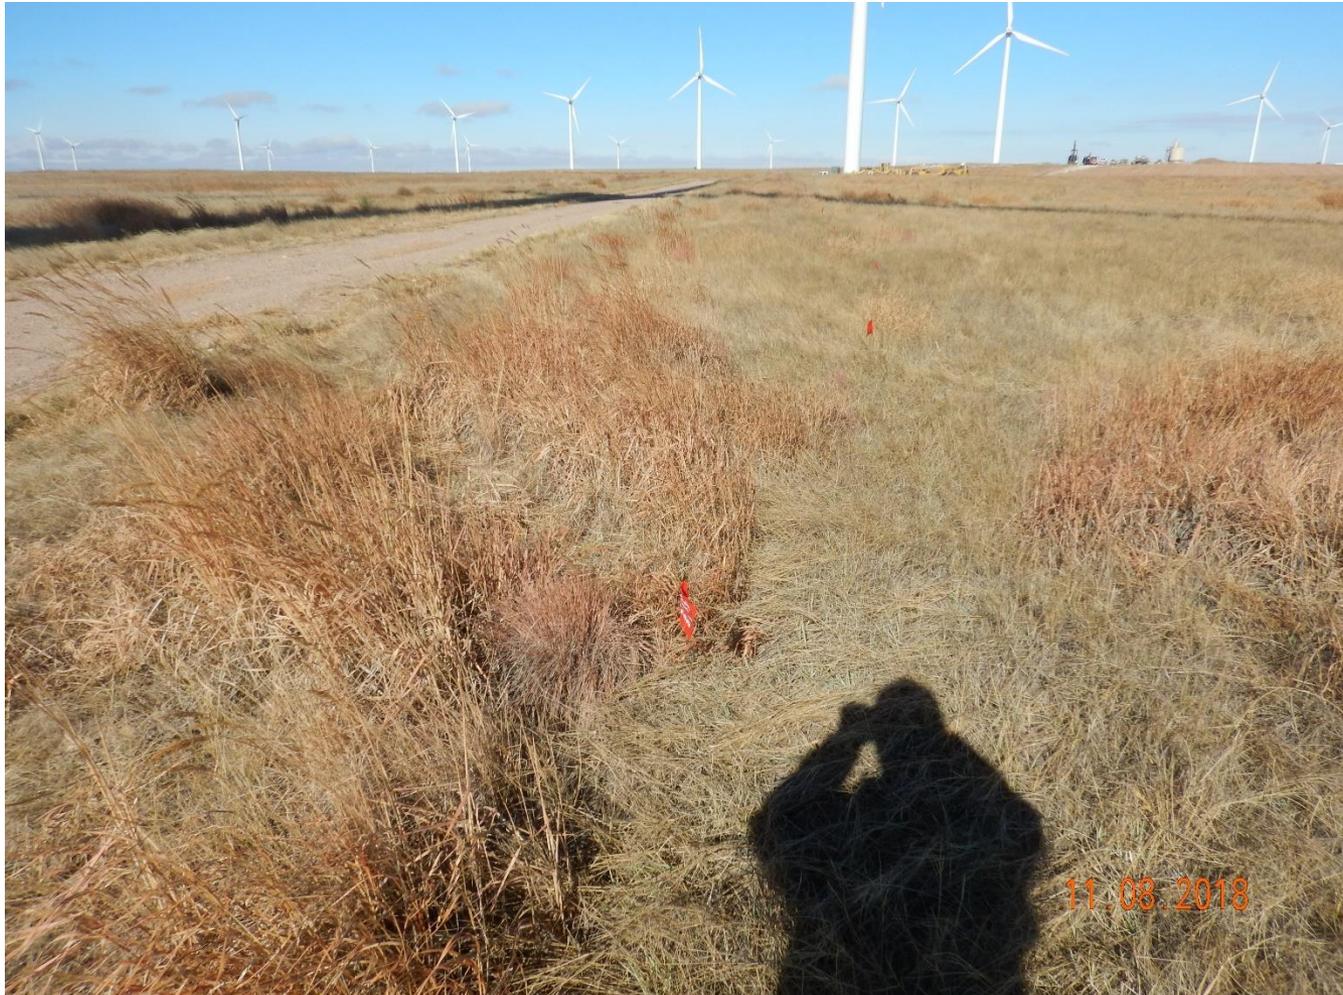
Photo 4: Photo taken from the west end of the location, facing north. Photo shows locate flags for an underground power line for the wind farm. Operator indicated that no soil salvage will be conducted on the pad due to the line.

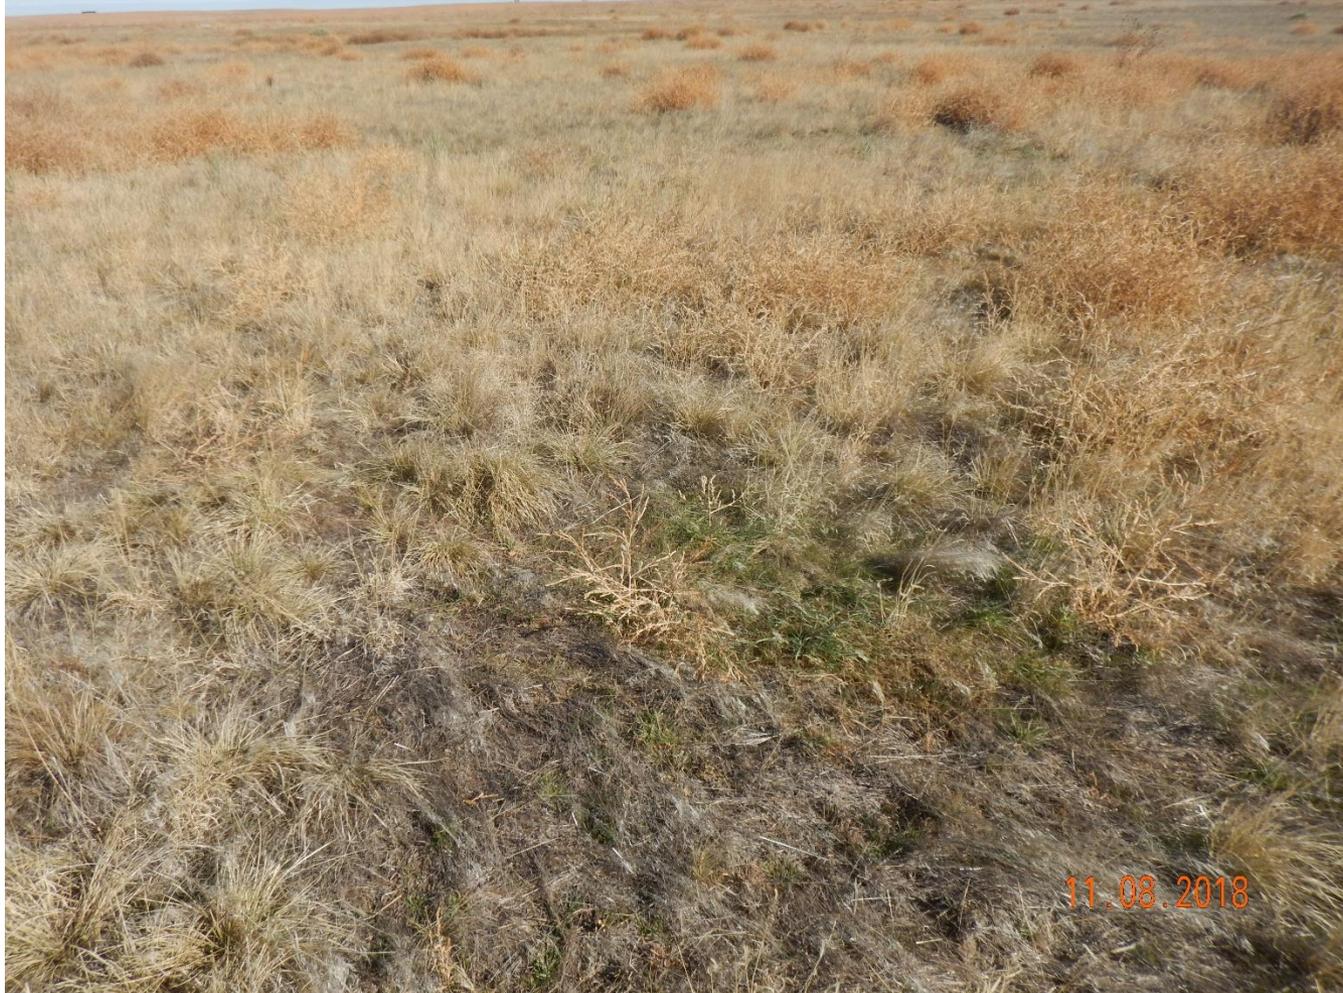
Photo 5: Photo taken from the location. Photo shows vegetation of the location prior to disturbance activities. Location appears to be in CRP. Vegetation observed appears to be predominantly Cheatgrass with patches of Smooth brome, Yellow Indian grass, Little Bluestem, Western Wheatgrass, Switchgrass, Blue Grama, Russian thistle, etc...

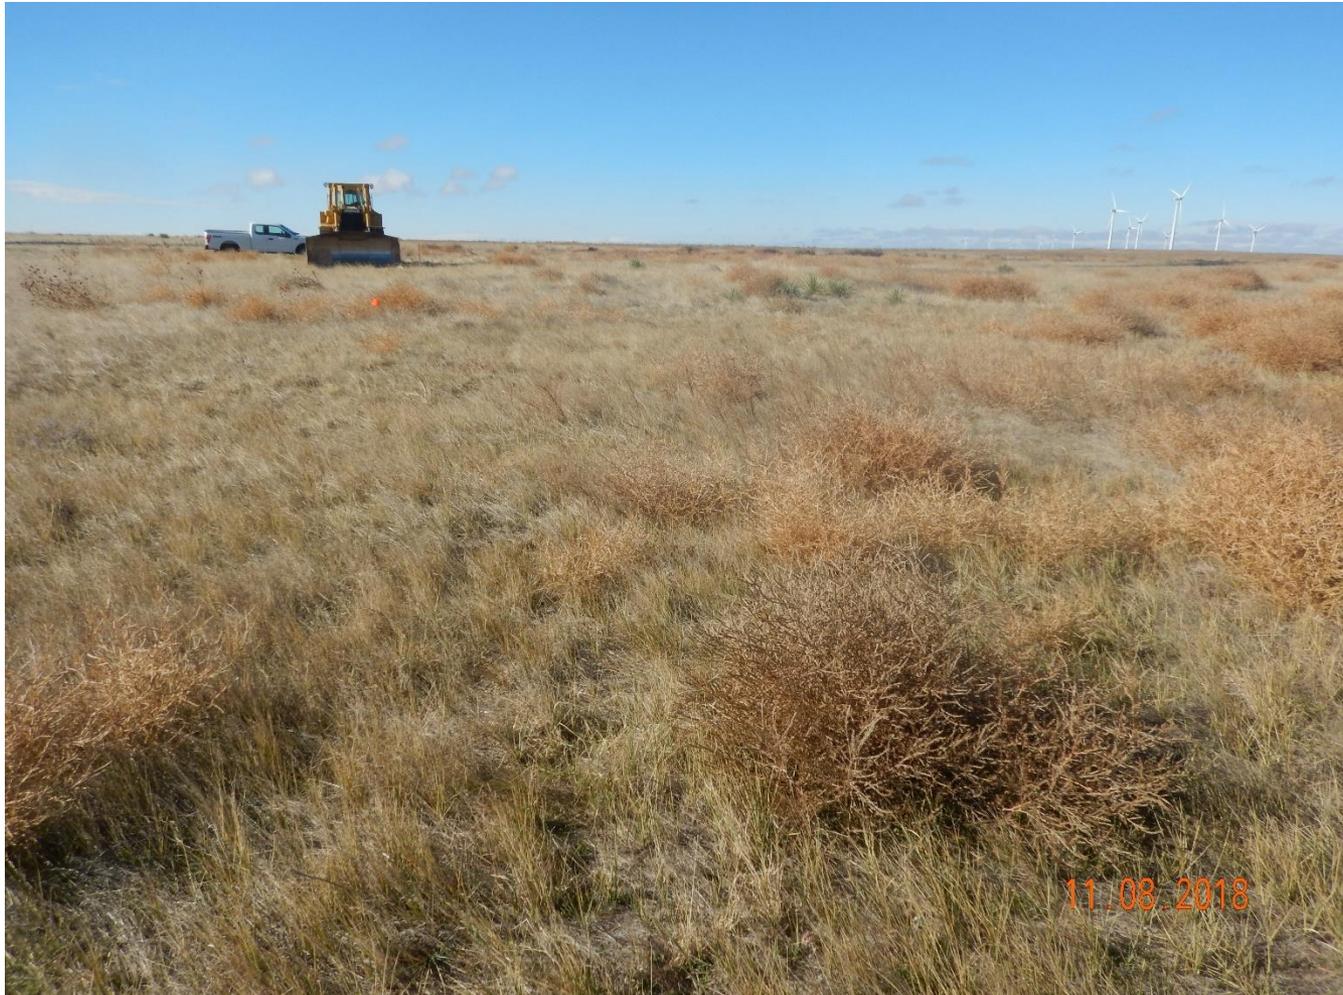
Photo 6: Photo taken from the southeast end of the location, facing west. No construction has begun on pad at time of the inspection. Photo shows vegetation of the location prior to disturbance activities.

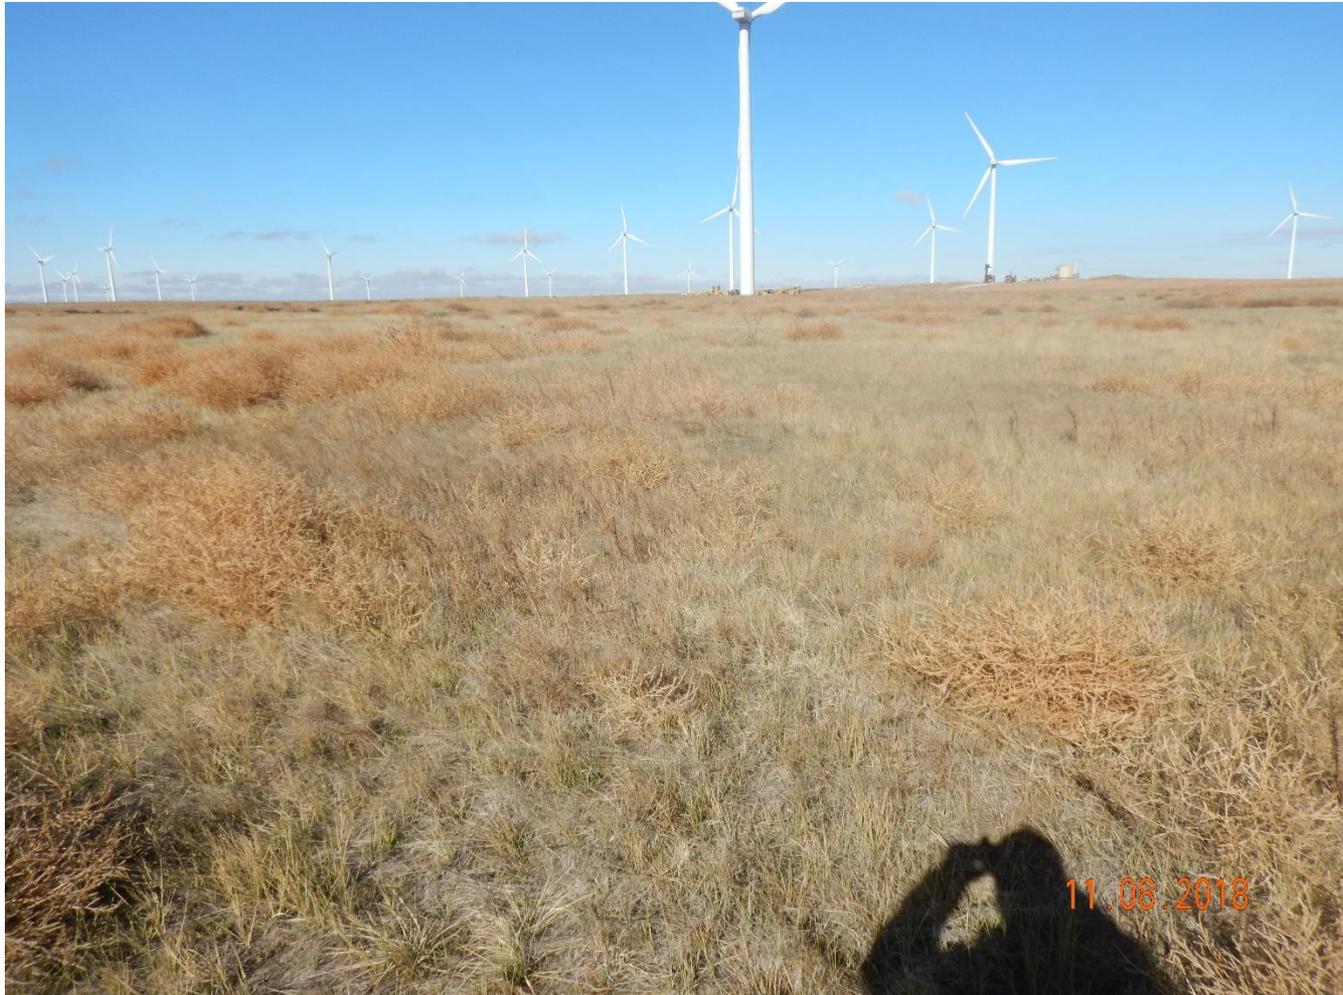
Photo 7: Photo taken from the southeast end of the location, facing northwest. No construction has begun on pad at time of the inspection. Photo shows vegetation of the location prior to disturbance activities.

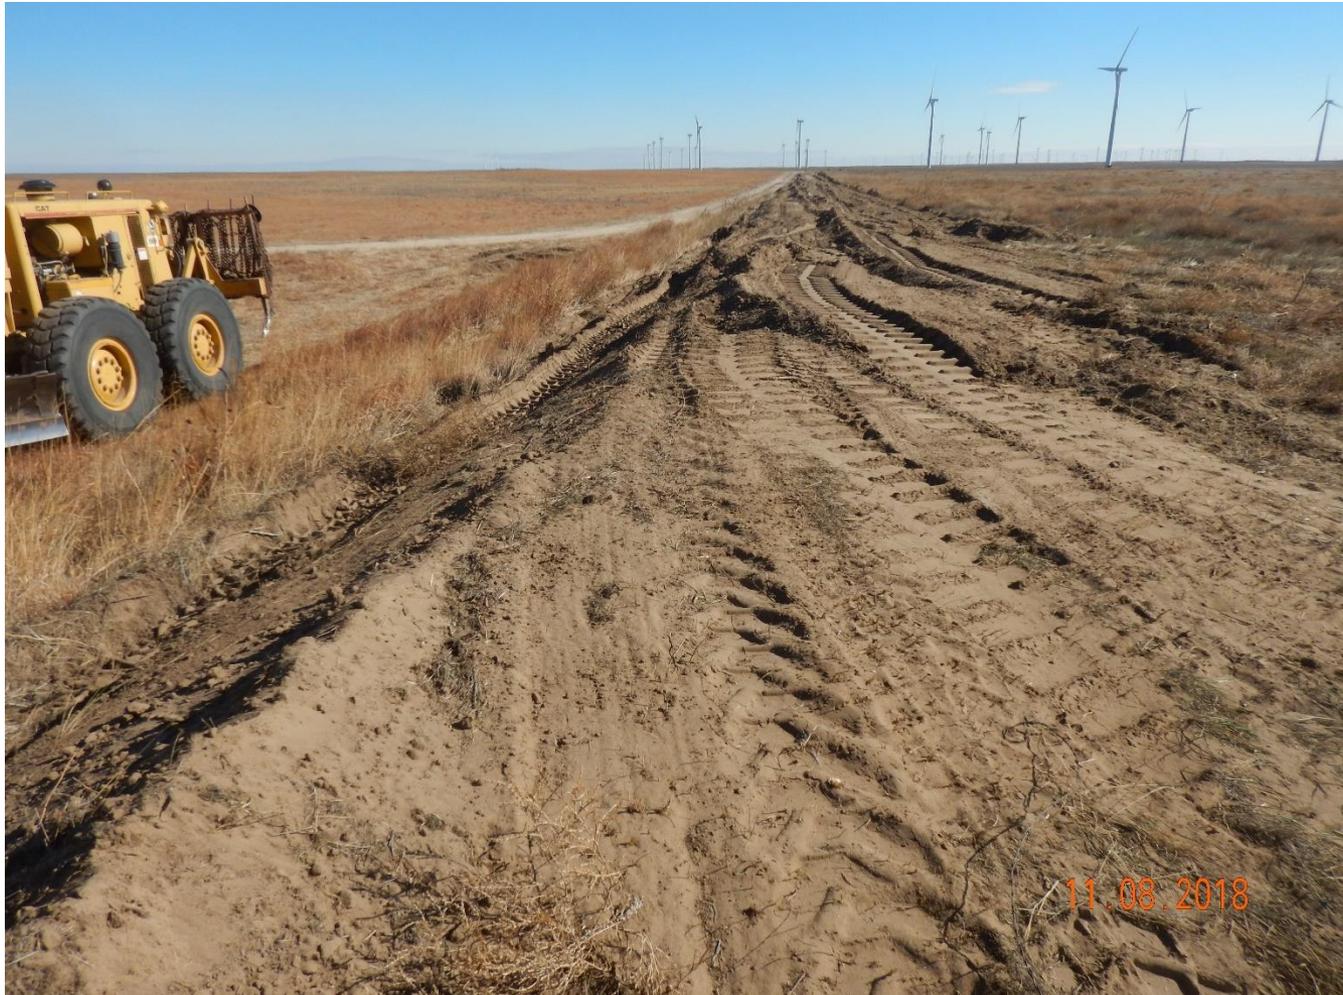
Photo 8: Photo taken from the north of the location. Photo shows a “wind blown” area where sediment deposition from the adjacent cropland has built up over time. Operator is taking soils from this area to build up the pad and a portion of the access road that passes over a pipeline.

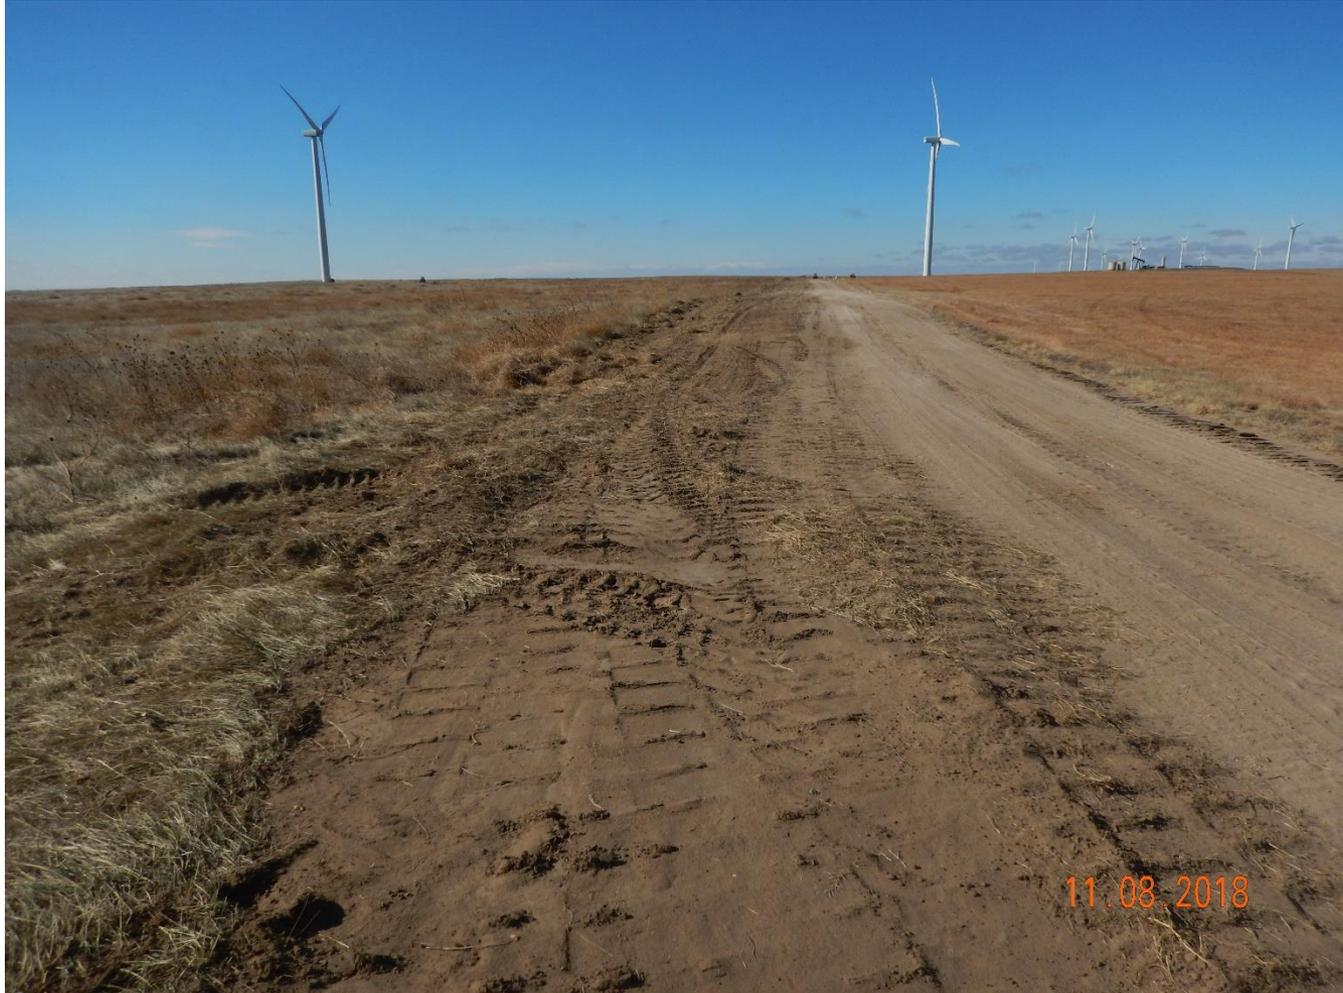
Photo 9: Photo taken from the section oil and gas access road that turns from North/south to east/west. Photo shows a “wind blown” area where sediment deposition from the adjacent cropland has built up over time. Operator is taking soils from this area to build up the pad and a portion of the access road that passes over a pipeline.

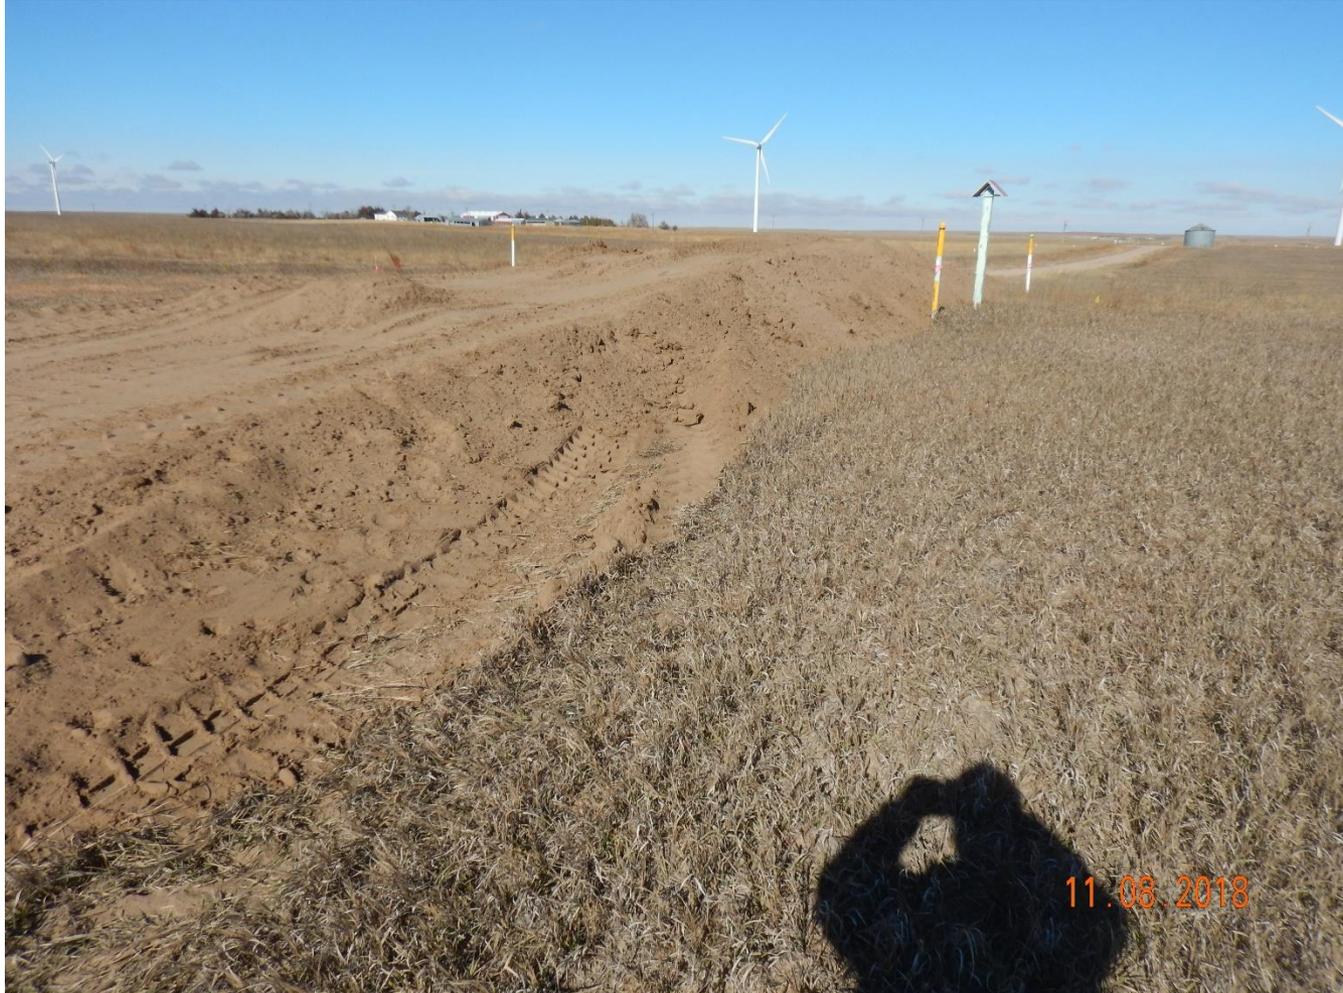
Photo 10: Photo taken from the access road north of the location. Photo shows area of access road operator has built up due to a pipeline.
