Inspection Photo
Hilltop 2F2 Ranch RMV 109-4
API # 045-13830
Inspection # 689302337

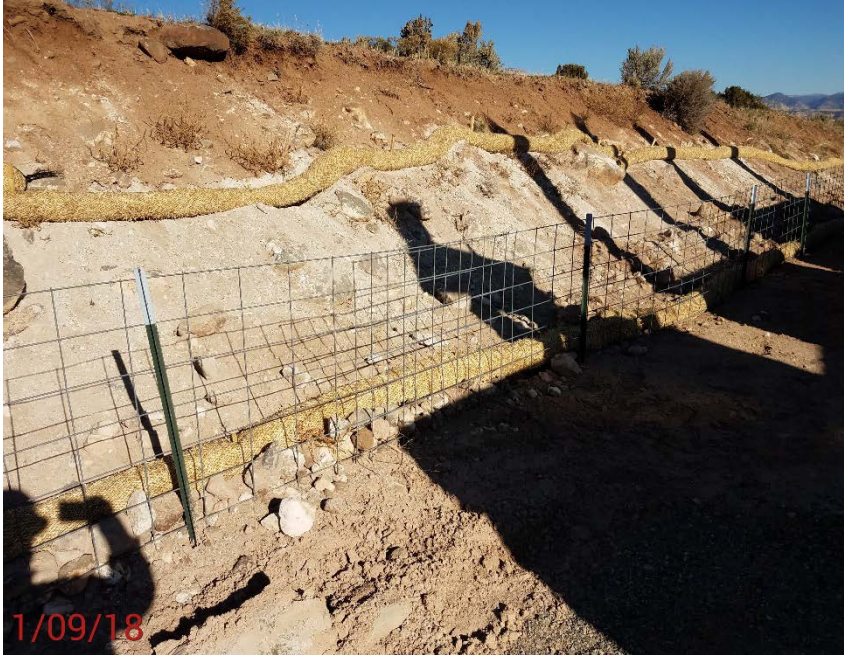
Location Photo #3, Waddles added behind separator to address storm water issue.
