Inspection Photos

Loc#436801

Operator: Sandridge

Inspection Number: 692400342

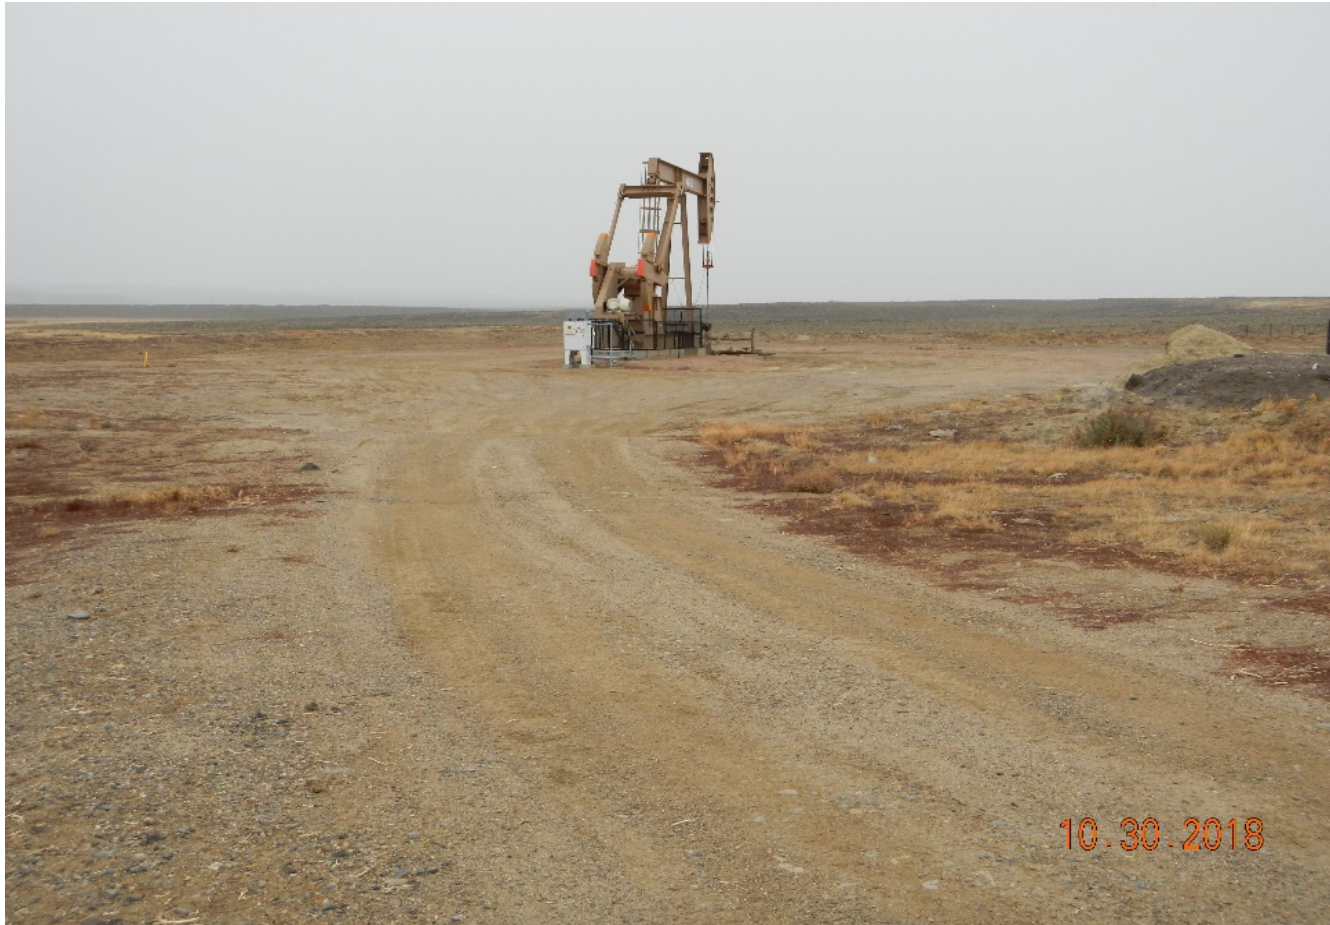
Photo#1:
Overview of Location from entry to North.

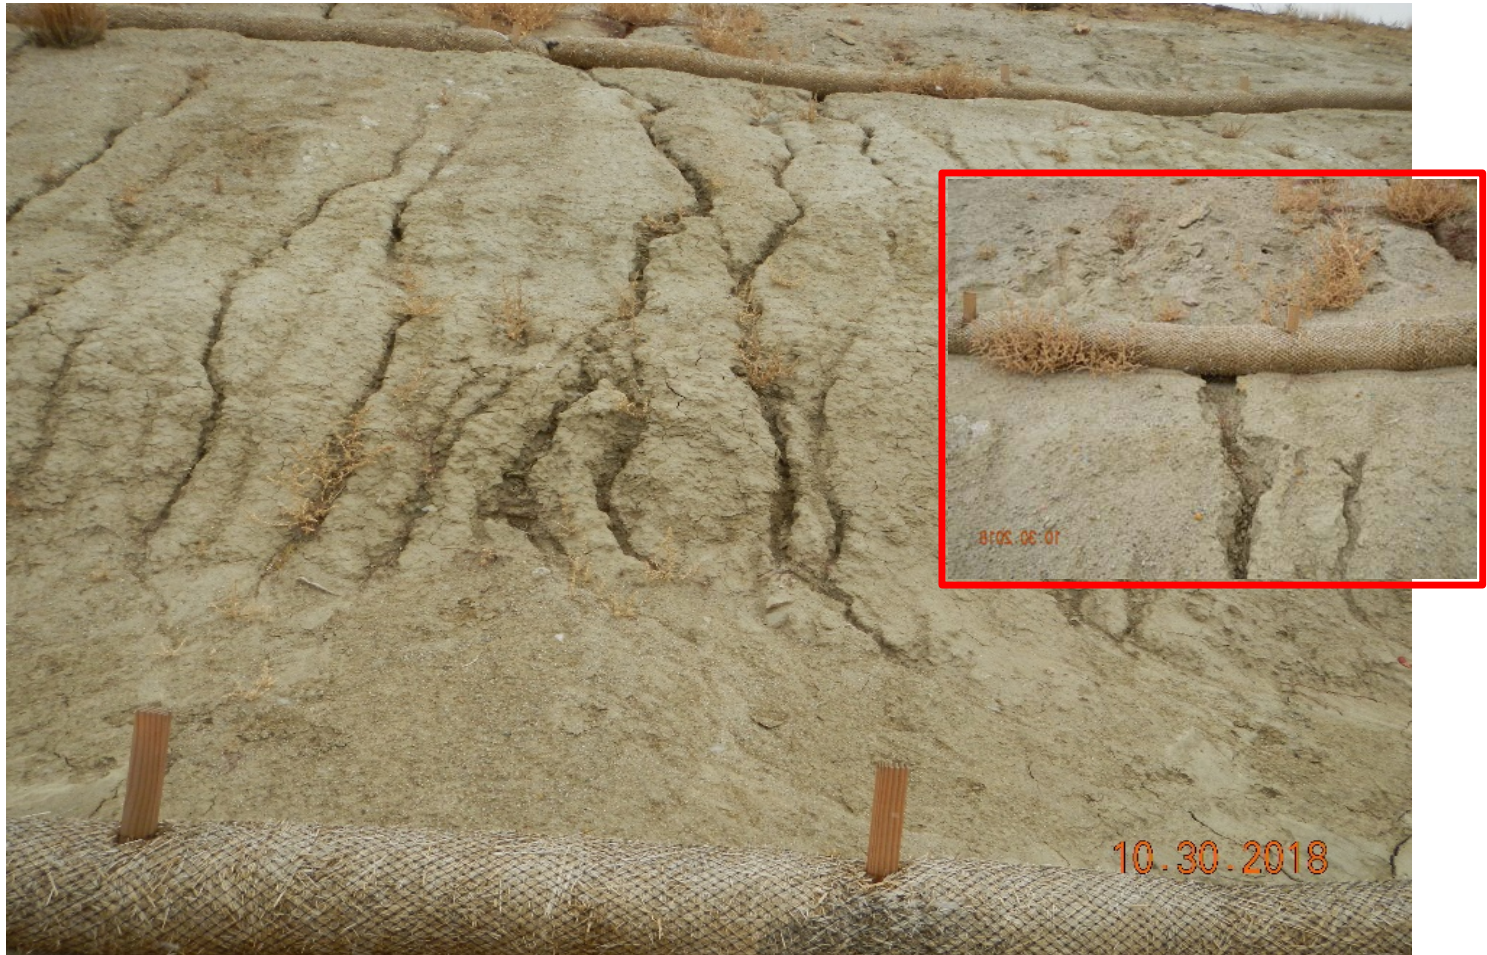
Photo#2:
View of erosion on East Cut slope.

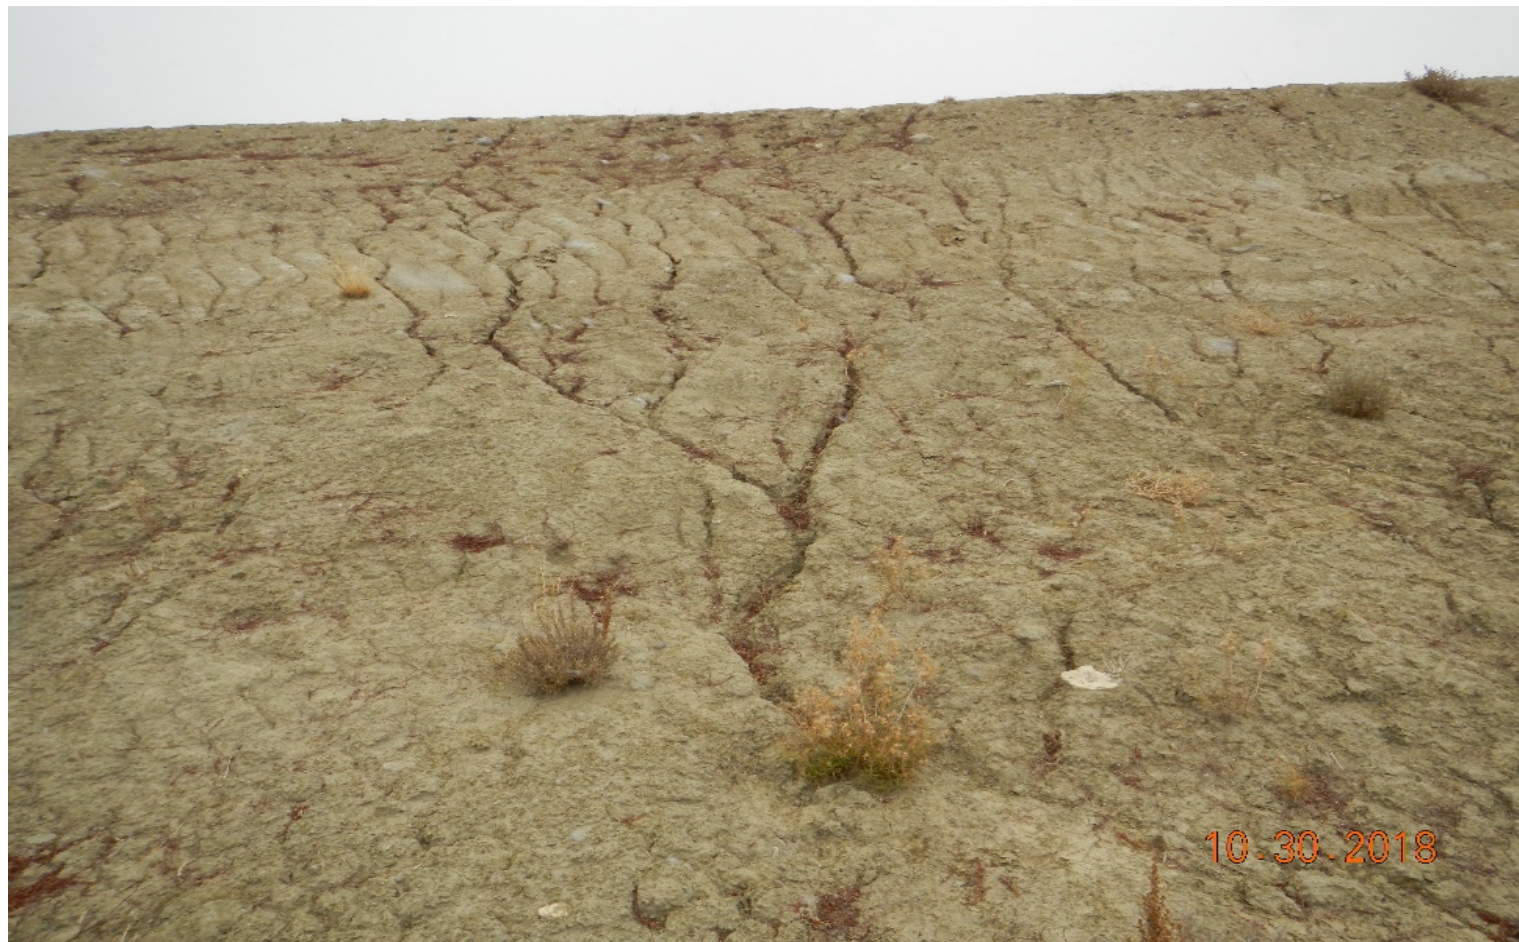
Photo#3:
View of Fill slope at West side of site.

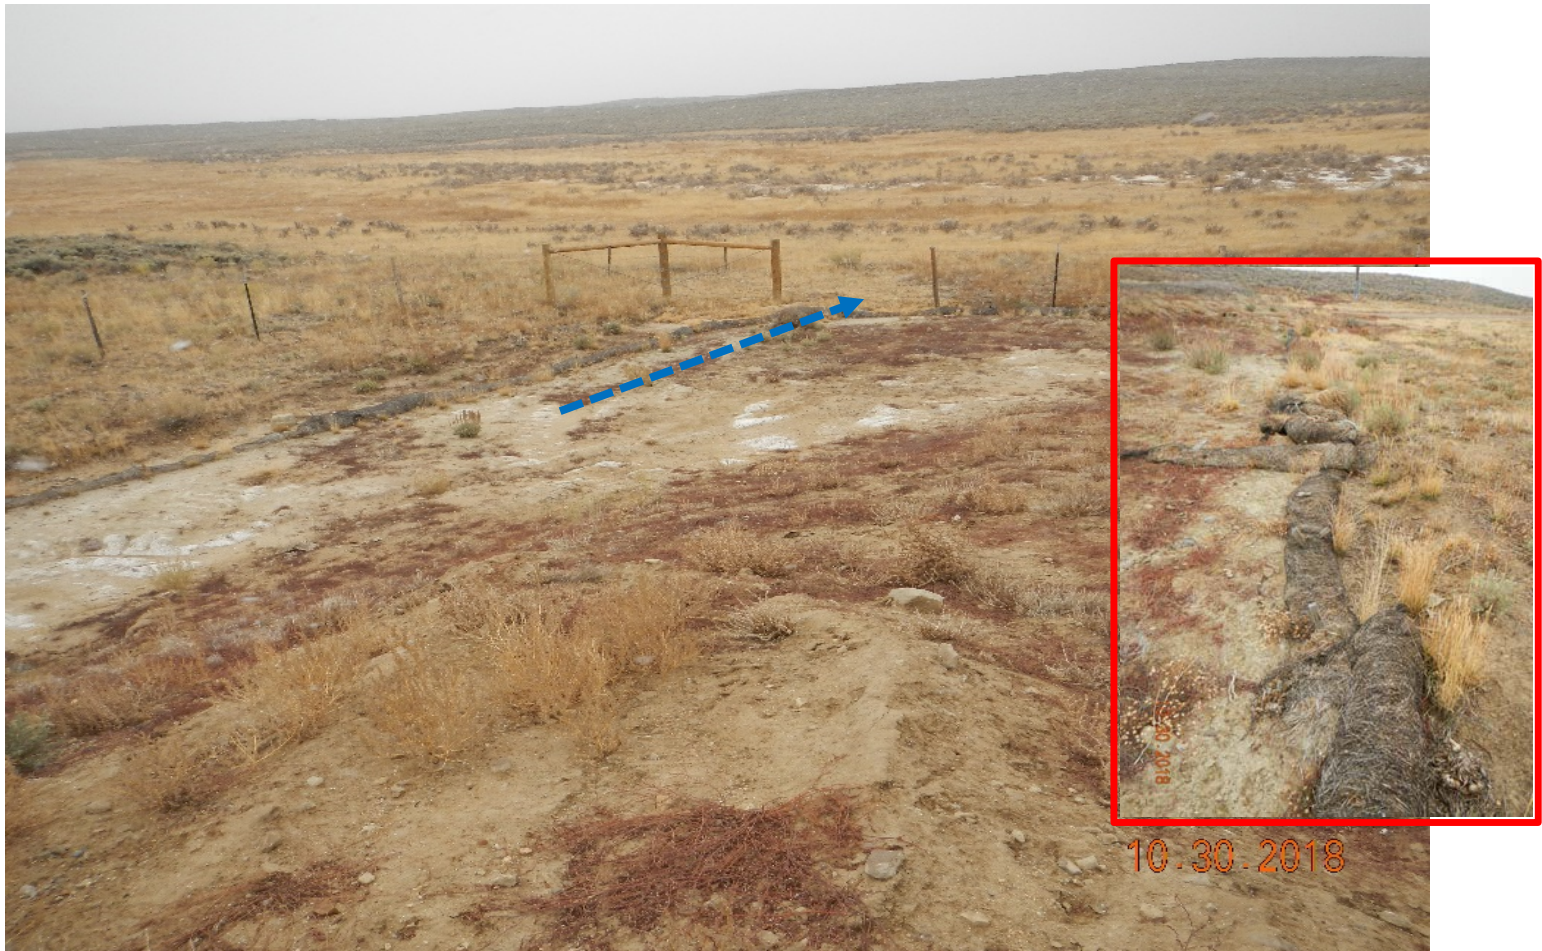
Photo#4:

View of drainage area at Southwest corner of site where sediment is collecting & moving off site. Insert of damaged wattles that have become debris.

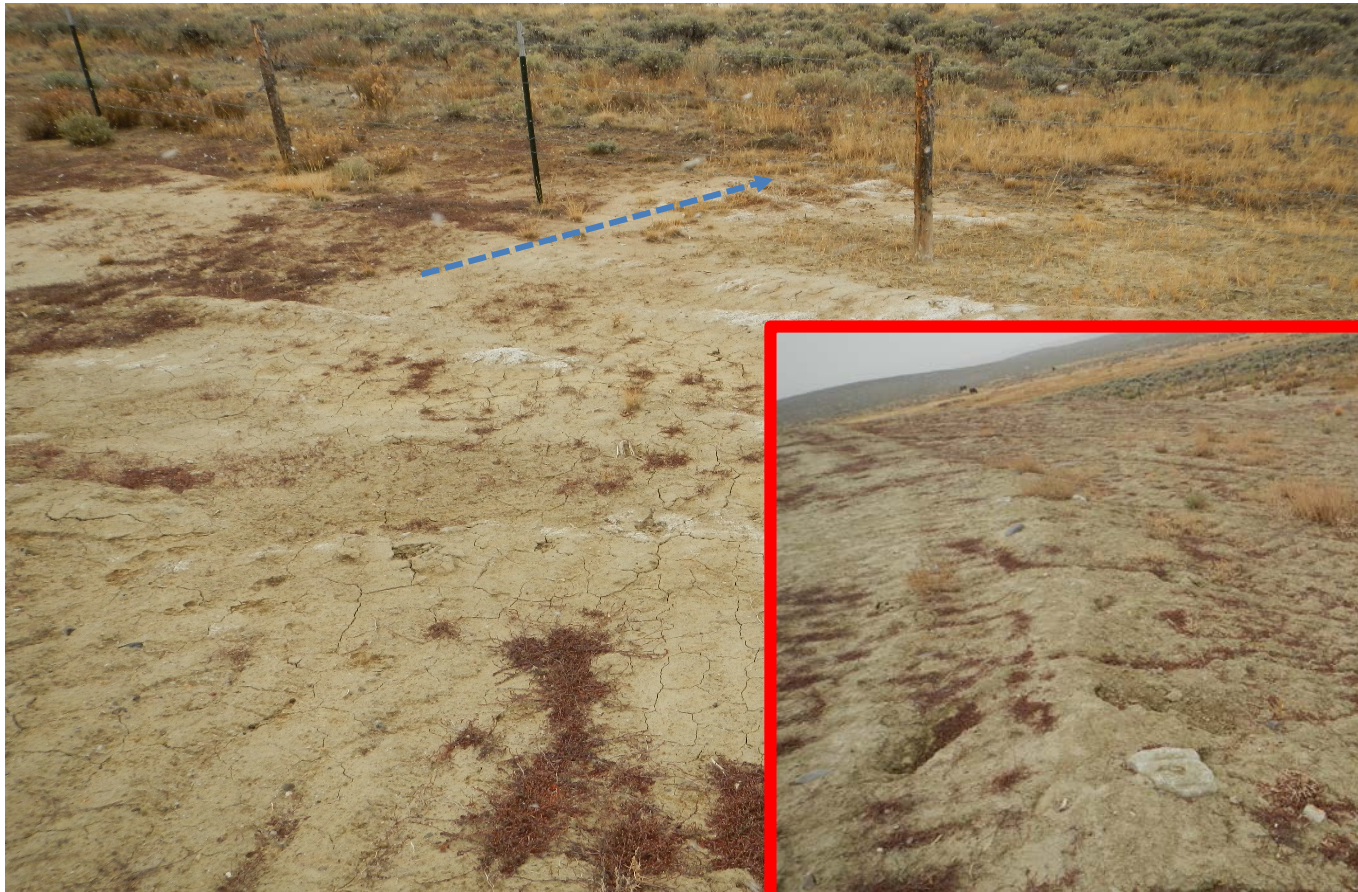
Photo#5:

Interim Reclamation areas are sparse to bare of desirable vegetation, areas are weedy & hard-packed. Arrow indicates where sediment is migrating.

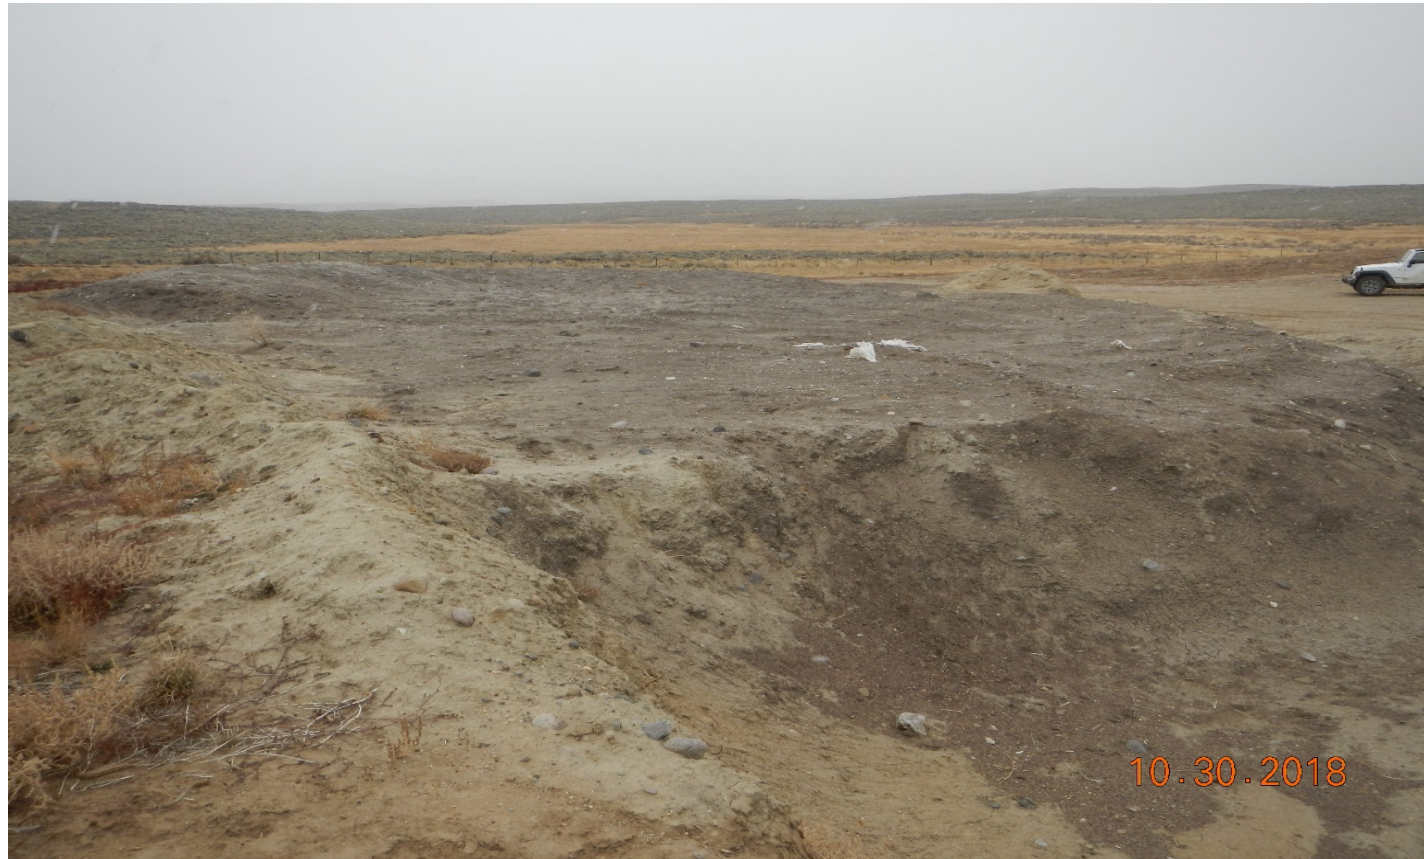
Photo#6:
Cuttings storage area at Southeast corner of site, adjacent to entry.
