Construction and Stormwater Inspection

Operator: KERR MCGEE OIL & GAS ONSHORE LP #47120

Location ID: 457013

Inspection Photos
Location ID: 457013
Location Name: REESE /22-21HZ

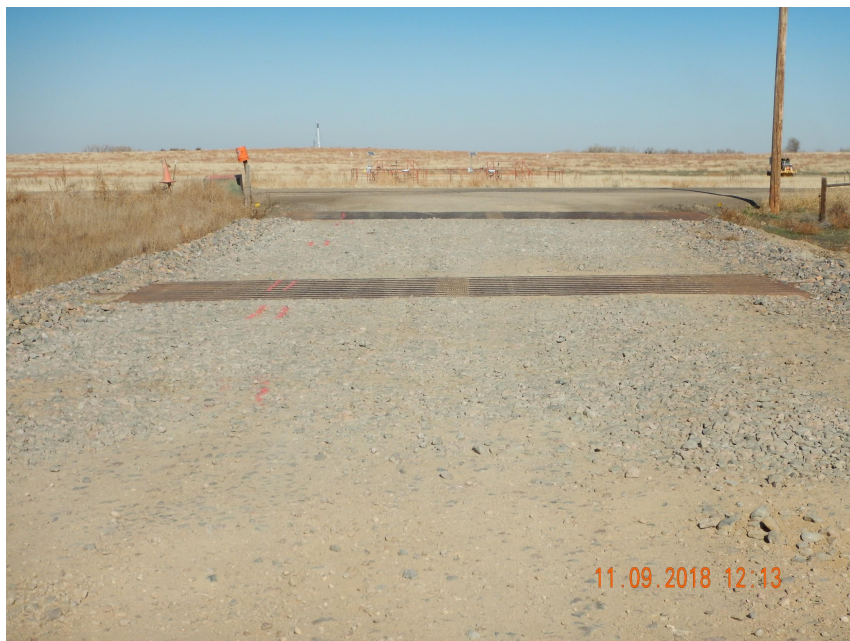
Photo 1. Photo taken from the entrance of location off CR20, facing North. Vehicle tracking devices have been installed and appear to be in proper functioning condition.

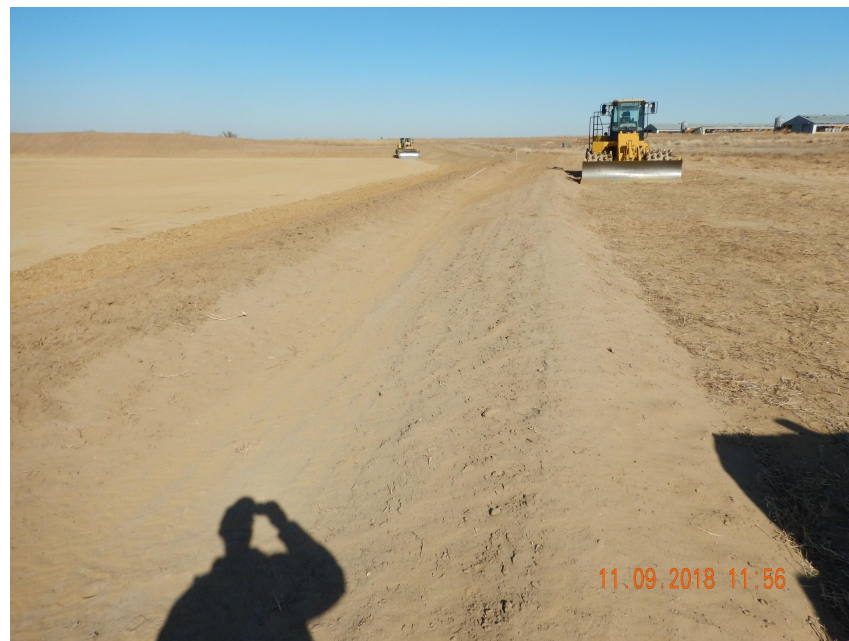
Photo 2. Photo taken from the eastern perimeter of the location, facing North. Photo illustrates a ditch and berm BMP.

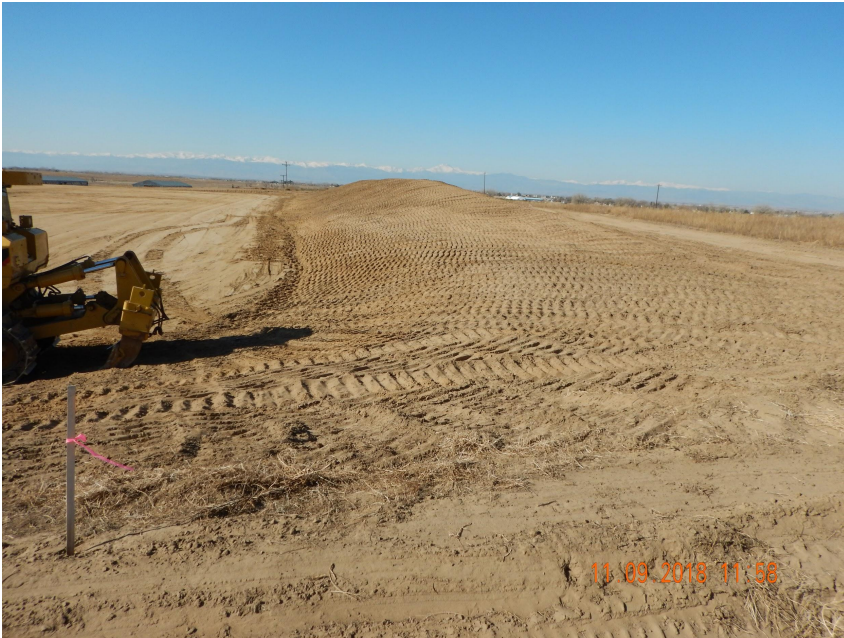
Photo 3. Photo taken from the northeastern location, facing West. Photo illustrates the topsoil stockpile which has been temporarily stabilized with equipment tracking.

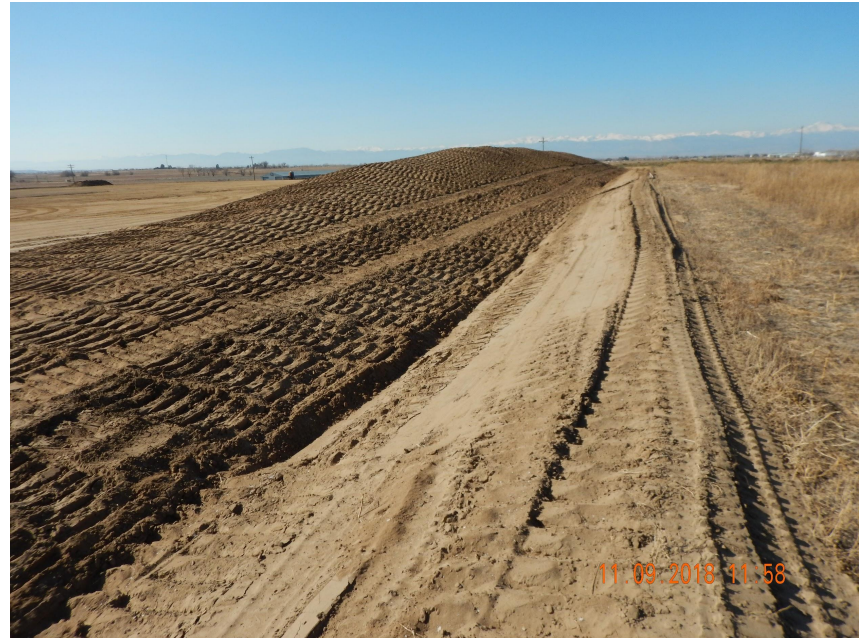
Photo 4. Photo taken from northeastern location, facing West. See comments under Photos 2 & 3.

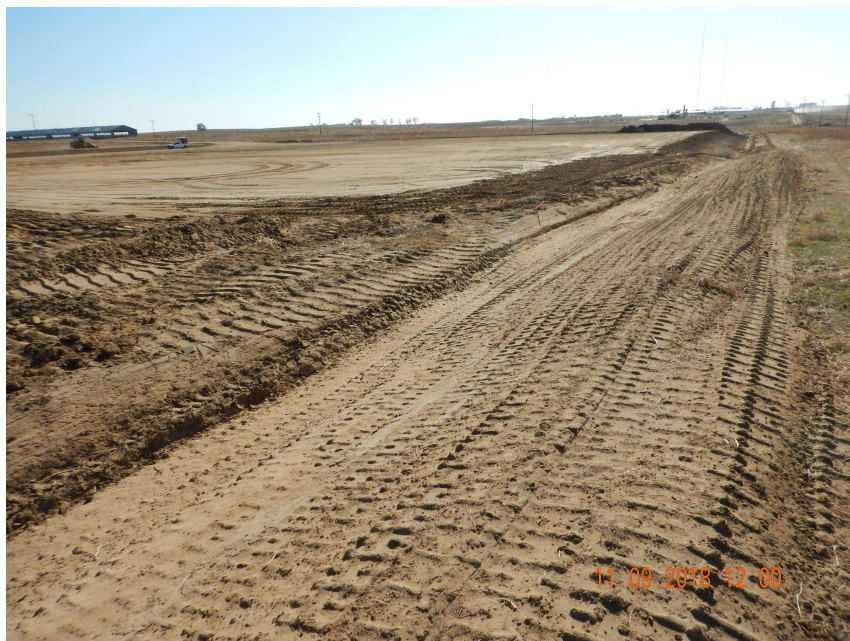
Photo 5. Photo taken from the northwest location, facing South. See comments under Photo 2.

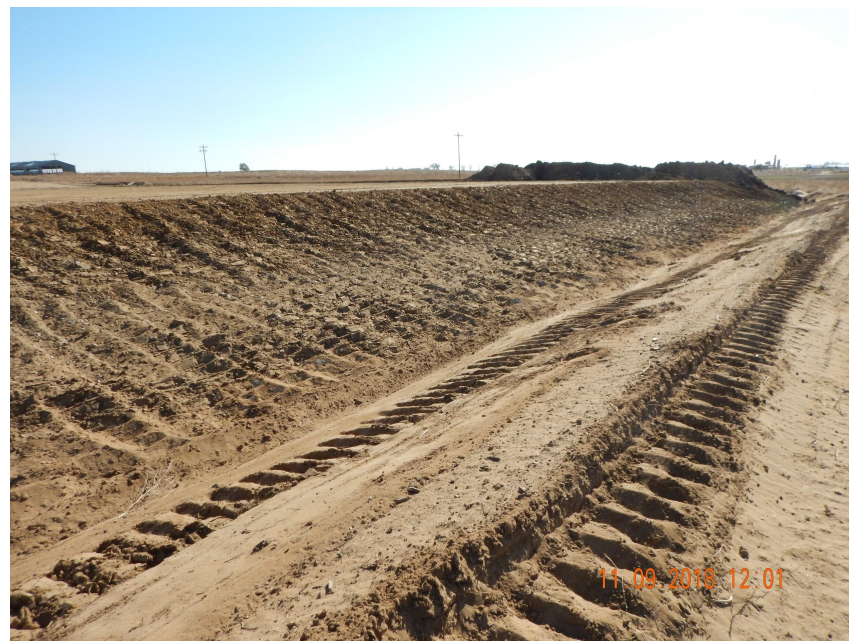
Photo 6. Photo taken from the western location, facing South. Fill slopes have been temporarily stabilized with equipment tracking. Location appears to be sandy and will likely need additional BMPs to control and manage for wind erosion.

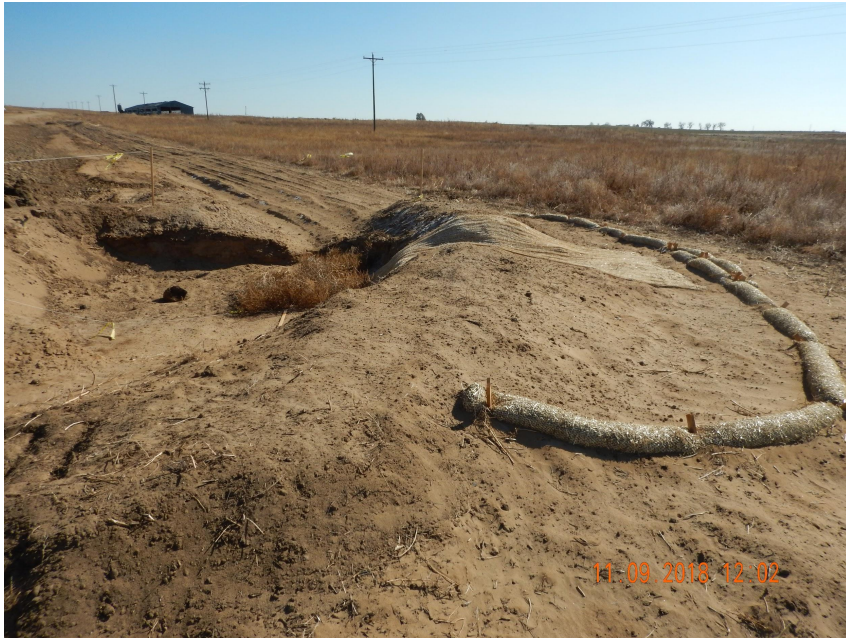
Photo 7. Photo taken from the southwest perimeter of the location, facing Southeast. Photo illustrates a sediment trap with a temporarily stabilized outlet.

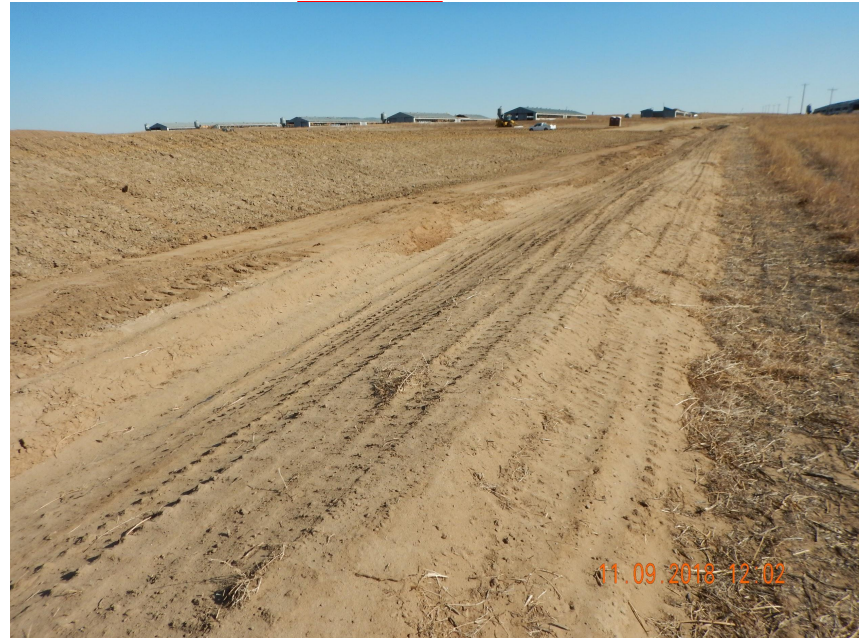
Photo 8. Photo taken from the southern perimeter of the location, facing East. See comments under Photos 2 and 6.

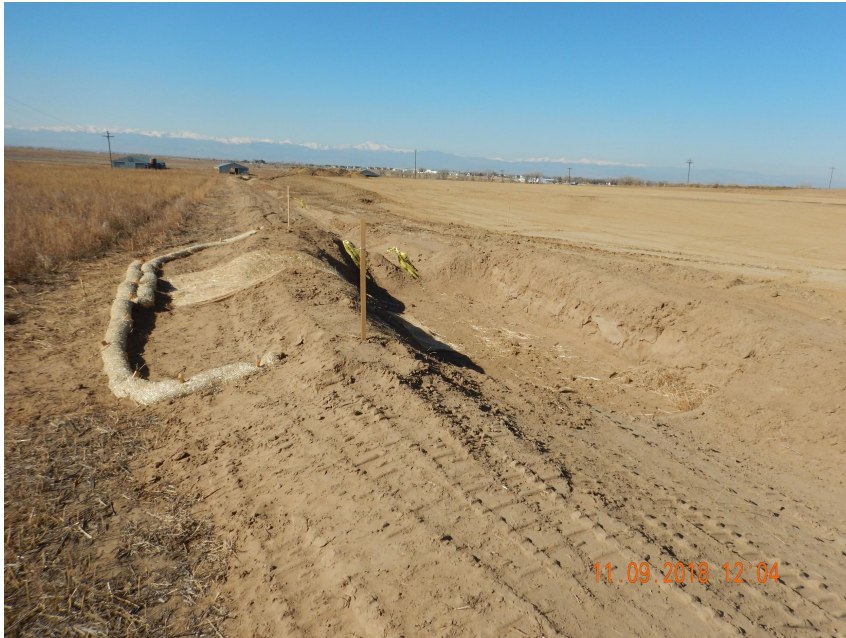
Photo 9. Photo taken from the southeast perimeter of the location, facing West. See comments under Photo 7. Sediment trap does not appear to be constructed in a logical location based off the topography of the well site.

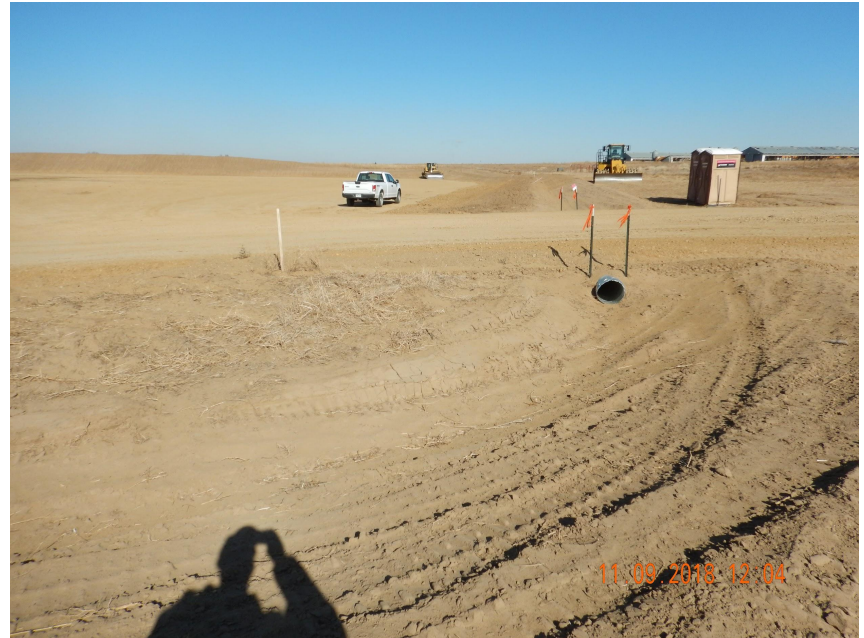
Photo 10. Photo taken from the southeast perimeter of the location, facing North. See comments under Photo 2.
