## Inspection Photos

Location Name: FORK UNIT 5-3-2-2

Location ID: 05-103-08405

Inspection: 679701705

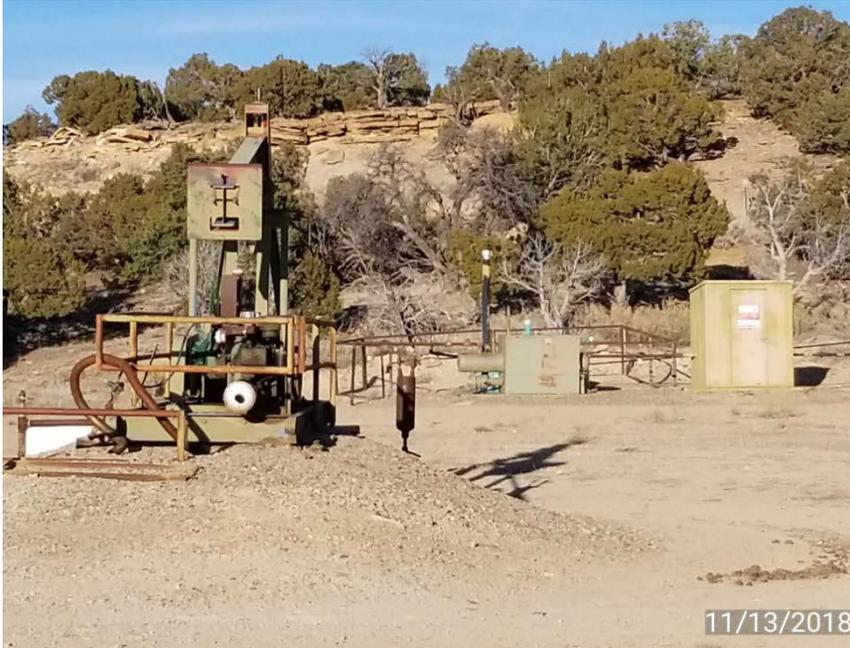
Photo 1. Location looking east

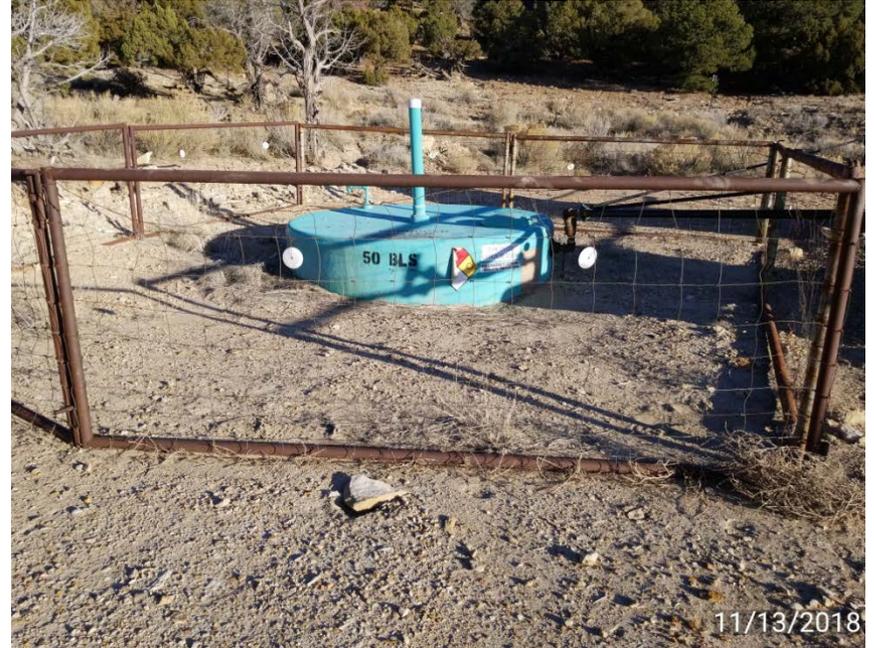
Photo 2. Tank with insufficient berm
