Construction and Stormwater Inspection

November 14, 2018

Operator: PDC ENERGY INC - #69175

Location ID: 452785

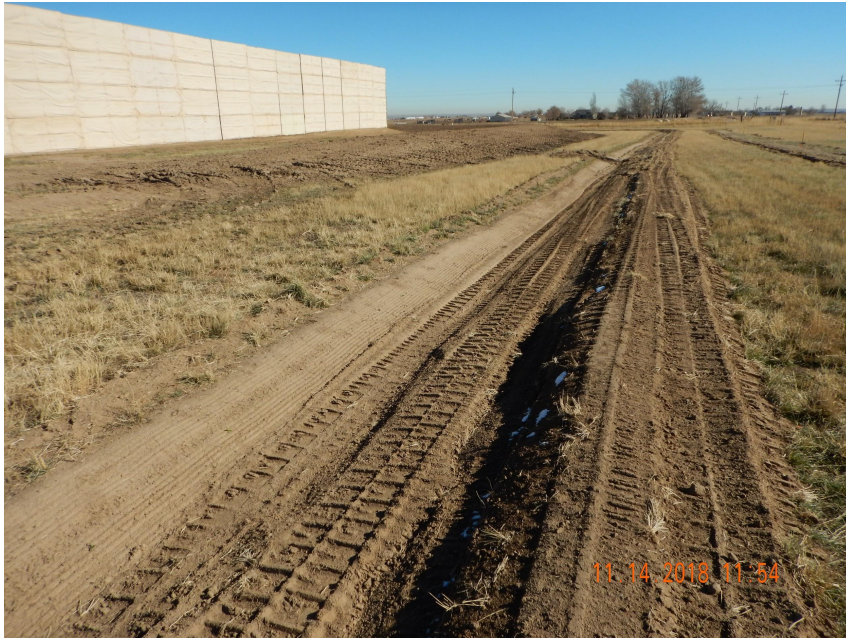
Photo 1. Photo taken from the southern perimeter of the location, facing East. Photo illustrates a ditch and berm BMP that has been installed around the entire perimeter of the location in conjunction with other BMPs.

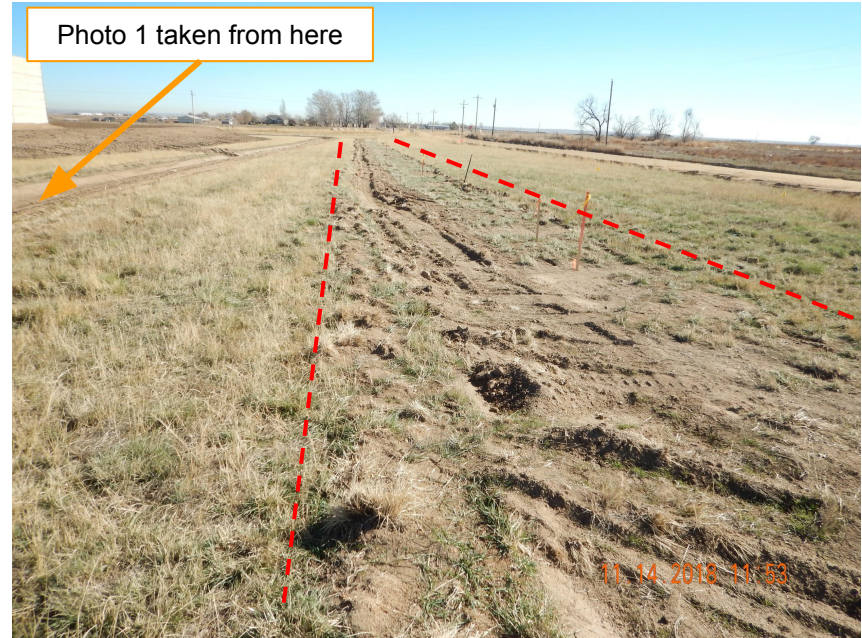
Photo 2. Photo taken from the southern perimeter of the location, facing East. Photo illustrates the start of a perimeter BMP disturbance. BMP was moved more north. Operator will be responsible for recontouring the said disturbance and comply with other Rule 1004 standards (i.e., vegetation).

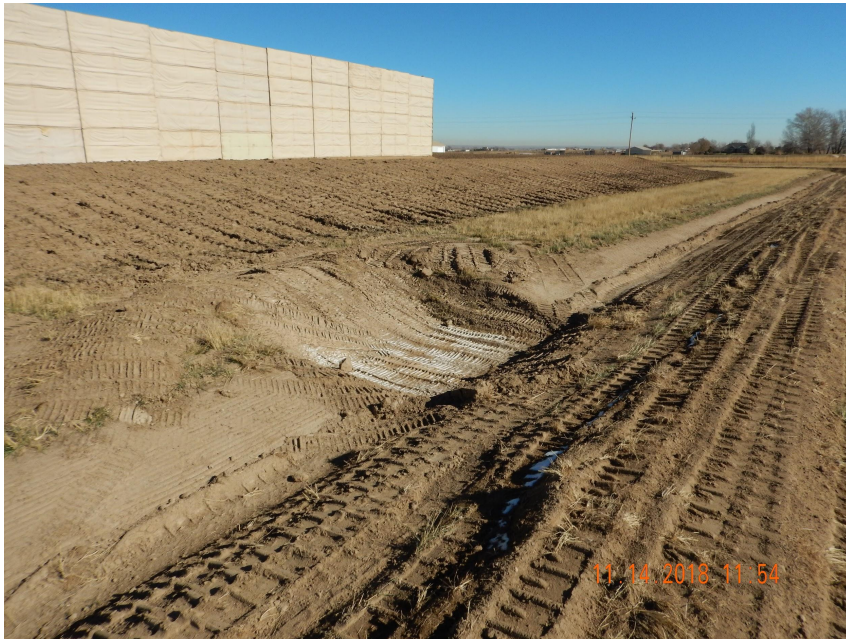
Photo 3. Photo taken from the southern perimeter of the location, facing Northeast. Photo illustrates the topsoil stockpile which has been temporarily stabilized with equipment tracking. Also, a retention area in conjunction with the ditch and berm BMP has been installed.

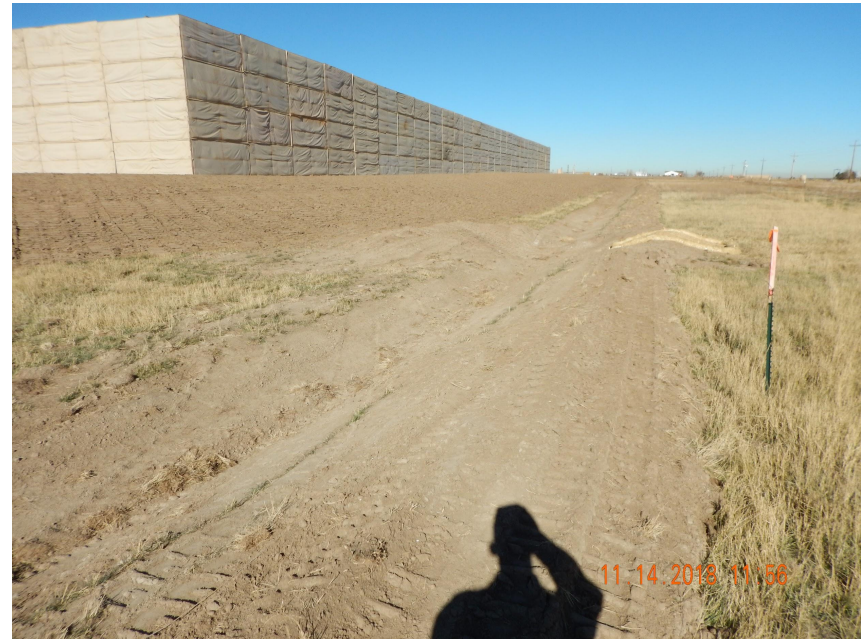
Photo 4. Photo taken from the southeastern perimeter of the location, facing North. See comments under Photo 1 & 3.

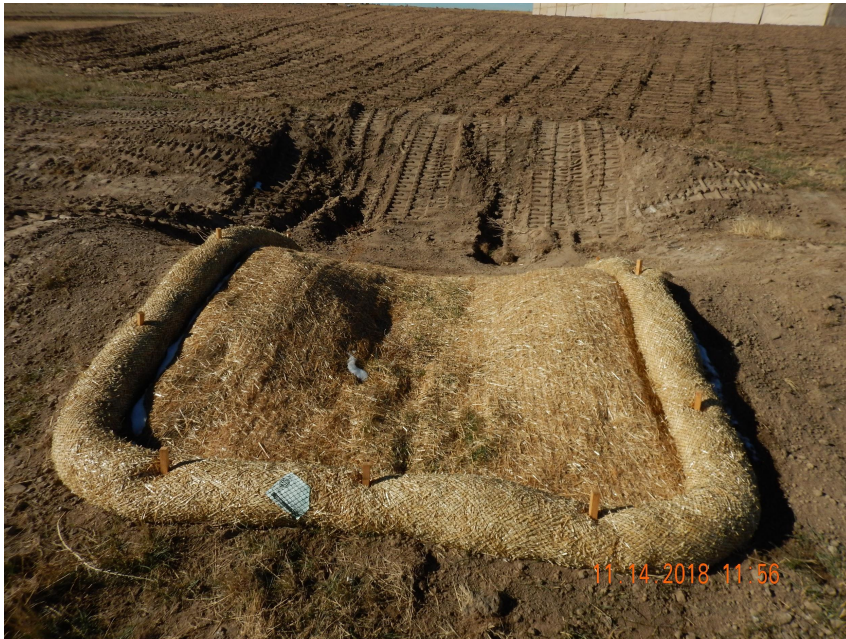
Photo 5. Photo taken from the eastern perimeter of the location, facing Southwest. Photo illustrates a sediment trap with a temporarily stabilized outlet. Also, photo illustrates the topsoil stockpile which has been temporarily stabilized with equipment tracking.

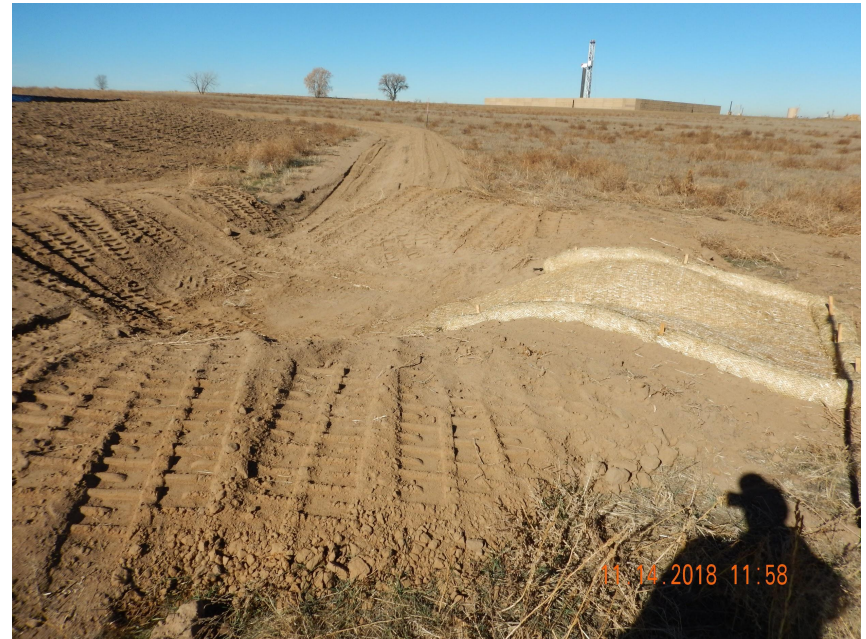
Photo 6. Photo taken from the northeastern perimeter of the location, facing North. See comments under Photo 5.

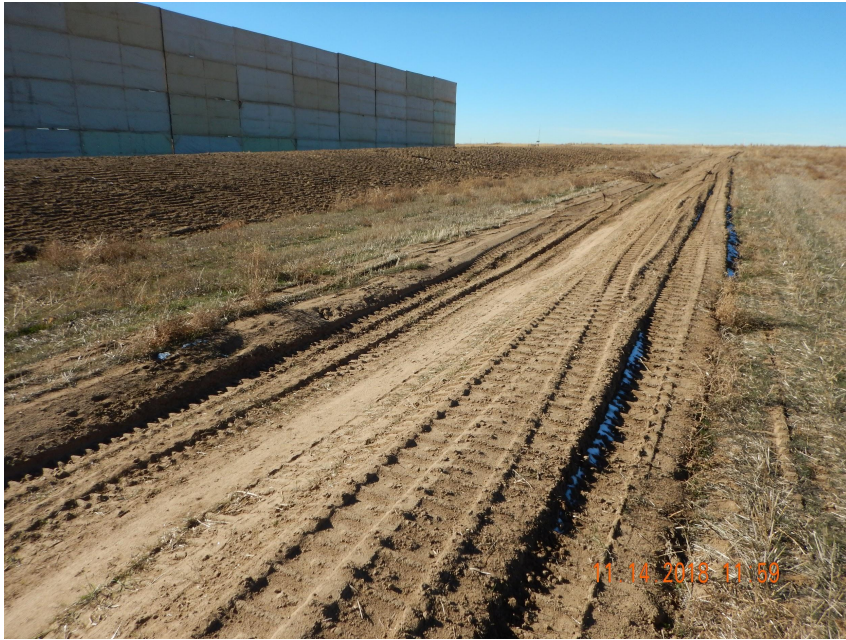
Photo 7. Photo taken from the northeastern perimeter of the location, facing West. Photo illustrates the ditch and berm BMP, and the temporarily stabilized topsoil stockpile.

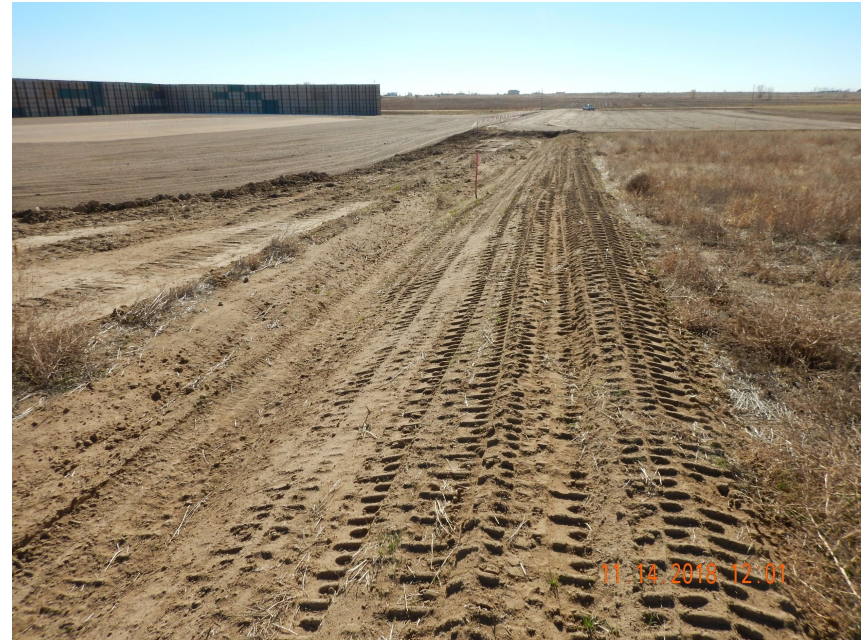
Photo 8. Photo taken from the northern perimeter of the location, facing South. See comments under Photo 1.

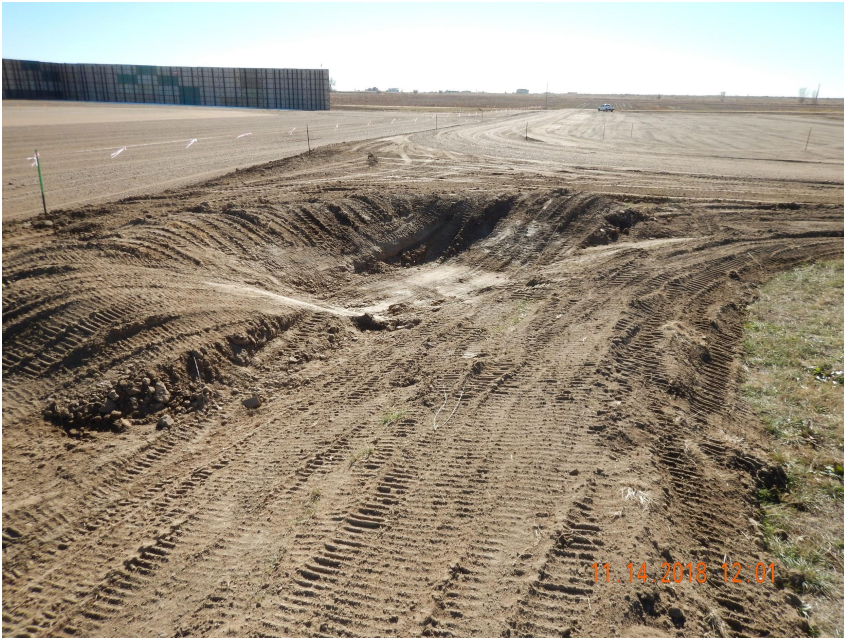
Photo 9. Photo taken from the northern perimeter of the location, facing South. See comments under Photo 3. Also, photo illustrates pad areas stabilized with gravel.

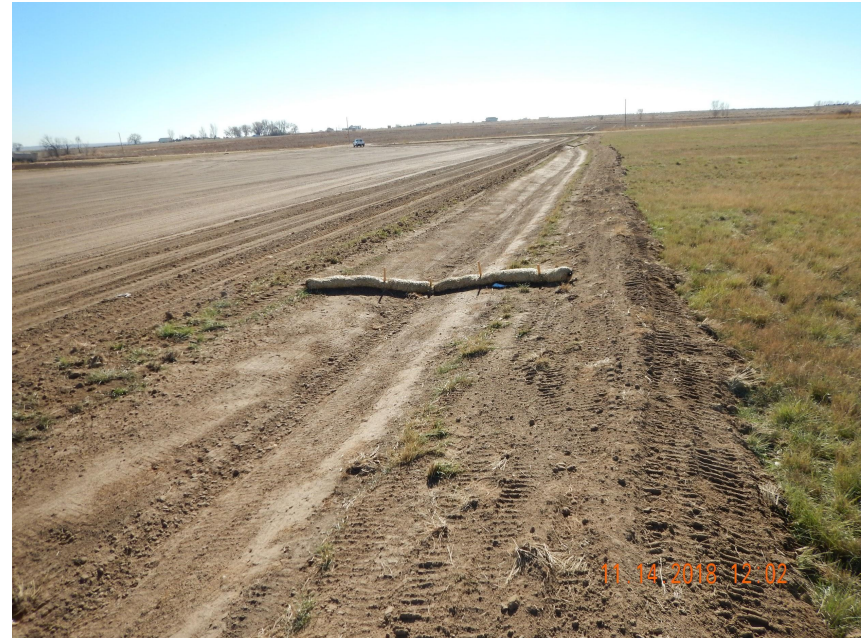
Photo 10. Photo taken from the western perimeter of the location, facing South. See comments under Photo 1. Straw wattles have been installed in conjunction with the western ditch and berm BMP.
