Inspection Photos 11/08-09/2018
Location: BP America – Thomas Jacquez E 1 PW Line Release
Spill ID # 458834

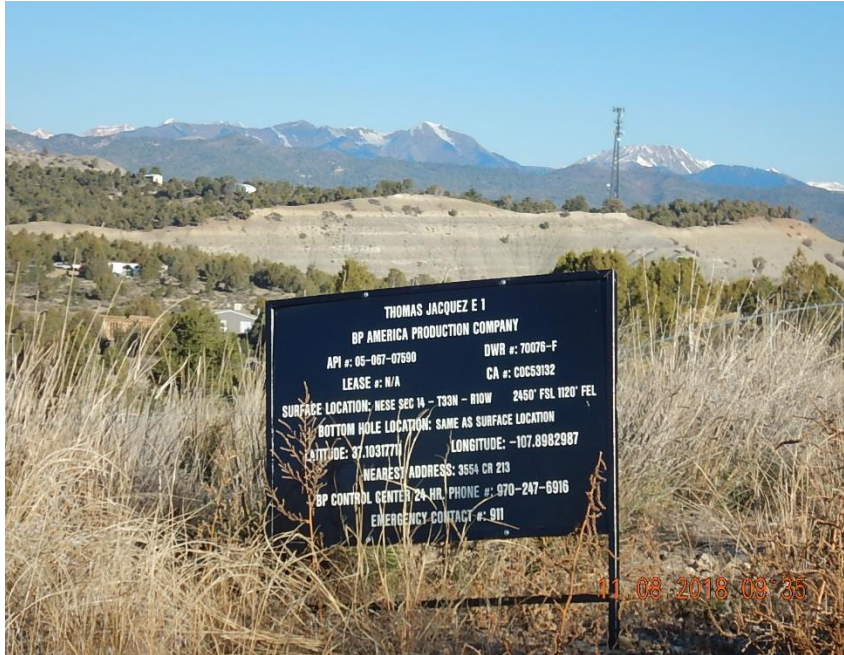
Signage on location

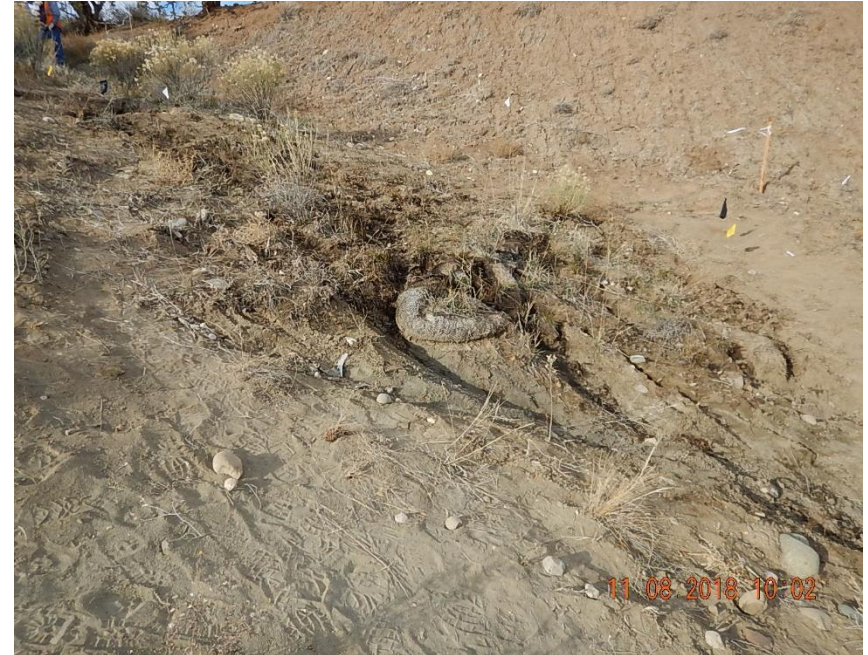
Release point on surface prior to excavation

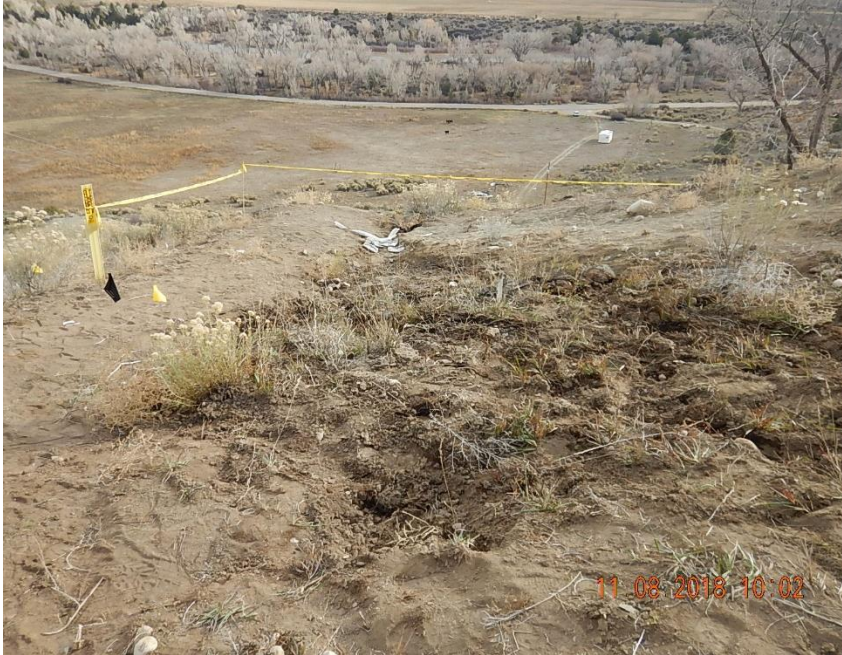
View of release point looking down gradient and to the east

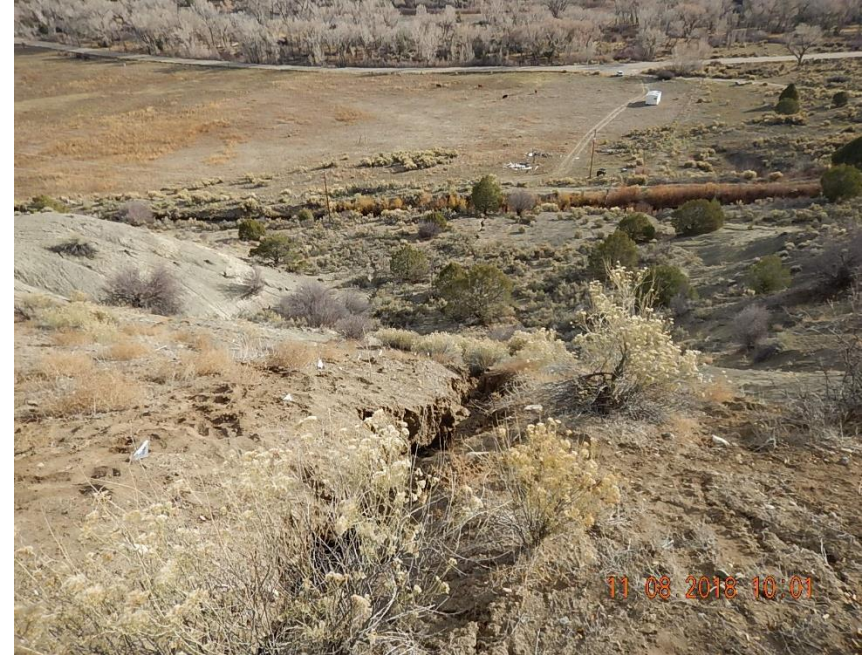
Closer view looking down slope at the path of flow of the produced water. View looking east.

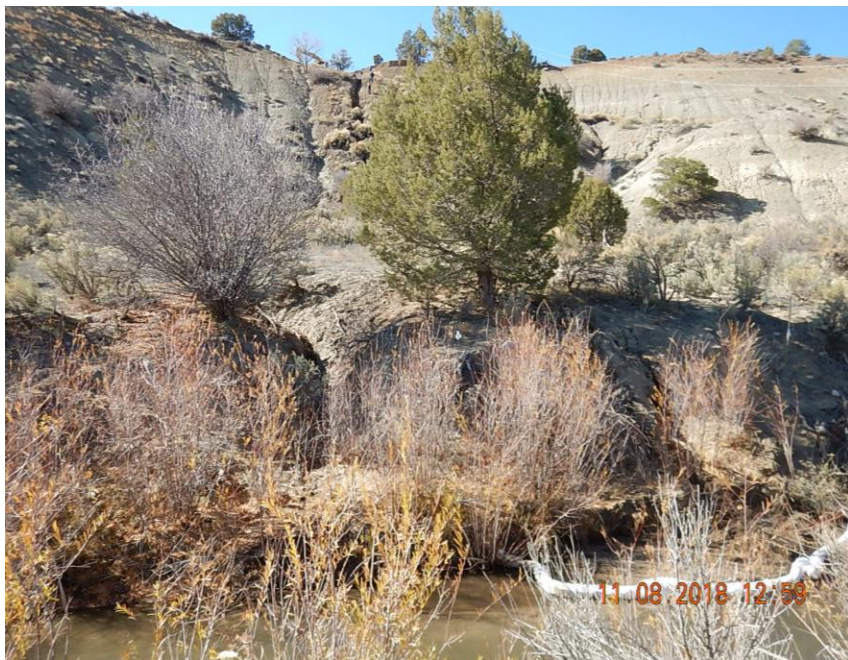
View to the west standing on the east side of the impacted Citizens Ditch . The path of PW flow can be seen (entrenched) as well as excavation activity near the top of the slope.

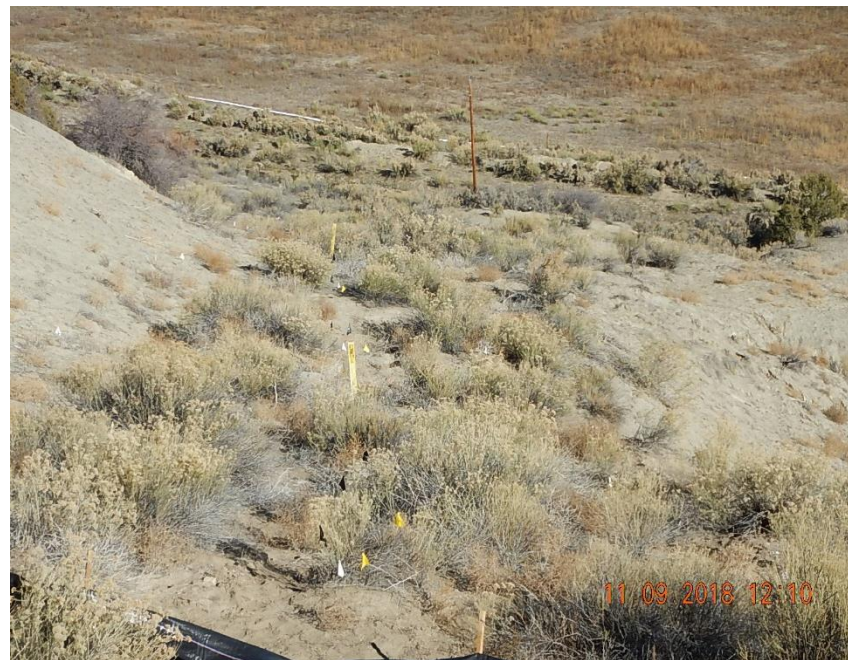
View to the northeast looking down the slope of the pipeline ROW; photo taken at the area of the PW line failure. Pipeline markers along ROW.

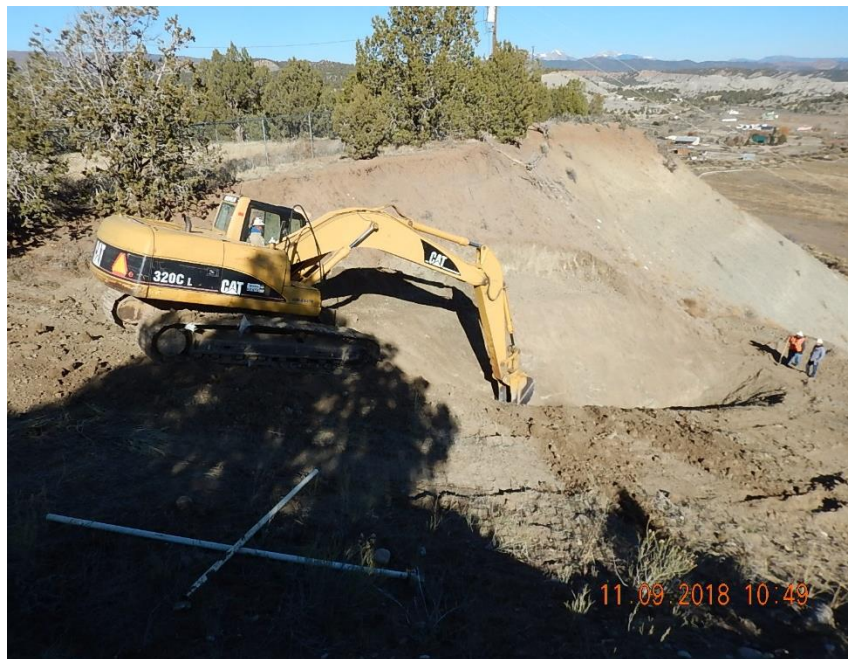
Initial excavation work on the pipeline ROW at the release point. Work is being done to expose and inspect the failed 6" fiberglass PW transfer line. View looking North.

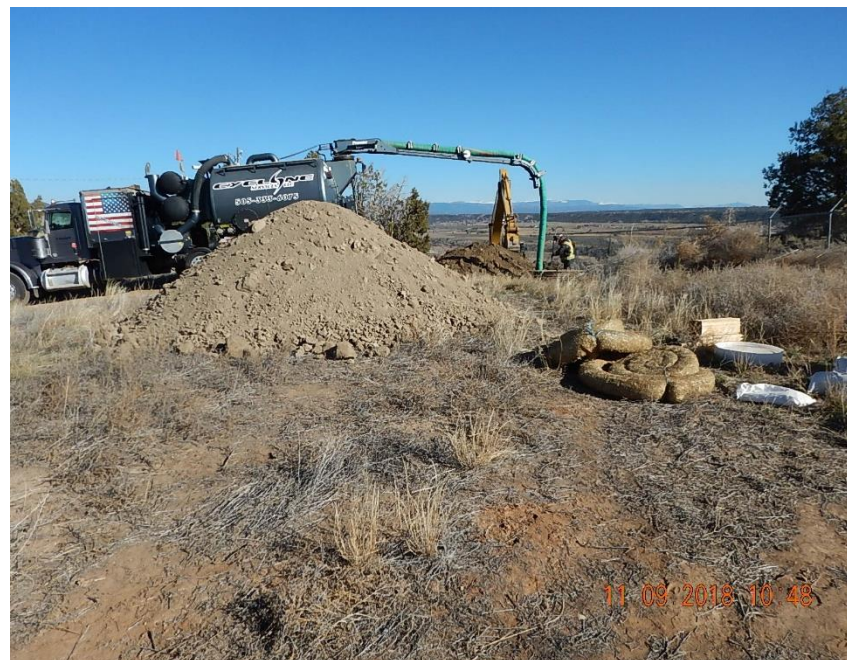
Hydro-excavation in progress at the valve can located approximately 115' SW of the water transfer line failure. Excavation in progress on the ROW downslope from the valve can.

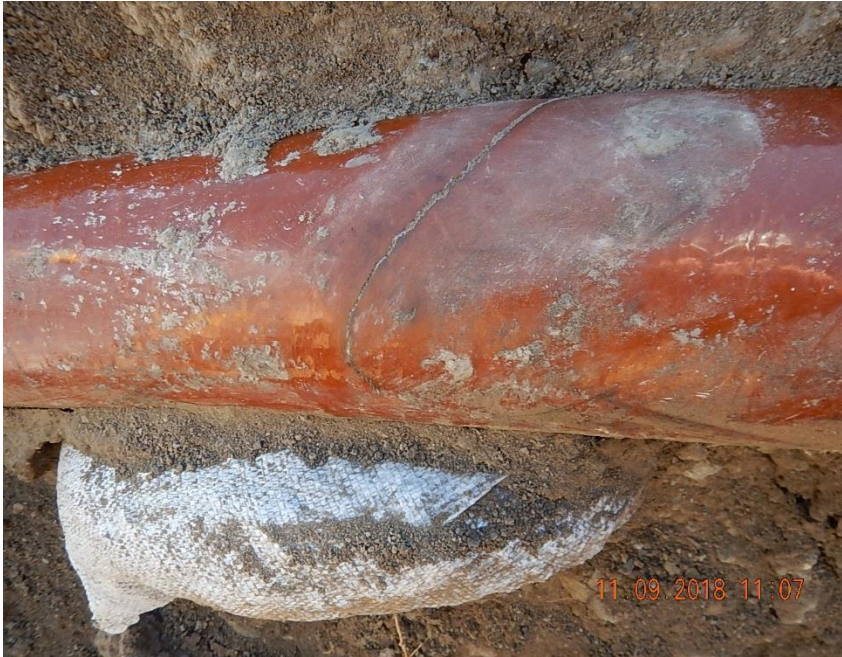
Close up view of (1 of 2) cracks identified on the 6" fiberglass produced water flowline. Both cracks were found at points where the pipe is being supported by sand bags and near the top of the slope. This is the furthest NE and downslope crack identified.

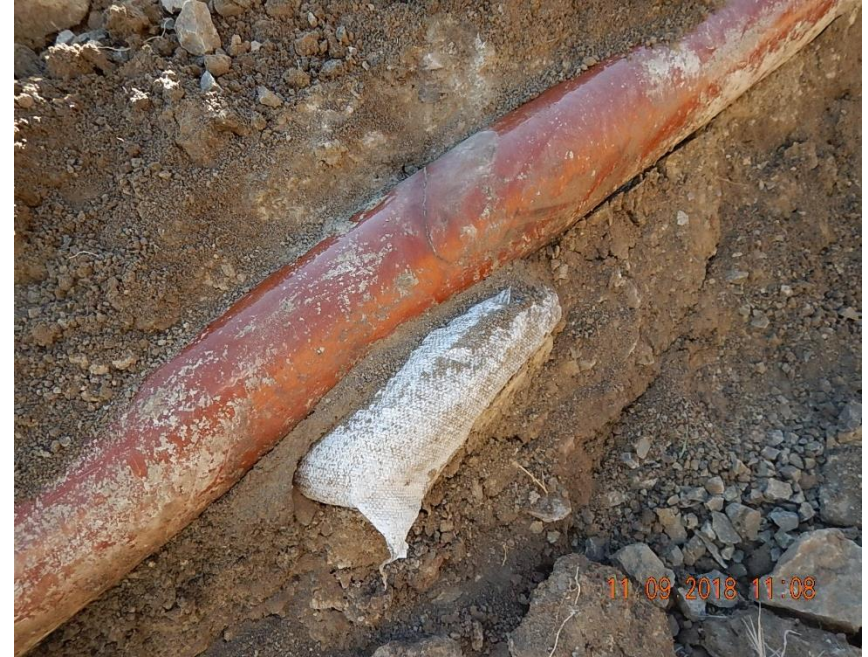
View of crack (1 of 2) at a greater distance showing a "bend" in the fiberglass pipe where the crack developed on the top of the sand bag.

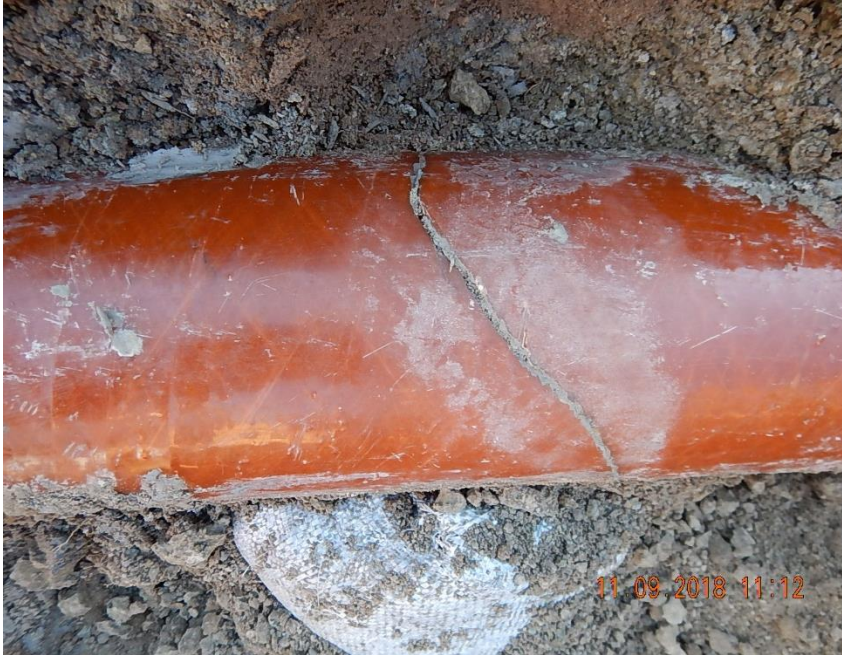
Close up view of (2 of 2) cracks identified on the 6" fiberglass produced water flowline. Both cracks were found at points where the pipe is being supported by sand bags near the top of the slope. This is the larger of the two failures and nearest to the top of the slope. The flowline runs horizontal and ties into a valve can at the top of the slope.

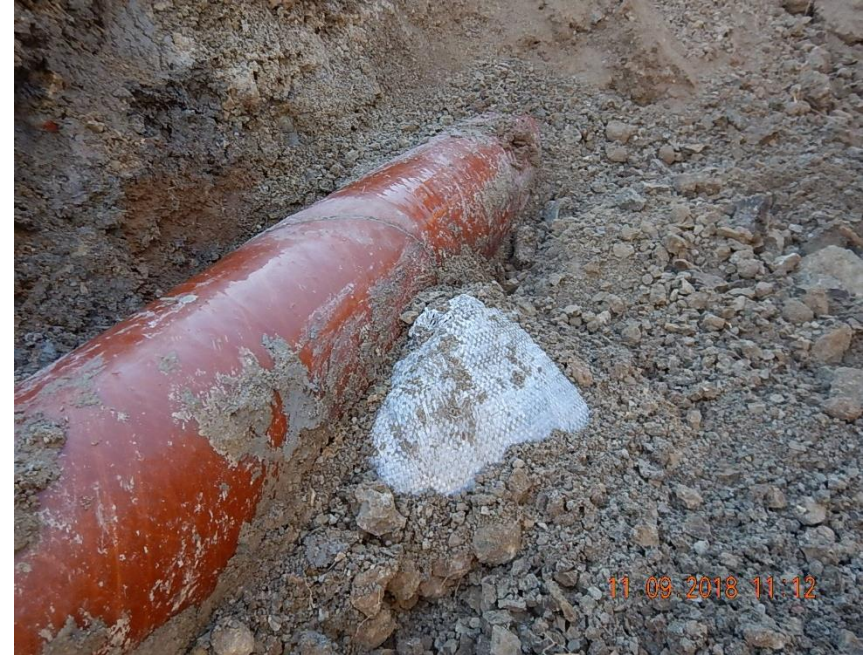
View of crack (2 of 2) at a greater distance showing a slight "bend" in the fiberglass pipe where the crack developed on the top of the sand bag.

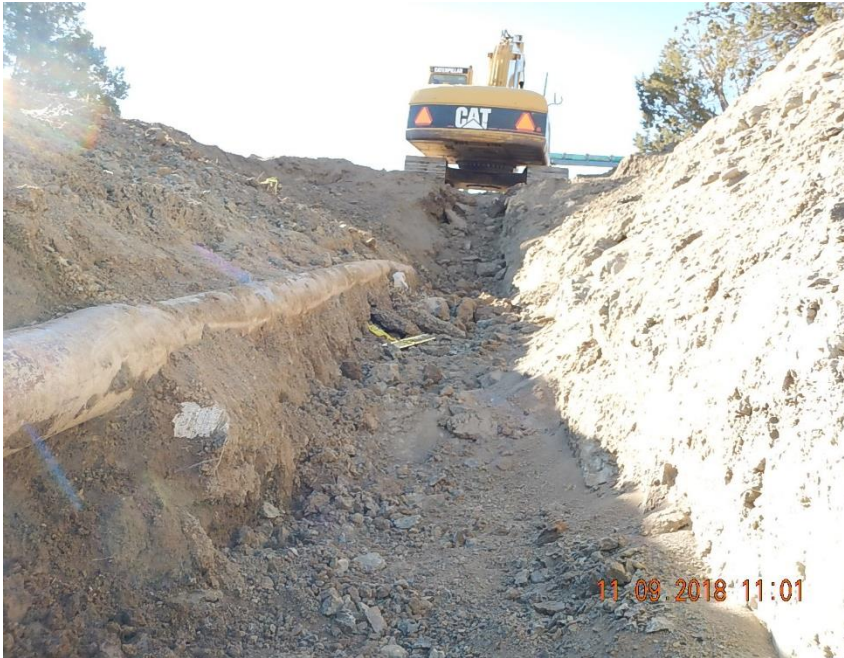
Photo of the 6" fiberglass produced water transfer flowline exposed in the excavation. Sandbags/ failure points can be seen. Note: A historically abandoned 8" carbon steel gas pipeline (yellow coating) is located adjacent to the produced water line (not shown).

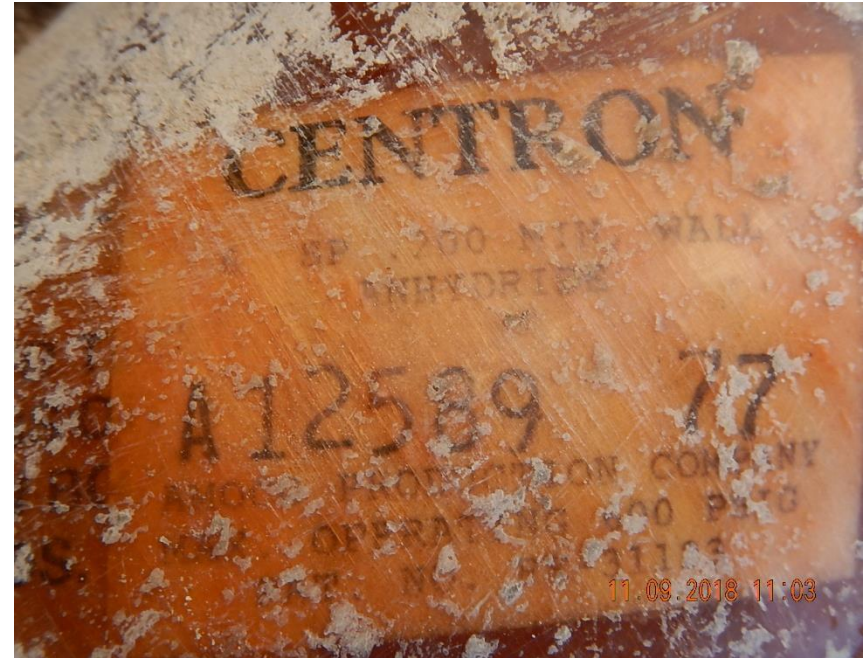
View of identification tag inlaid in the fiberglass pipe.
