Inspection Photos
Location Name: CHURCH 2
Location ID: 05-103-05331
Inspection: 679701727

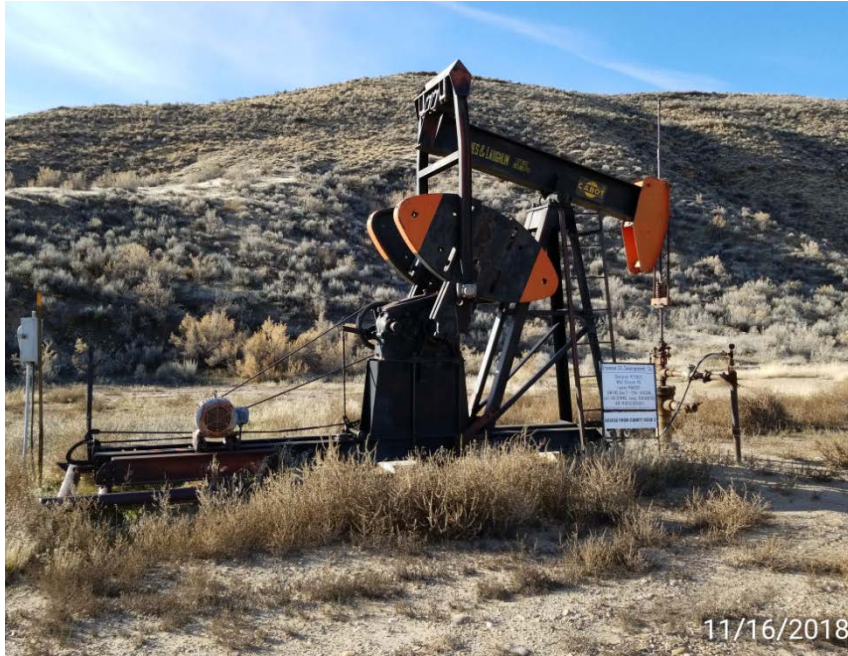
Photo 1. Location looking south.

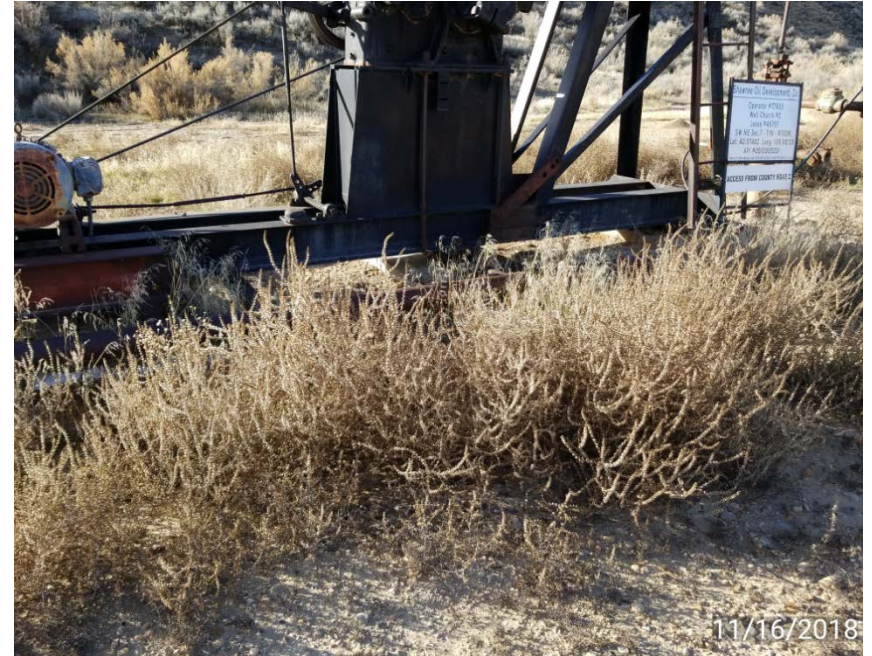
Photo 2. Weeds next to pump jack.

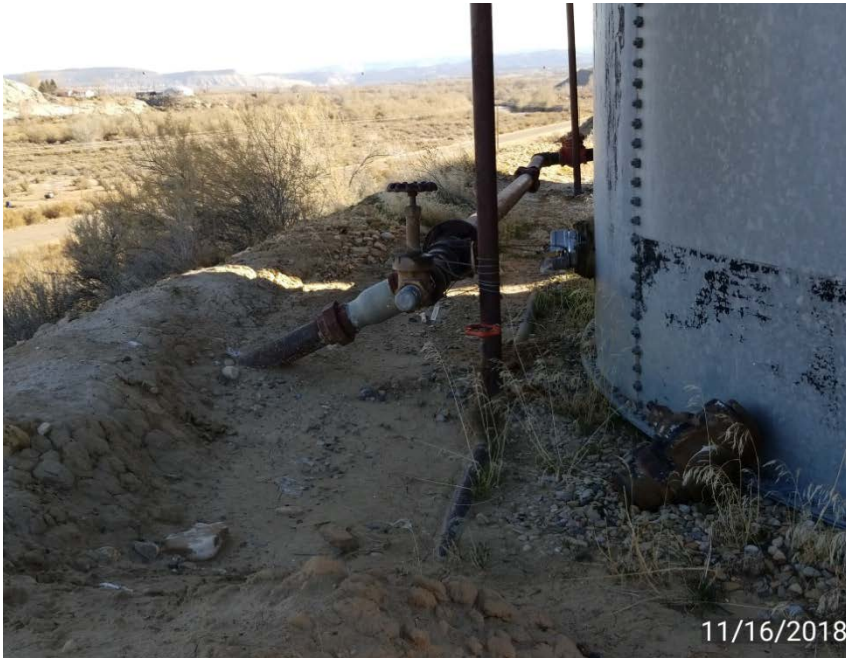
Photo 3. Insufficient berm capacity due to short berm on north side.

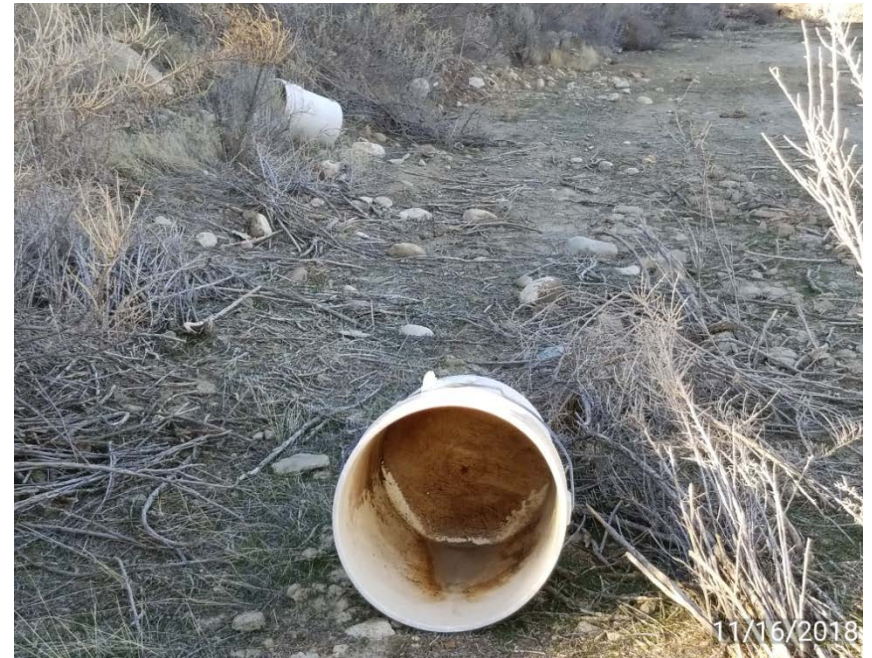
Photo 4. Trash on loading road below tank battery.

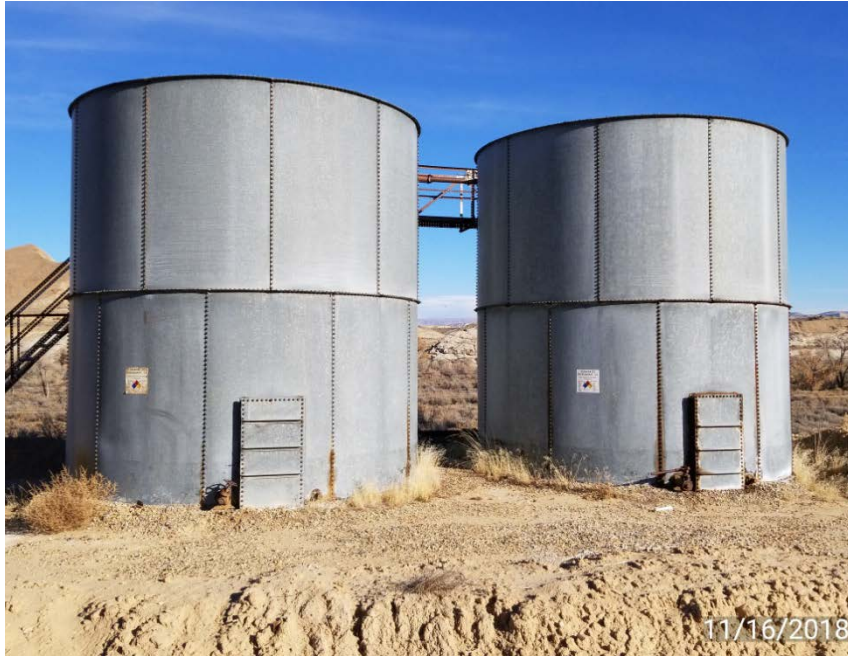
Photo 5. Tank battery looking north.
