Inspection Photos

Location Name: Sooner Unit - 68N58W / 28NWNE

Location #: 323461

COLORADO
Oil & Gas Conservation
Commission
Department of Natural Resources

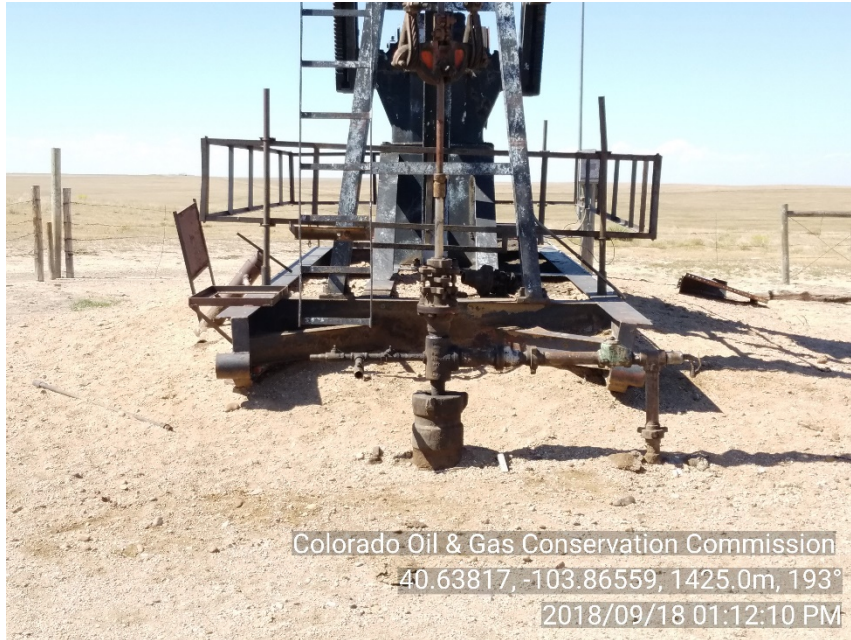
Photo #1

Sooner Unit 2-28 (API # 05-123-13065) wellsite

Bradenhead NOT plumbed to surface

from previous FIR

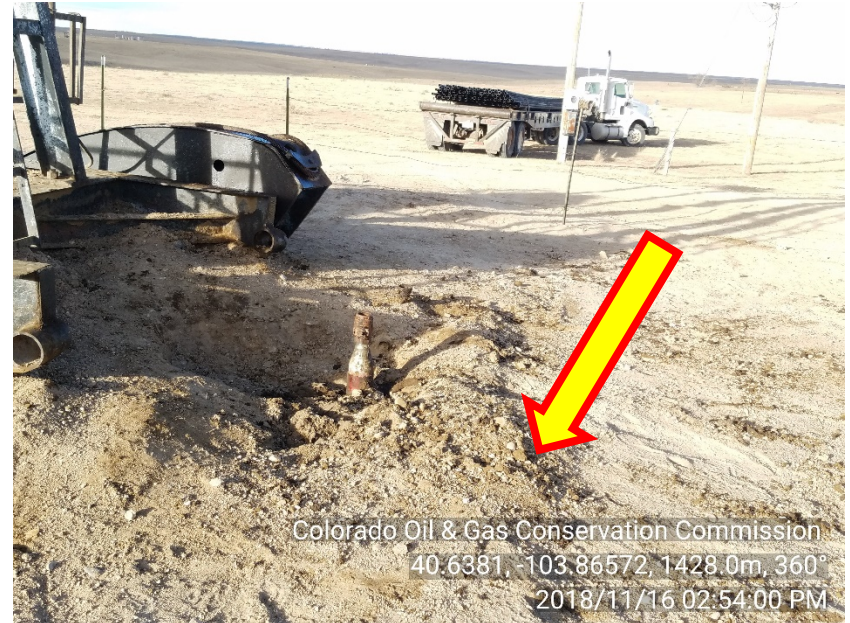
Photo #2

Sooner Unit 2-28 wellsite

Bradenhead NOT plumbed to surface

Tubing appears to have been pulled from well

Stained soil

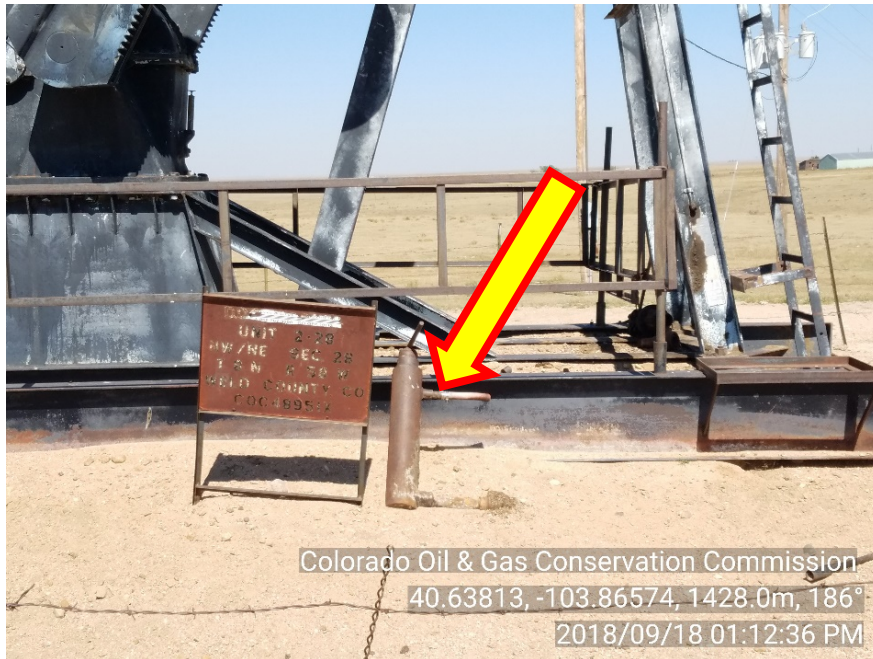
Photo #3

Sooner Unit 2-28 wellsite

Sign not legible

Emergency number not legible

Unused equipment from previous FIR

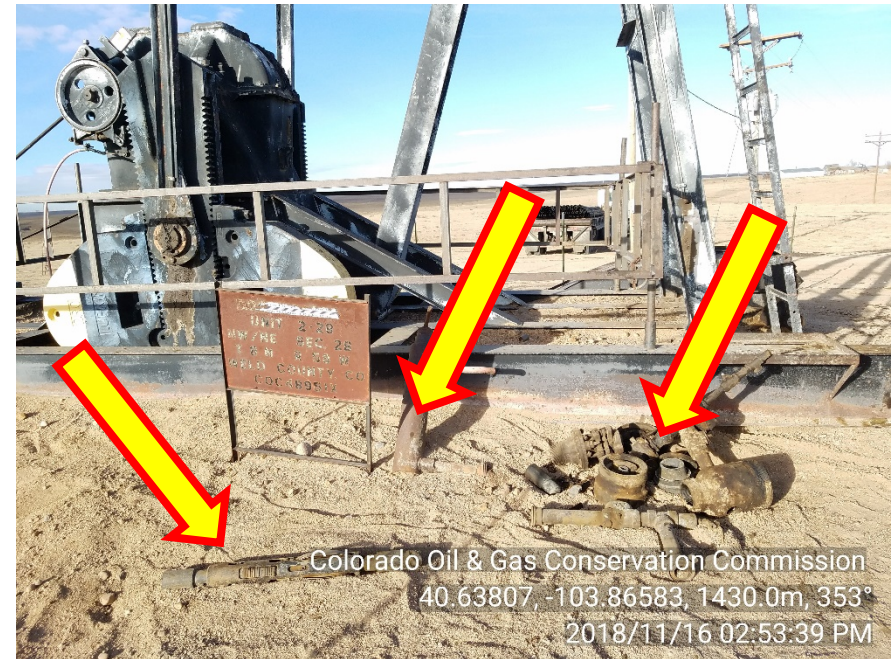
Photo #4

Sooner Unit 2-28 wellsite

Sign not legible

Emergency number not legible

Unused equipment

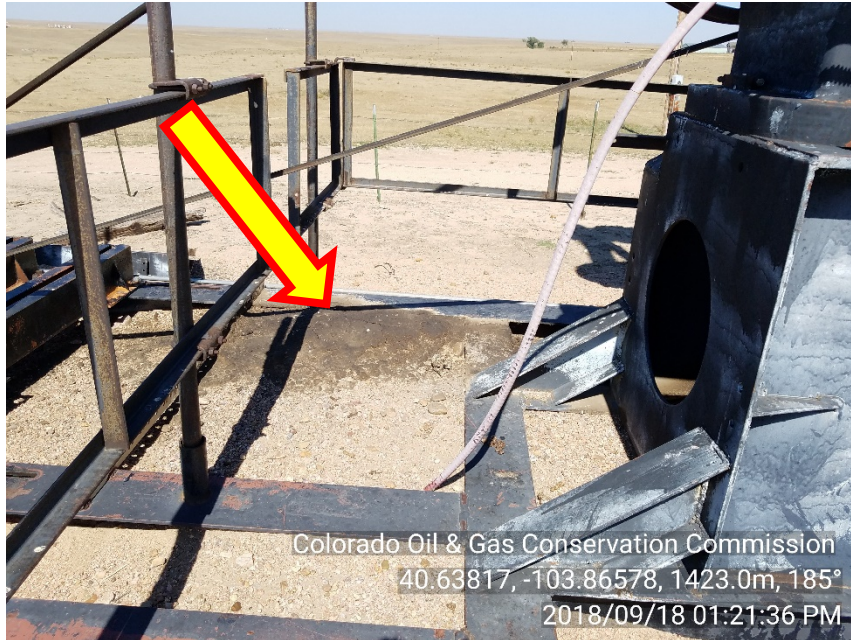
Photo #5

Sooner Unit 2-28 Pump jack - gearbox

Stained soil

from previous FIR

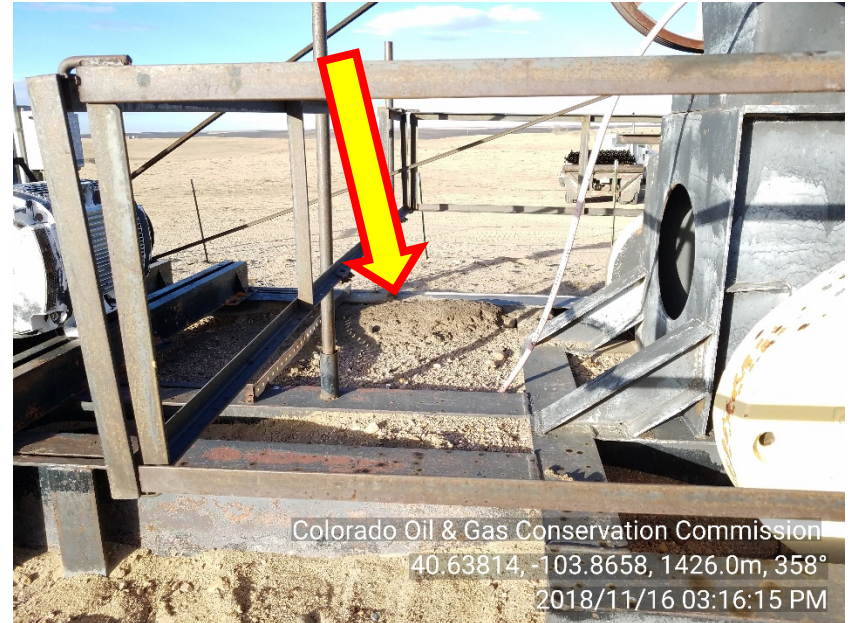
Photo #6

Sooner Unit 2-28 Pump jack - gearbox

Stained soil

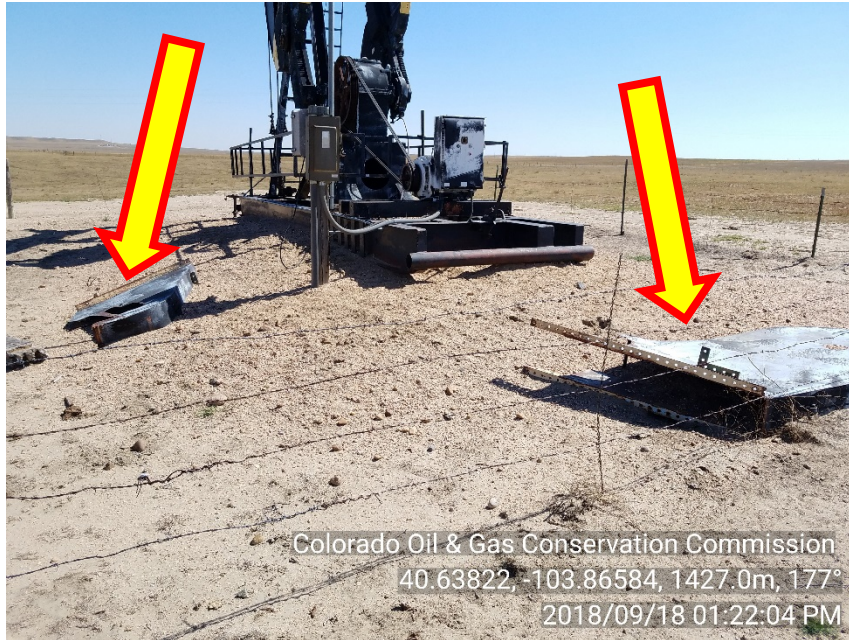
Photo #7

Sooner Unit 2-28 Pump jack
Unused equipment – belt guards
from previous FIR

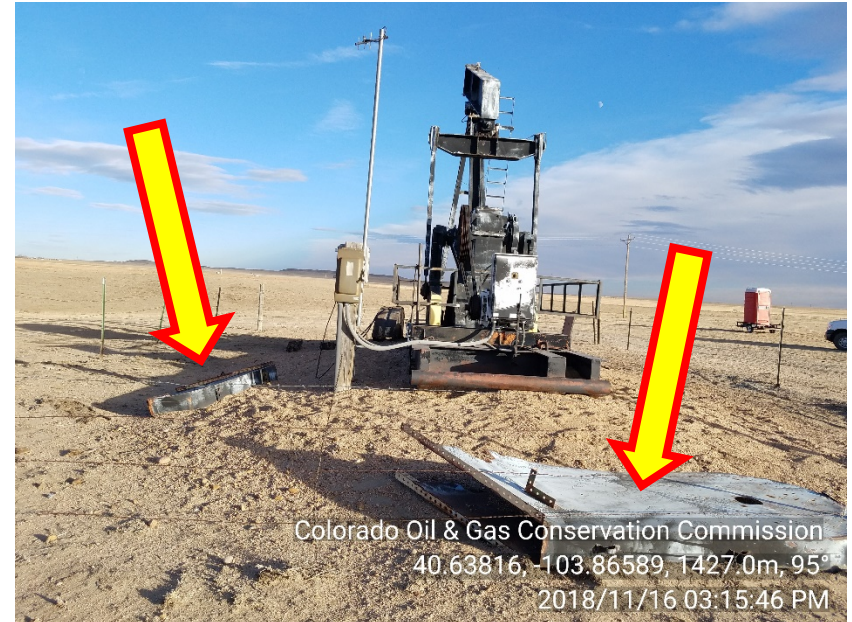
Photo #8

Sooner Unit 2-28 Pump jack
Unused equipment – belt guards

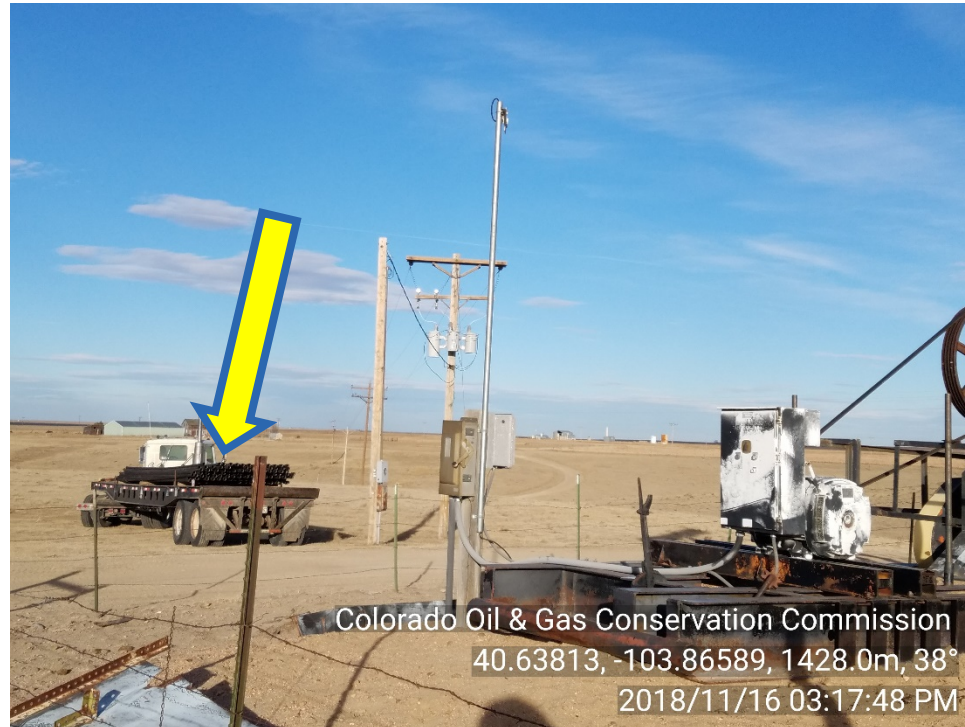
Photo #9

Sooner Unit 2-28 wellsite area

Tubing appears to have been pulled from well

Tubing on trailer

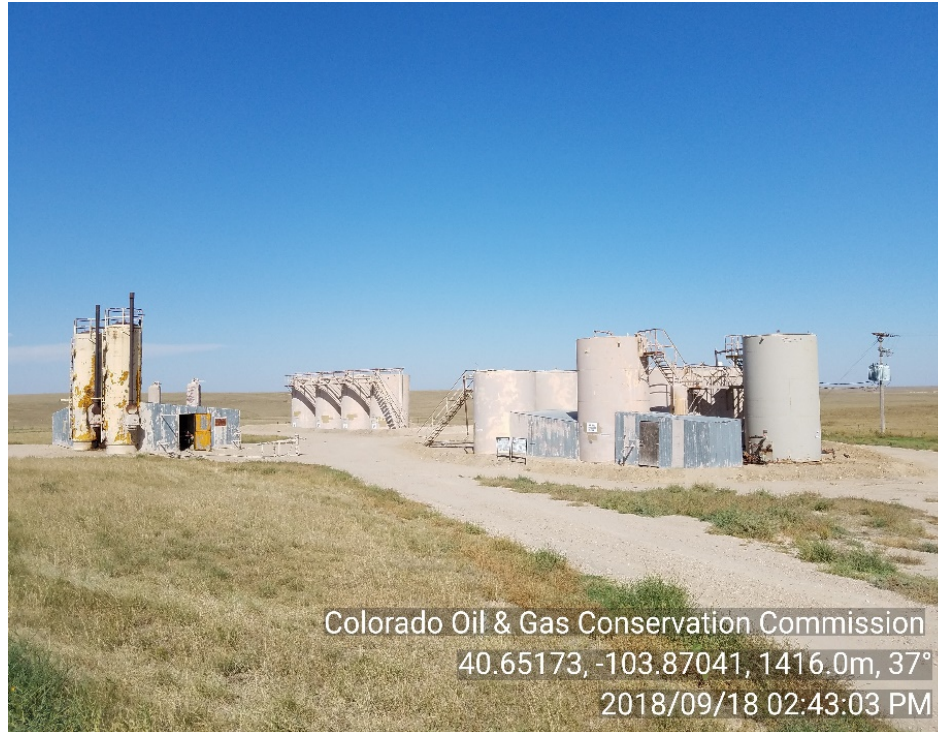
Photo #10

Sooner Unit Battery

from previous FIR
