**Inspection Photo
Schirer 13D-26
API # 045-14917
Inspection # 689302378**

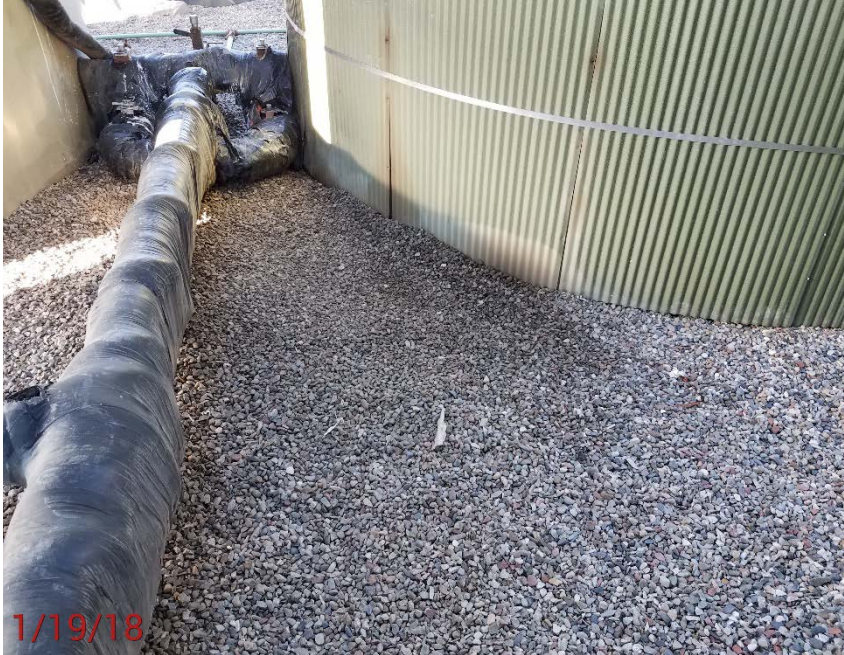
Location Photo #3, Oily stained rock in battery containment.

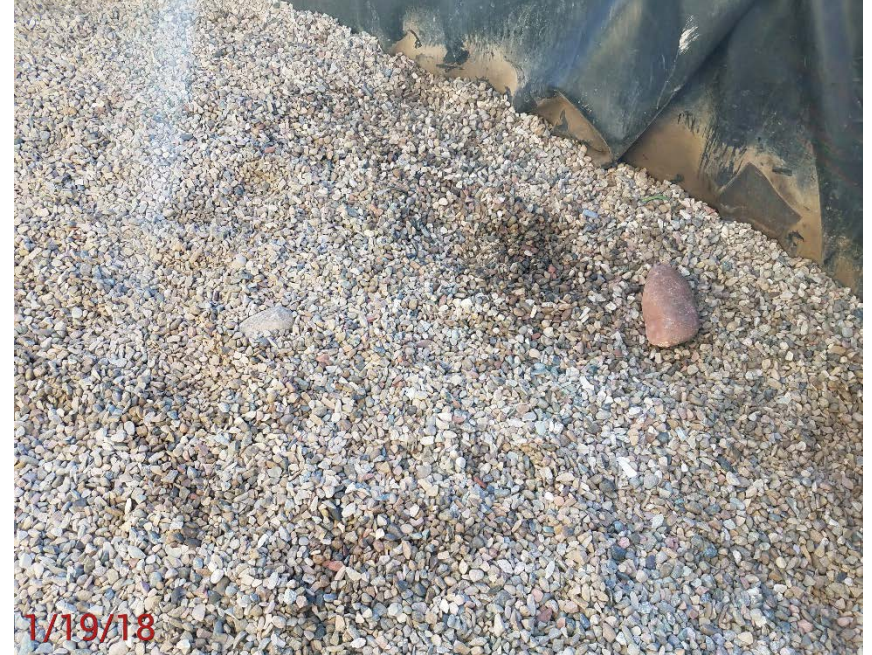
Location Photo #4, Stained Material on West end of battery.
