**Inspection Photo  
Last Dance 34-10C  
API # 045-12985  
Inspection # 689302392**

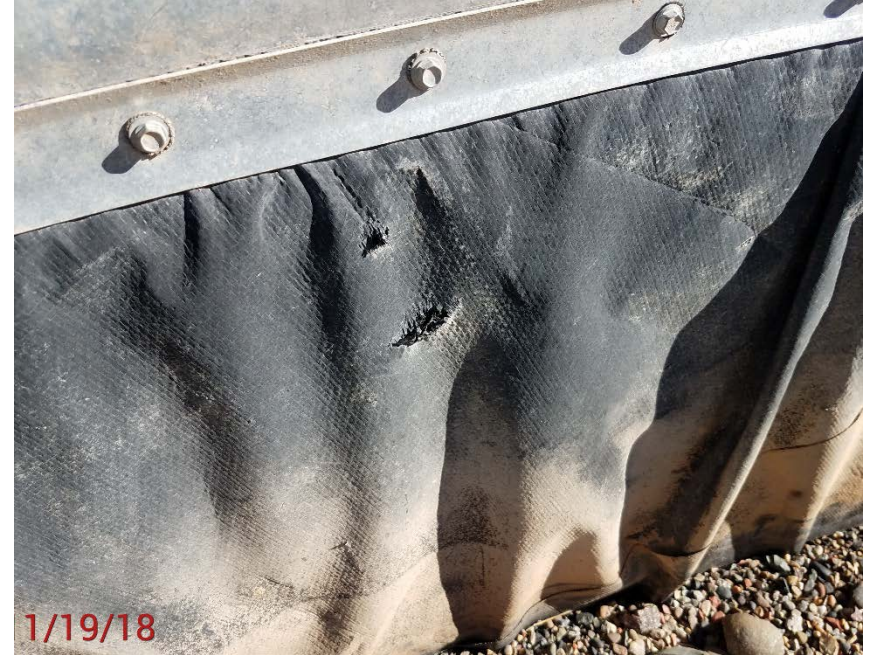
**Location Photo #4, Holes in battery liner.**

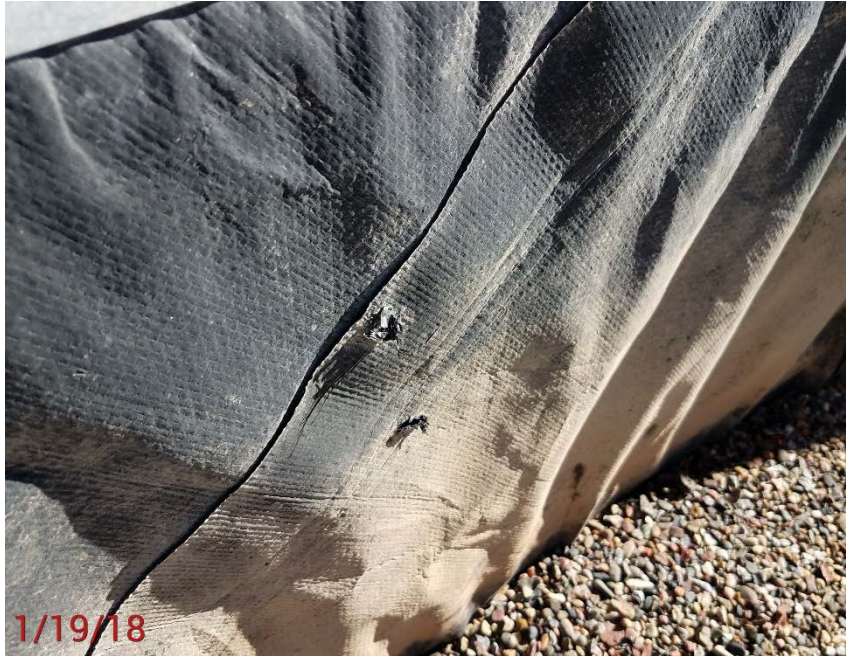
**Location Photo #5, Holes in battery liner**

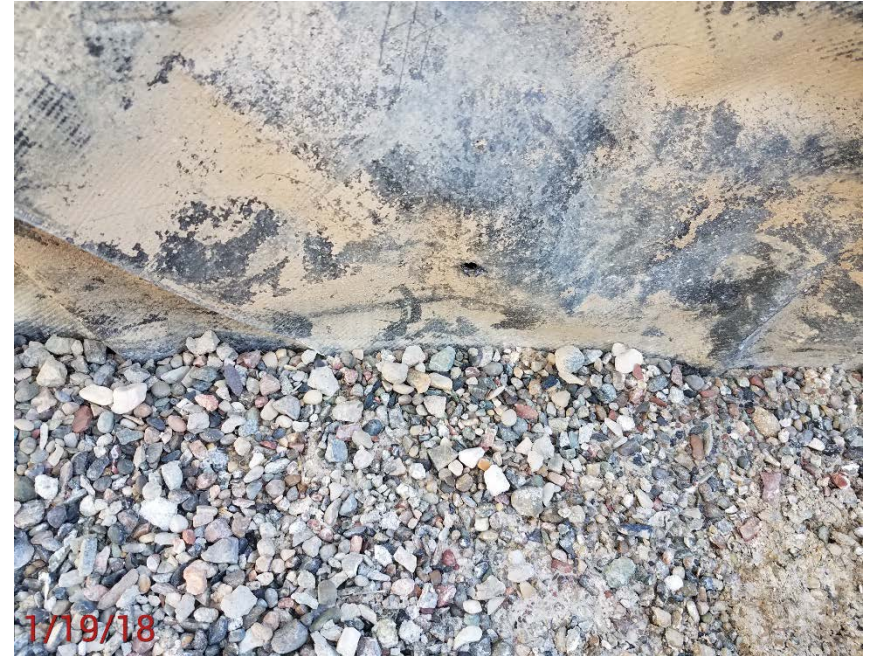
**Location Photo #6, Holes in battery liner.**
