Inspection Photos
Location Name: Thomas Jacquez E #1 PW Line
Spill/Release Point ID #458834

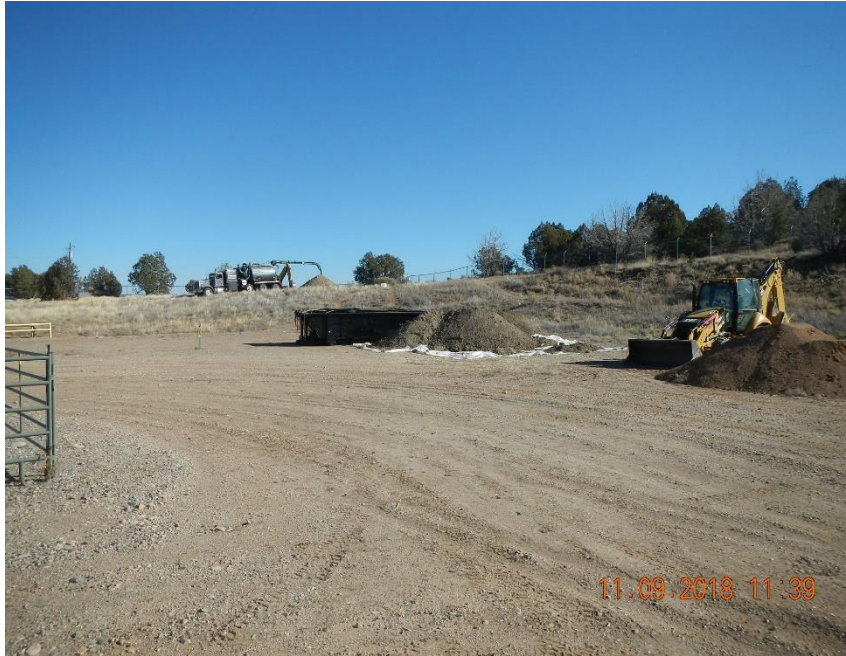
Excavated material staged on Thomas Jacquez E #1 location.

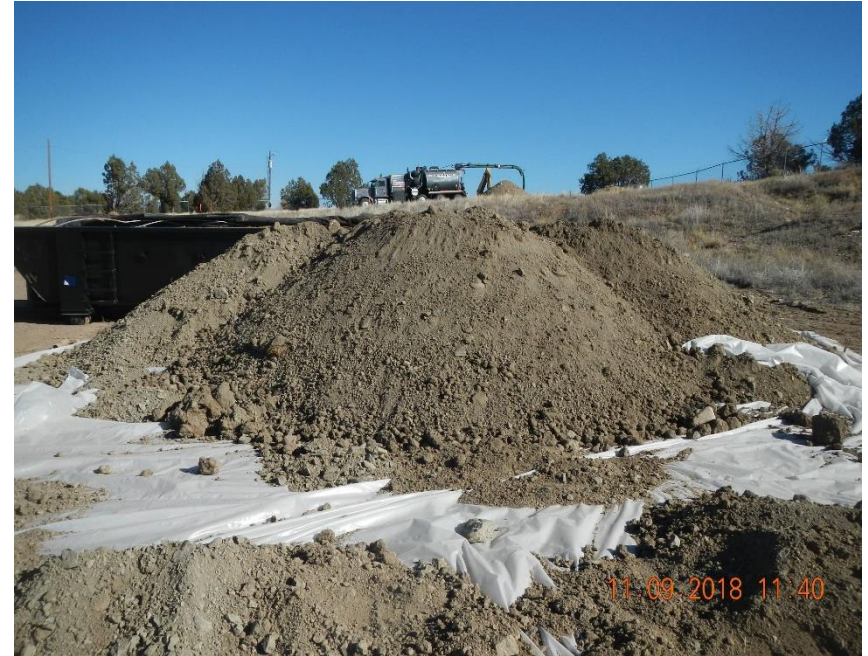
Soil excavated from pipeline ROW.

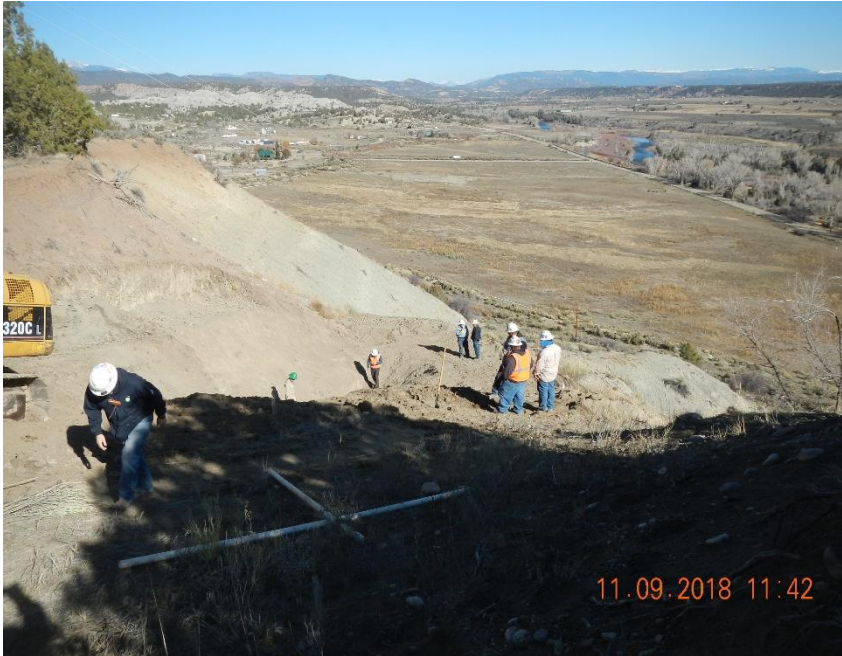
Spill/Release Point ID #458834 source.

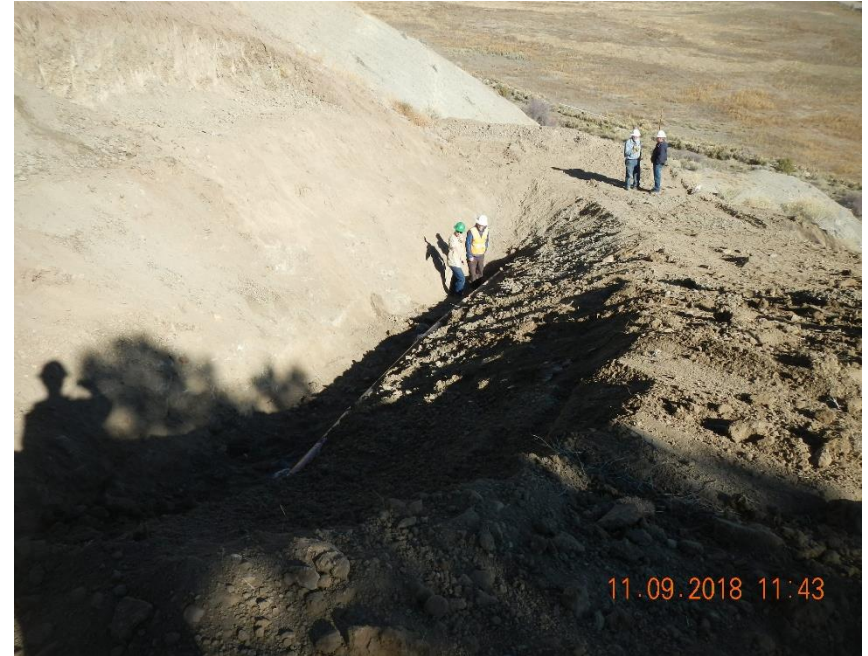
Excavated 6" fiberglass produced water pipeline.

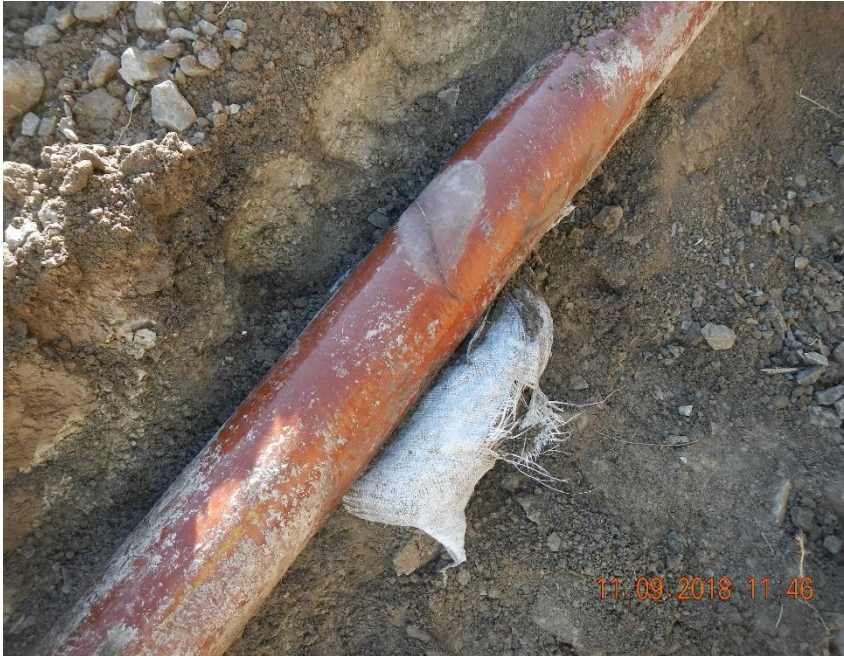
Downstream failure of fiberglass line.

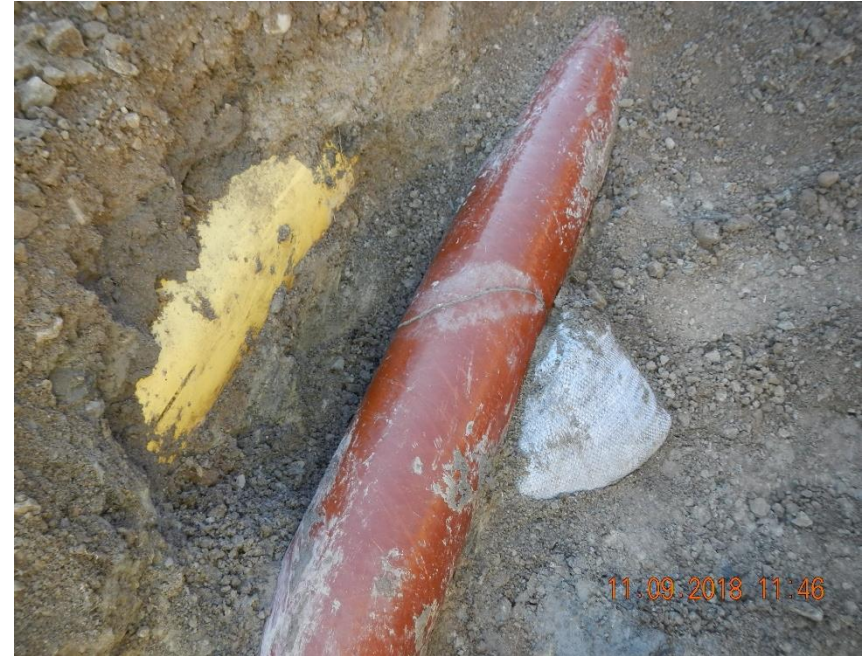
Upstream failure of fiberglass line. Abandoned steel gathering line in left of photo.

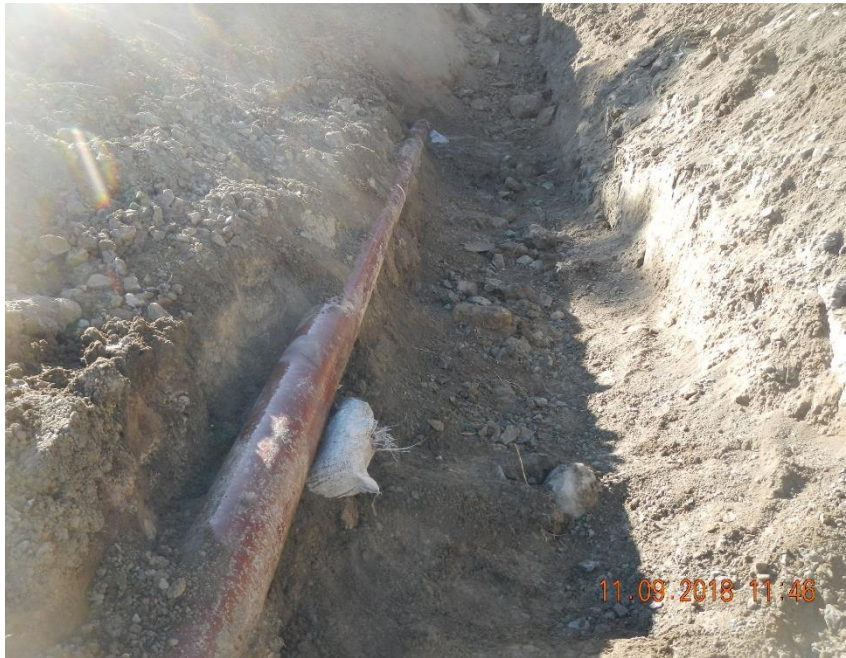
Failure points located above sandbags.

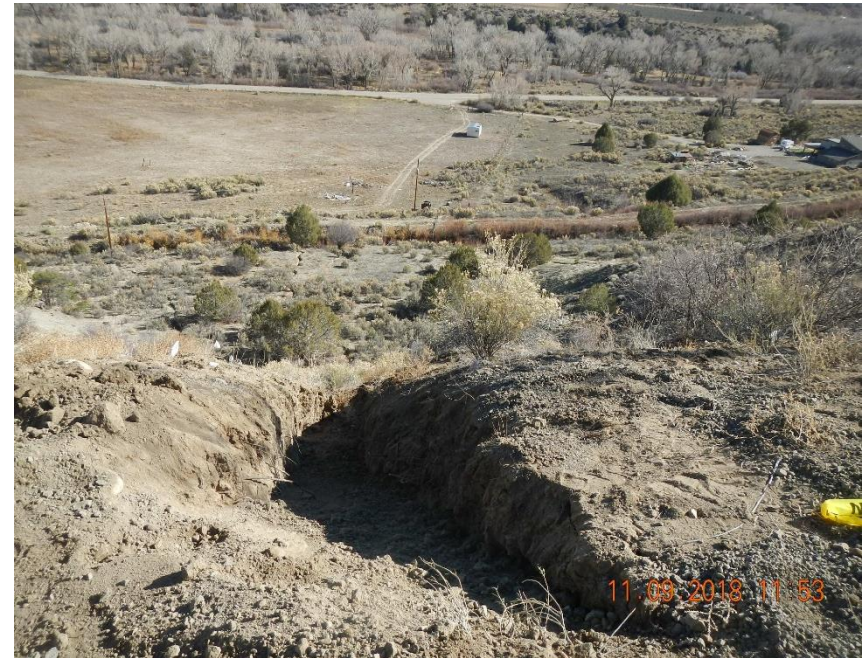
Initial excavation of flow path.

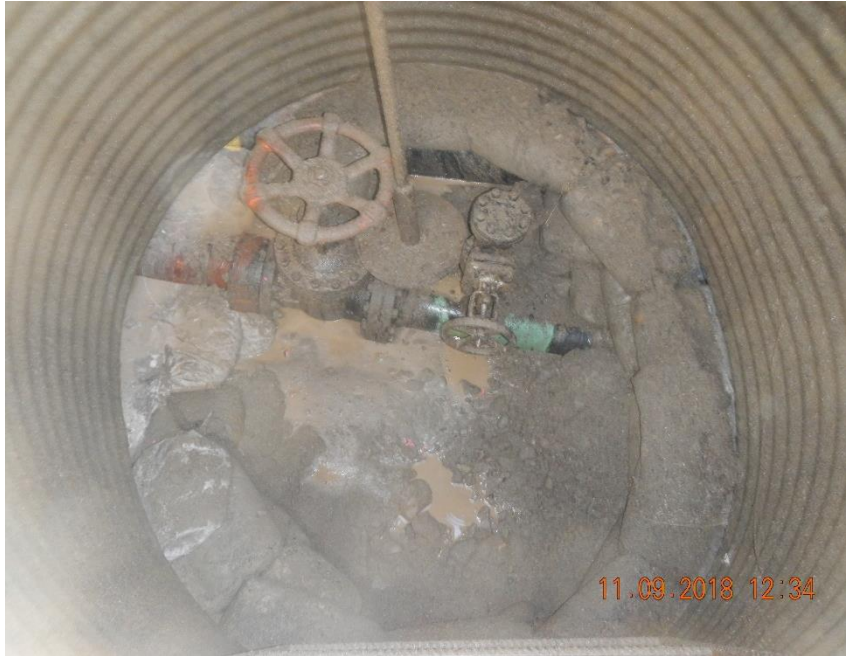
Valve can upstream of release point.

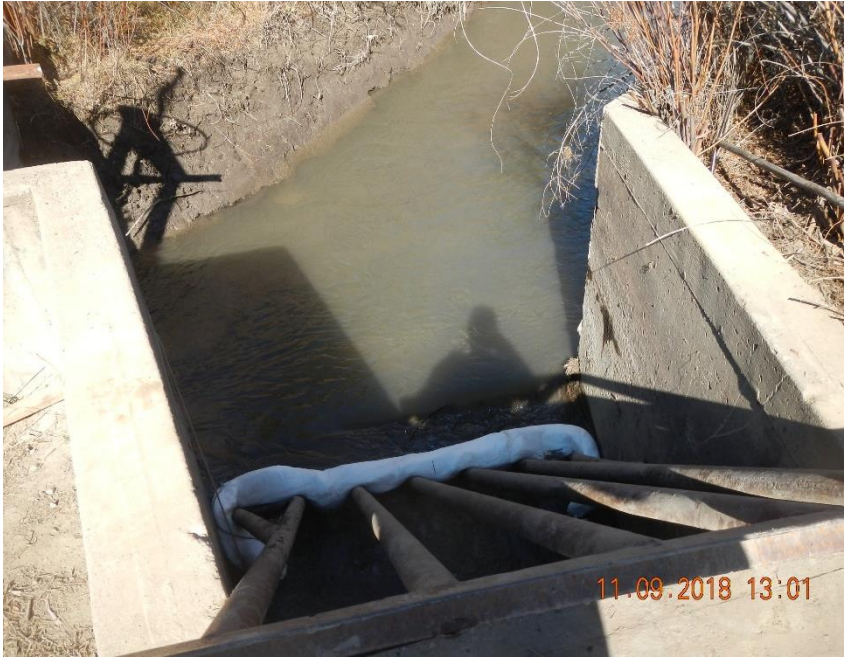
Boom across High Flume Canyon siphon inlet.

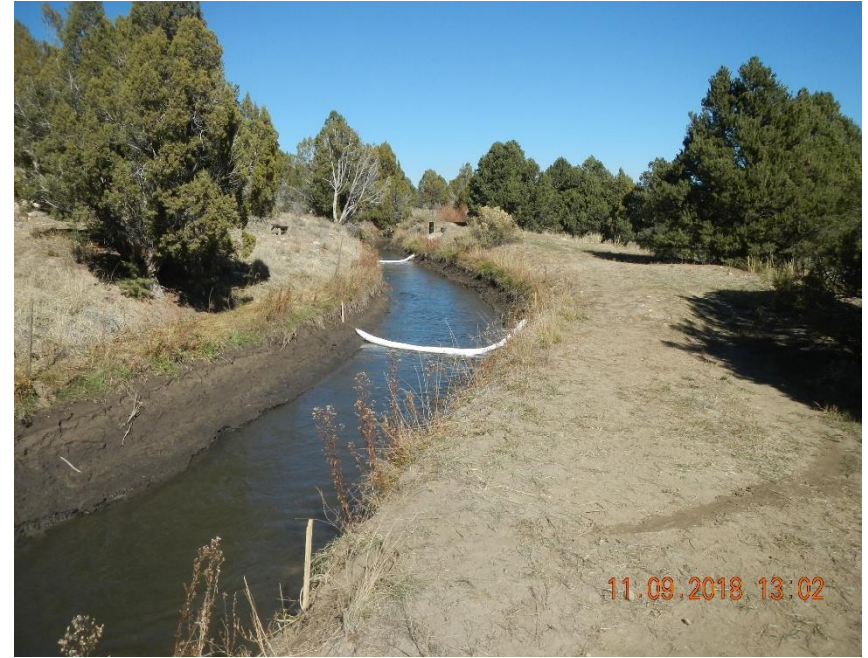
Booms in place along Citizen's Animas Ditch.

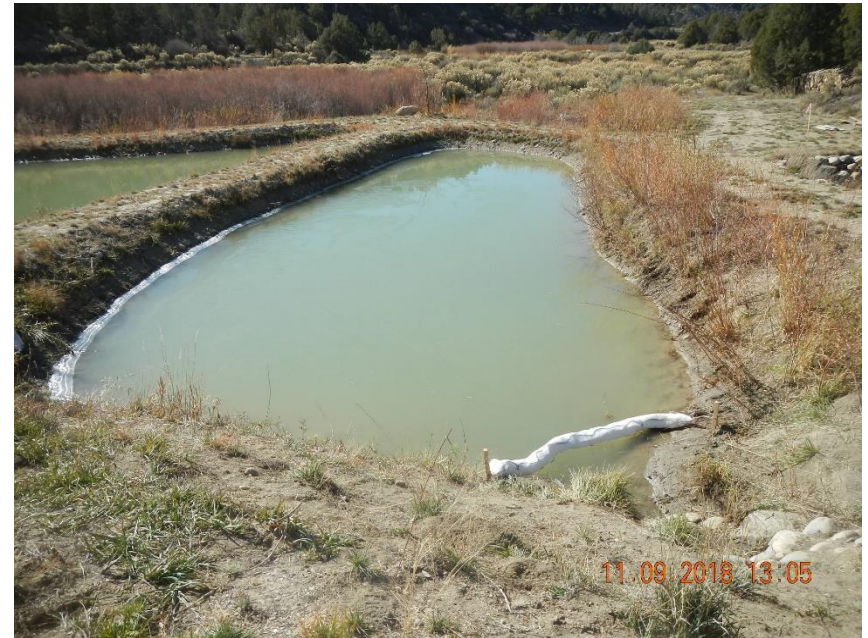
Boom in Pond #4 near inlet.

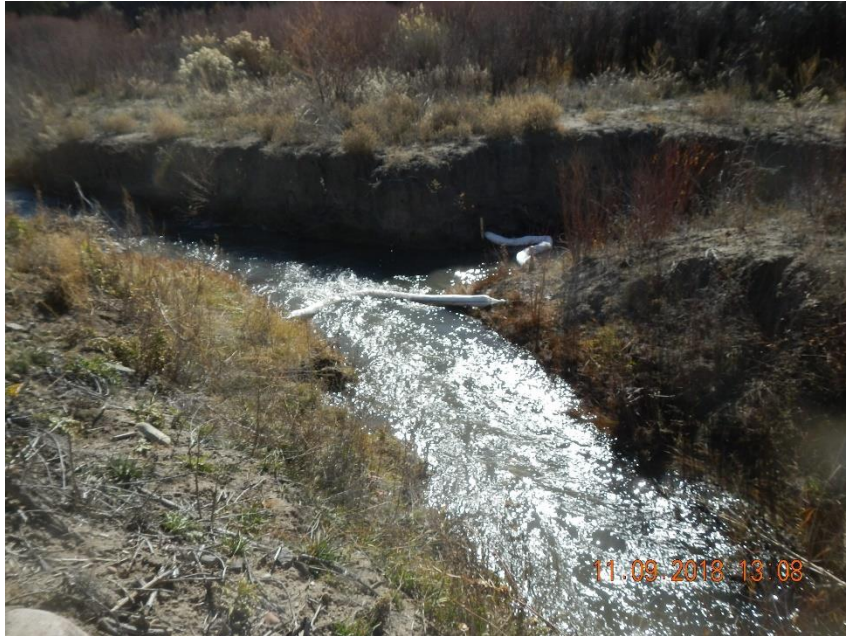
Absorbent booms across siphon bypass and High Flume Canyon.

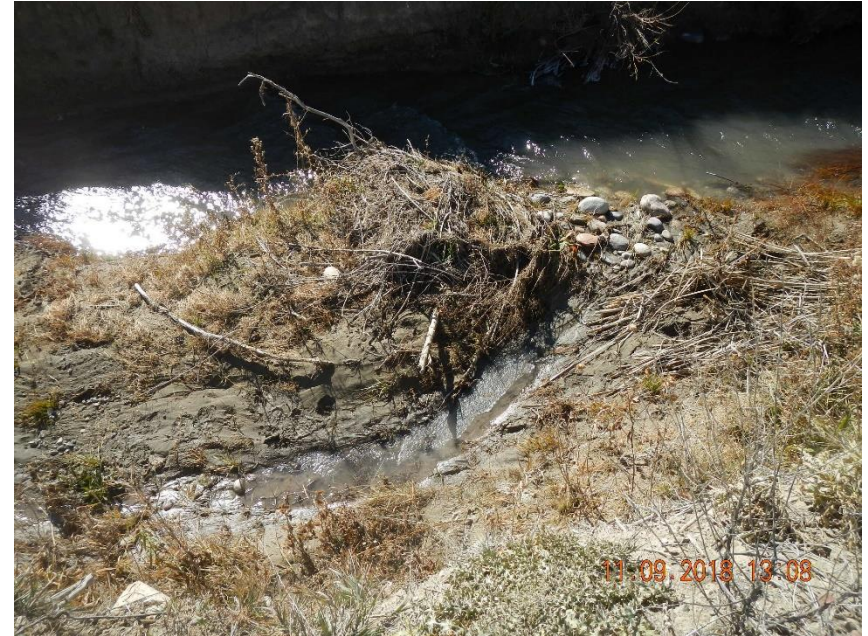
Photo along High Flume Canyon, downstream of last photo.
