Inspection Photos
Location Name: Airco #2 Natural Gas Well
Spill/Release Point ID #458267

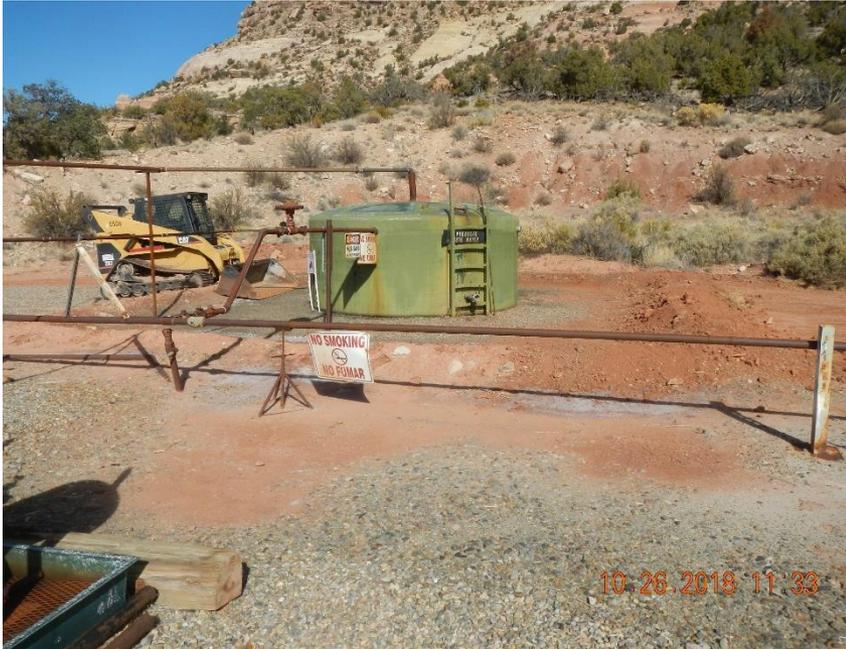
2,500 gallon fiberglass produced water AST where release occurred.

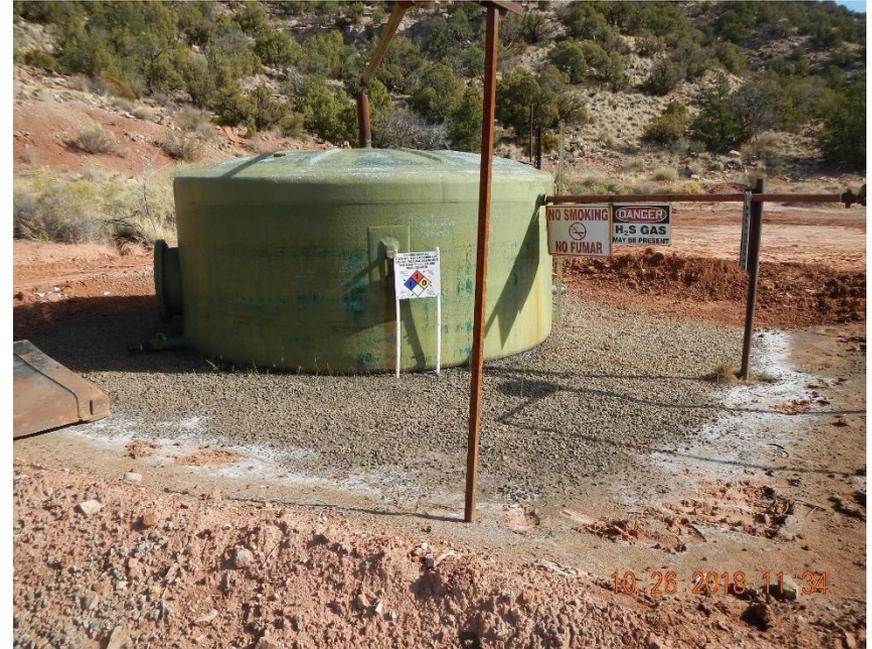
White residue present within secondary containment berm.

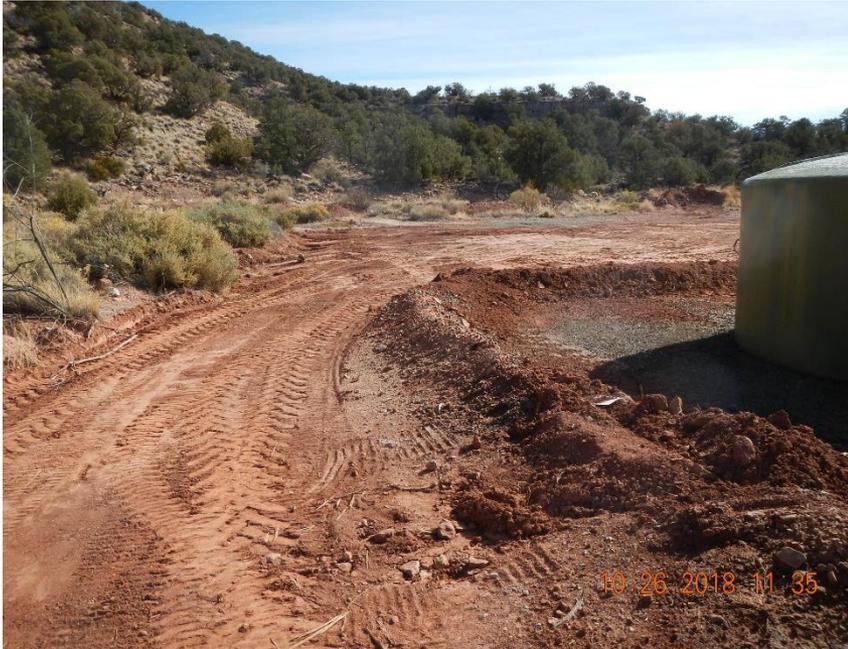
Impacted material was being removed from the location.

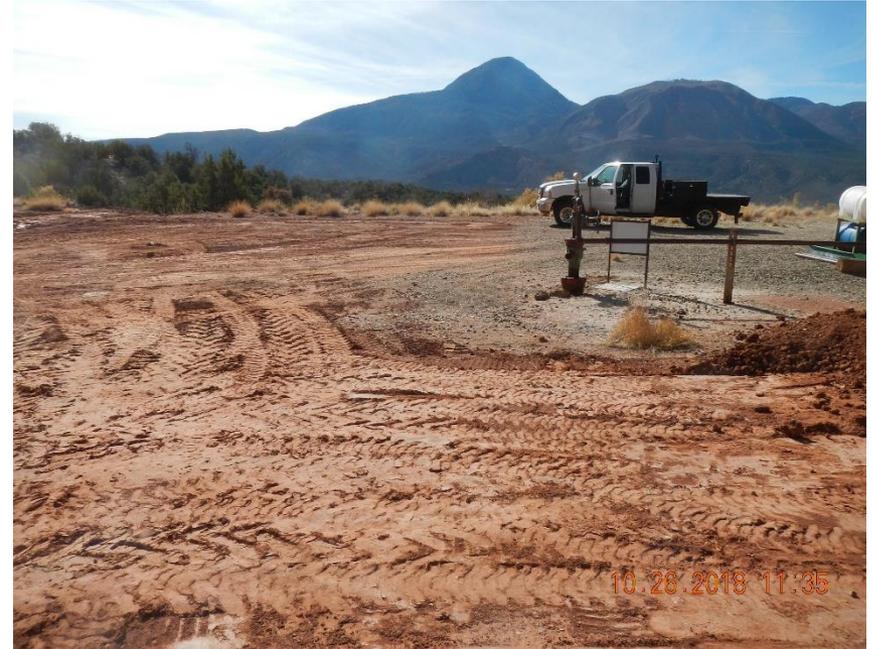
Impacted area on location had been scraped.

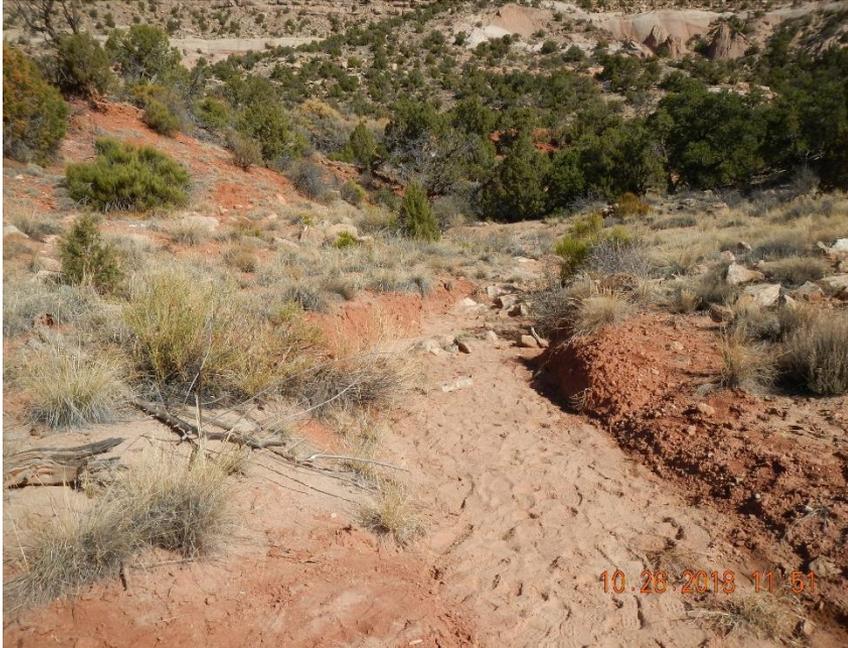
Looking upstream at the drainage feature that the release followed.

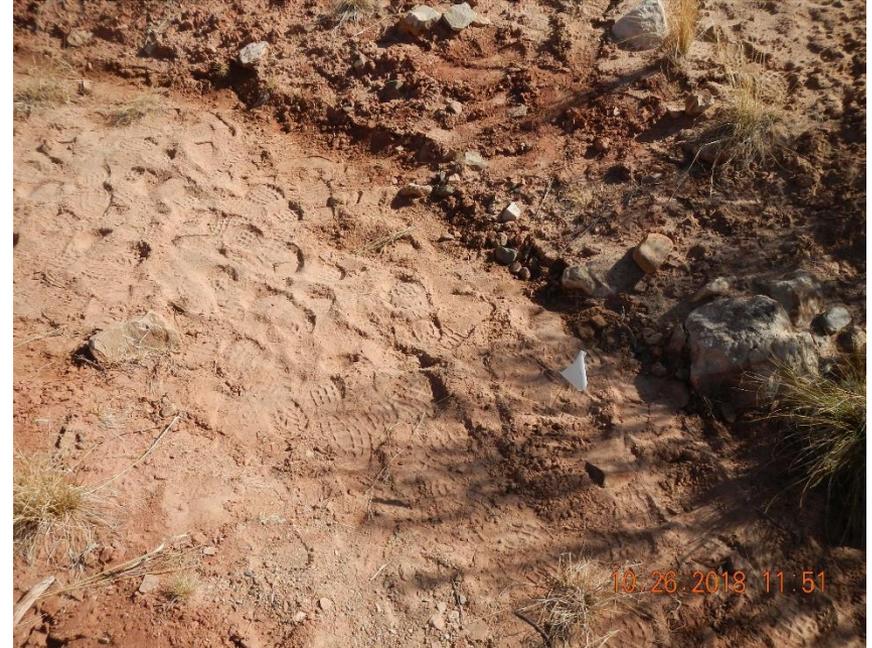
Pin flags in drainage feature along flow path.

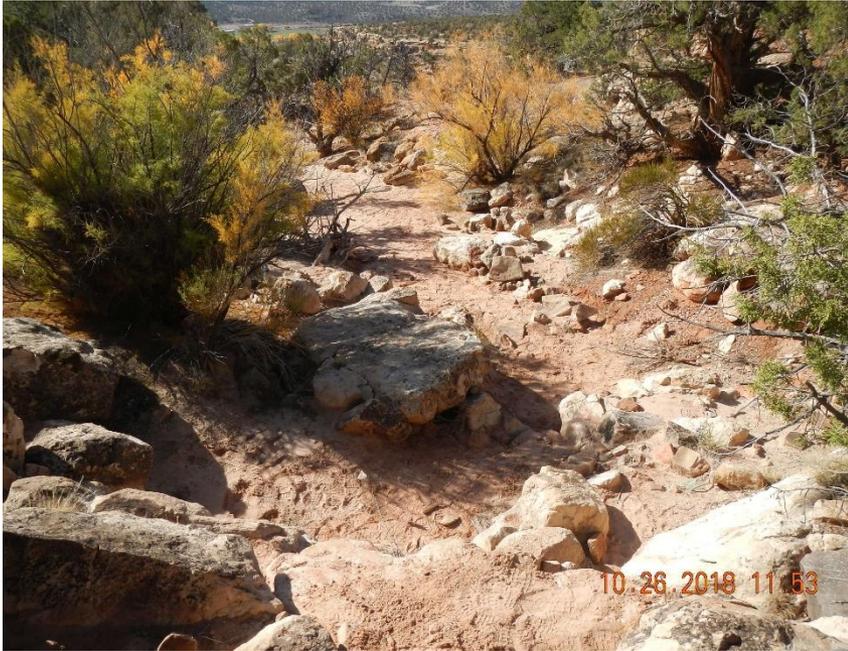
Looking downstream within flow path.

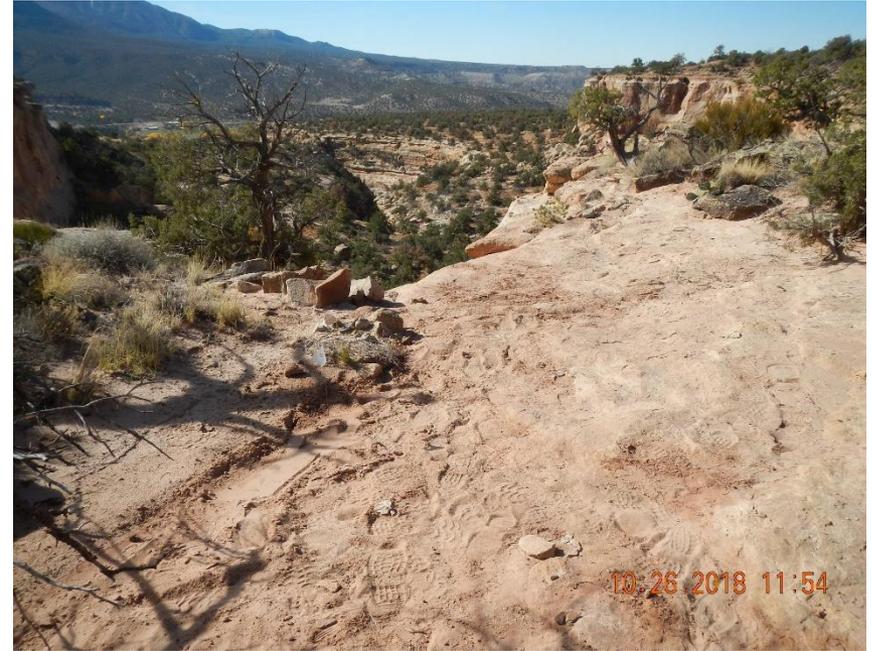
Flow path leads to cliff edge.

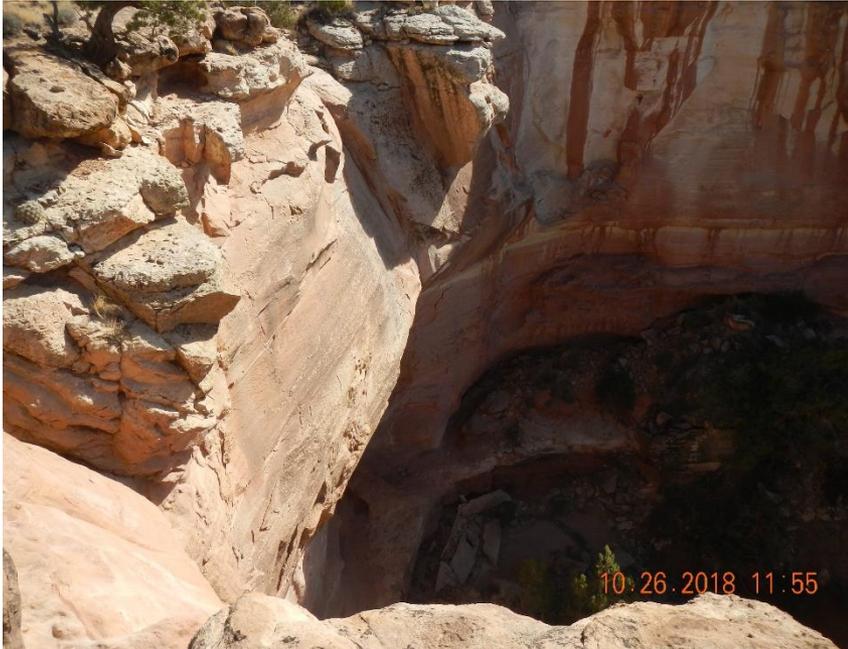
Produced water flow path off of sandstone cliff.

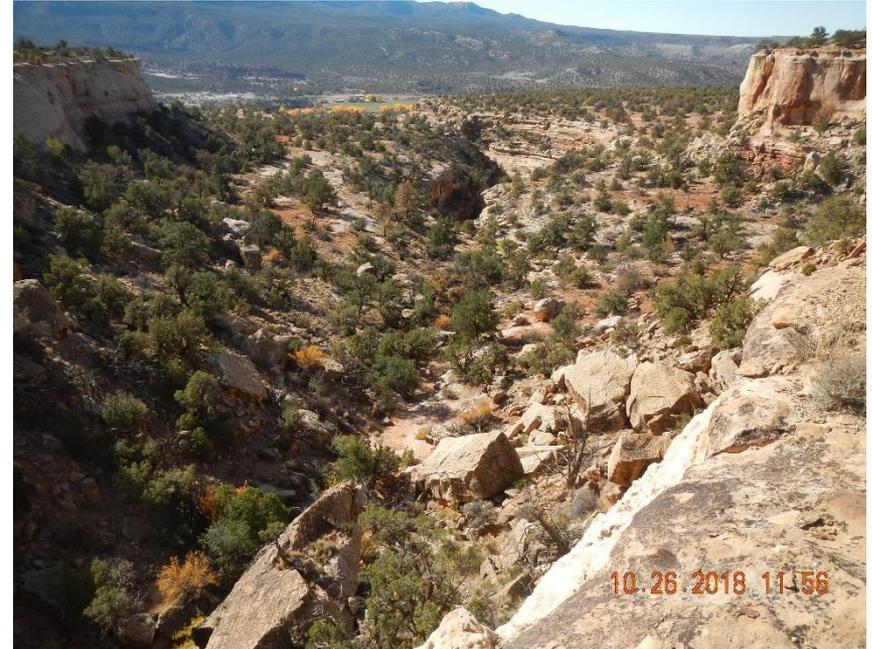
Drainage feature that flow path terminated in.
