Inspection Photos

Operator: FOUNDATION ENERGY
MANAGEMENT LLC - 10112

Location ID: 327492

Inspection Doc. Number: 682504195
Weld County, CO

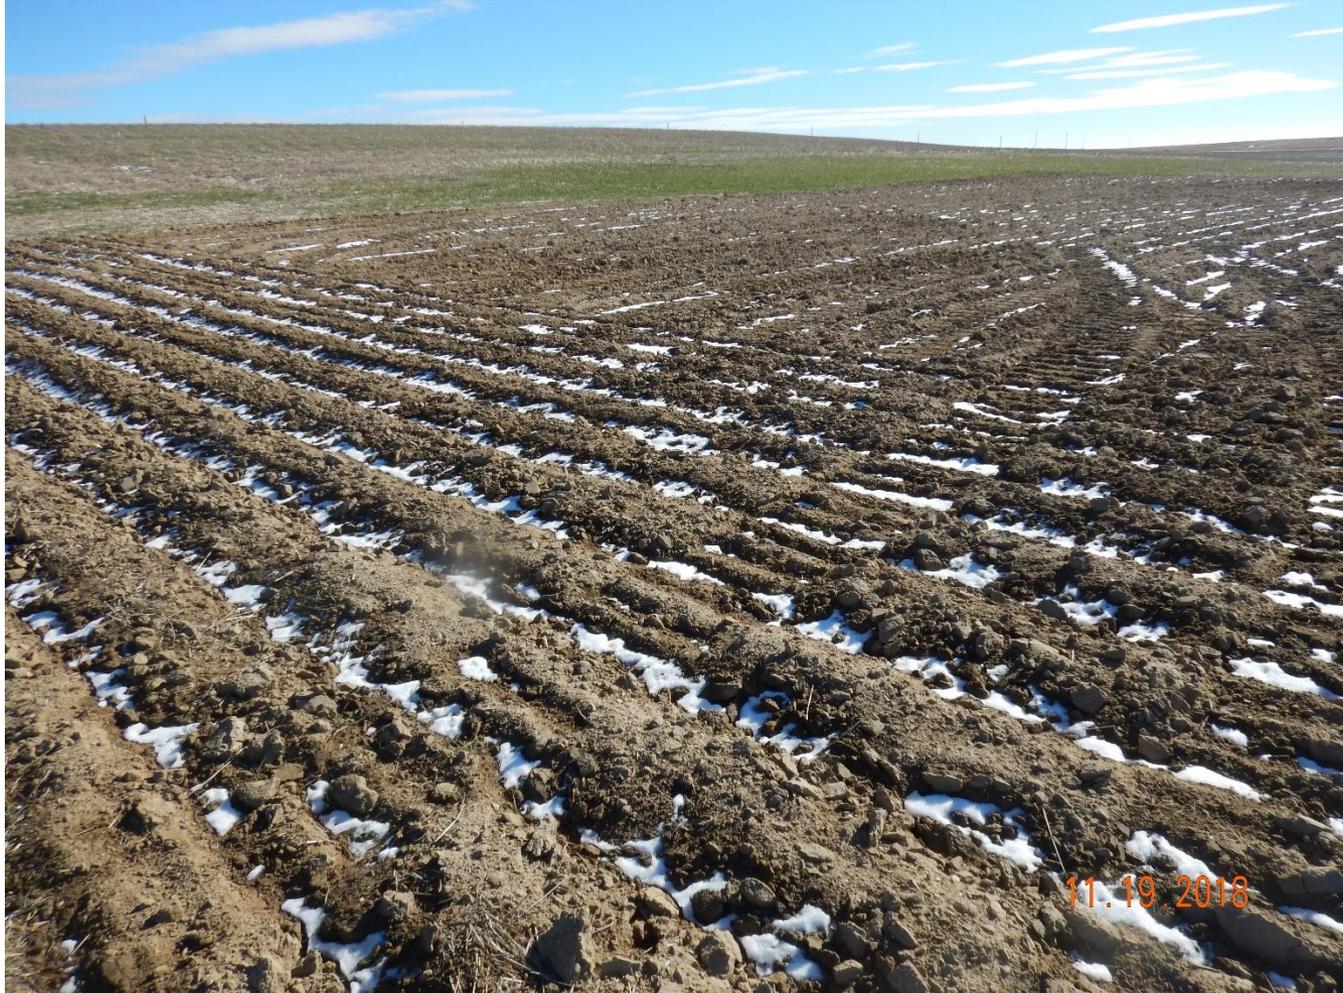
Photo 1: Photo taken from the north end of the location. Photos 1-3 provide an overview of the location from east, to south, to west. Photos also show that additional reclamation appears to have been conducted, however reclamation does not appear to have been conducted in accordance with 1000 reclamation requirements; 1004.a requires compaction alleviation to be conducted by cross-ripping to a depth of 18 inches. Location has not been cross-ripped. Compaction concerns remain evident.

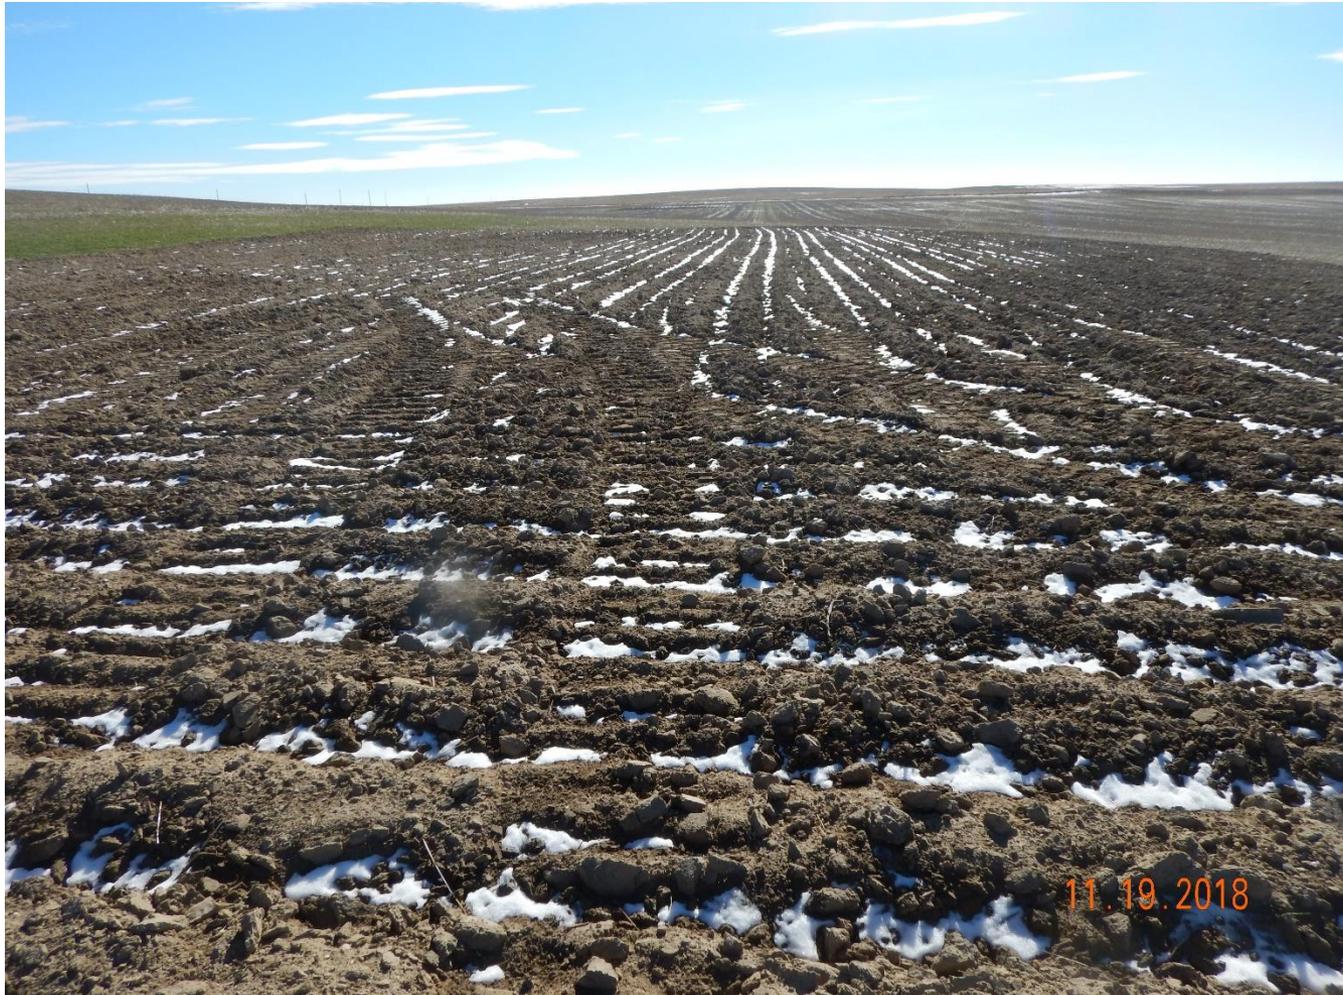
Photo 2: See Comments under photo 1.

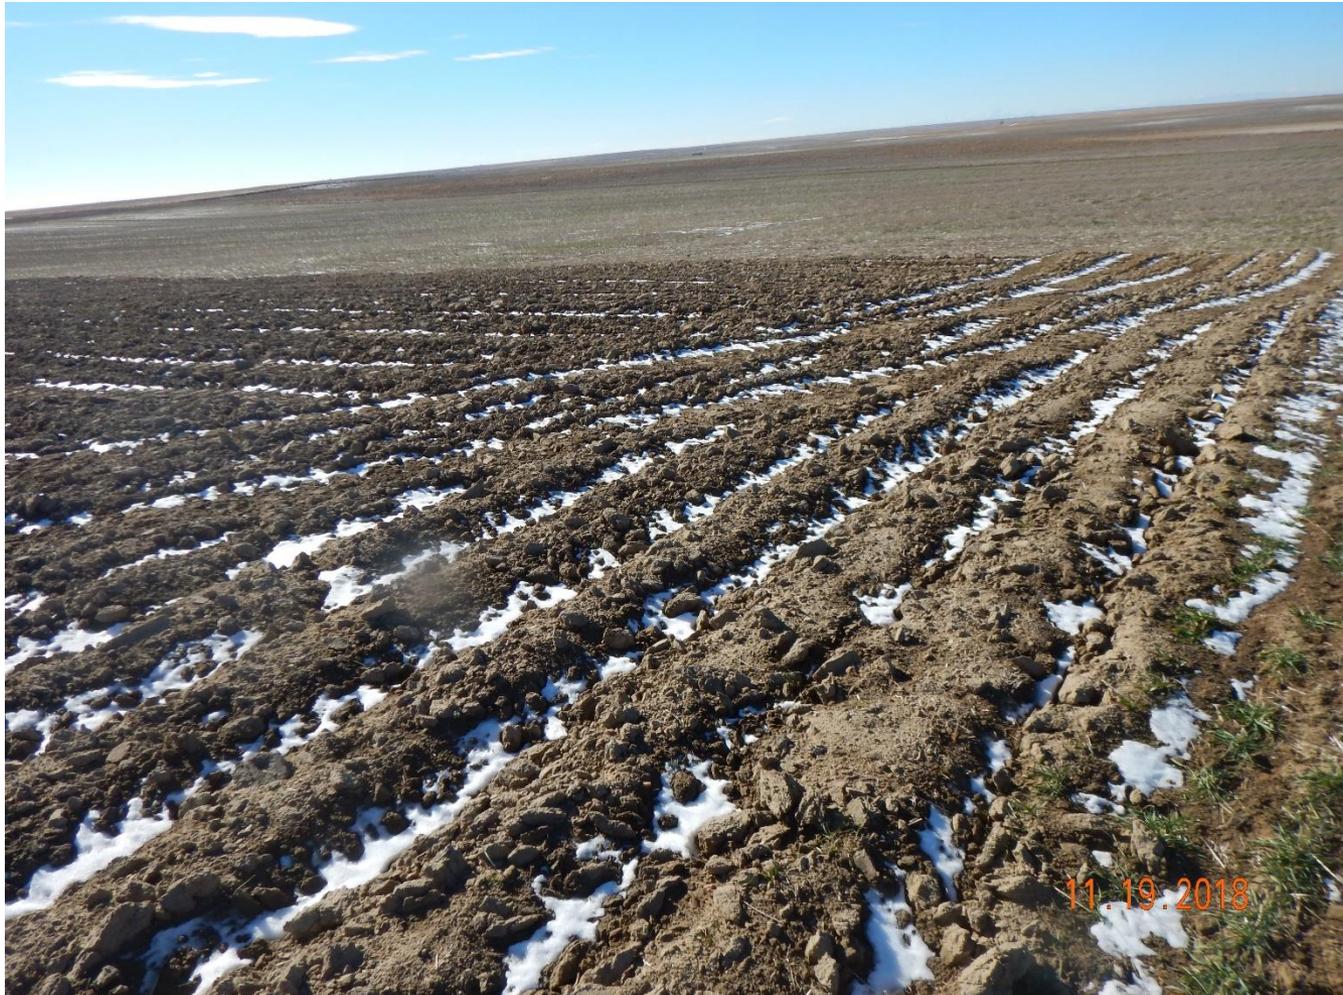
Photo 3: See Comments under photo 1.

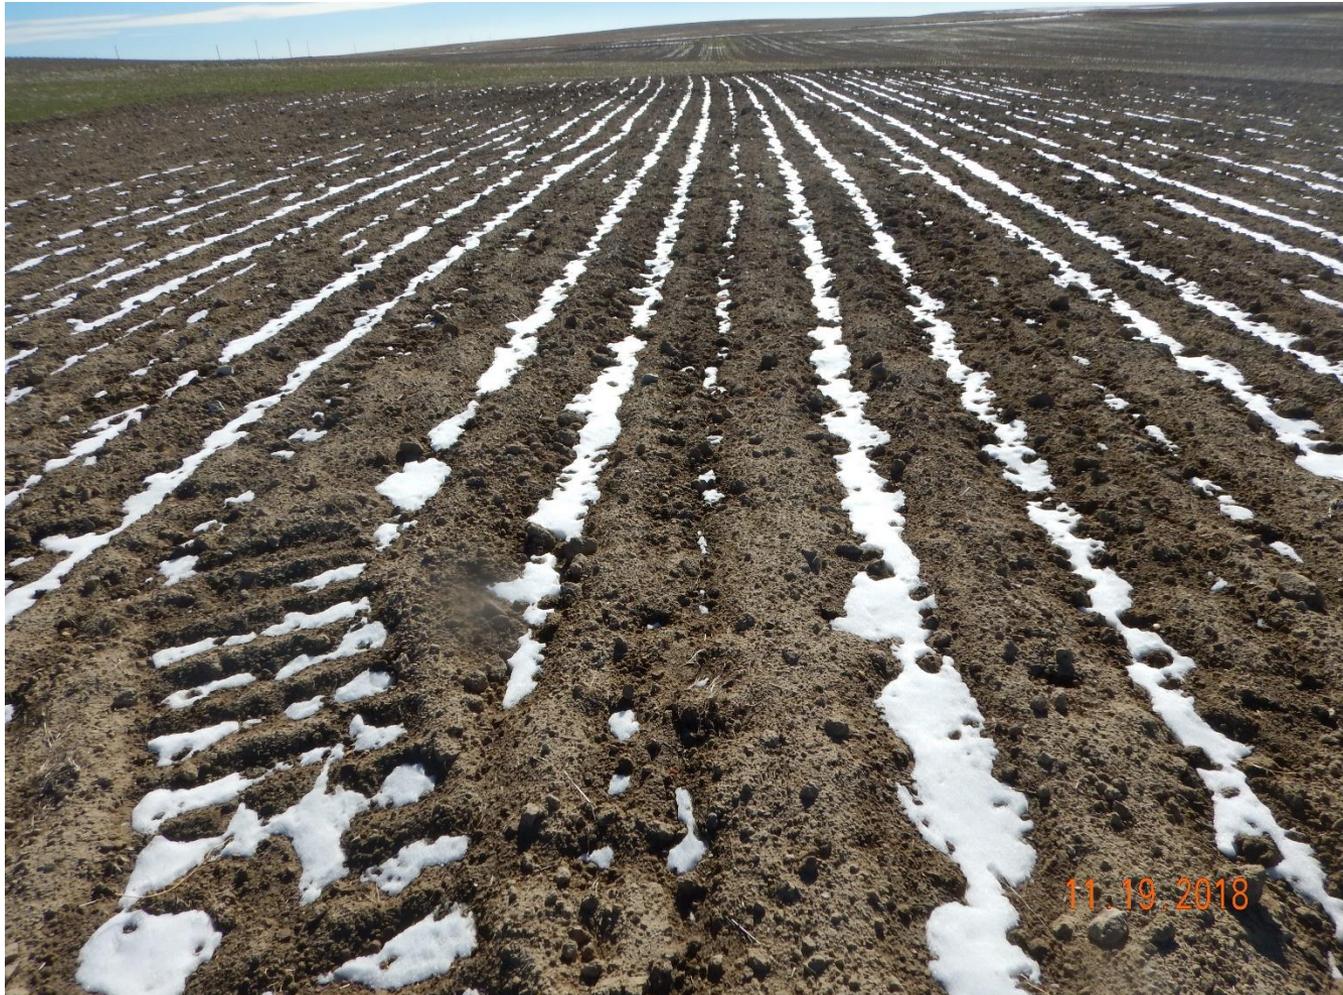
Photo 4: Photo taken from the location, facing south. Photo shows location appears to have been ripped in one direction. 1004.a requires compaction alleviation to be conducted by cross-ripping to a depth of 18 inches. Location has not been cross-ripped. Compaction concerns remain evident.

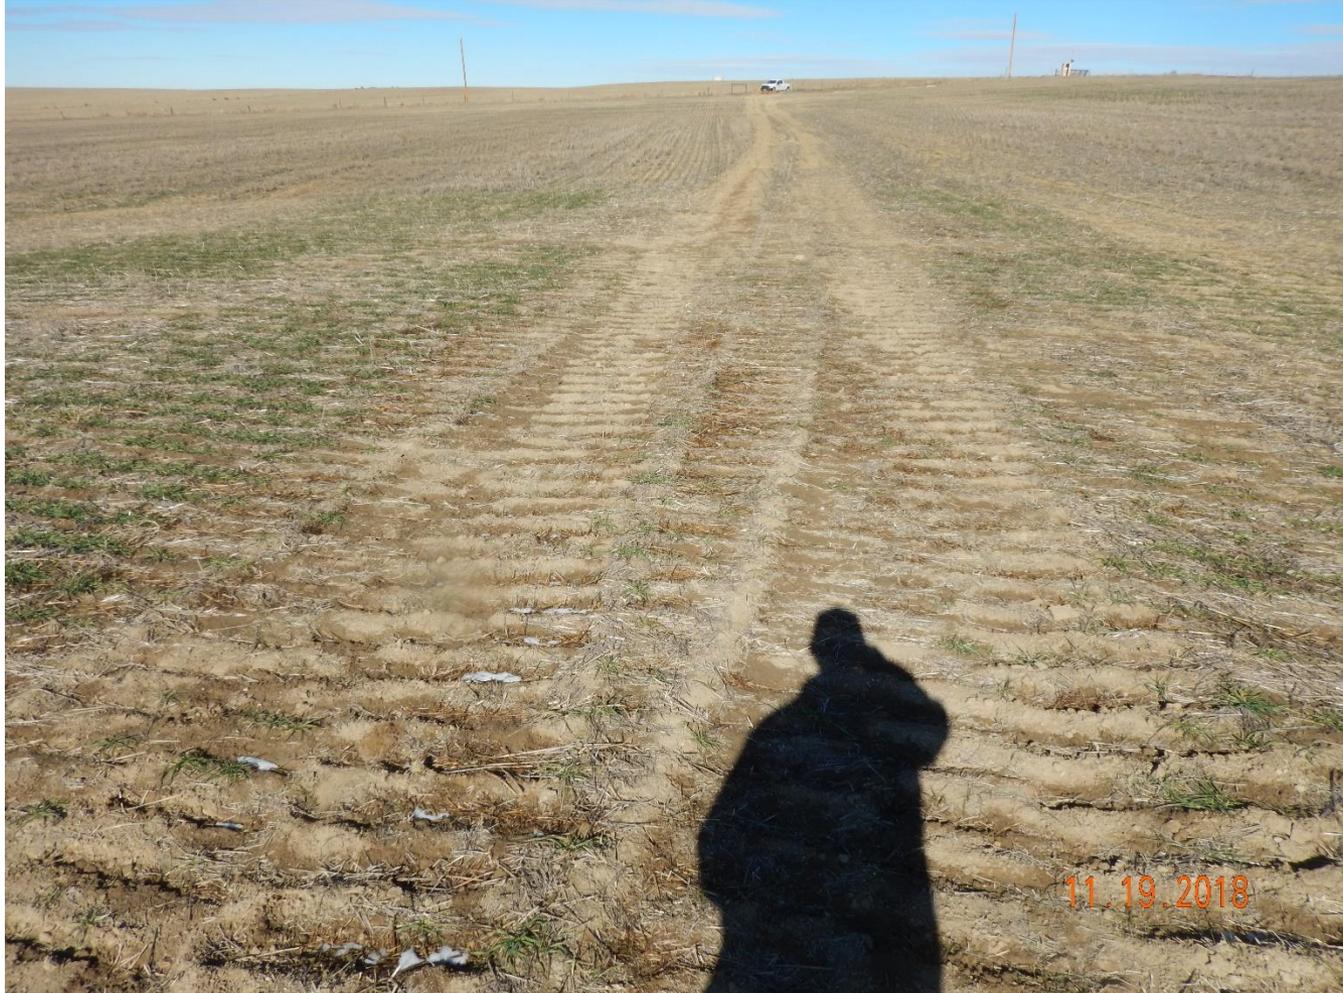
Photo 5: Photo taken from the north end of the location, facing north. Photo shows access road. Unable to find evidence that compaction alleviation has been conducted in accordance with 1004.a

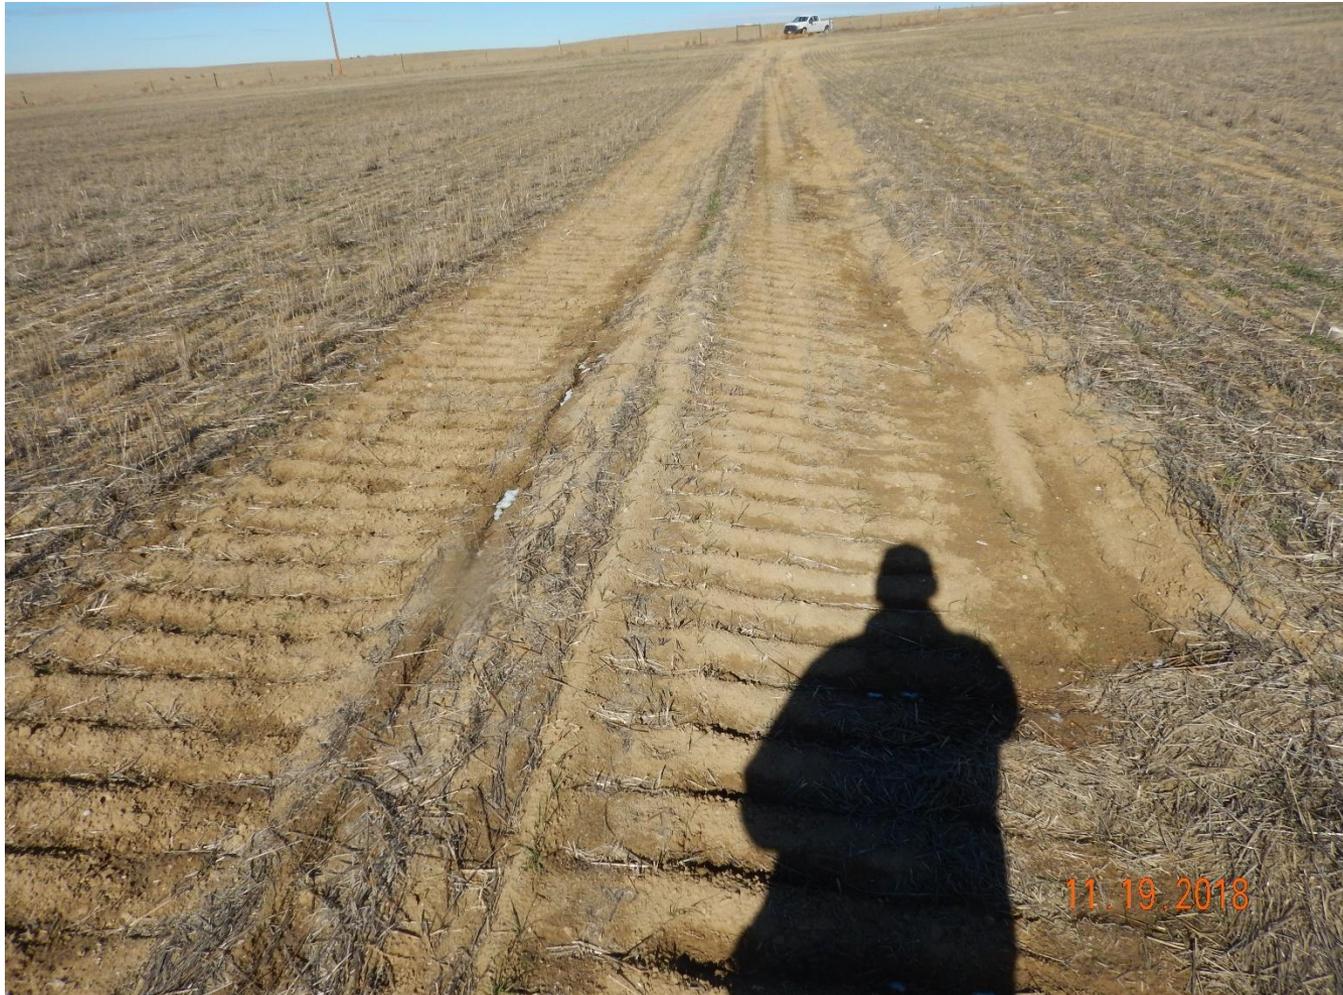
Photo 6: Photo taken from the access road, facing north. Photo shows access road. Unable to find evidence that compaction alleviation has been conducted in accordance with 1004.a. Access road also does not appear to have been re-contoured or re-graded.

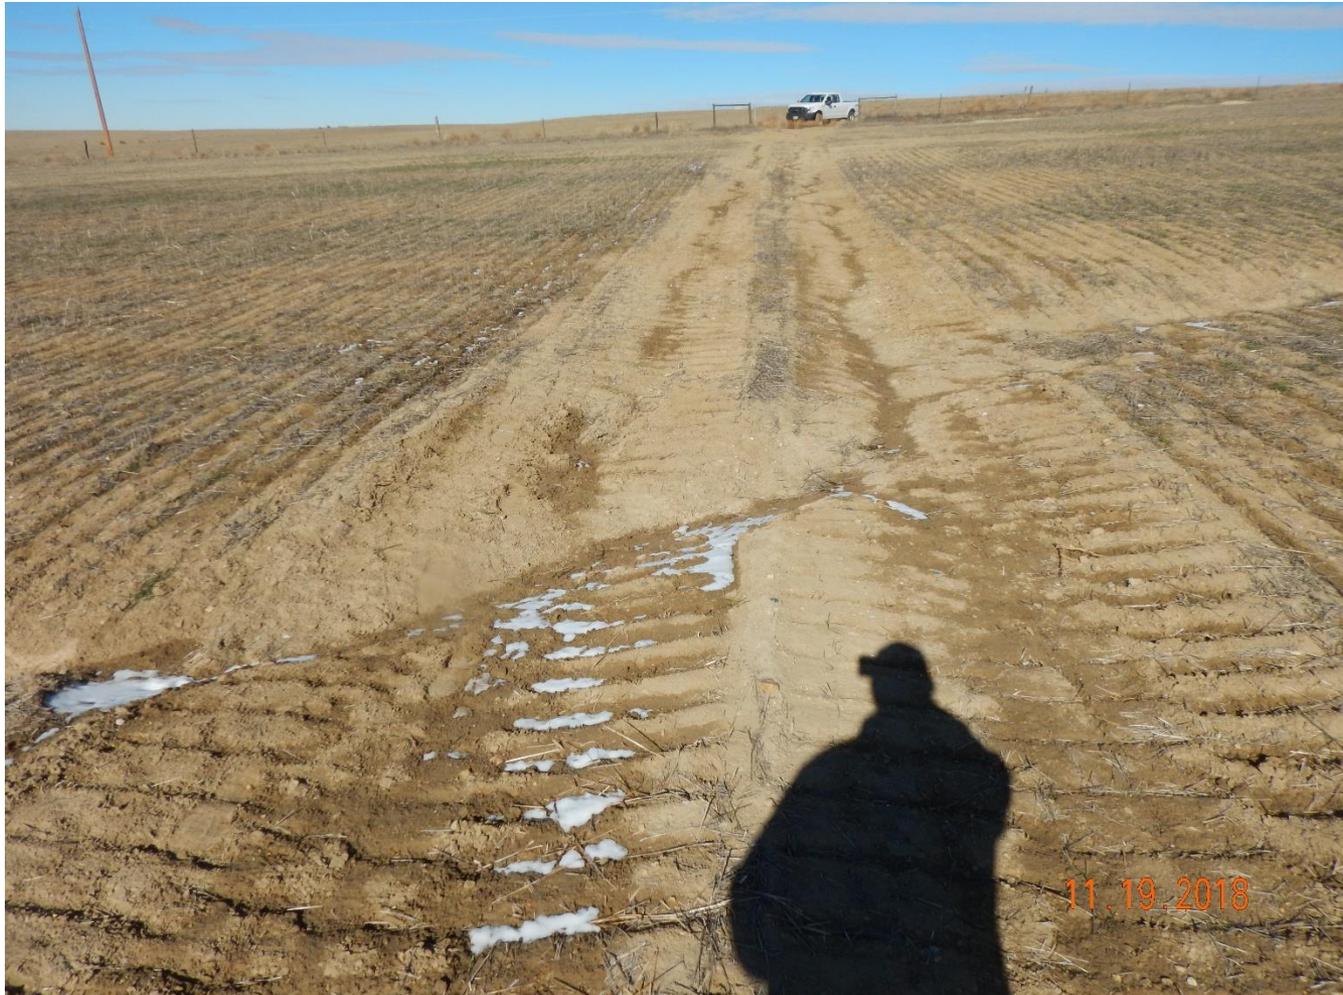
Photo 7: Photo taken from the access road, facing north. Photo shows access road. Unable to find evidence that compaction alleviation has been conducted in accordance with 1004.a. Access road also does not appear to have been re-contoured or re-graded. Photo also shows erosion degradation on road.

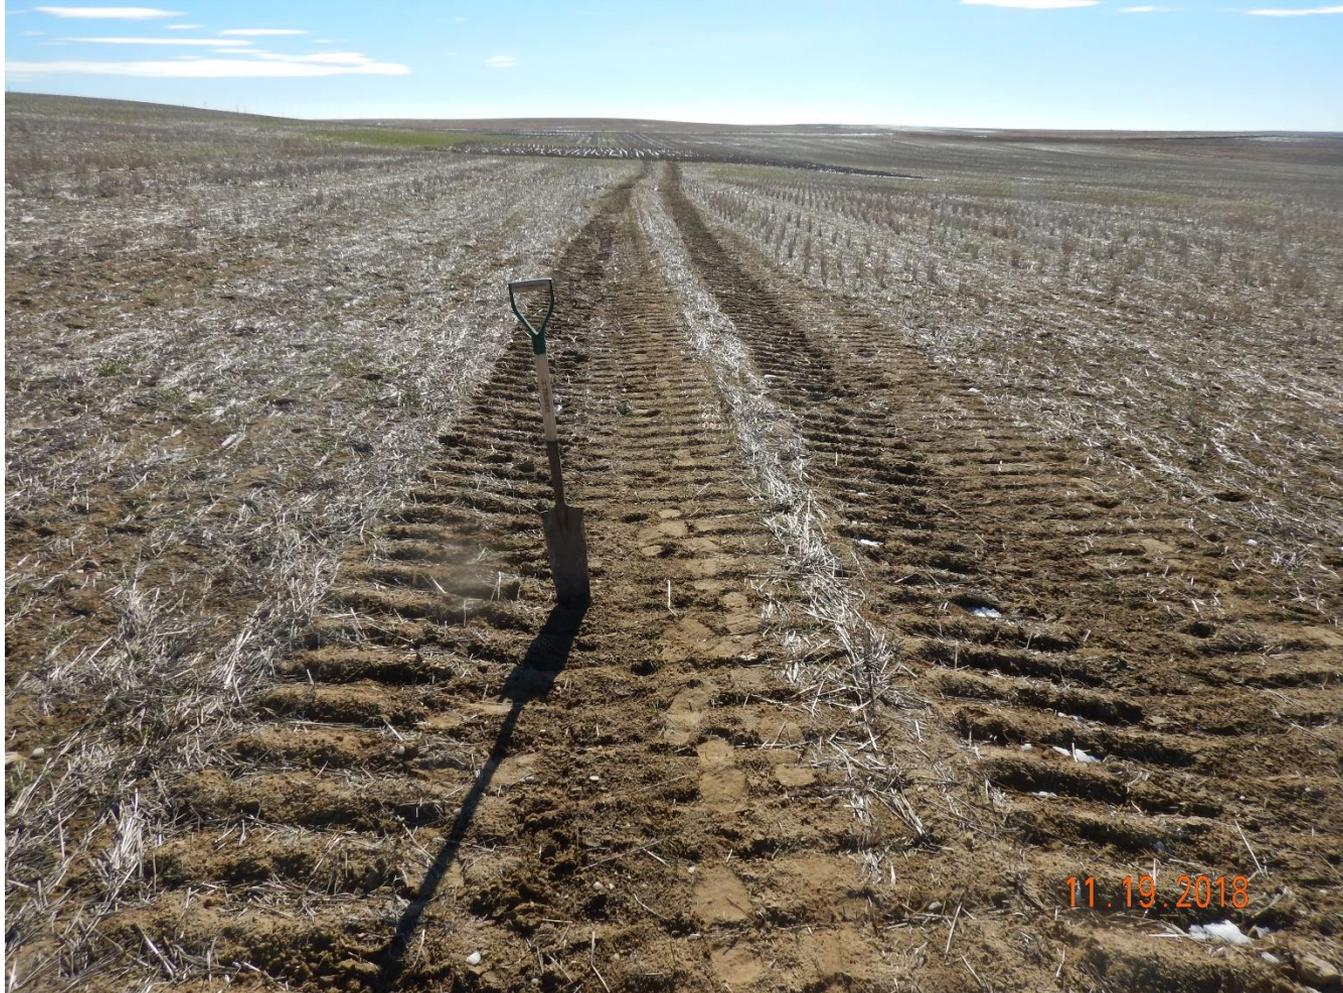
Photo 8: Photo taken from the access road, facing south. Photo shows inspector tested the access road for compaction. Photo shows inspector was only able to penetrate the top inch of soil on the access road. Compaction concerns evident.

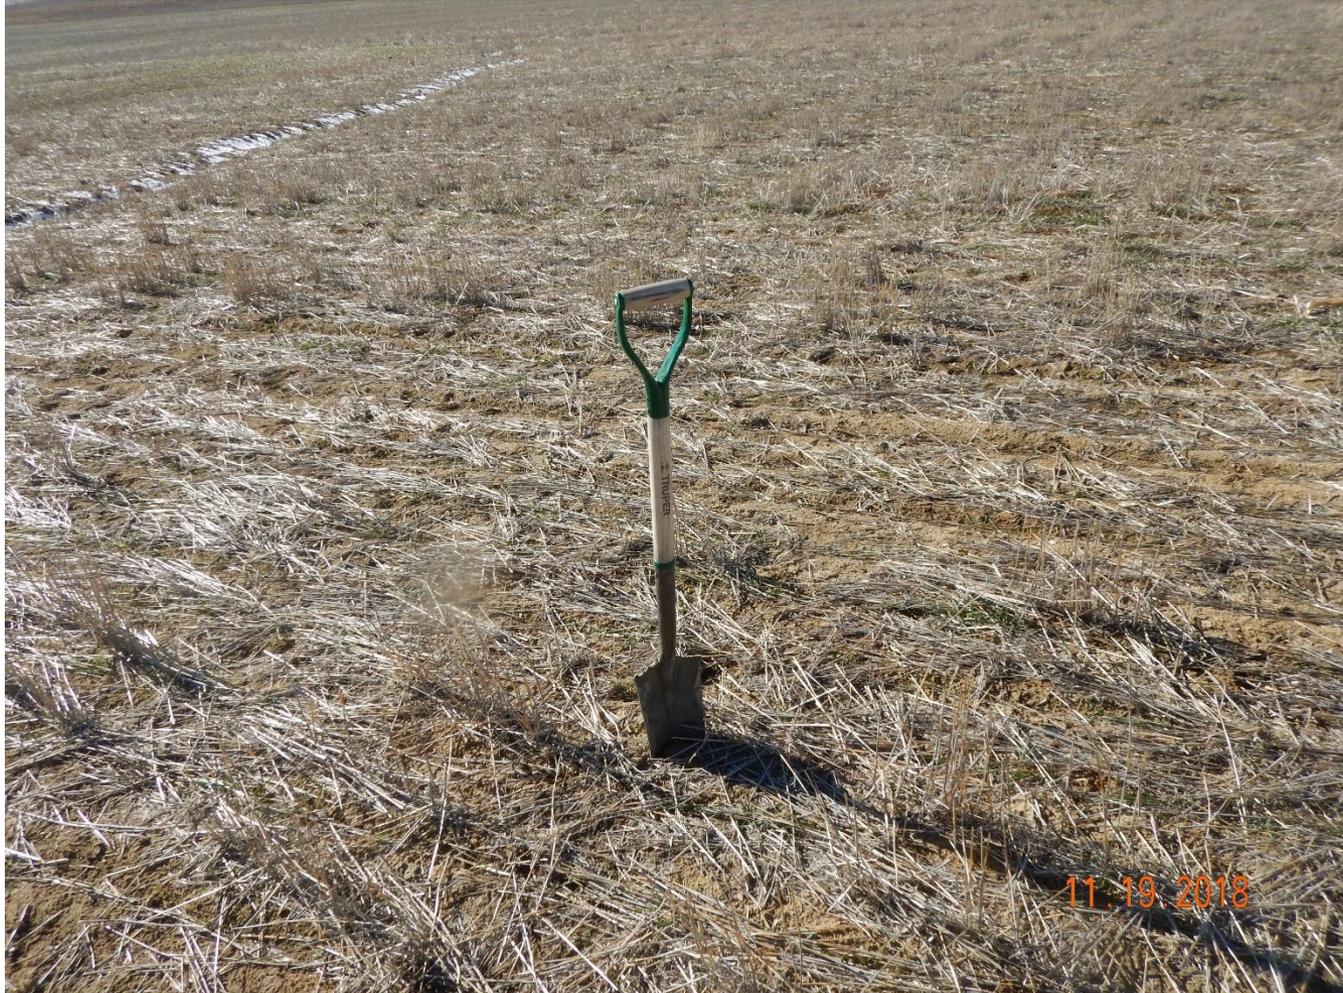
Photo 9: Photo taken from the adjacent reference area. Photo shows inspector was able to easily penetrate the top 6-8 inches of soil.

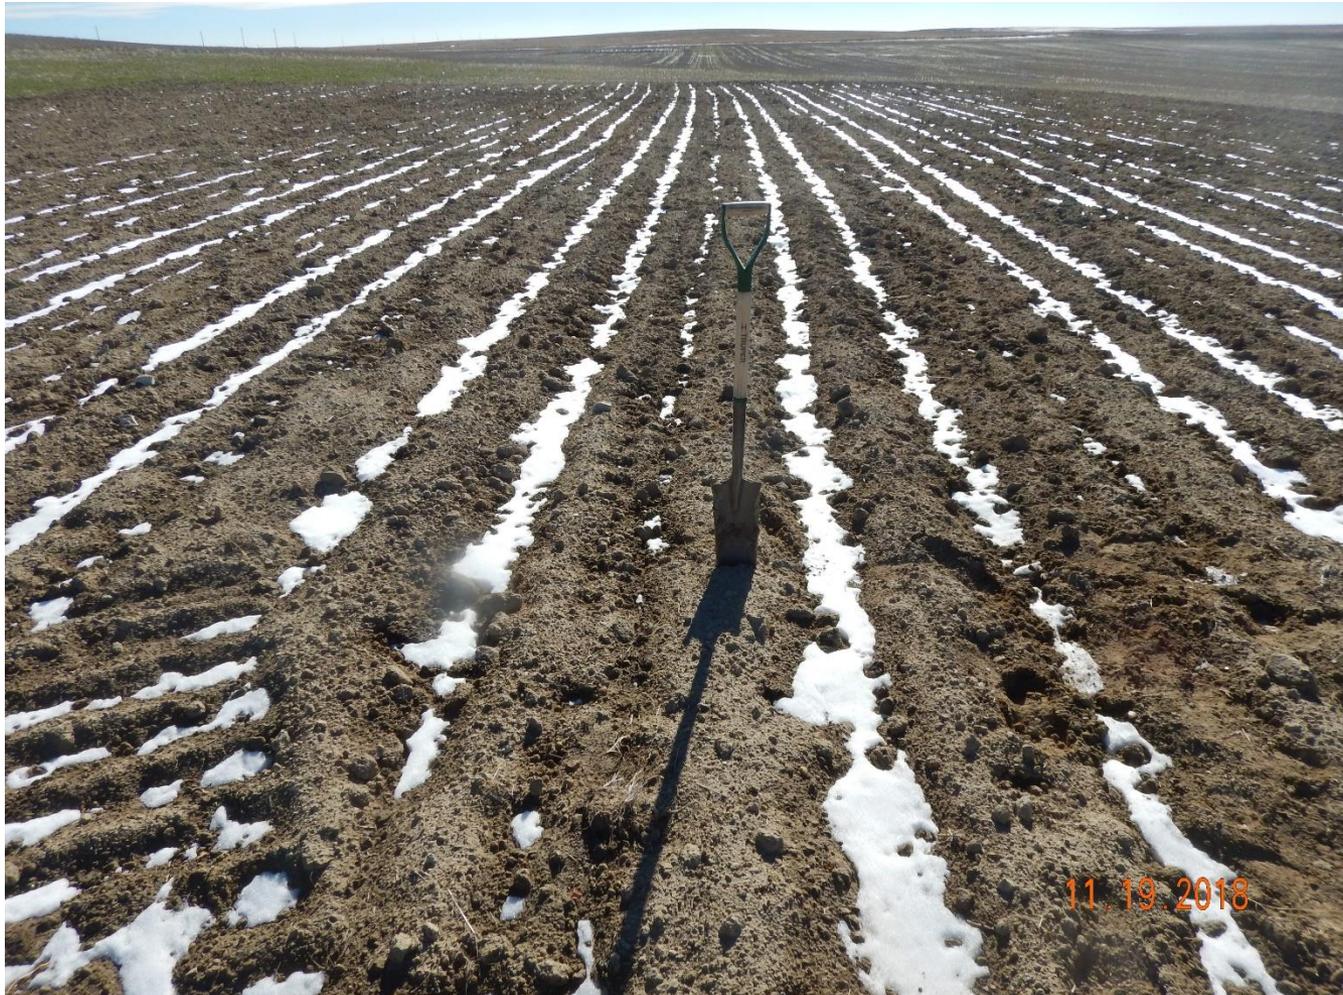
Photo 10: Photo taken from the location, facing south. Photo shows inspector tested the location for compaction. Photo shows inspector was only able to penetrate the top couple of inches of soil on the areas of location that were not ripped. Compaction concerns evident.
