Inspection Photos

Operator: FOUNDATION ENERGY
MANAGEMENT LLC - 10112

Location ID: 327573

Inspection Doc. Number: 682504199
Weld County, CO

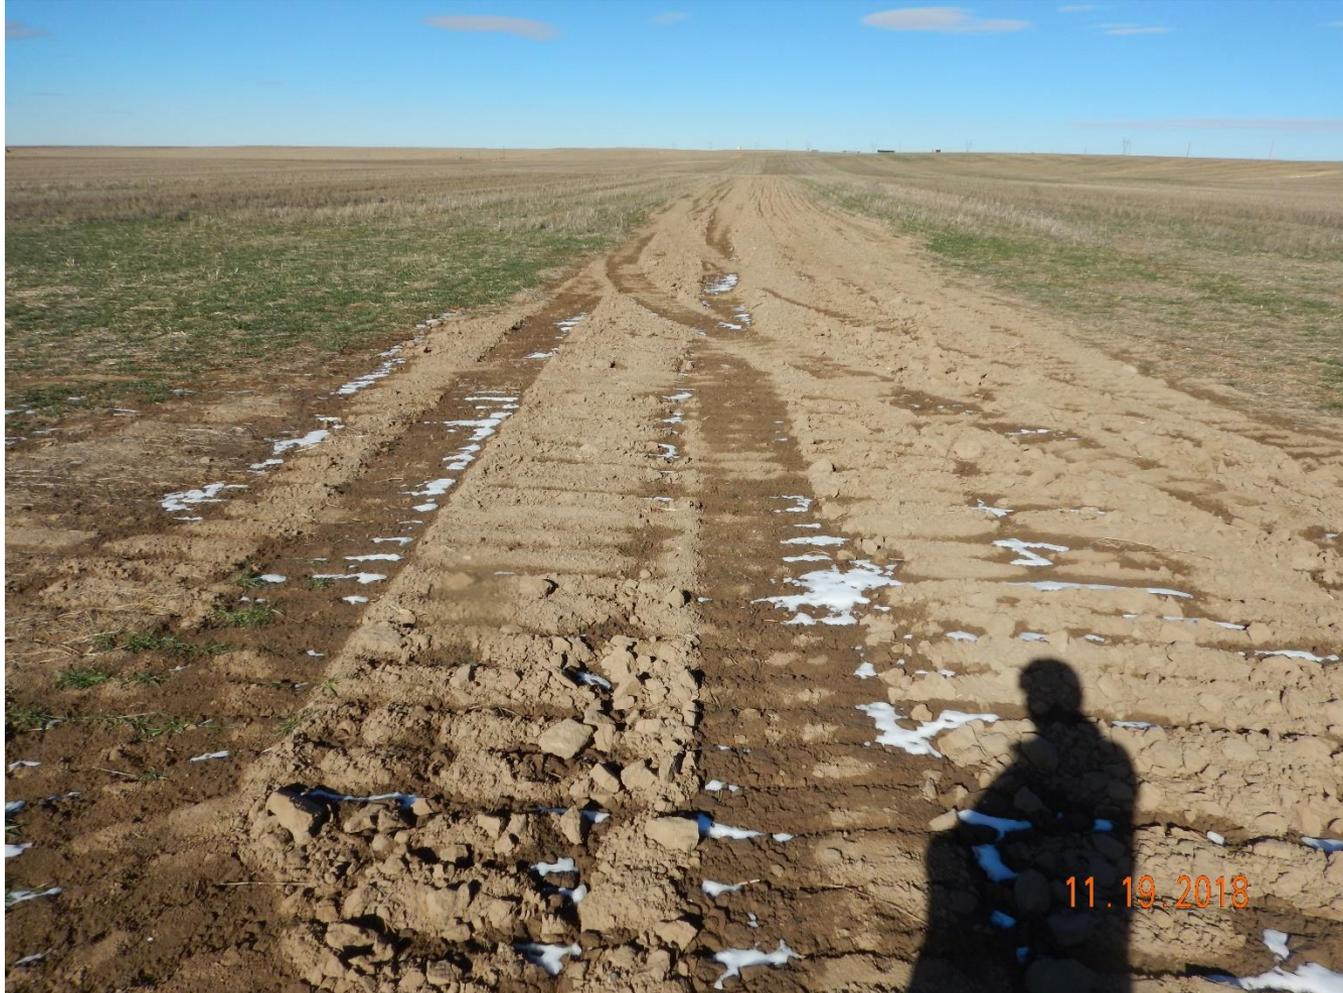
Photo 1: Photo taken from the access road, facing north. Unable to find evidence that compaction alleviation has been conducted in accordance with 1004.a on access road.

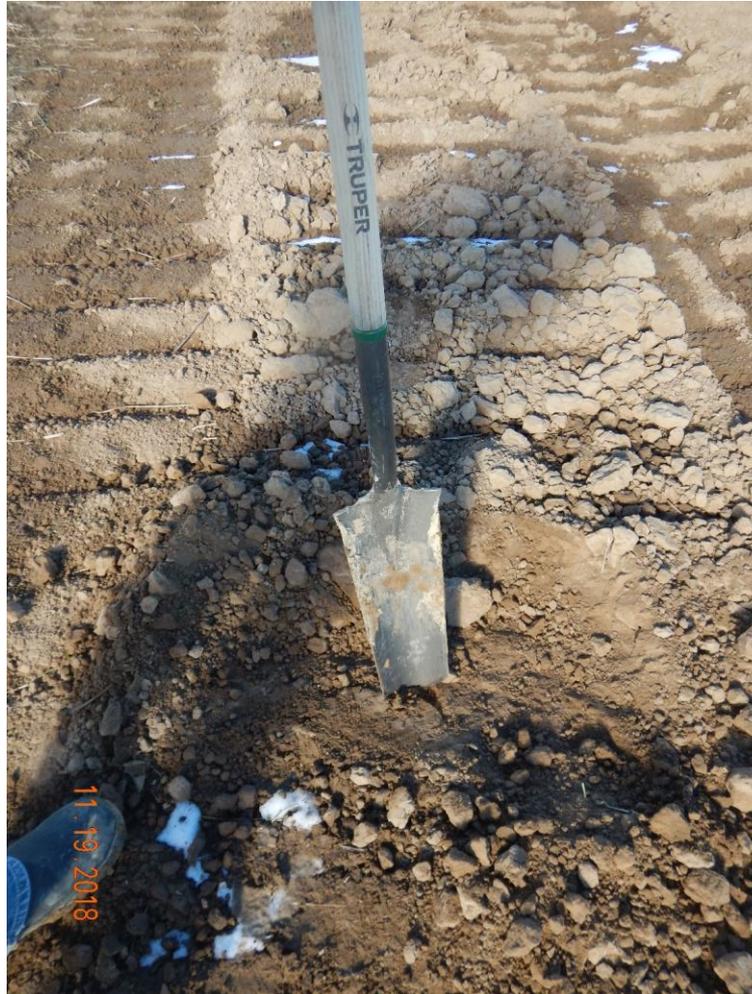
Photo 2: Photo taken from the access road. Photo shows inspector tested the access road for compaction. Photo shows inspector was able to find a compaction layer only a couple of inches sub-surface. Unable to find evidence that compaction alleviation has been conducted in accordance with 1004.a on access road.

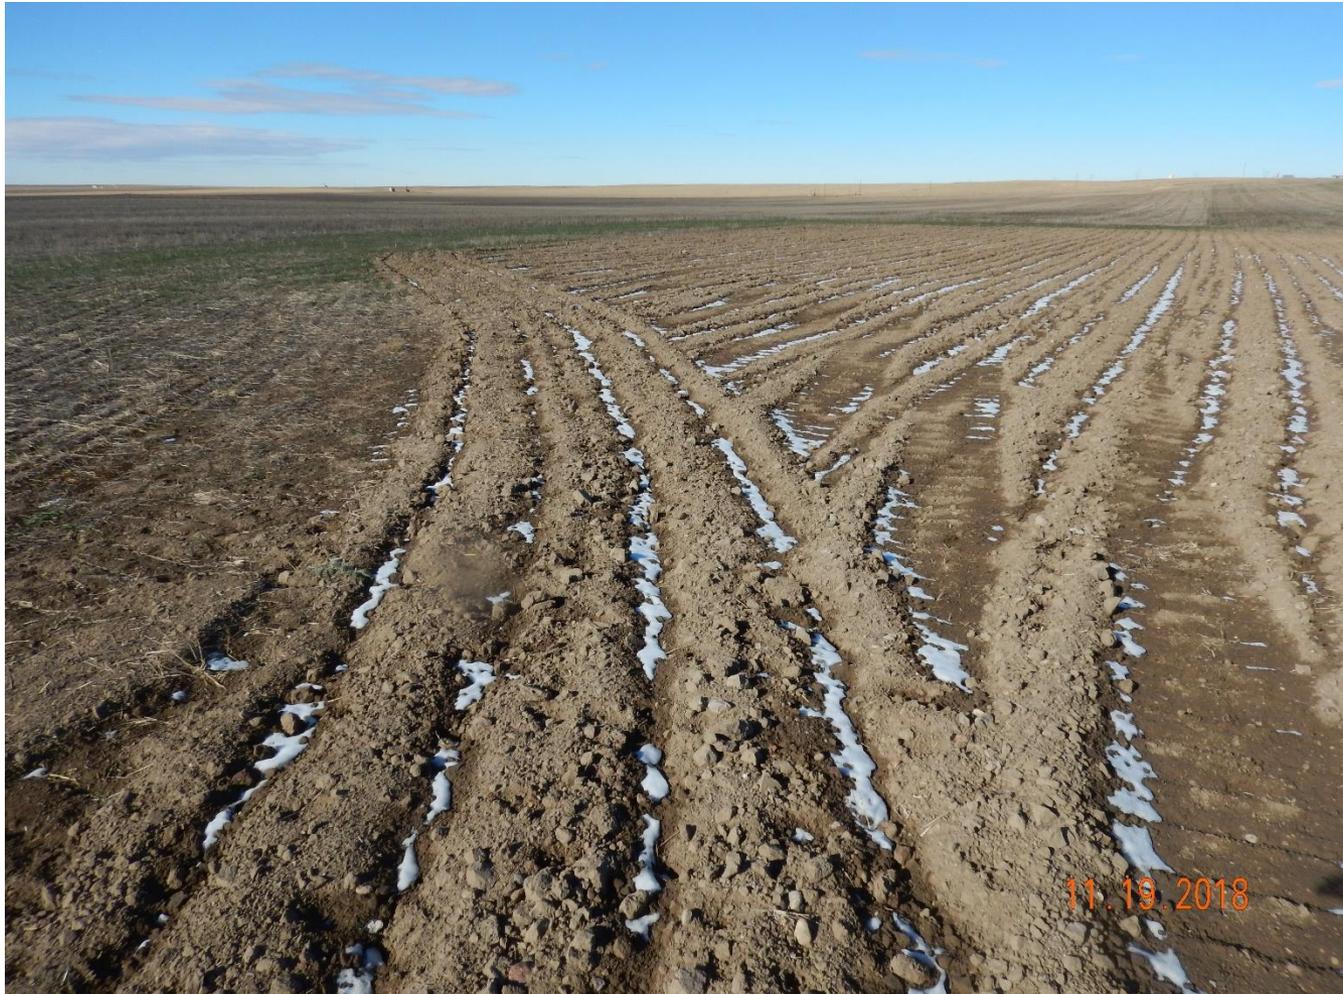
Photo 3: Photo taken from the south end of the location, facing northwest. Photos 3-5 provide an overview of the location from northwest, north, to northeast. Photos show reclamation does not appear to have been conducted in accordance with 1000 series reclamation requirements; 1004.a requires compaction alleviation to be conducted by cross-ripping to a depth of 18 inches. Location has not been cross ripped. Compaction concerns remain evident.

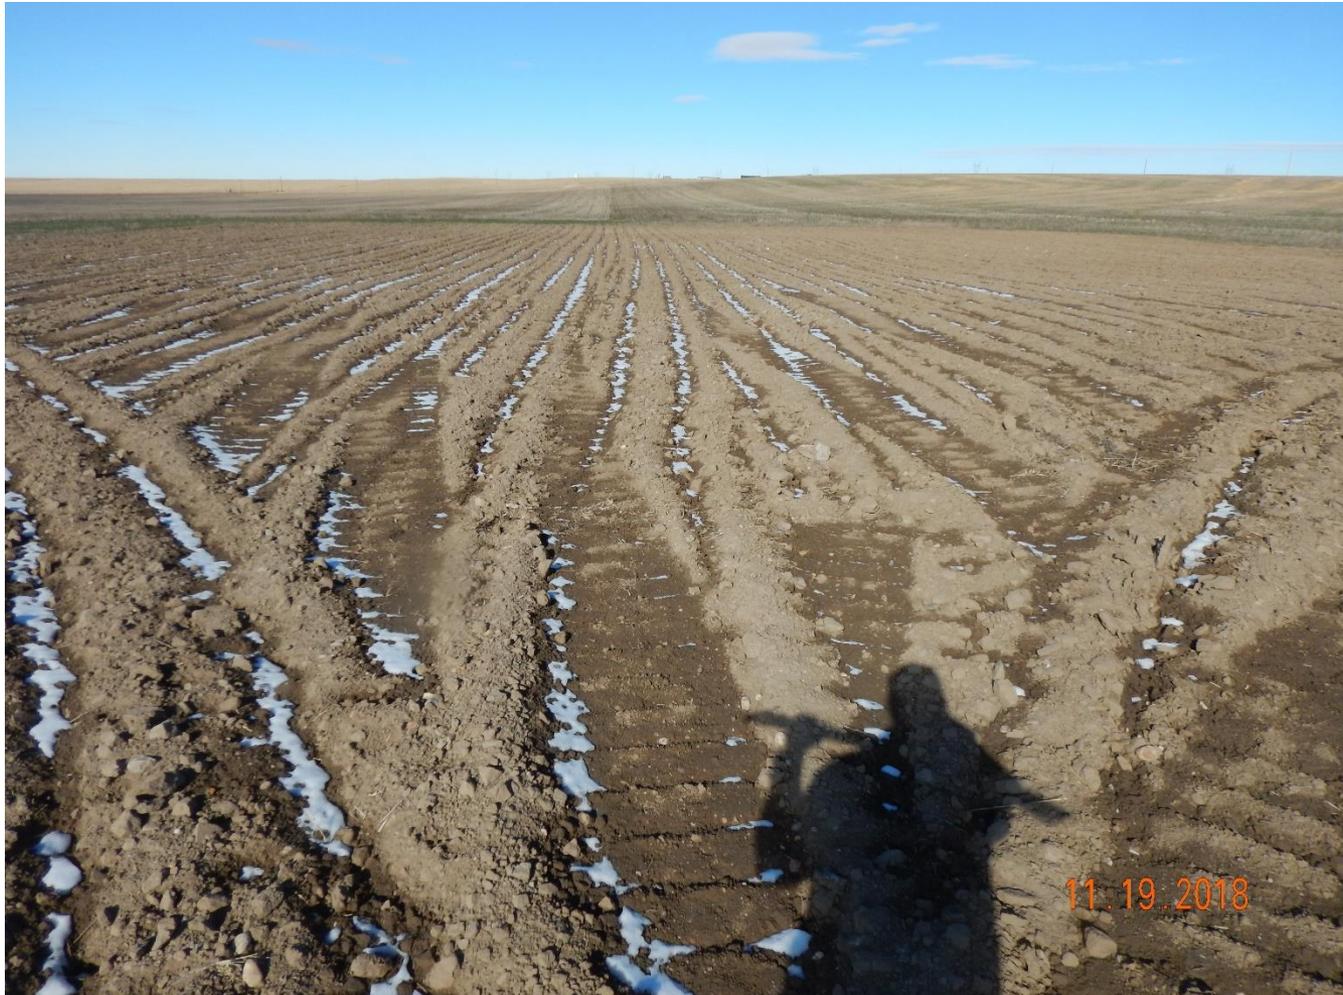
Photo 4: See comments under photo 3.

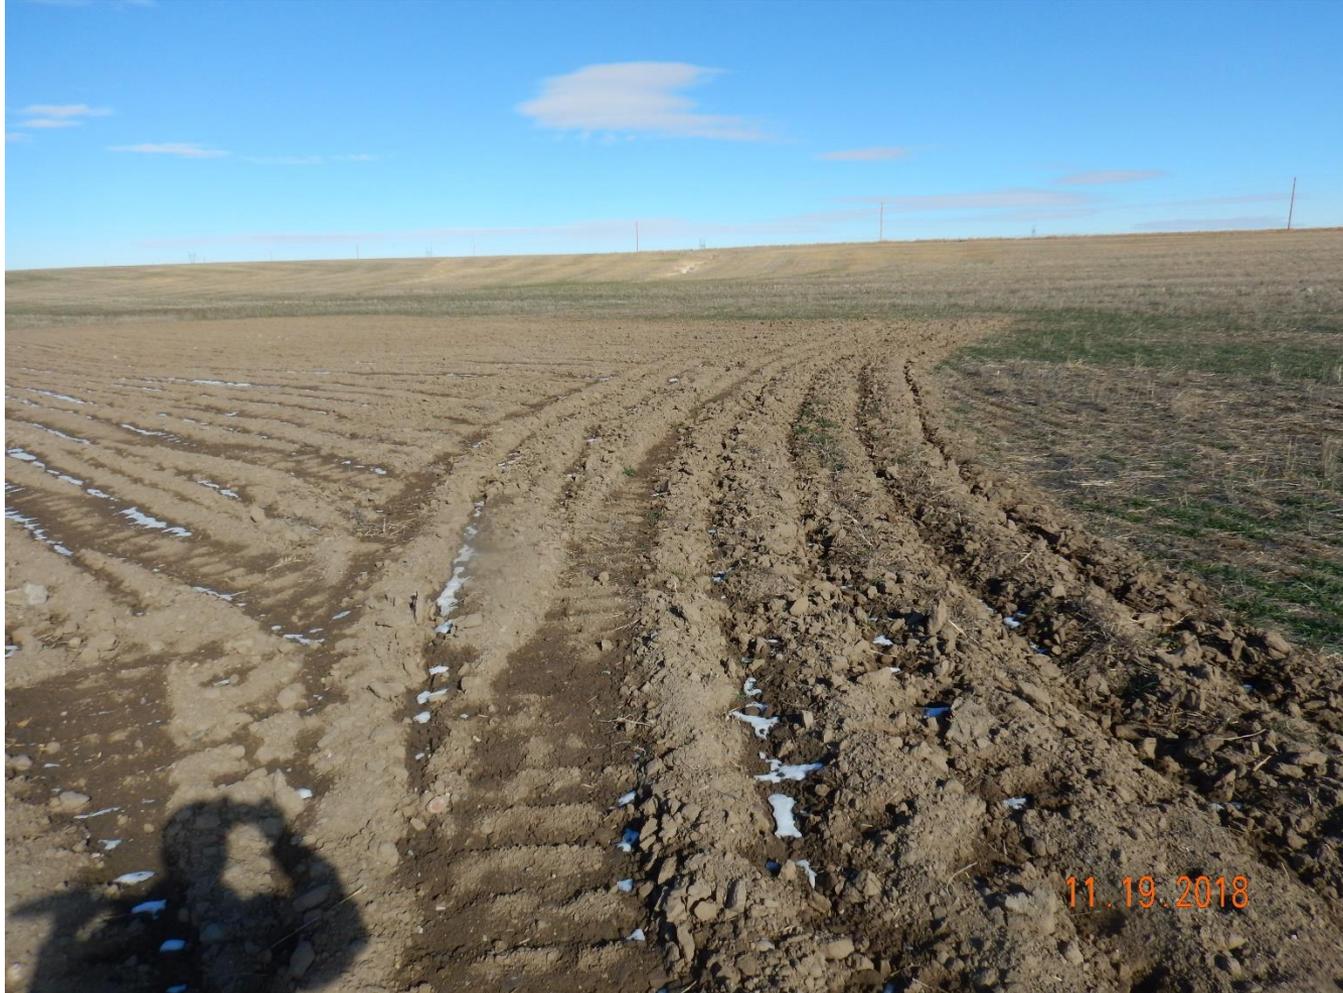
Photo 5: See comments under photo 3

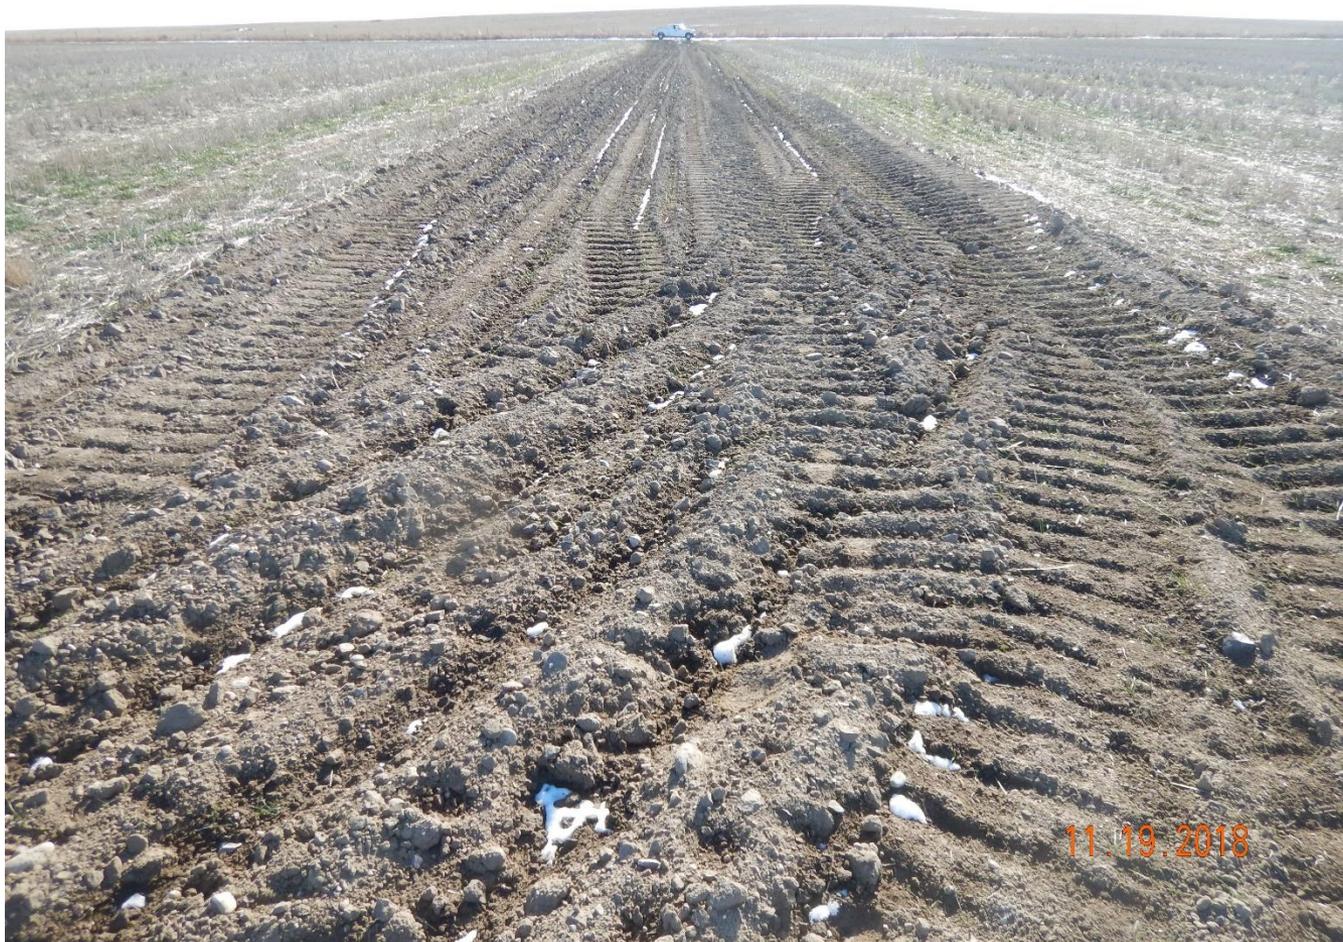
Photo 6: Photo taken from the location, facing south. Photo shows access road. See comments under photo 1.

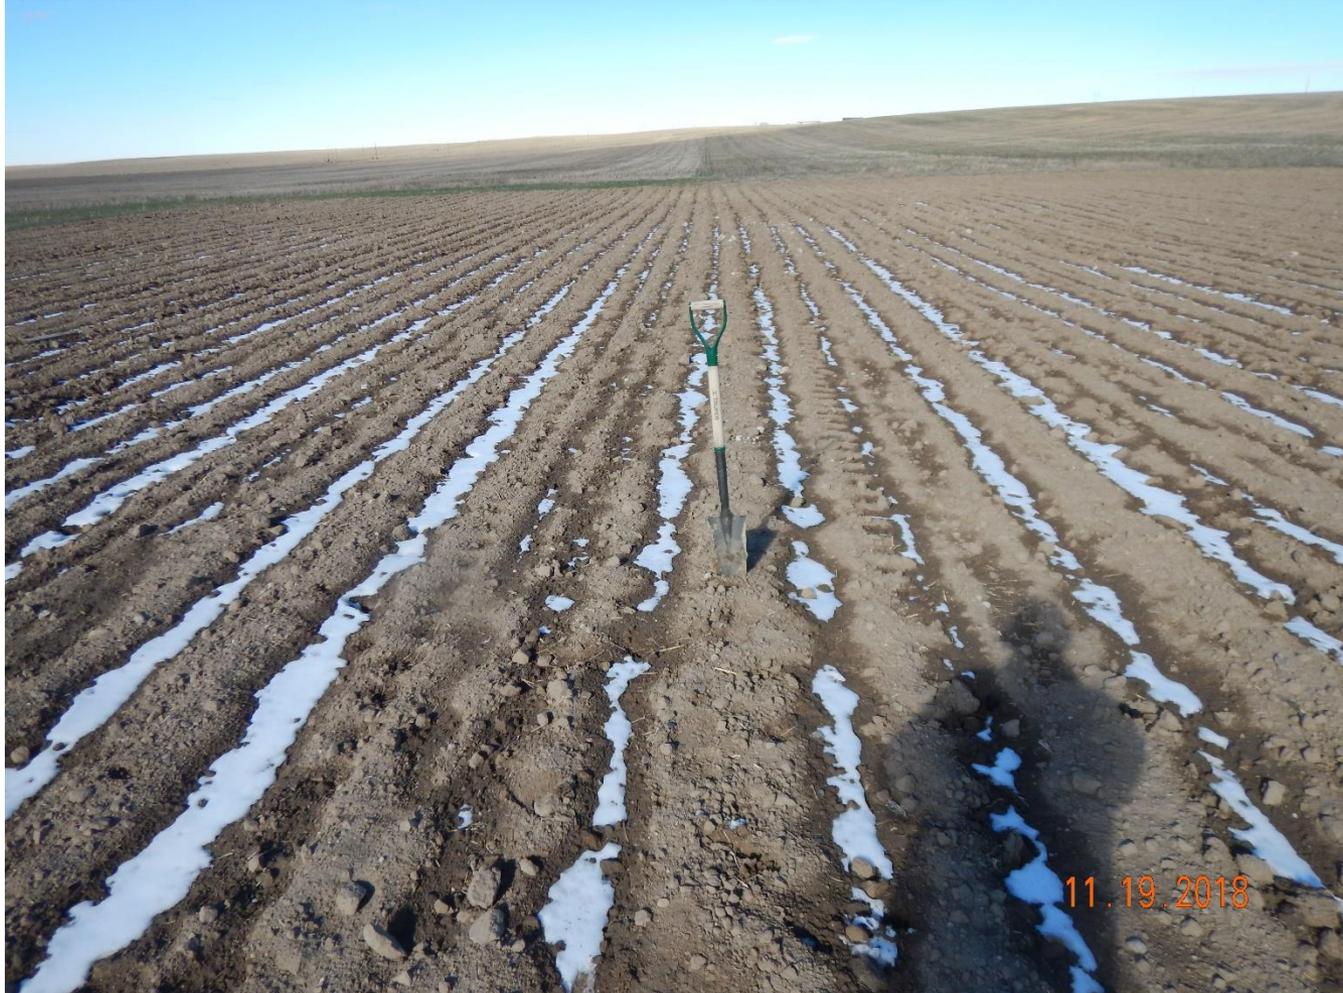
Photo 7: Photo taken from the location, facing north. Photo shows inspector tested the location for compaction. Photo shows inspector was only able to penetrate the top couple of inches of soil on the areas of location that were not ripped. Compaction concerns evident.
