# Inspection Photos

Operator: FOUNDATION ENERGY  
MANAGEMENT LLC - 10112

Location ID: 327445

Inspection Doc. Number: 682504201  
Weld County, CO

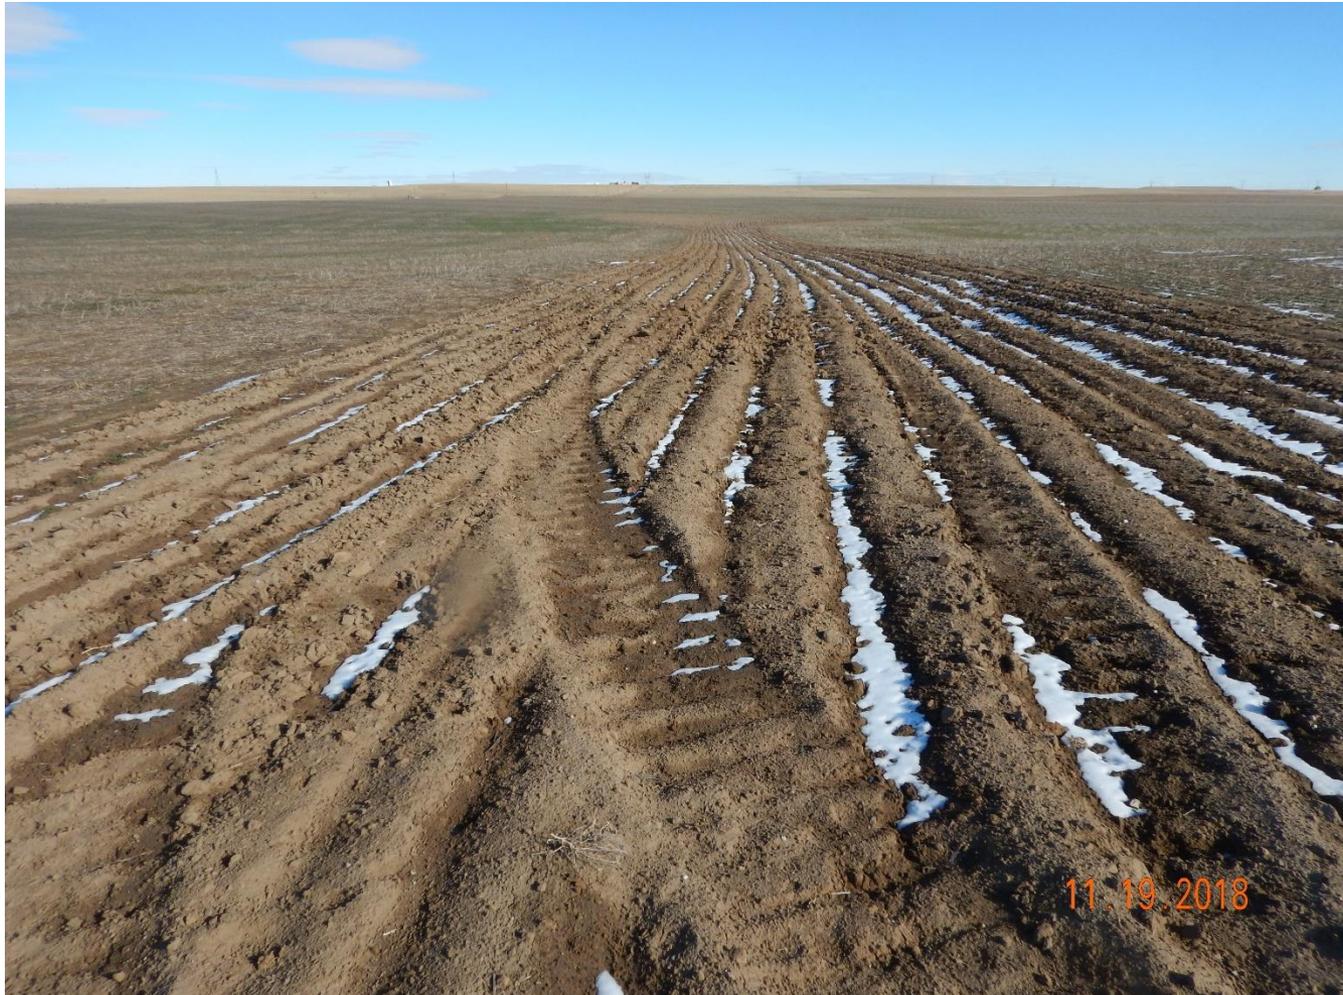
**Photo 1:** Photo taken from the access road, facing east. Unable to find evidence that compaction alleviation has been conducted in accordance with 1004.a on access road; access road does not appear to have been cross-ripped.

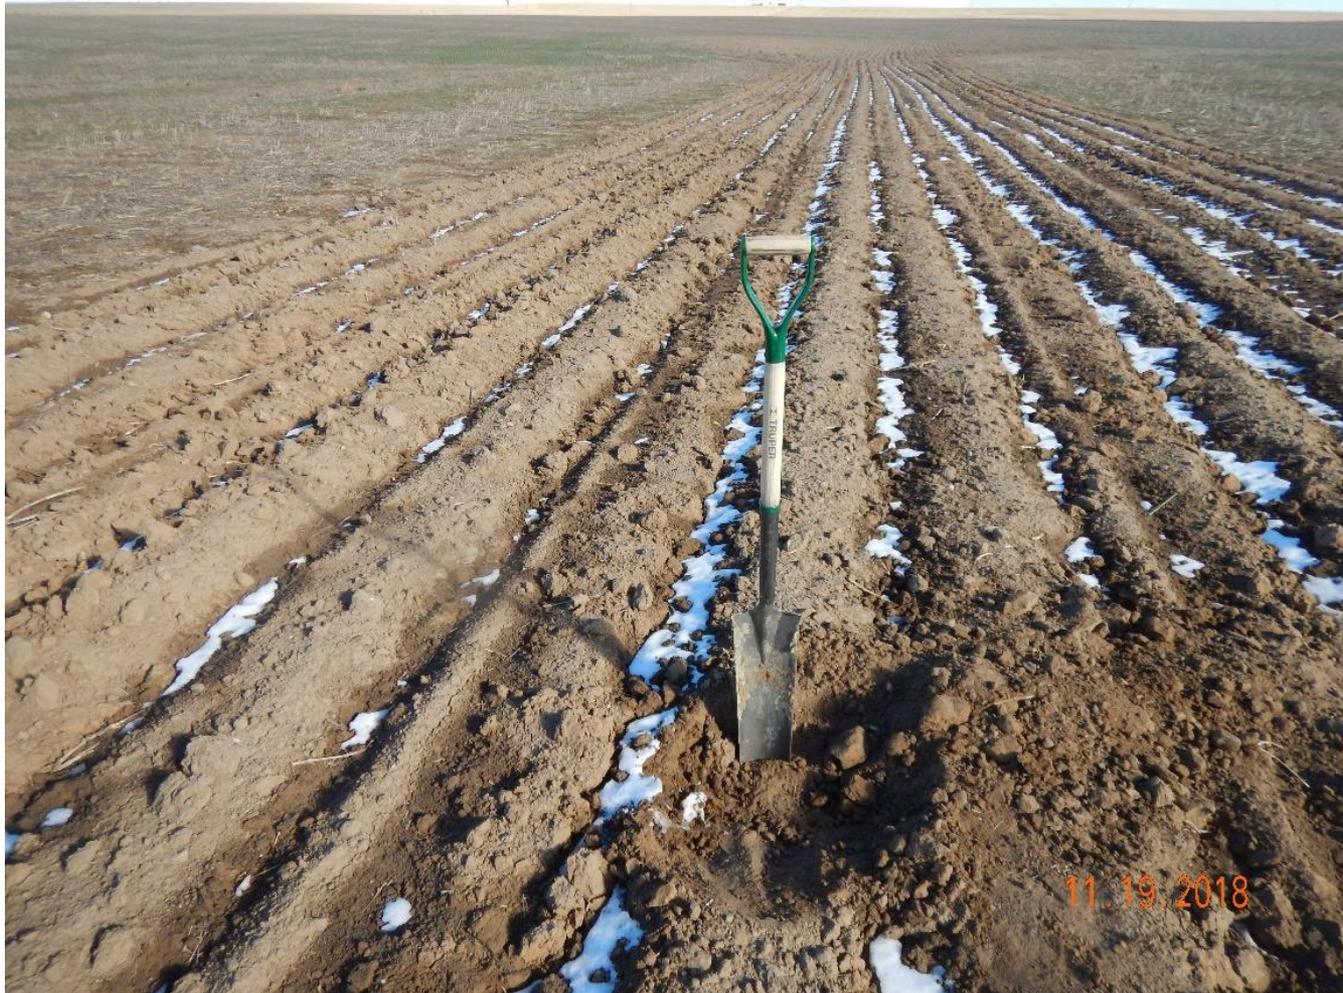
**Photo 2:** Photo taken from the access road, facing east. Photo shows inspector tested the location for compaction. Photo shows inspector found compaction zones a few inches sub-surface within areas of the road that were not cross-ripped.

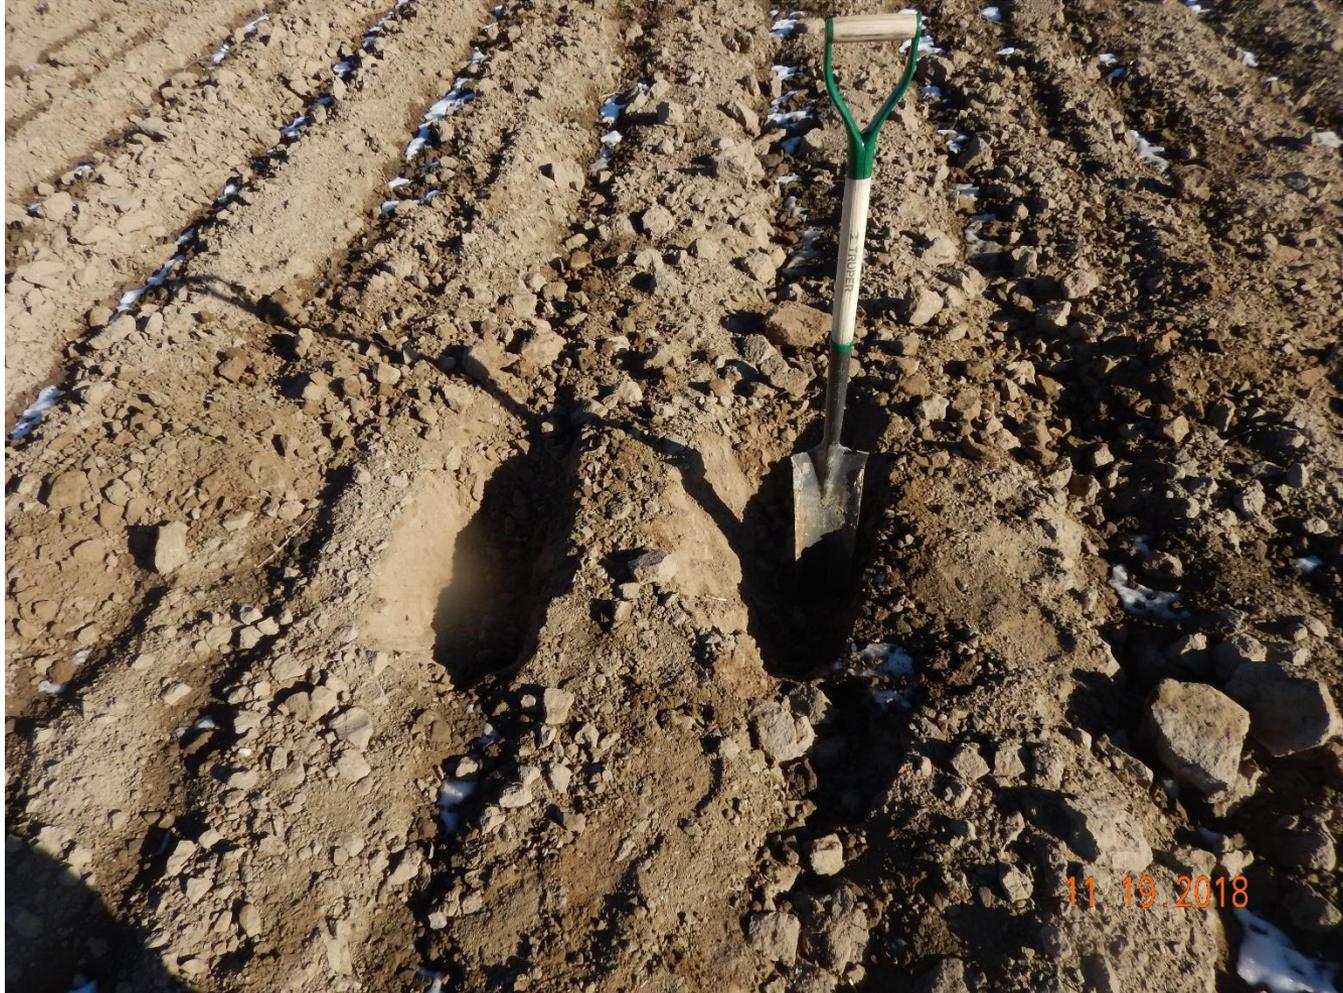
**Photo 3:** See comments under photo 2.

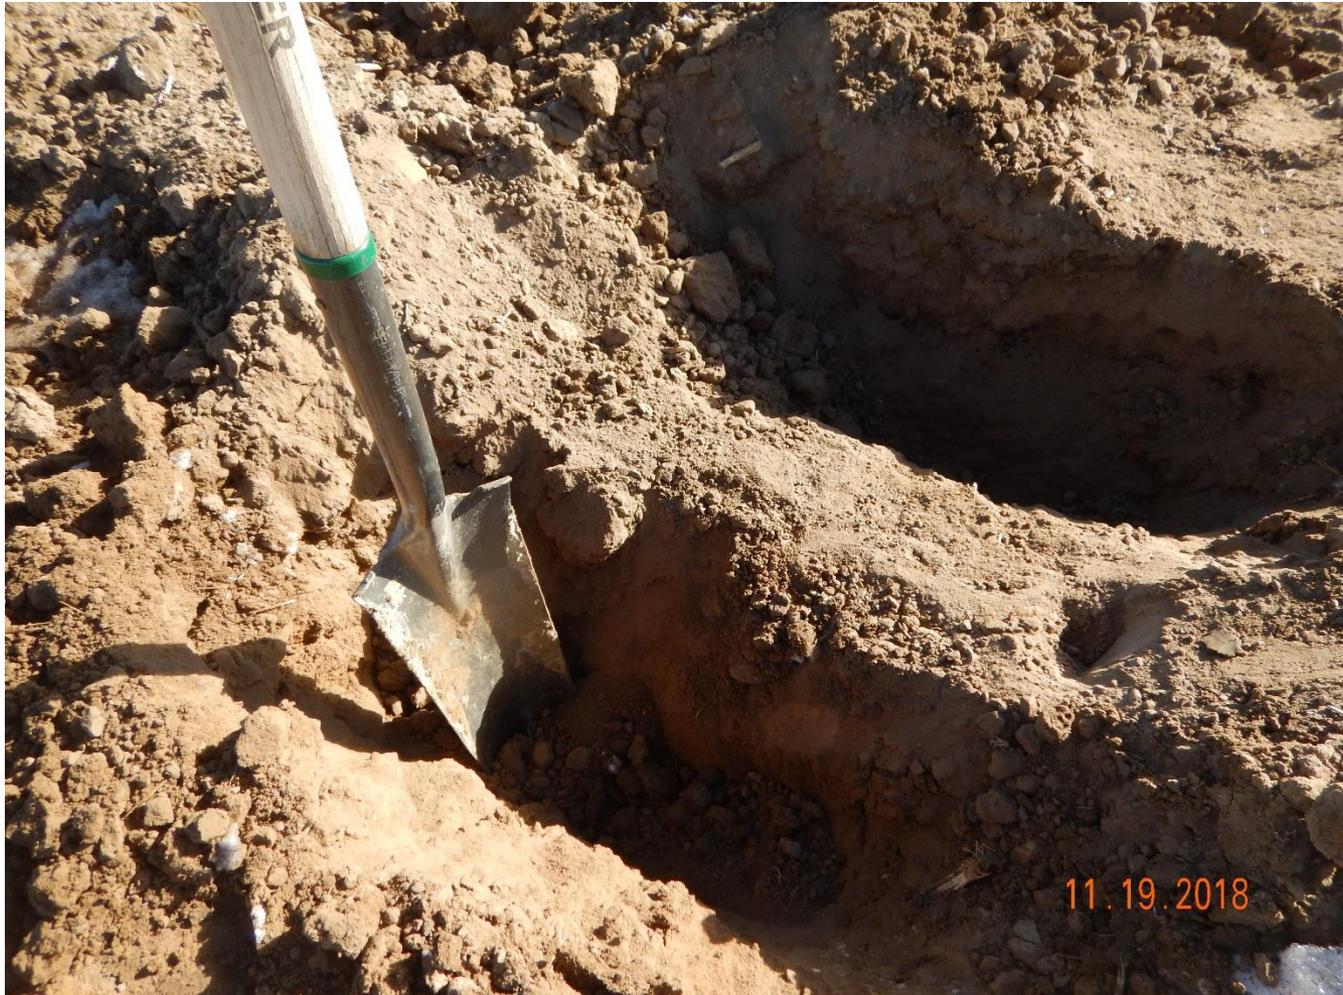
**Photo 4:** See comments under photo 2.

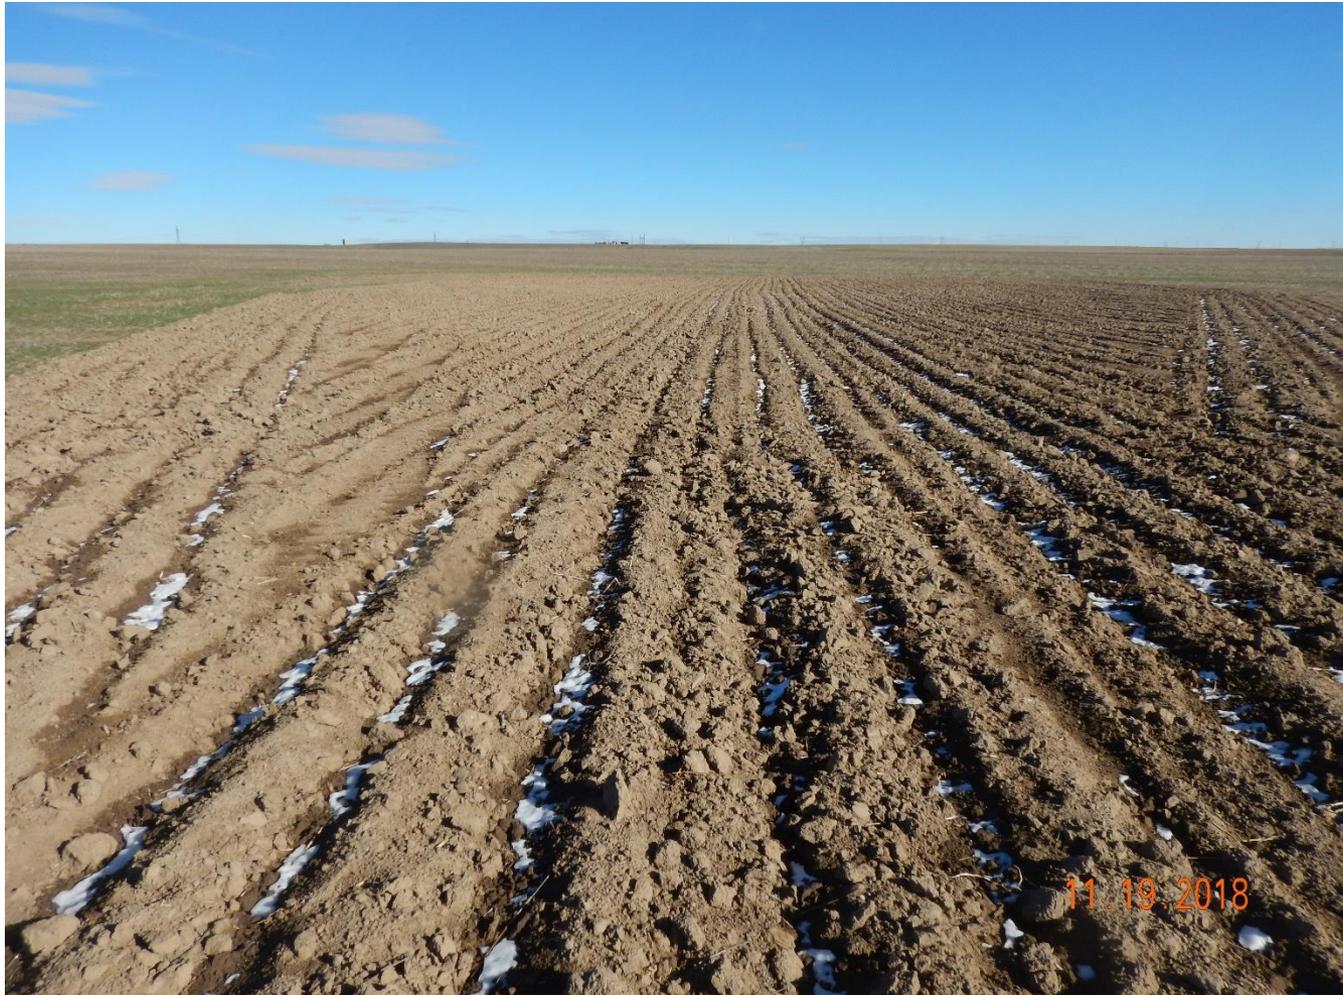
**Photo 5:** Photo taken from the location, facing east. Photo shows overview of the location. Photo shows reclamation does not appear to have been conducted in accordance with 1000 series reclamation requirements; 1004.a requires compaction alleviation to be conducted by cross-ripping to a depth of 18 inches. Location has not been cross ripped. Compaction concerns remain evident.

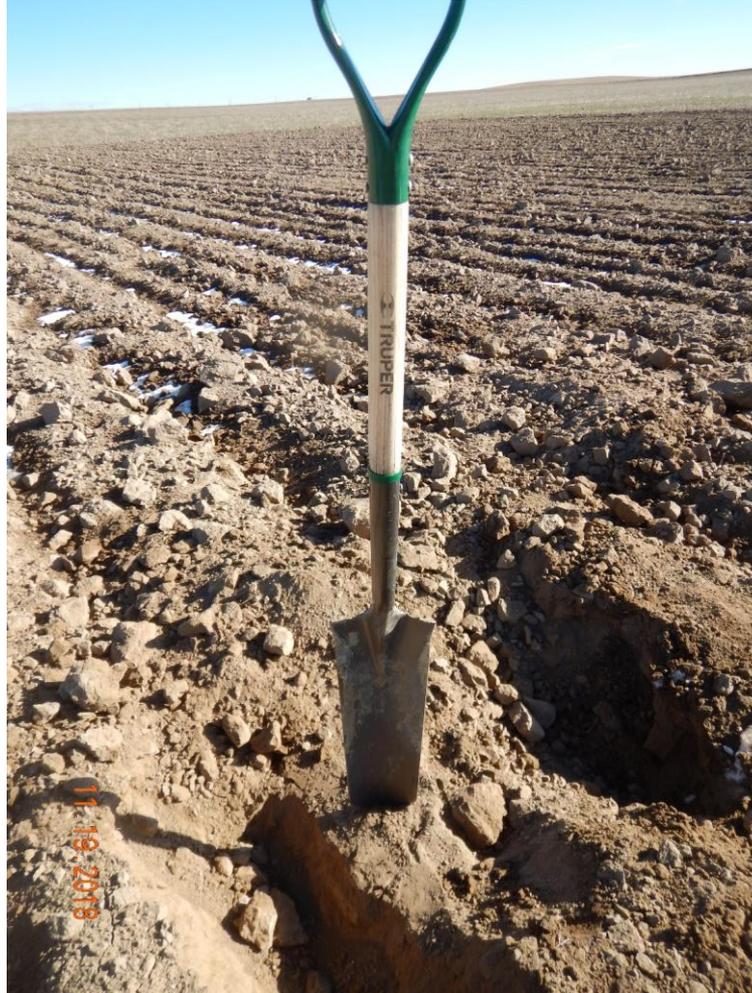
**Photo 6:** Photo taken from the location. Photo shows inspector tested the location for compaction. Photo shows inspector was only able to penetrate the top couple of inches of soil on the areas of location that were not ripped. Compaction concerns evident.

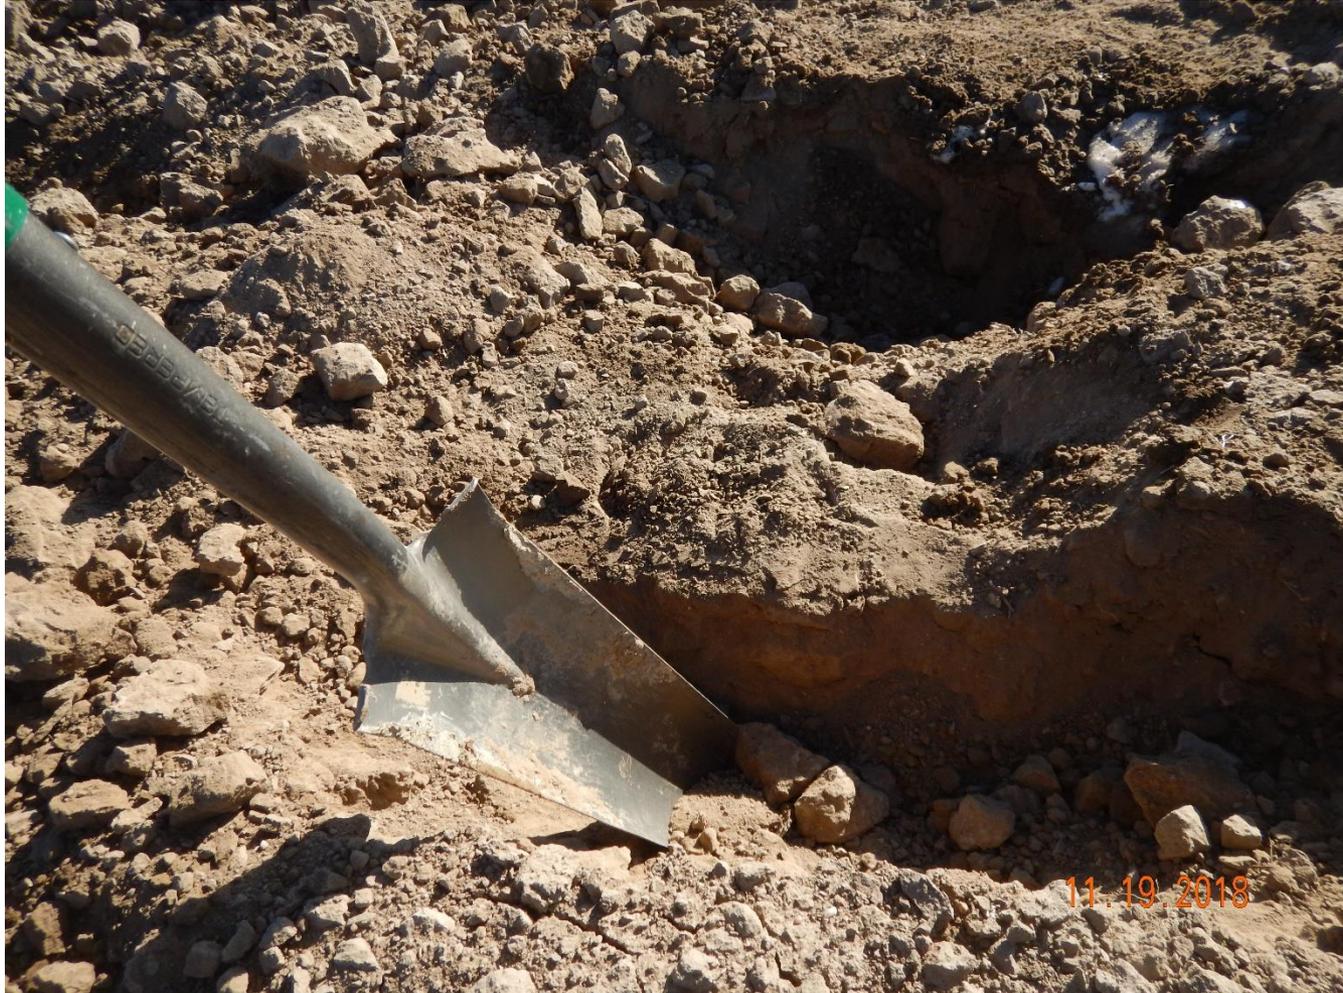
**Photo 7:** See comments under photo 6.
