Construction and Stormwater Inspection

Operator: HIGHPOINT OPERATING CORPORATION- #10071

Location ID: 458768

Inspection Document #: 682404223

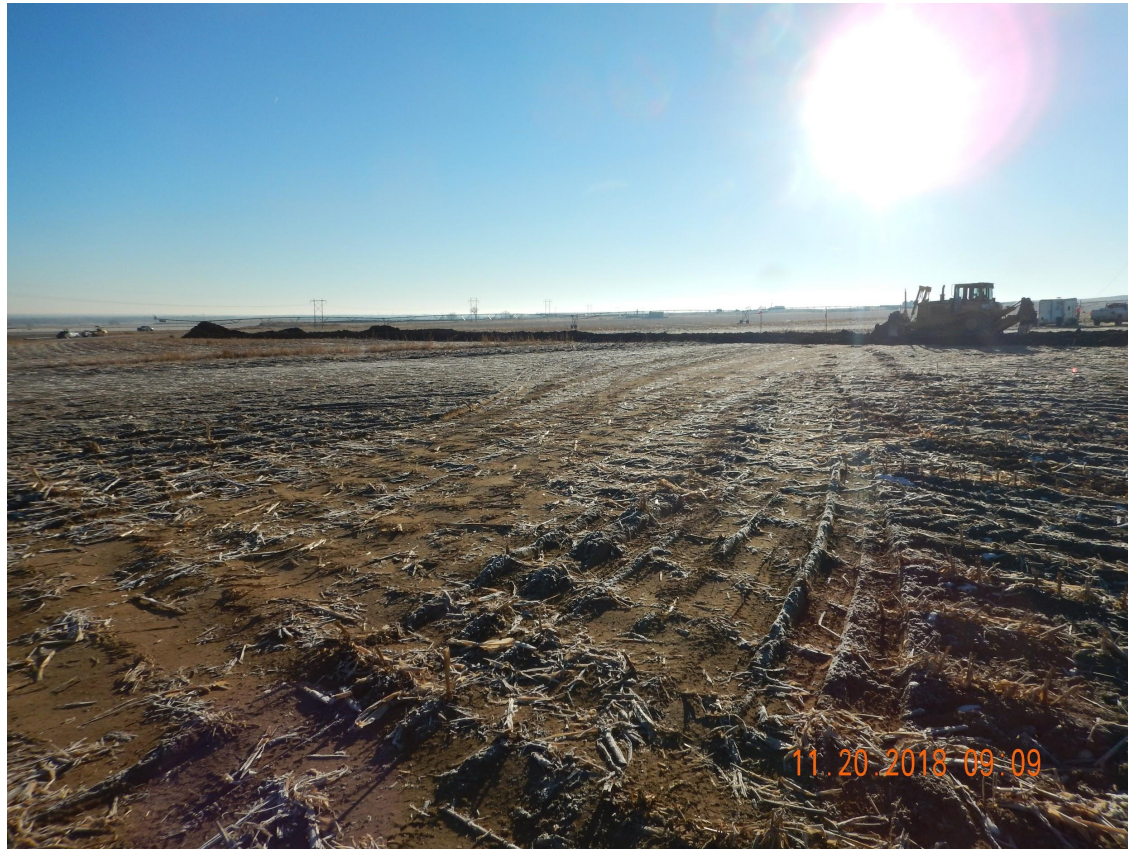
Photo 1. Photo taken from the northern location, facing South. Photo illustrates the start of topsoil salvage operations.

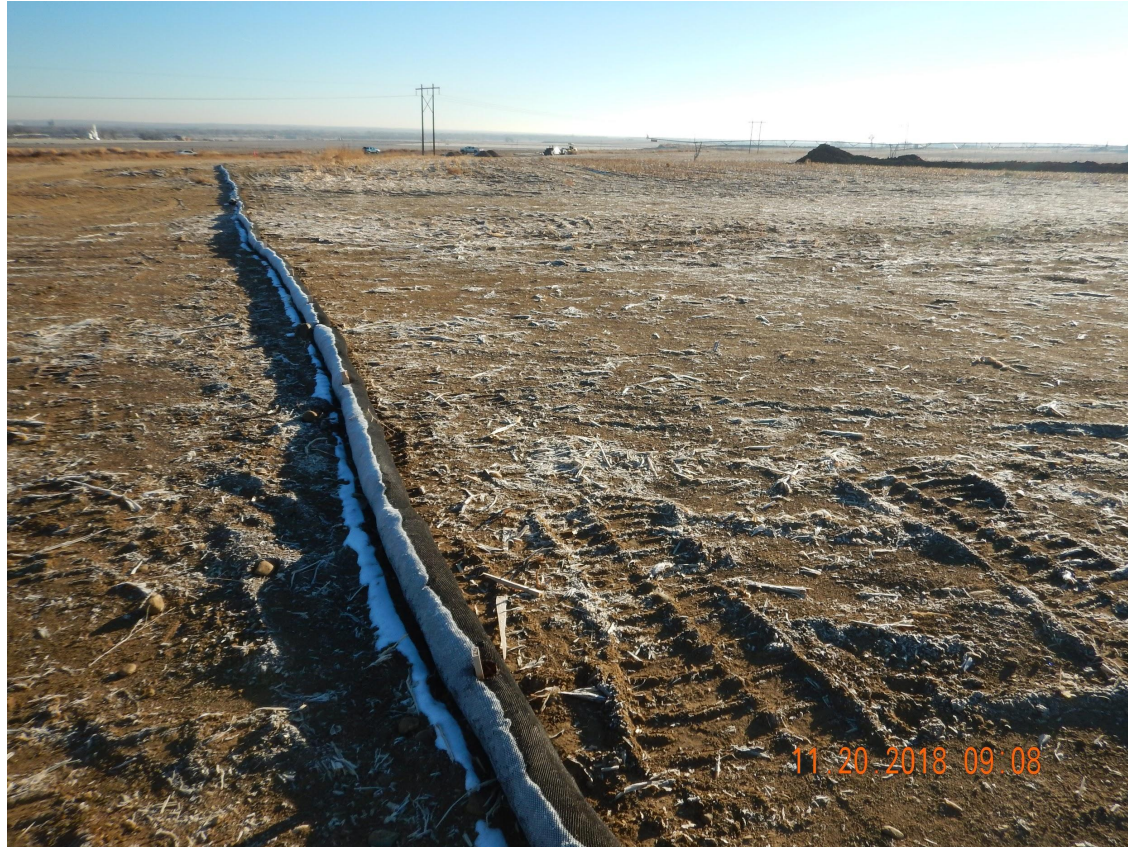
Photo 2. Photo taken from the northern perimeter of the location, facing East. Photo illustrates a temporary stormwater BMP which has been installed around the entire perimeter of the location. Filtrex wattle has been staked and trenched.

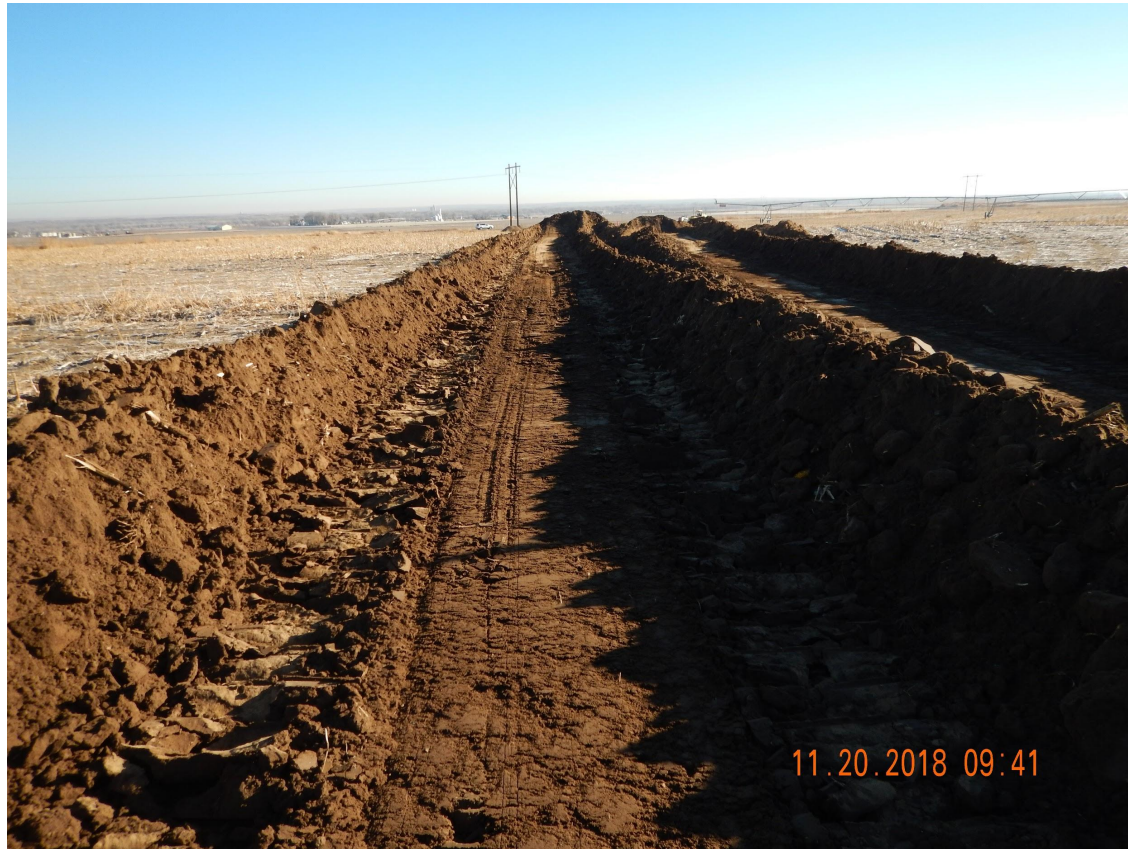
Photo 3. Photo taken from the initial topsoil salvage area, facing East. COGCC Staff is observing that all topsoil is being salvaged. Operator stated that topsoil would be salvaged from the entire disturbance area to a depth of 12”.

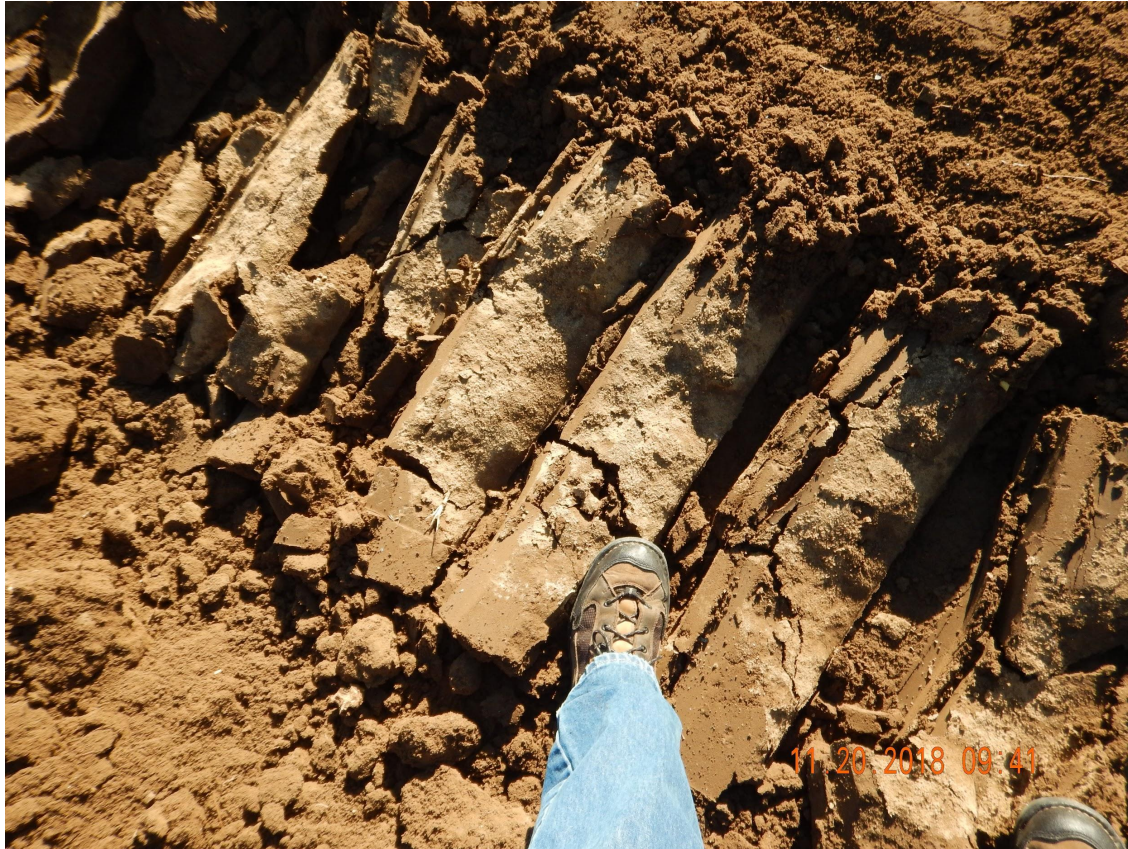
Photo 4. Close-up photo illustrating the first subsoil layer (sand) being encountered at a depth of 12”.
