Inspection Photos
Location Name: Mark 11,12,14-35
Facility ID: 326785

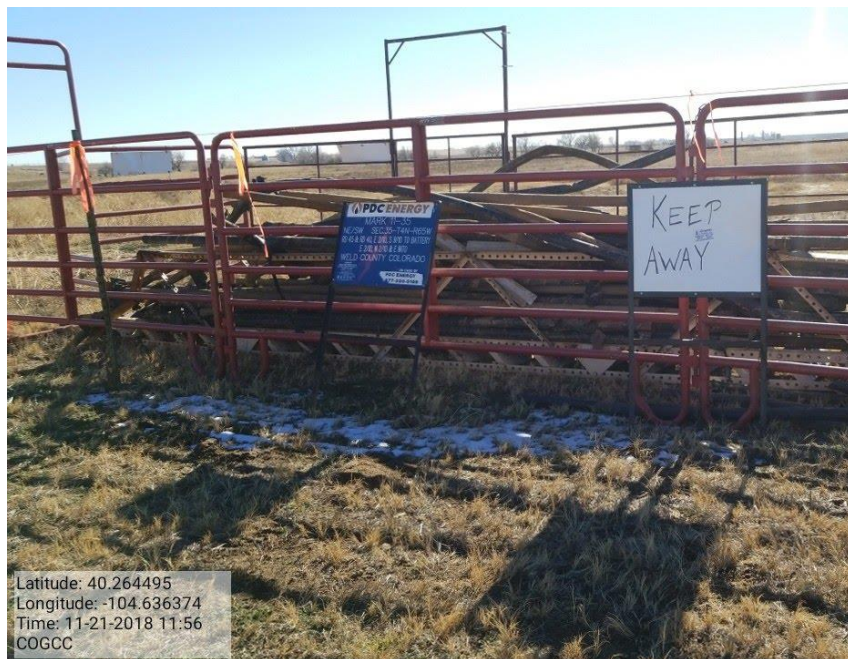
Photo 1 – Location sign and removed flow lines behind livestock fencing.

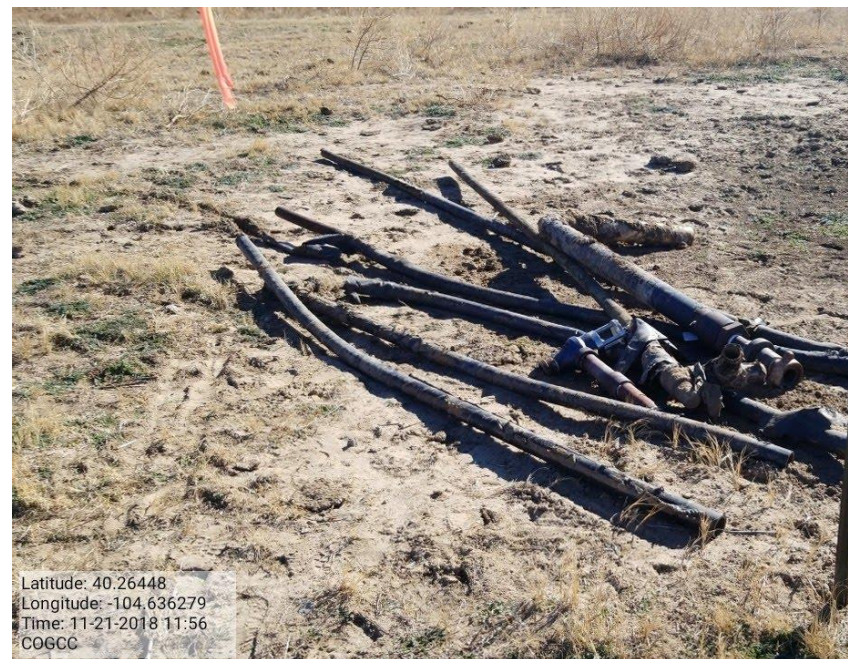
Photo 2 – Additional removed flow lines outside of fenced area.

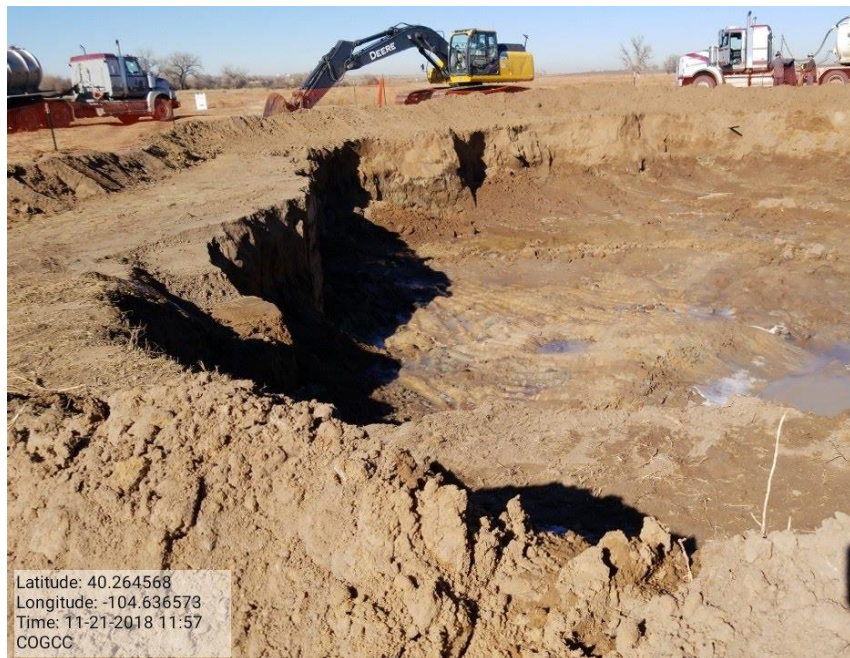
Photo 3 – Western pit; remedial vacuuming of groundwater had ended approximately 15 minutes prior to picture.

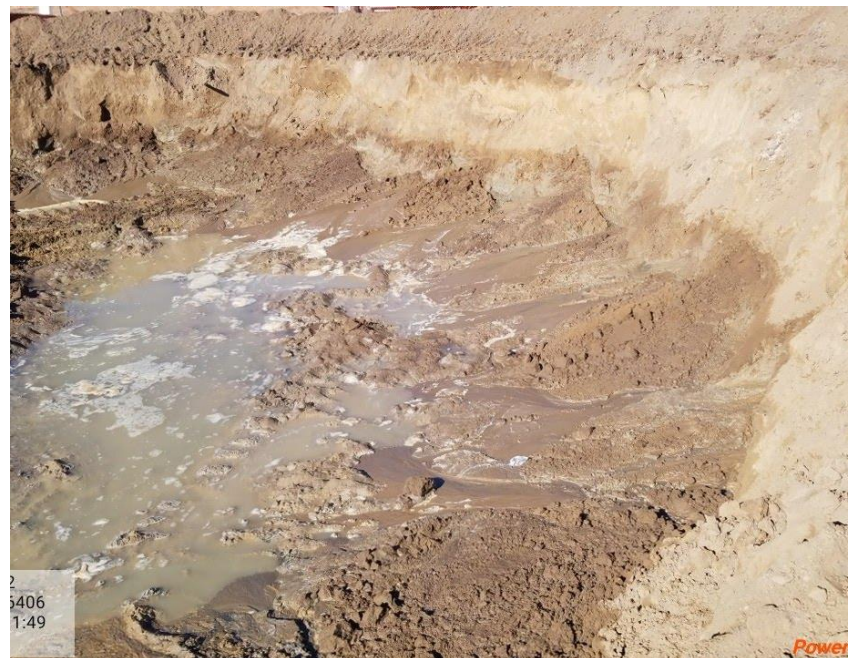
Photo 4 – Groundwater recharging into western pit.

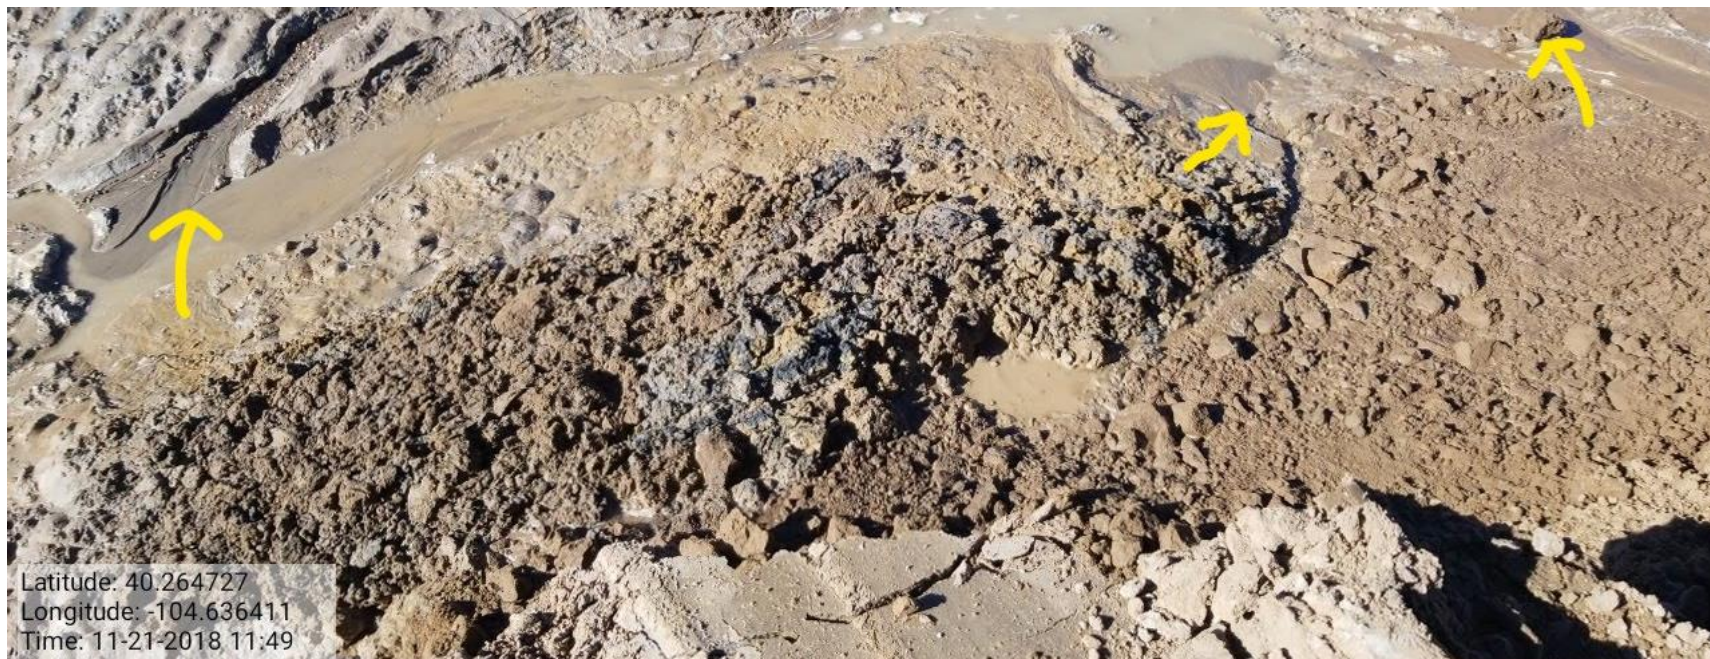
Photo 5 – Recharging groundwater carrying impacted sediment into excavation area along the southeastern wall.

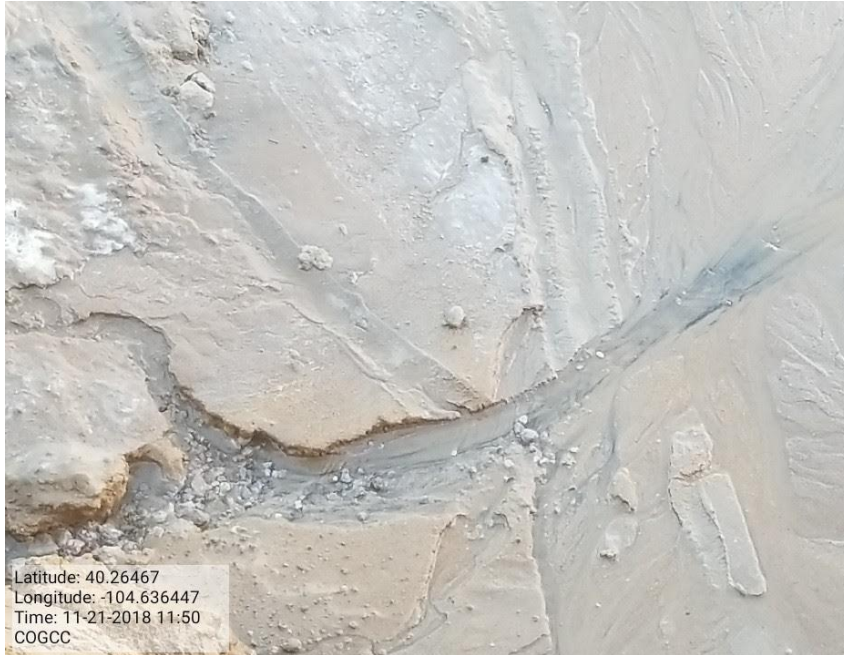
Photo 6 – Recharging groundwater carrying impacted sediment into excavation area along the southeastern wall.

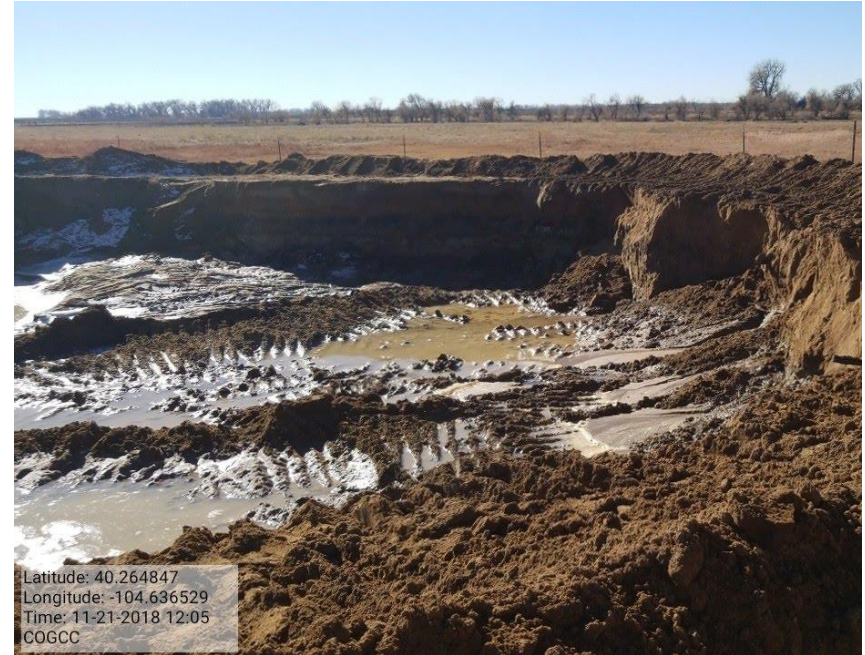
Photo 7 – Groundwater flowing into north wall. No signs of impact in deposited sediment

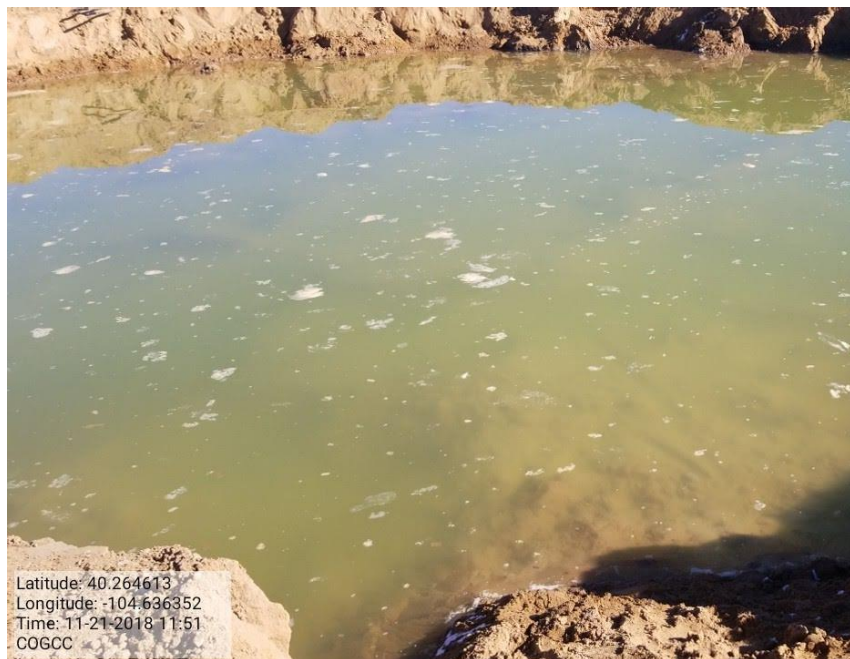
Photo 8 – Stabilized groundwater in eastern pit.

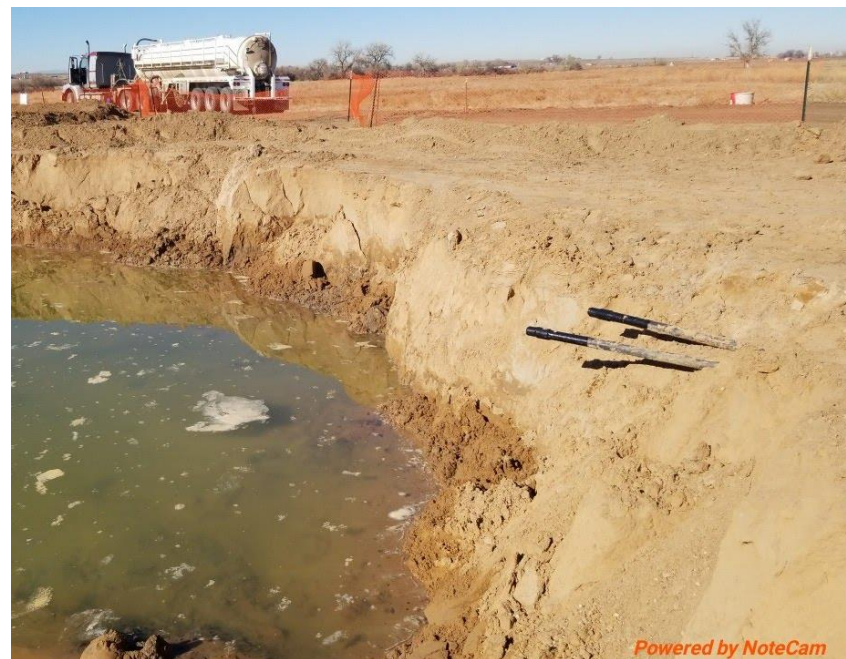
Photo 9 – Flow lines in place on sidewall of eastern pit.

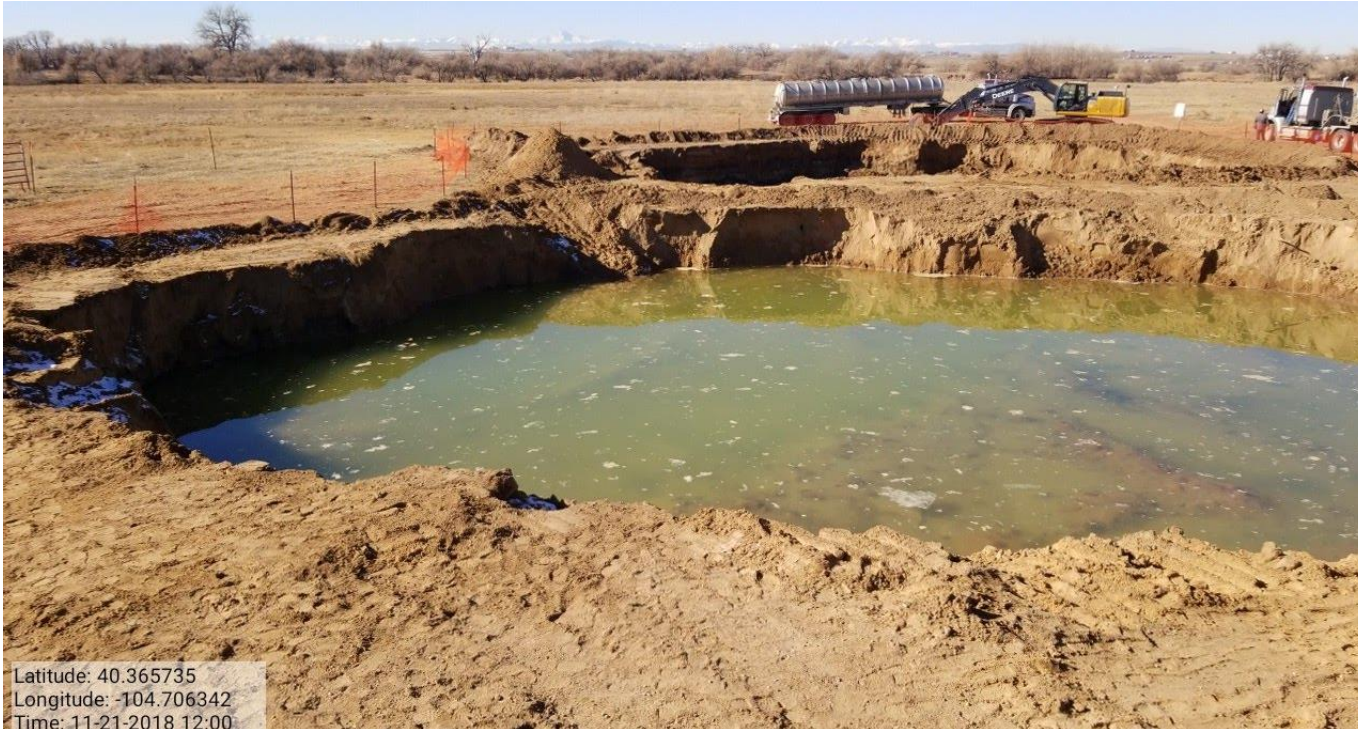
Photo 10 – Site overview; Eastern pit in foreground.

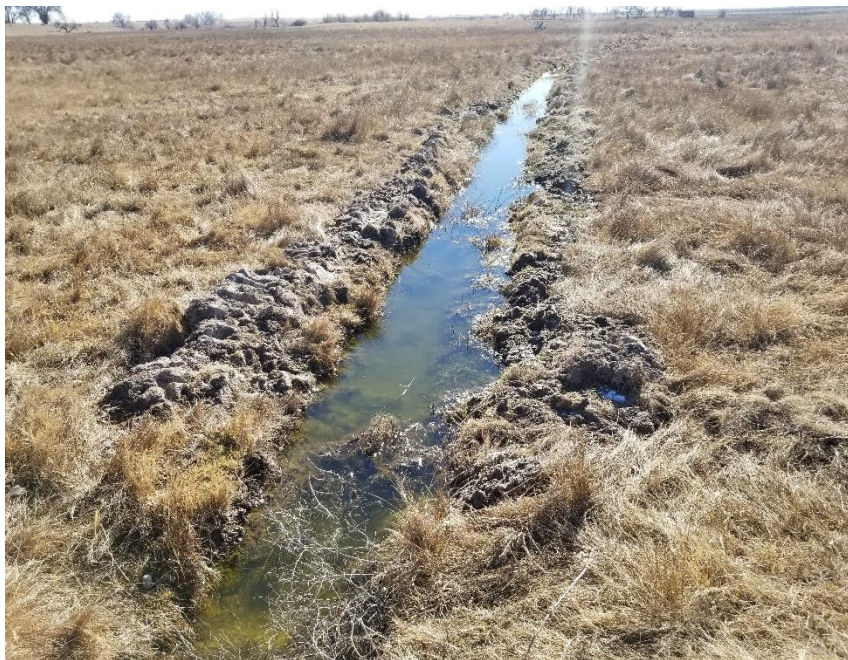
Photo 11 – Adjacent irrigation canal. Flowing at time of inspection.

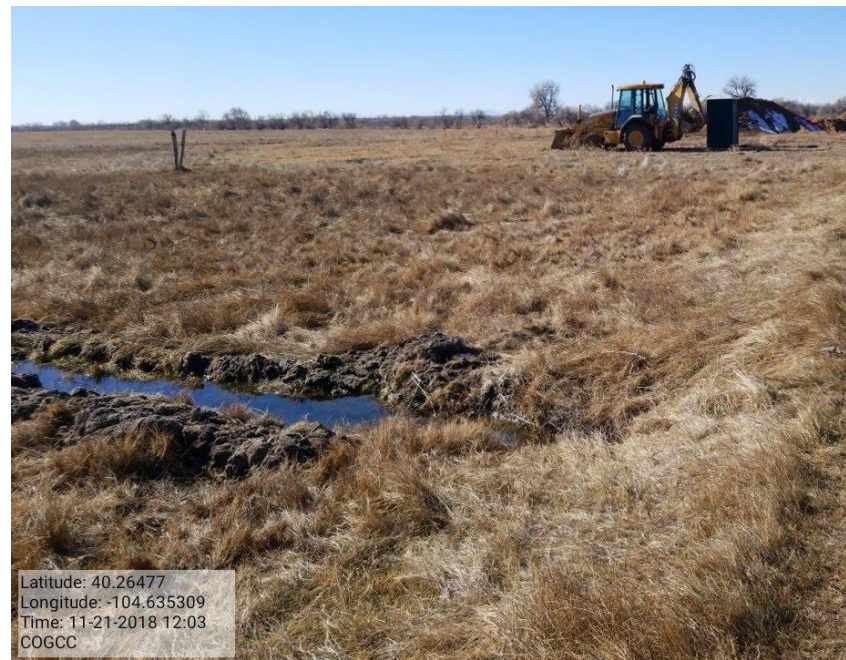
Photo 12 – Photo of site from adjacent irrigation canal.
