Inspection Photos
Operator Name: TEP Rocky Mountain
Location ID: 429828

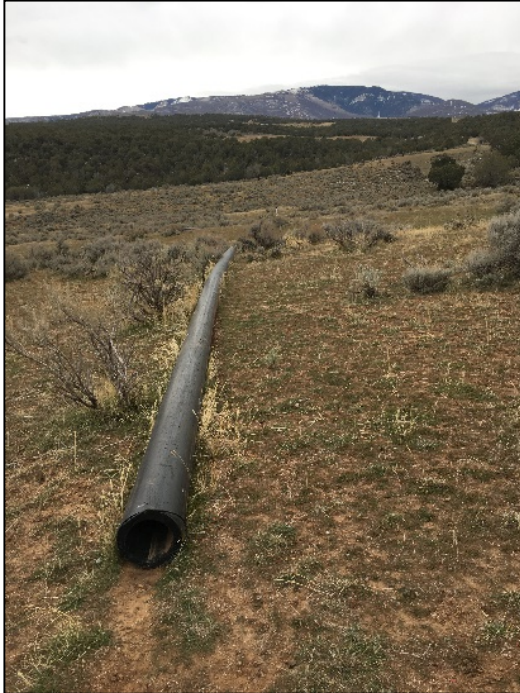
Poly Flowline

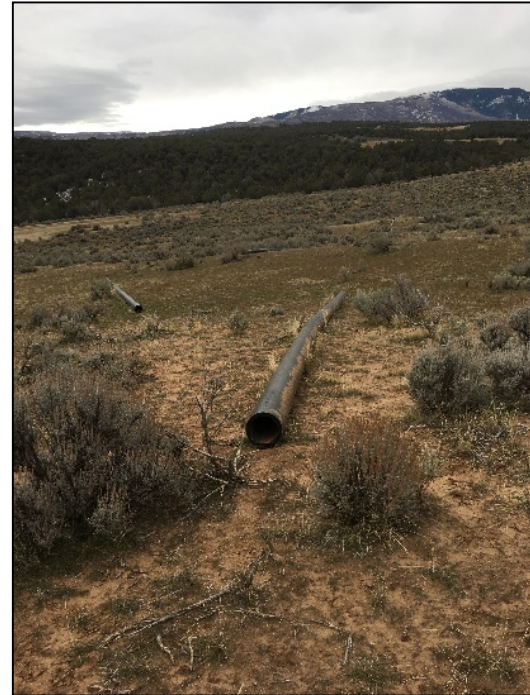
Poly Flowline cut into 30' joints

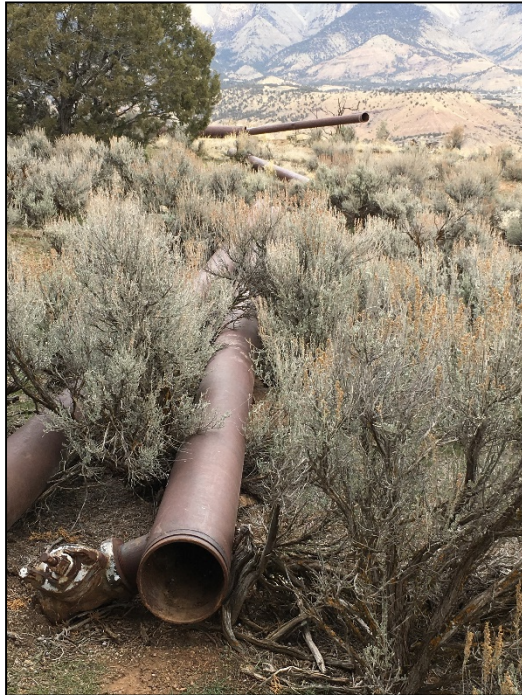
Steel Flowlines

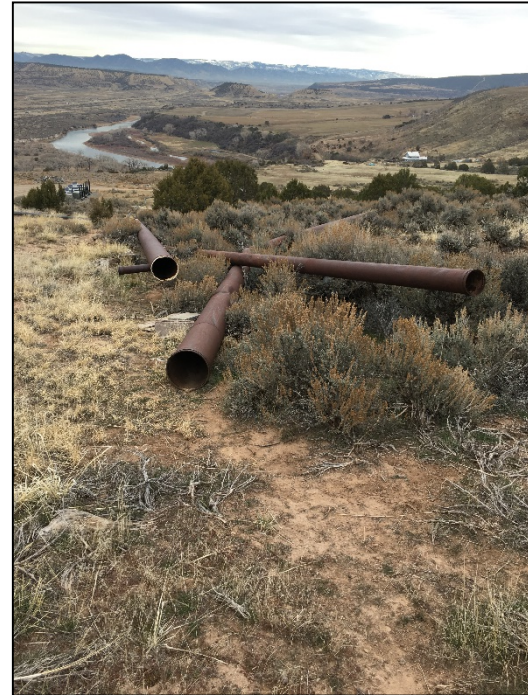
Steel flowlines

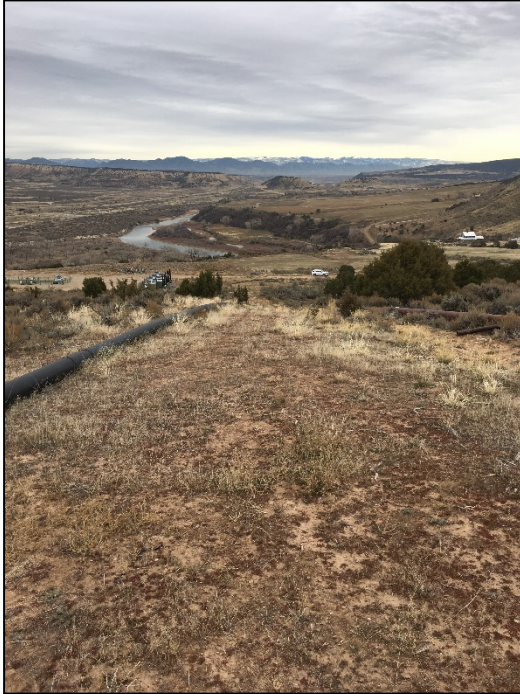
Poly flowline from pit towards location

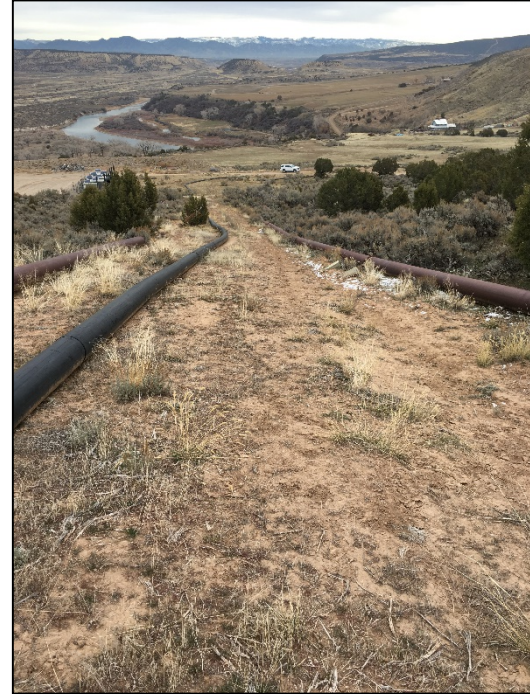
Poly and steel flowline from pit towards location

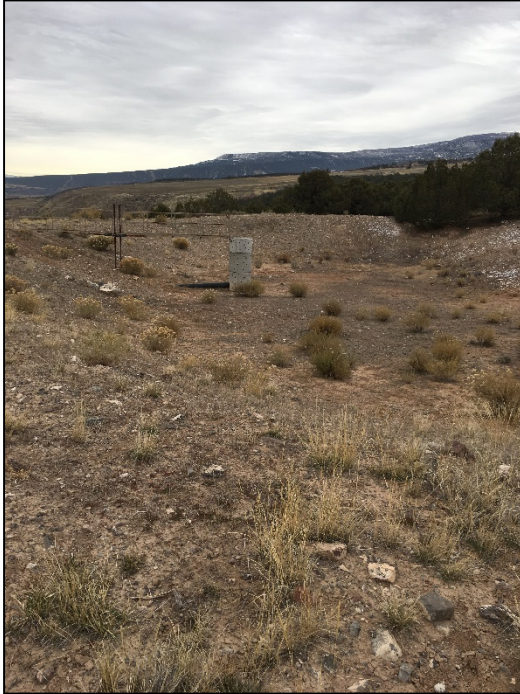
Pit and cement drainage structure

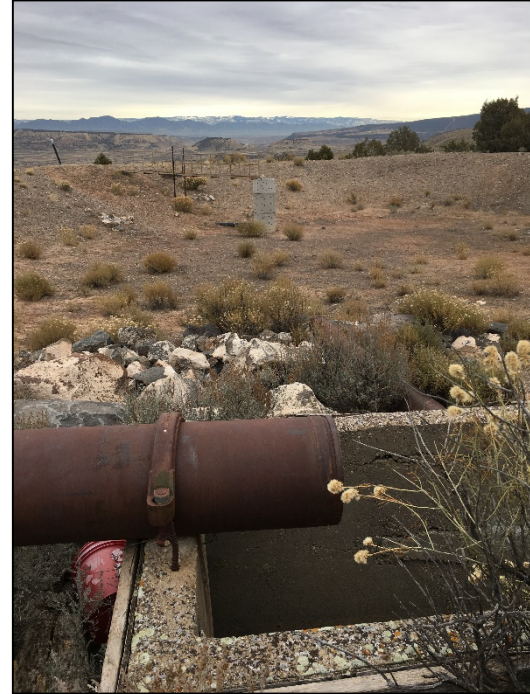
Pit Inlet flowline

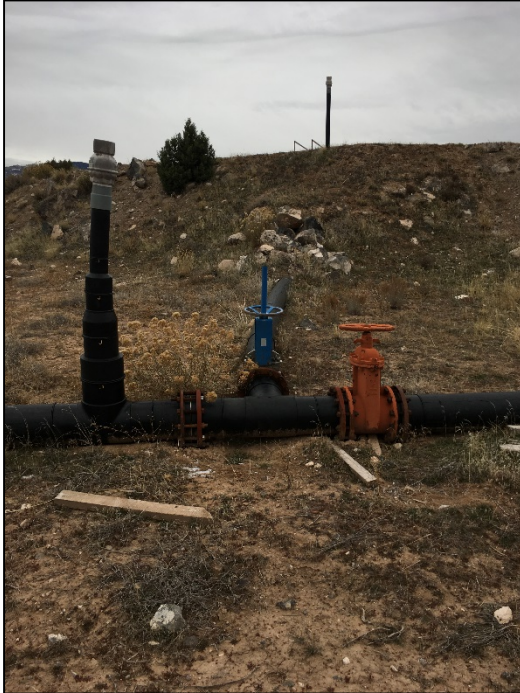
Poly exiting pit
