Inspection Photos

Operator: Petrox Resources

API: 05-007-06278

Date: 11/06/2018

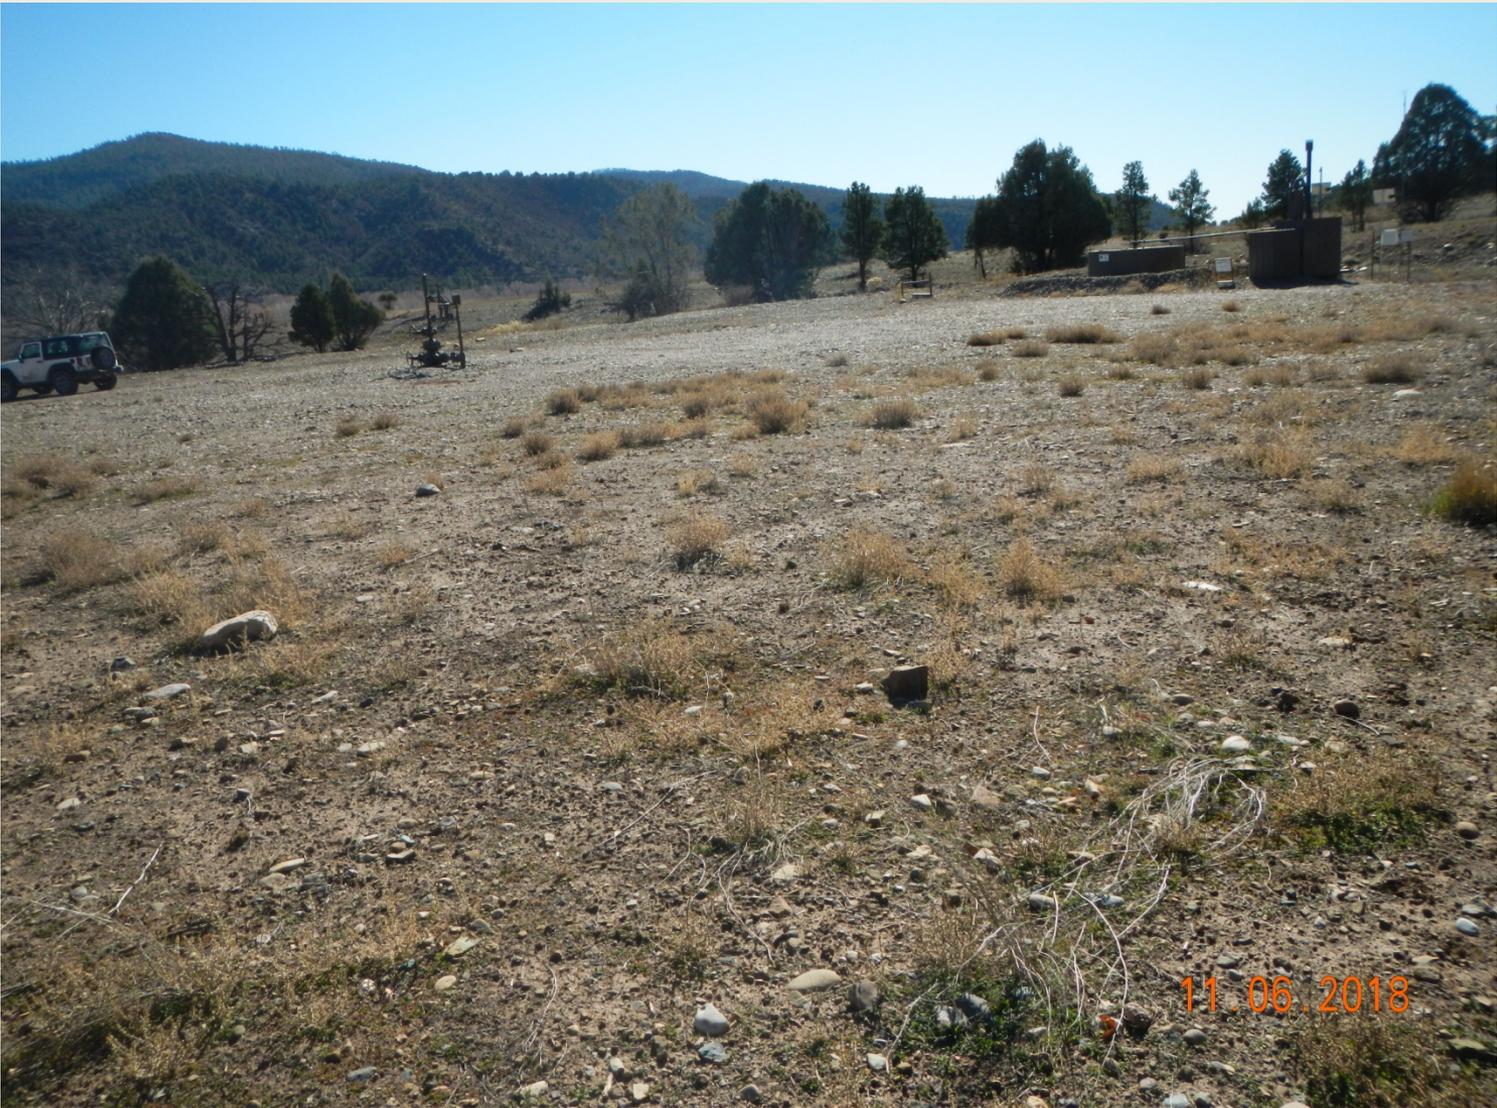
Photo 1. View of the project area from northeastern corner facing center.

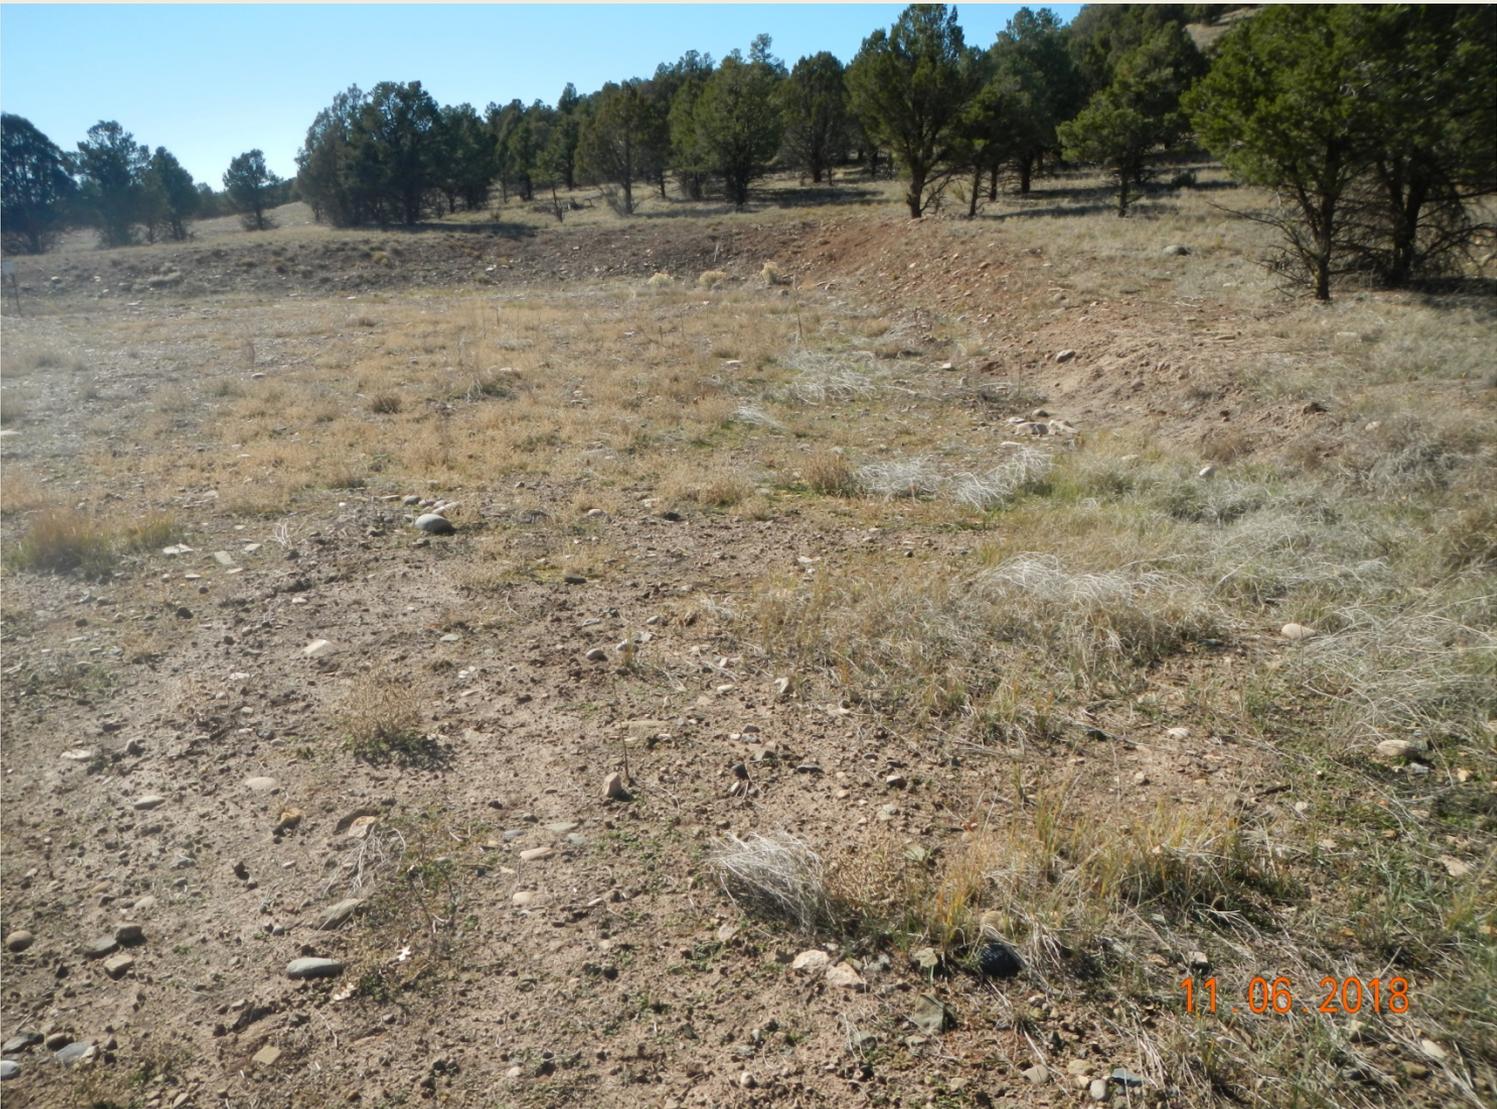
Photo 2. View of the northern project area from the northeastern corner facing westward. Revegetation is progressing within portions of the interim reclamation with grasses such as western wheatgrass (*Pascopyrum smithii*) area and sparse in other portions.

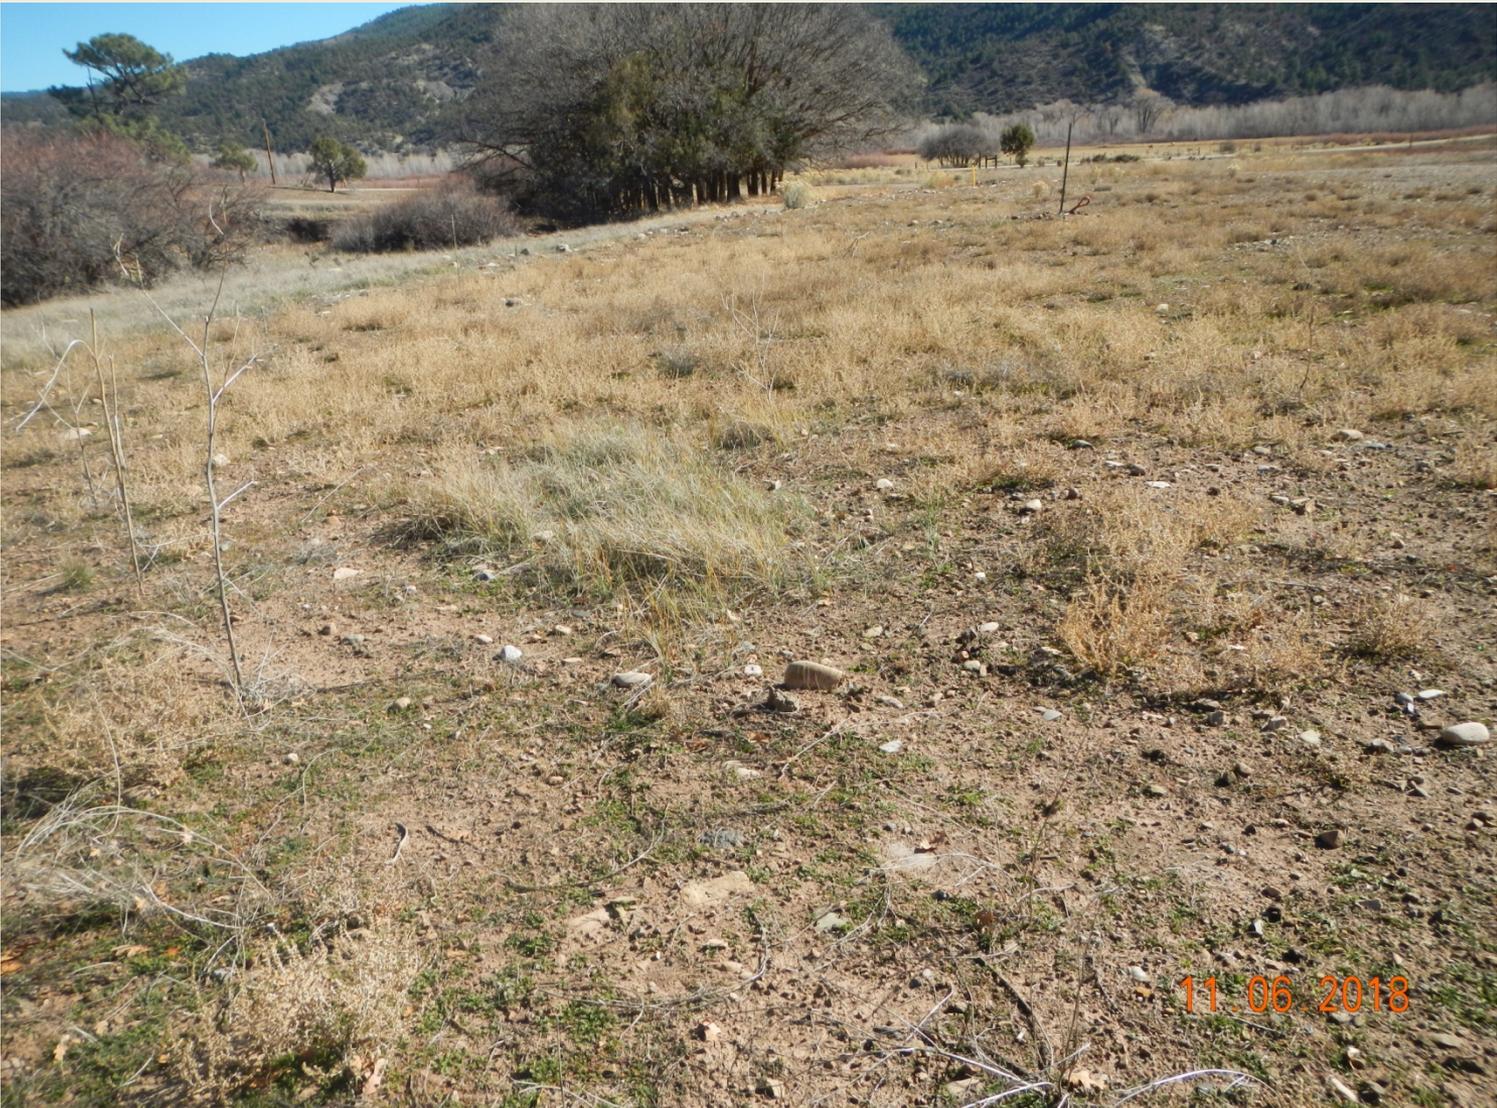
Photo 3. View of the eastern project area from the northeastern corner facing southward.

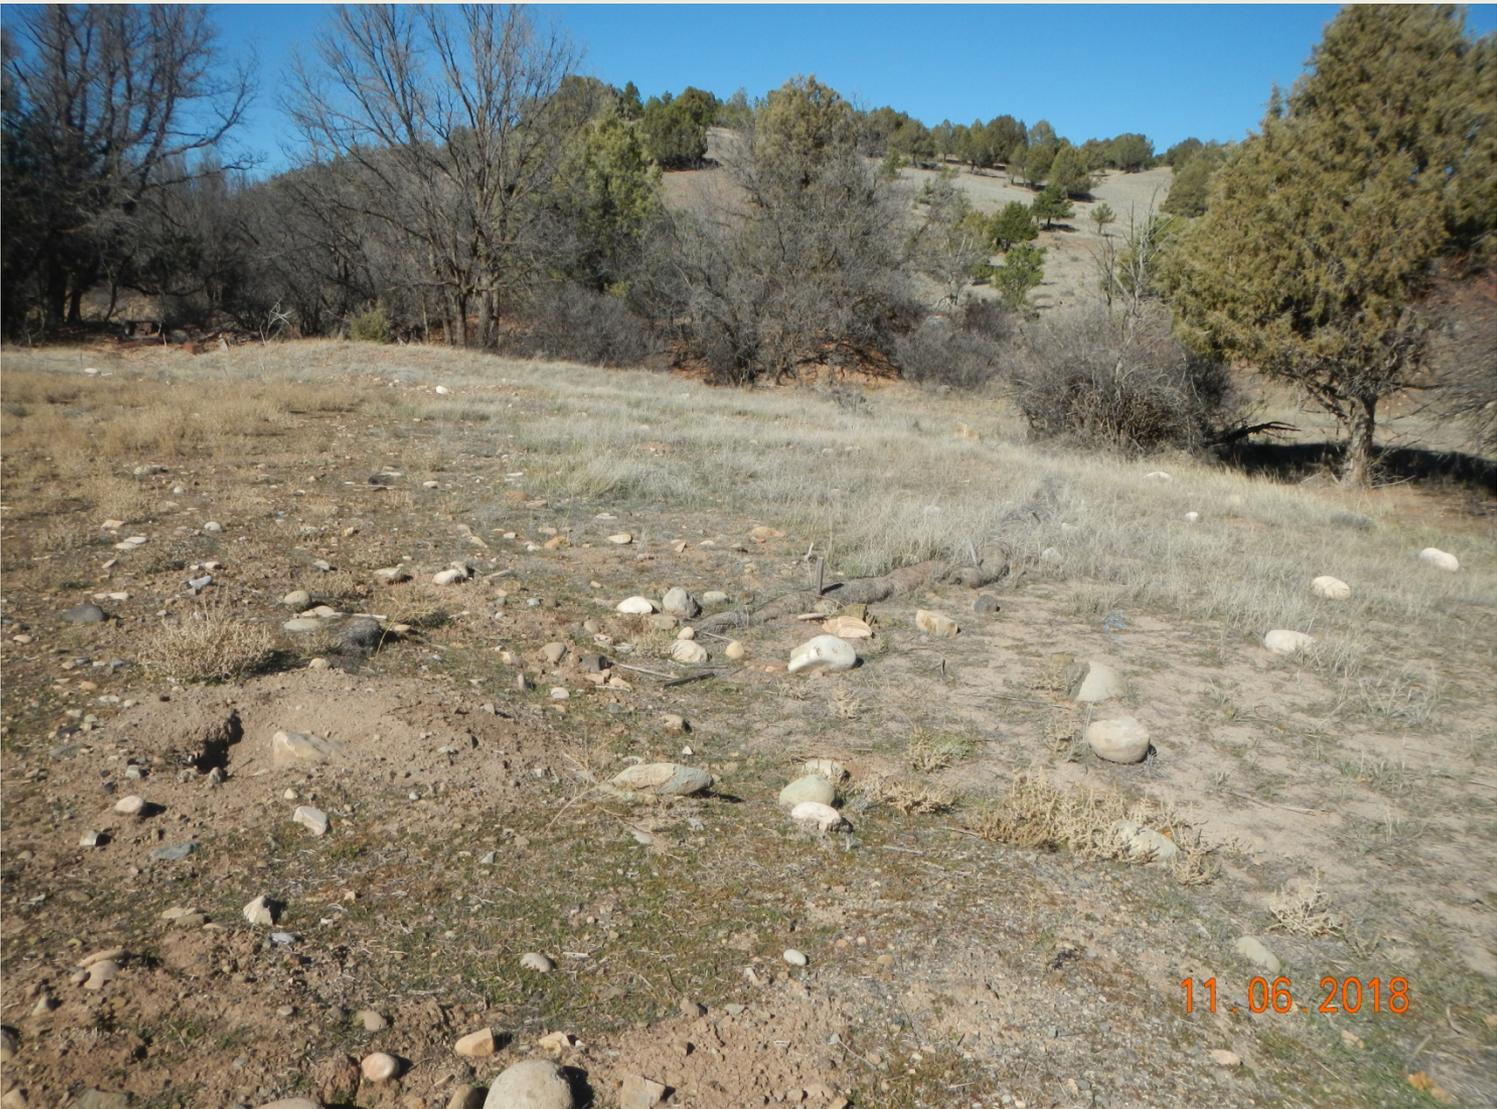
Photo 4. View of the southeastern project area.
