Inspection Photos

Operator: Petrox Resources

API: 05-007-06269

Date: 11/06/2018

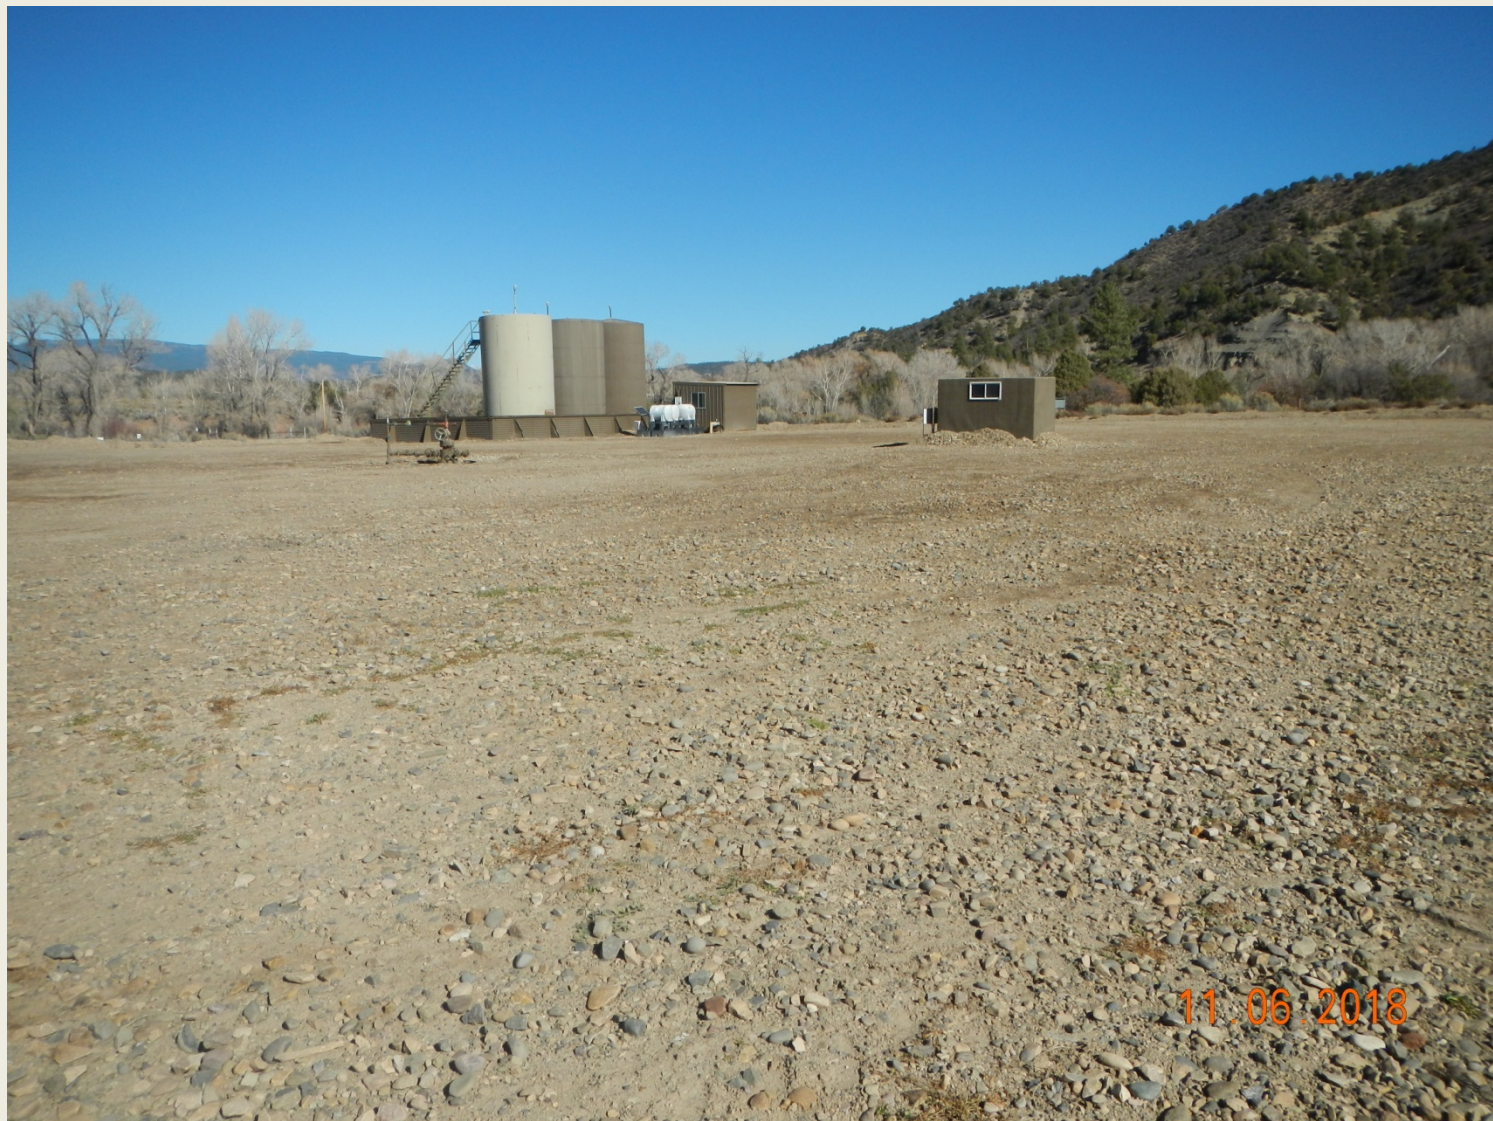
Photo 1. View of the project area from southwestern corner facing center.

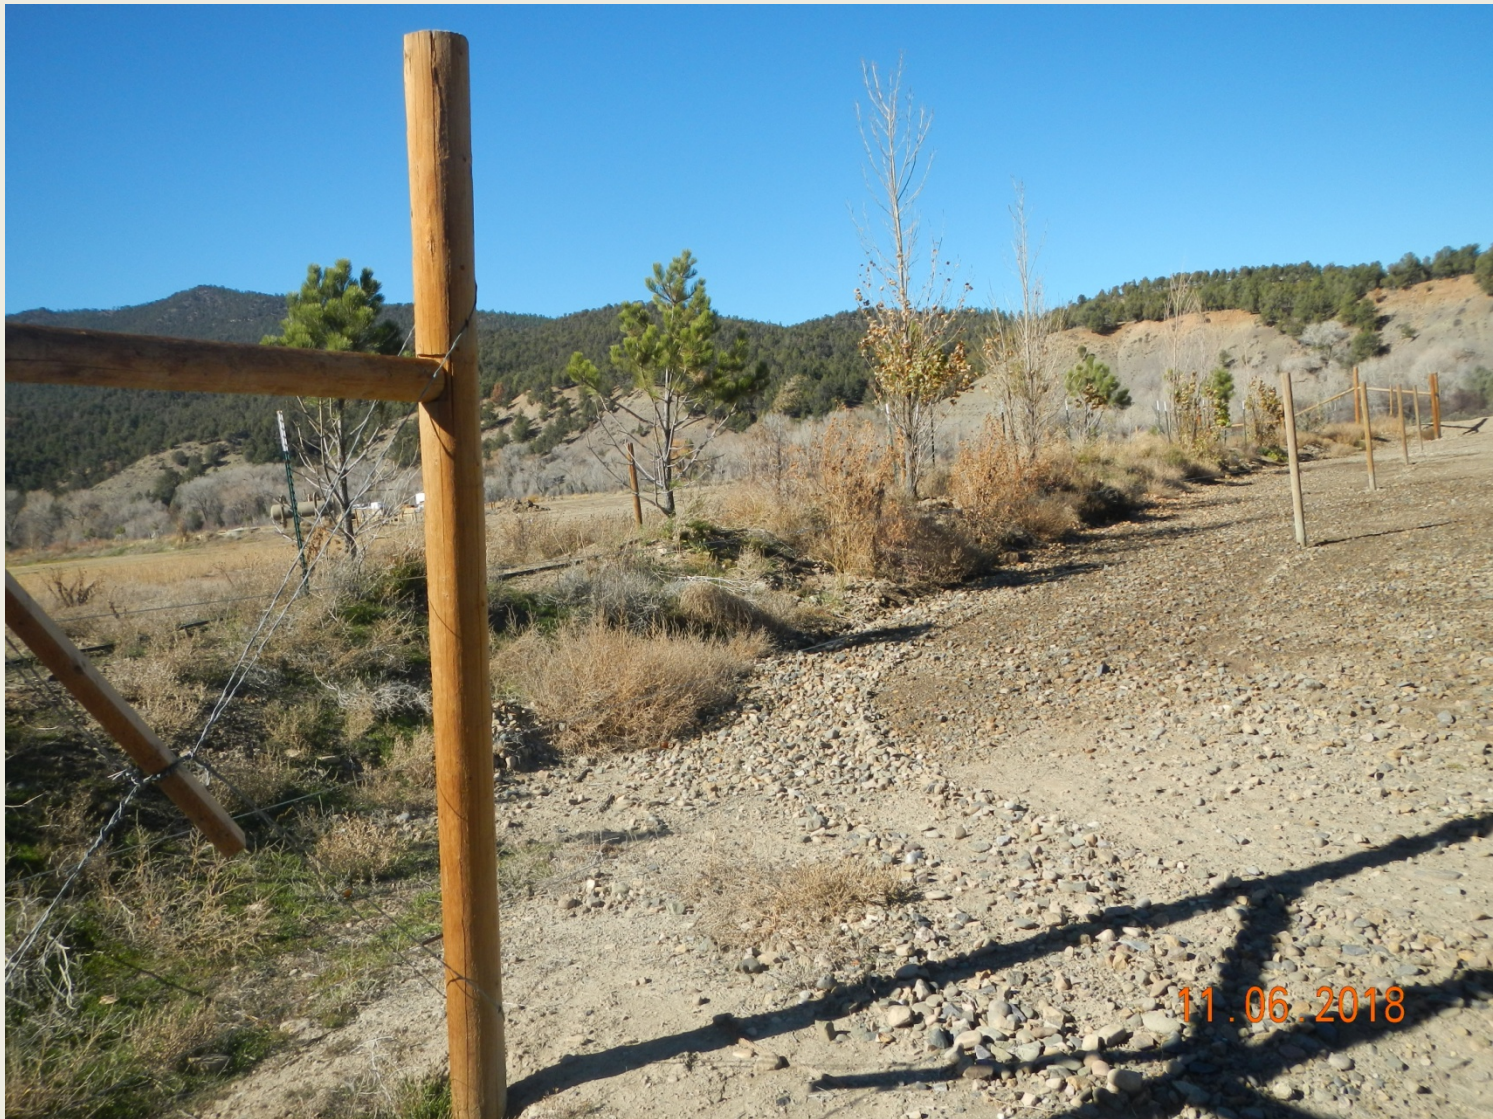
Photo 2. View of the western project area from the southwestern corner facing northward. Outer portions of the project area are bermed and trees are planted. Understory is largely weeds such as cheatgrass (*Bromus tectorum*) and Russian thistle (*Salsola tragus*).

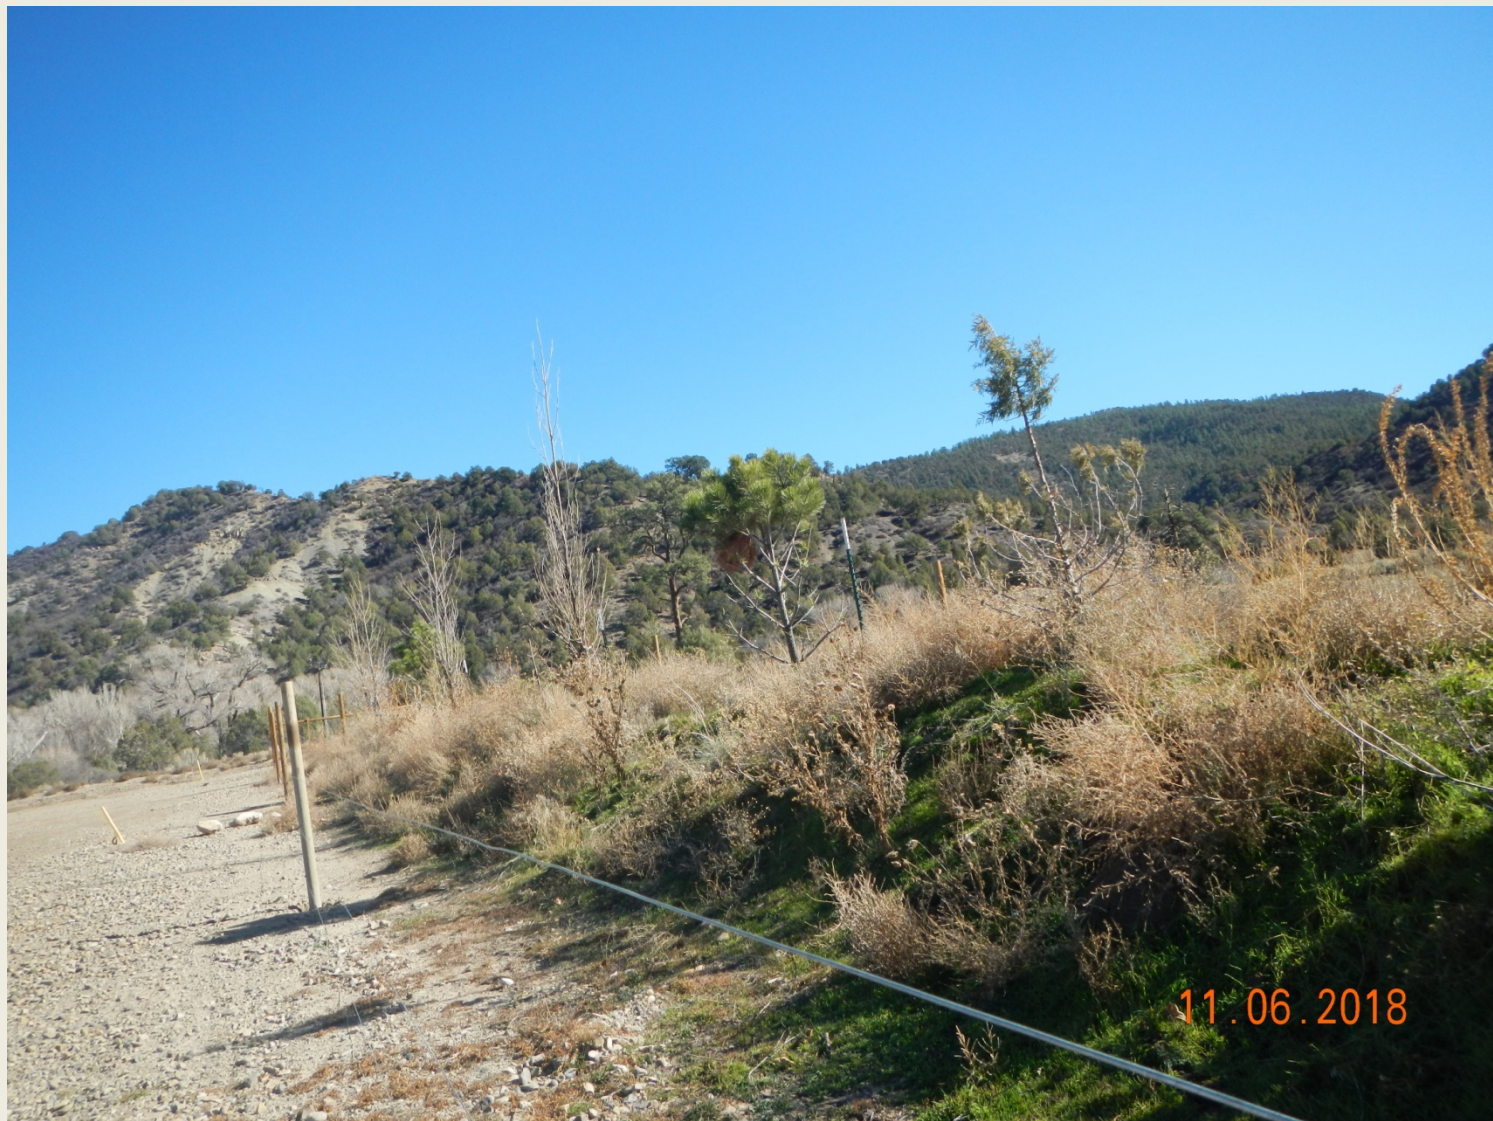
Photo 3. View of the southern project area from the southwestern corner facing eastward.

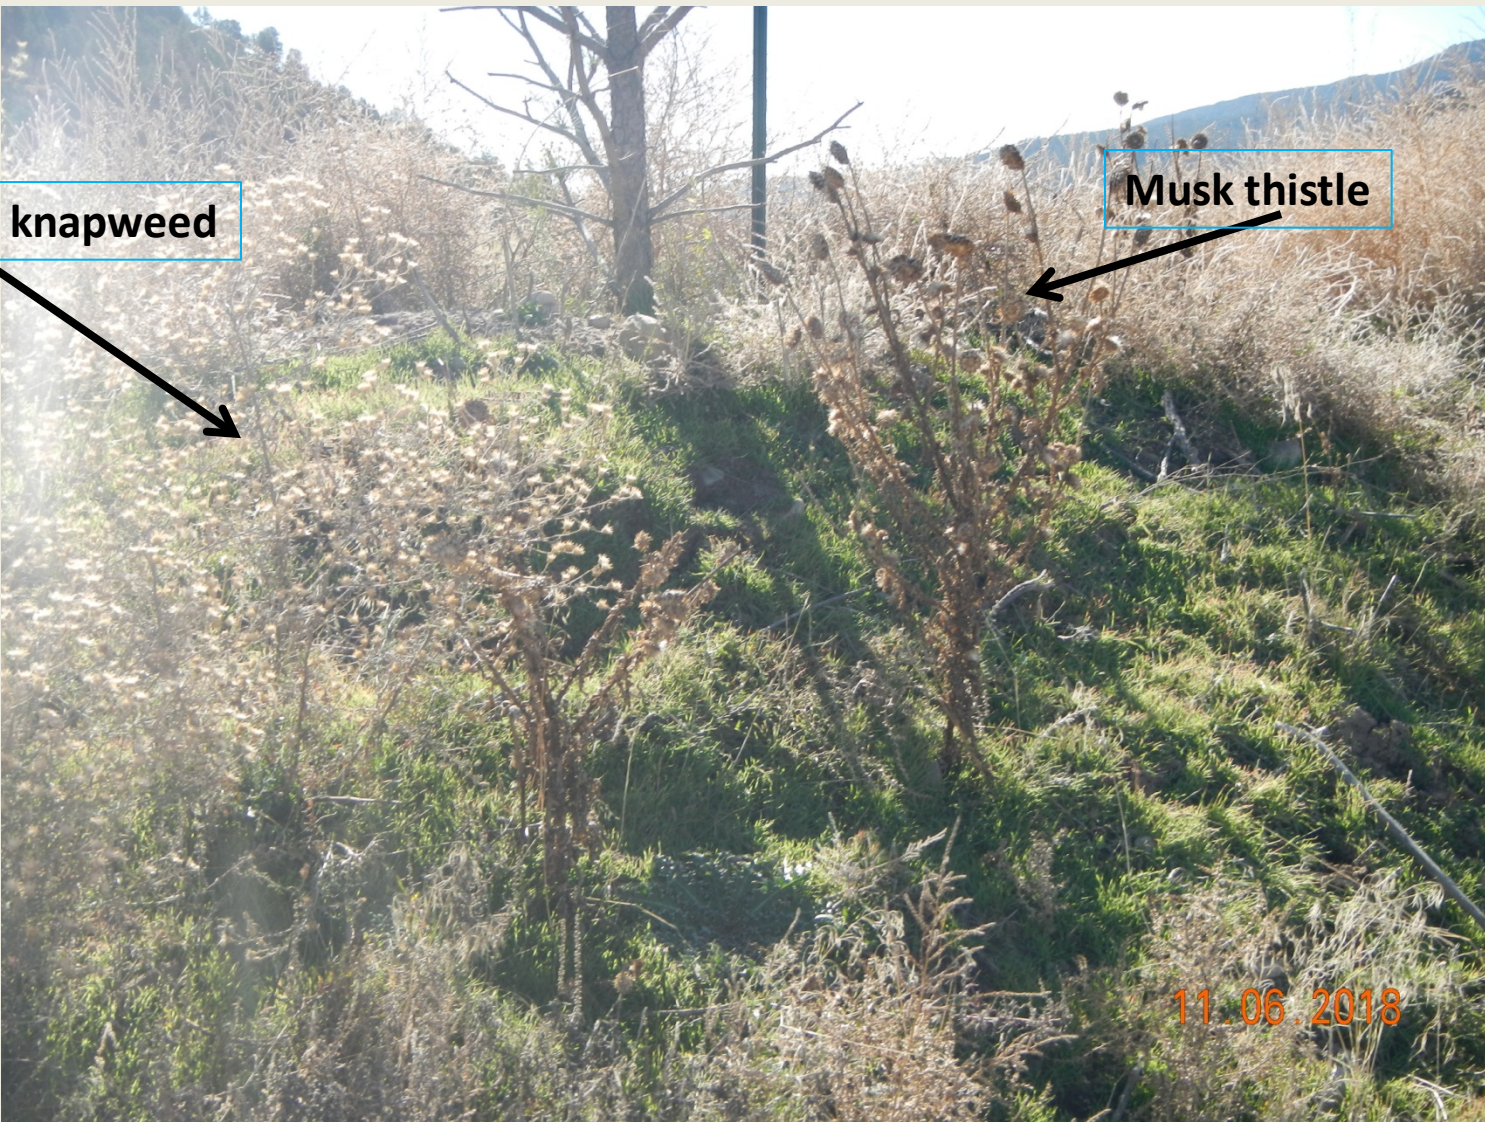
Photo 4. View of noxious weeds: spotted knapweed (*Centaurea maculosa*) and musk thistle (*Carduus nutans*) growing on the outer project berms within the project area.. Approximately 200 spotted knapweed and 150 musk thistles observed.

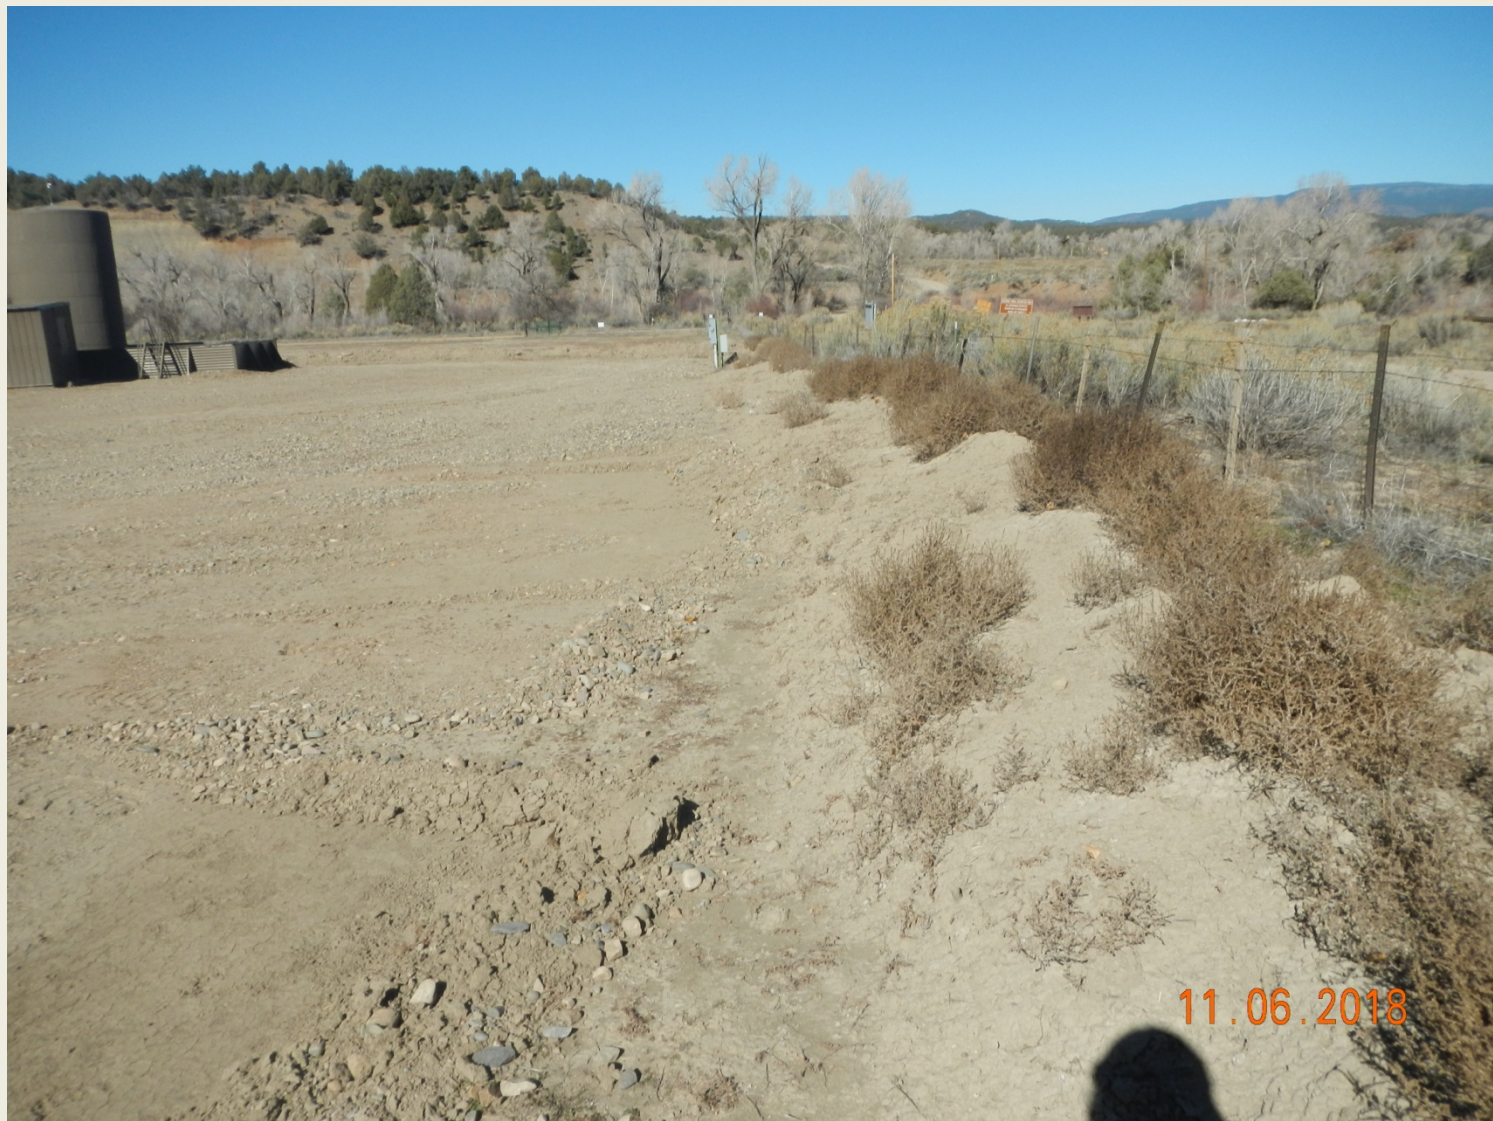
Photo 5. View of the western project berm that needs to be stabilized with perennial vegetation or otherwise stabilized.
