Inspection Photos

Operator: Petrox Resources

API: 05-007-06272

Date: 11/06/2018

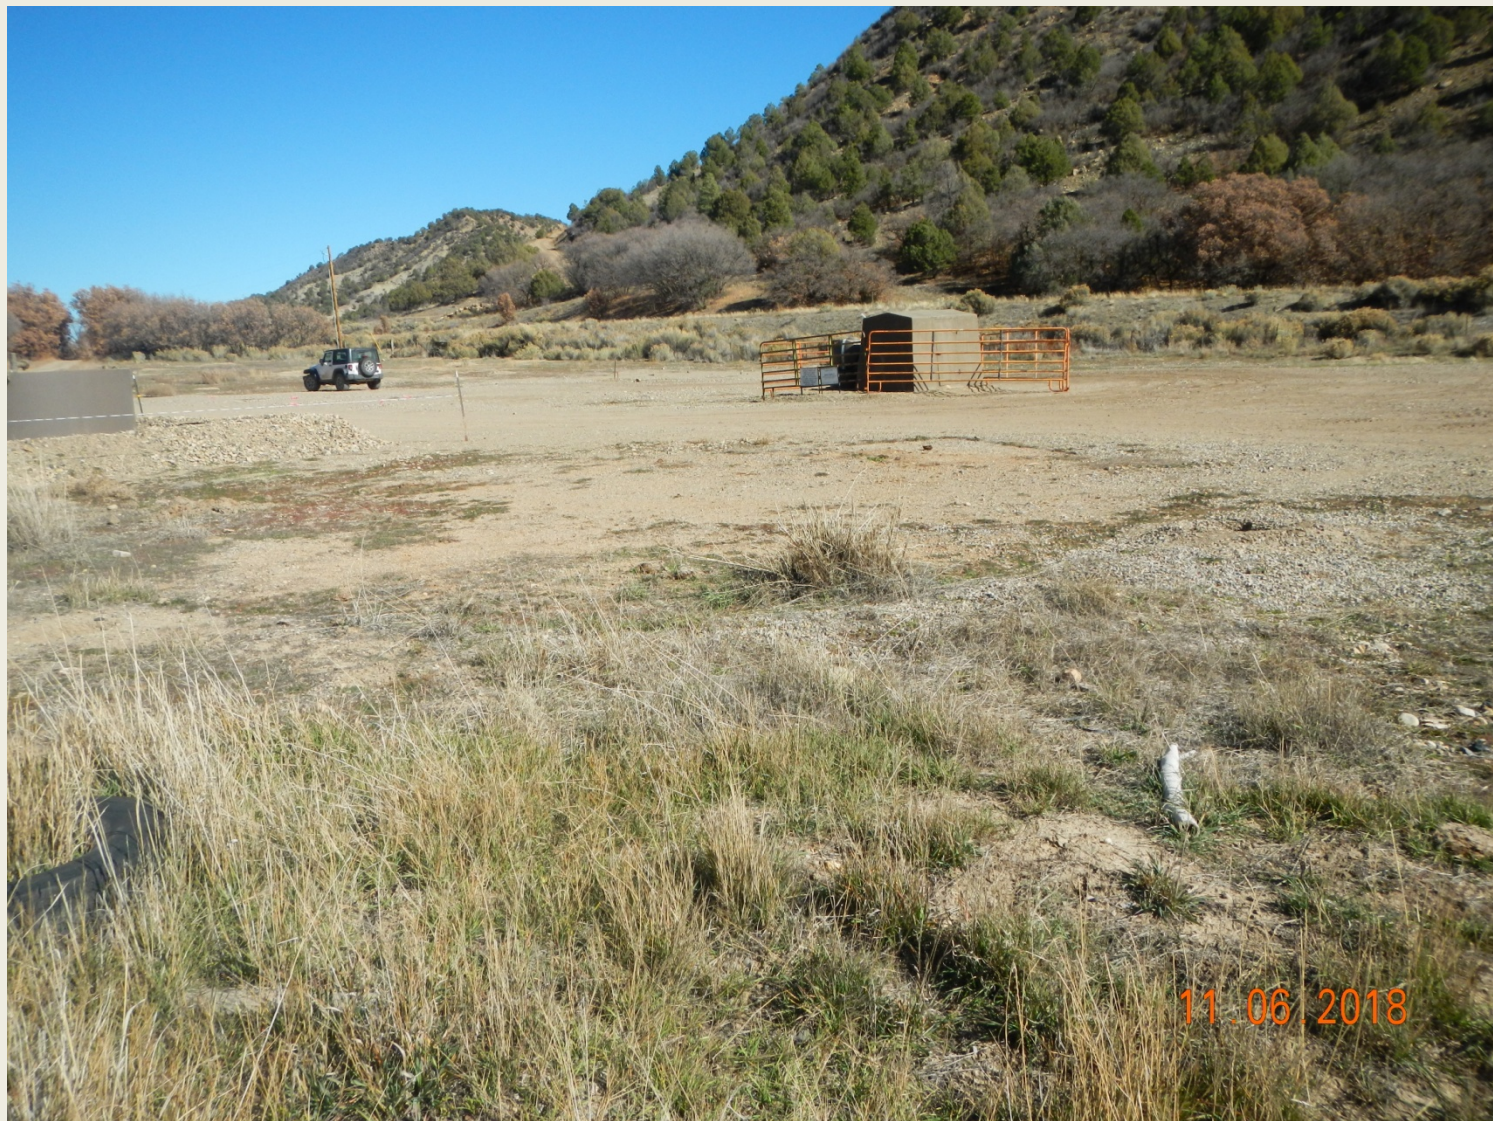
Photo 1. View of the project area from southwestern edge facing center.

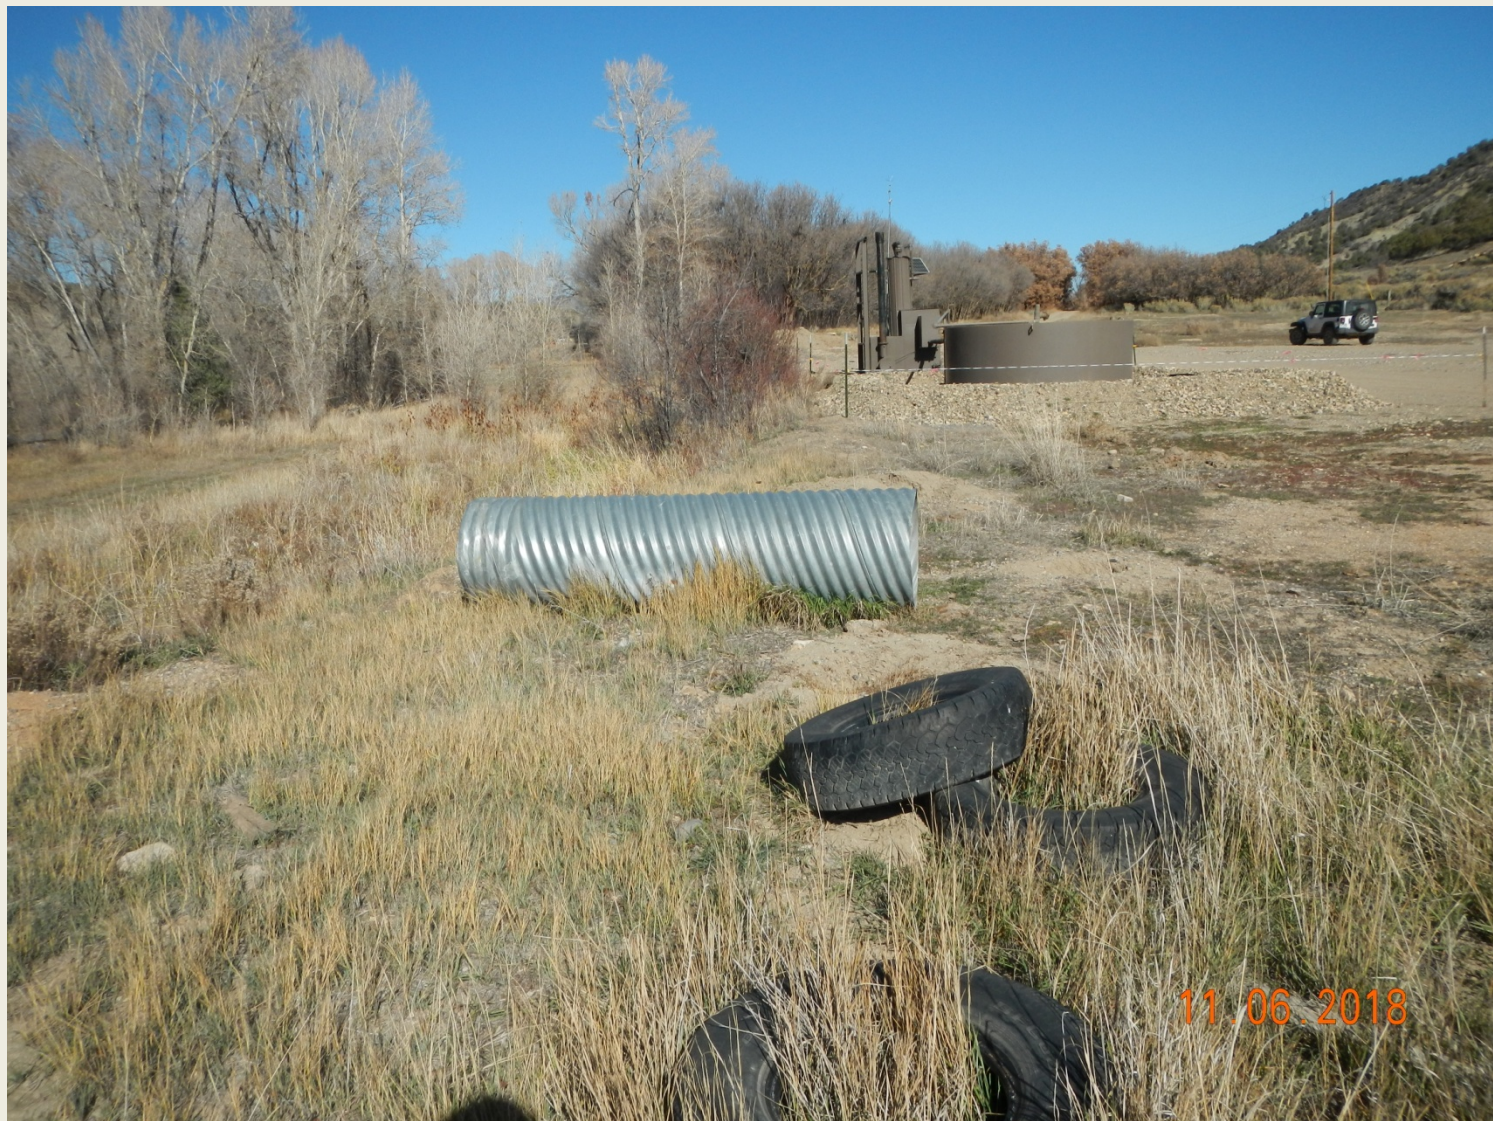
Photo 2. View of the northwestern project area from the western edge facing northward. Irrigation ditch runs adjacent to this area. Stormwater runoff needs to be carefully monitored to prevent contamination of waterway due to proximity. Tires, culvert, and other debris need to be removed.

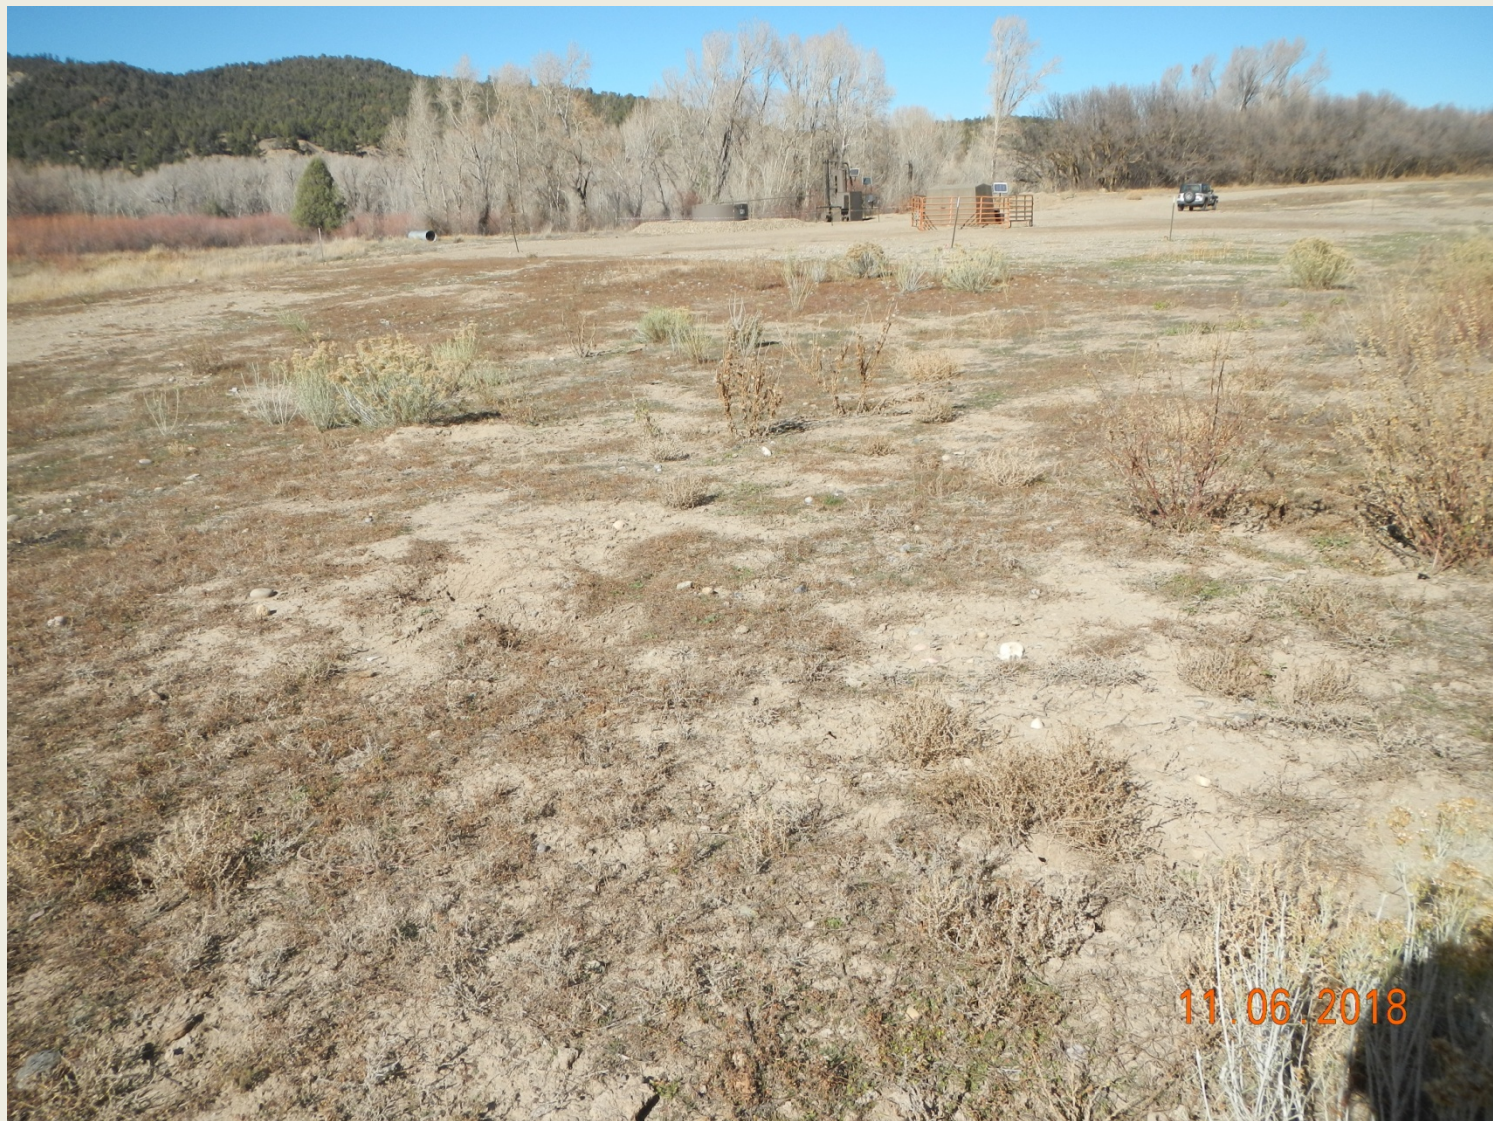
Photo 3. View of the southern project area from the southeastern corner facing center. Little desirable vegetation growing hear. Area appears to need seeding/revegetation.

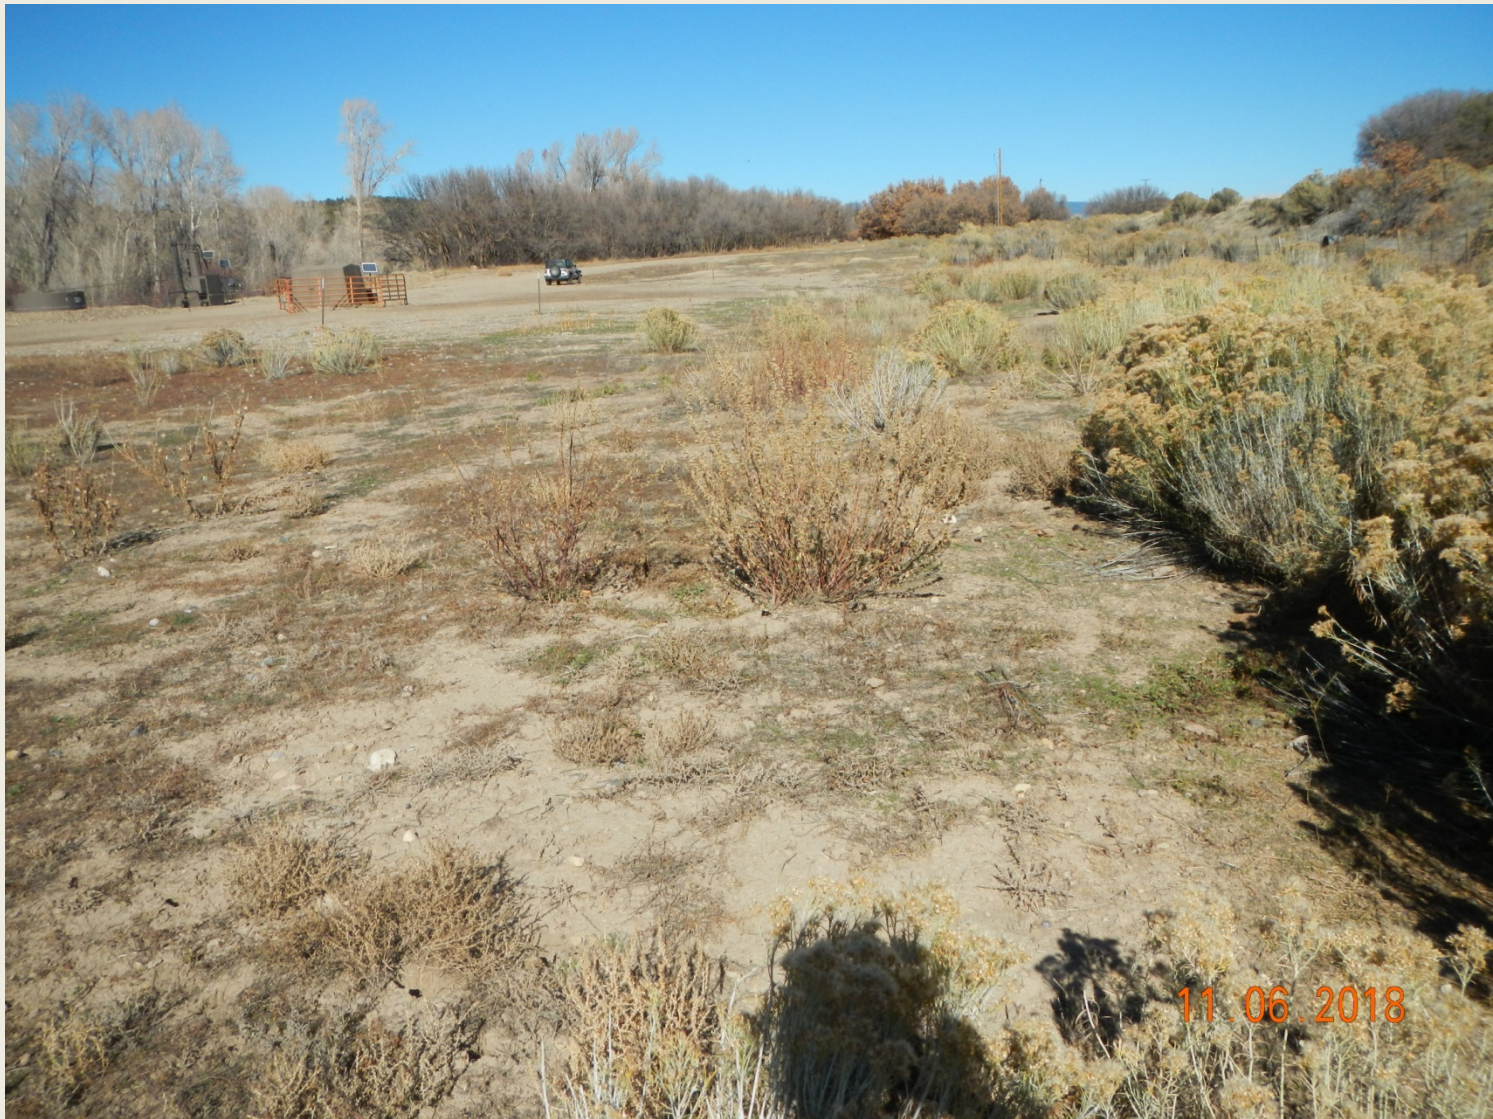
Photo 4. View of the eastern project area from the southeastern corner facing northward.

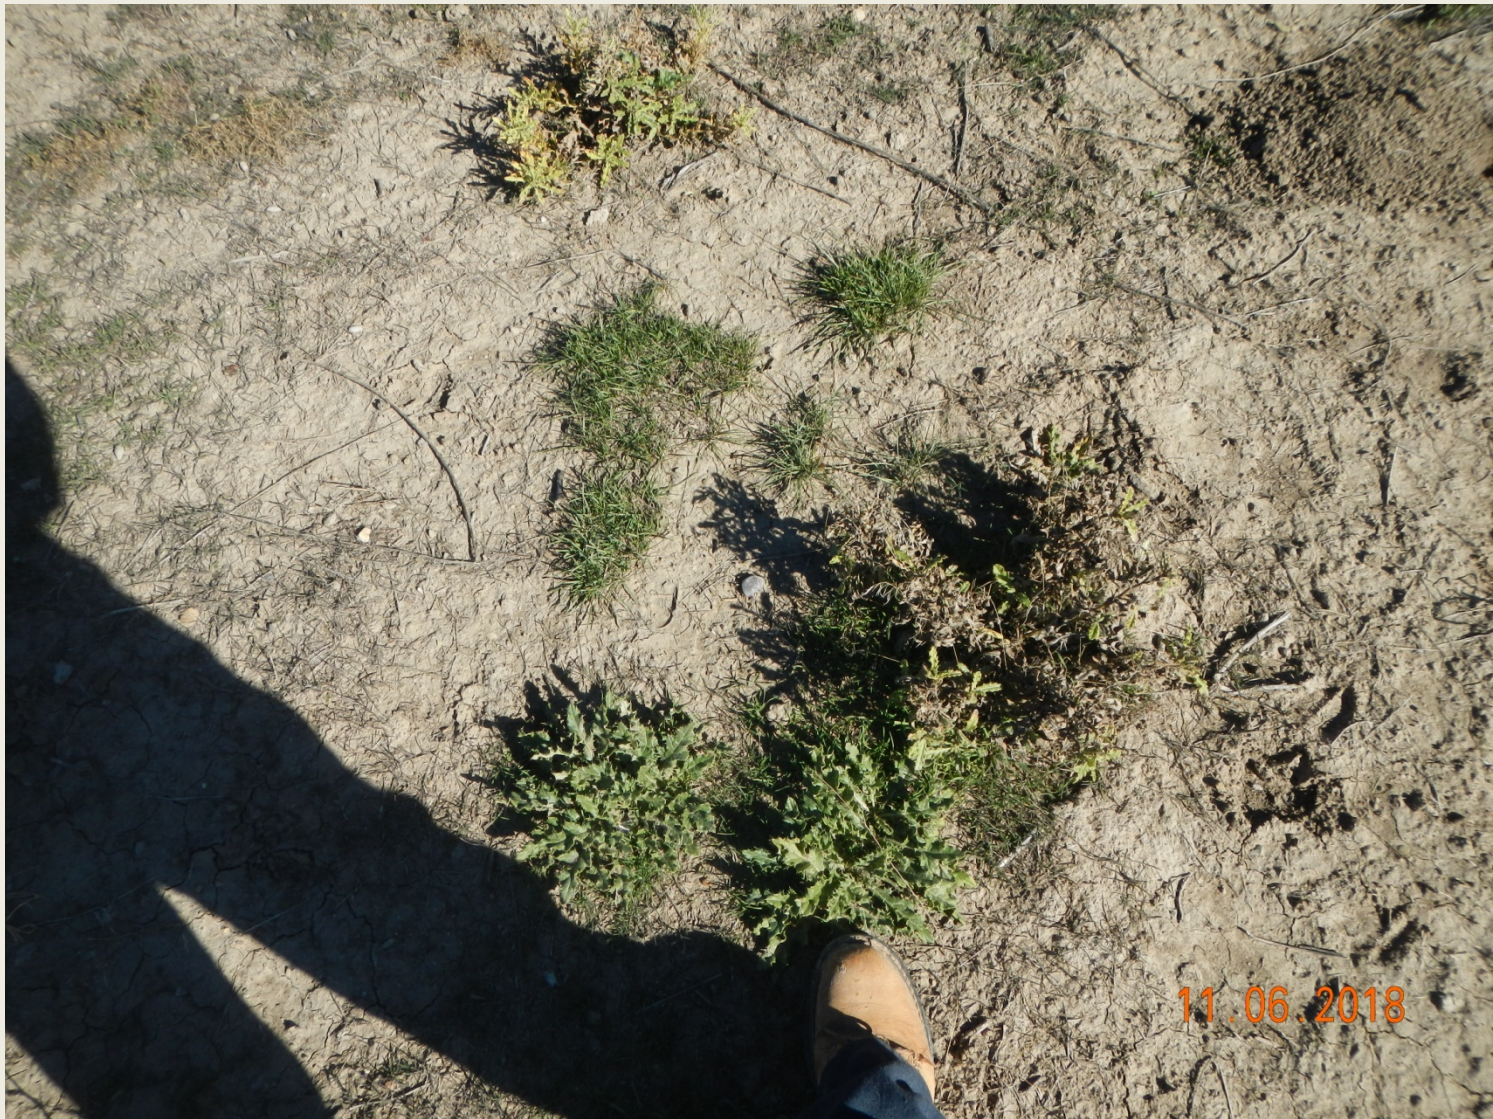
Photo 5. View of Canada thistles (*Cirsium arvense*) within the eastern project area.
