Inspection Photos

Operator: Petrox Resources

API: 05-007-06277

Date: 11/06/2018

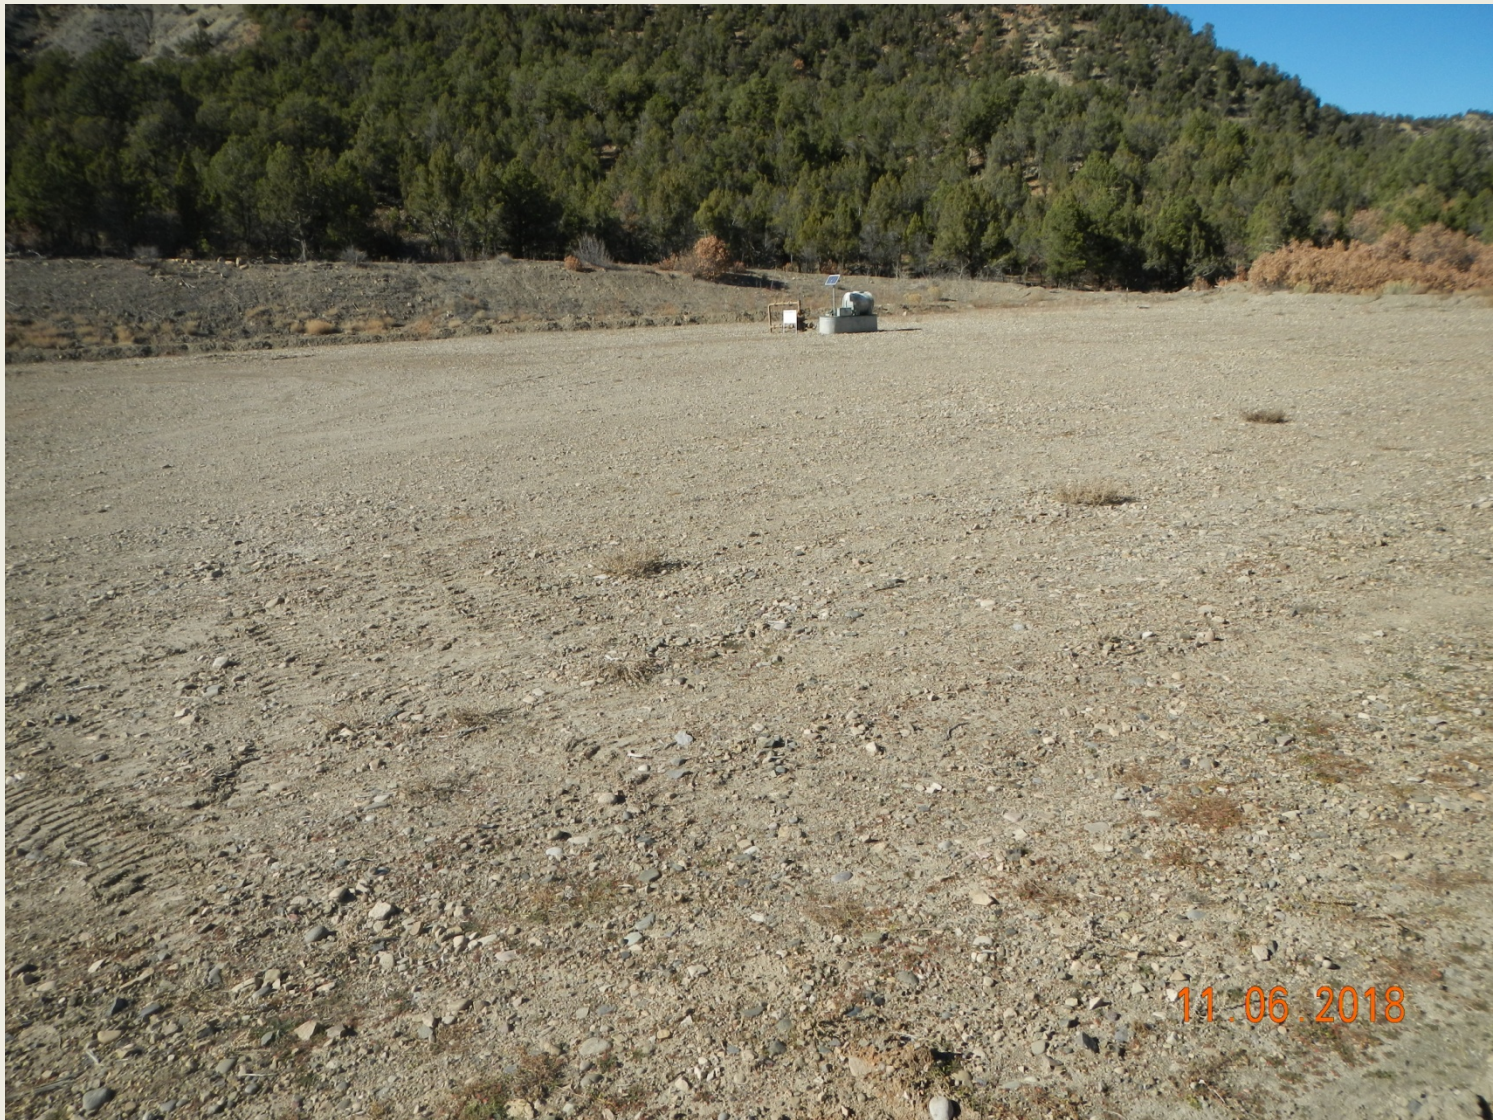
Photo 1. View of the project area from southeastern corner facing center. Interim reclamation is not conducted.

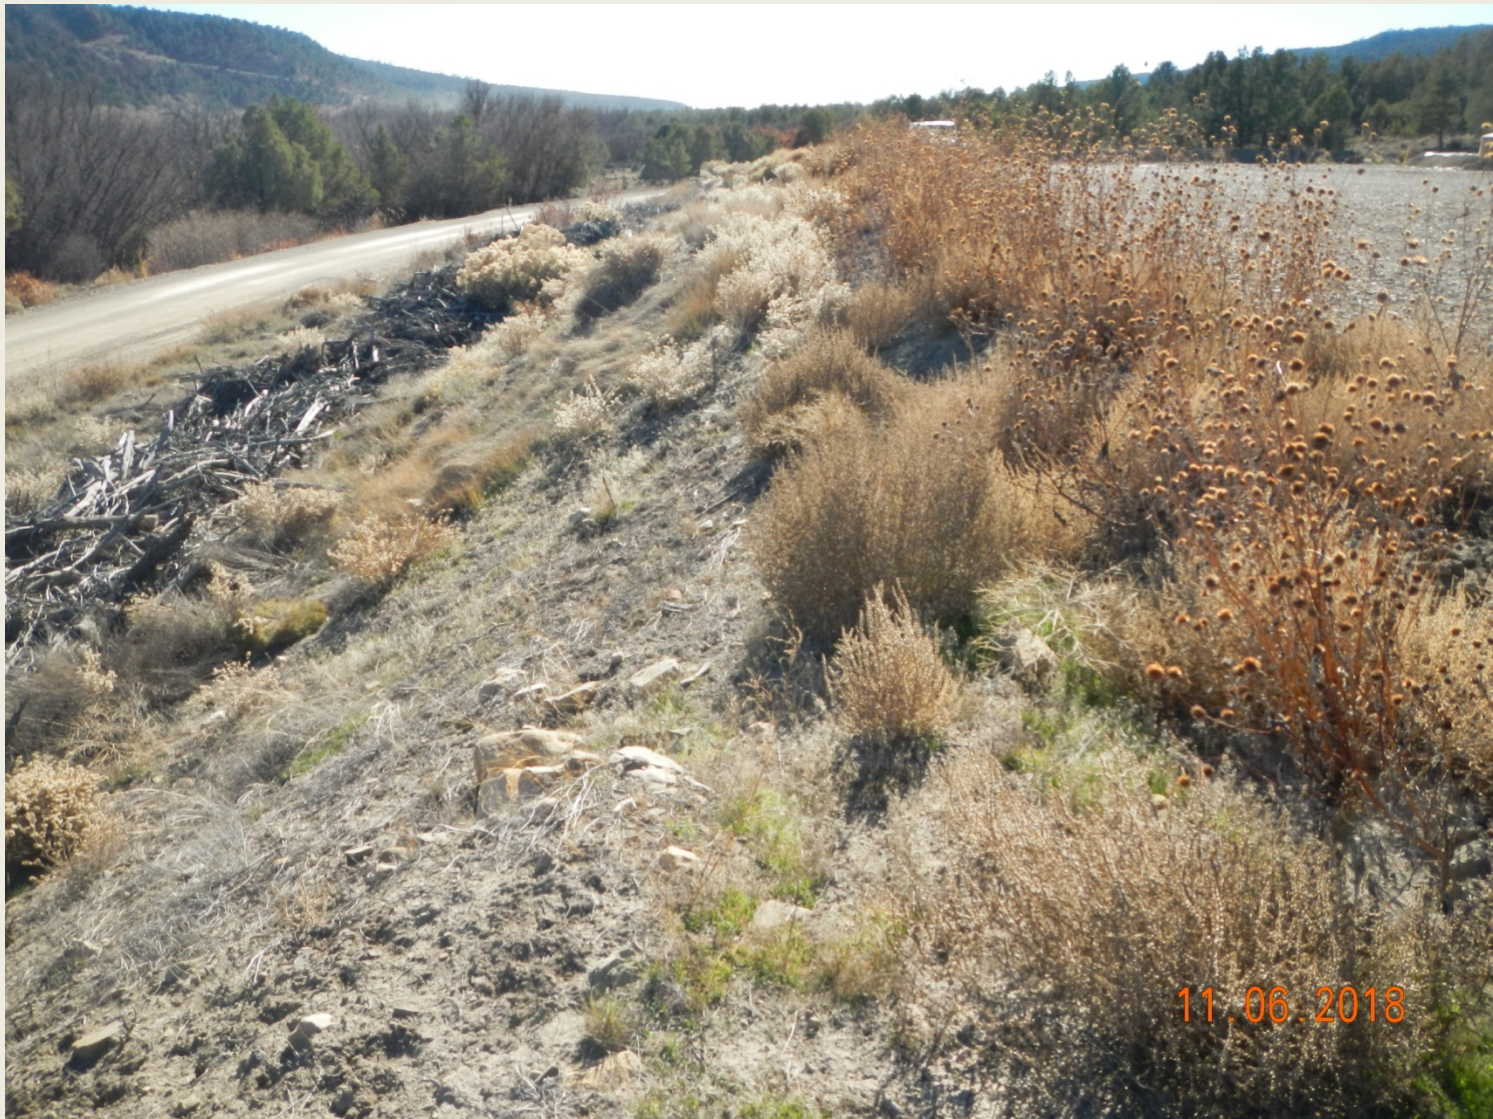
Photo 2. View of the eastern project area from the northeastern corner facing southward. Little desirable vegetation on slope. Russian thistle (*Salsola tragus*) debris up to three feet tall, growing along the outer edges of the working area.

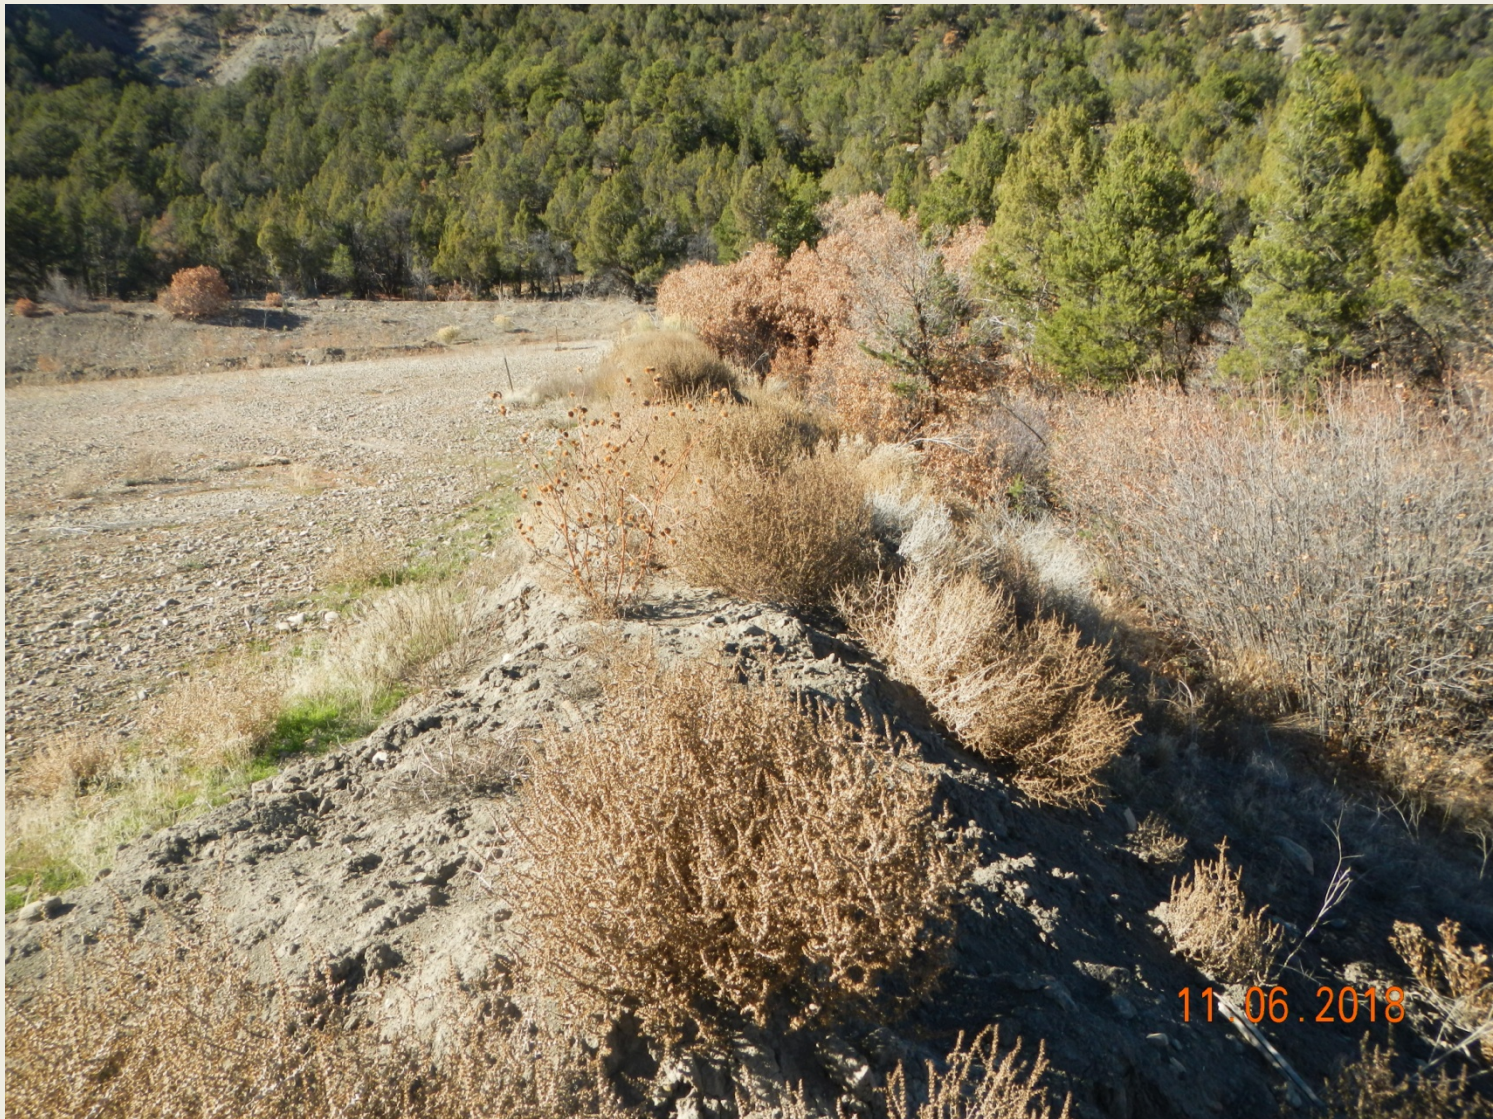
Photo 3. View of the northern project area from the northeastern corner facing westward.

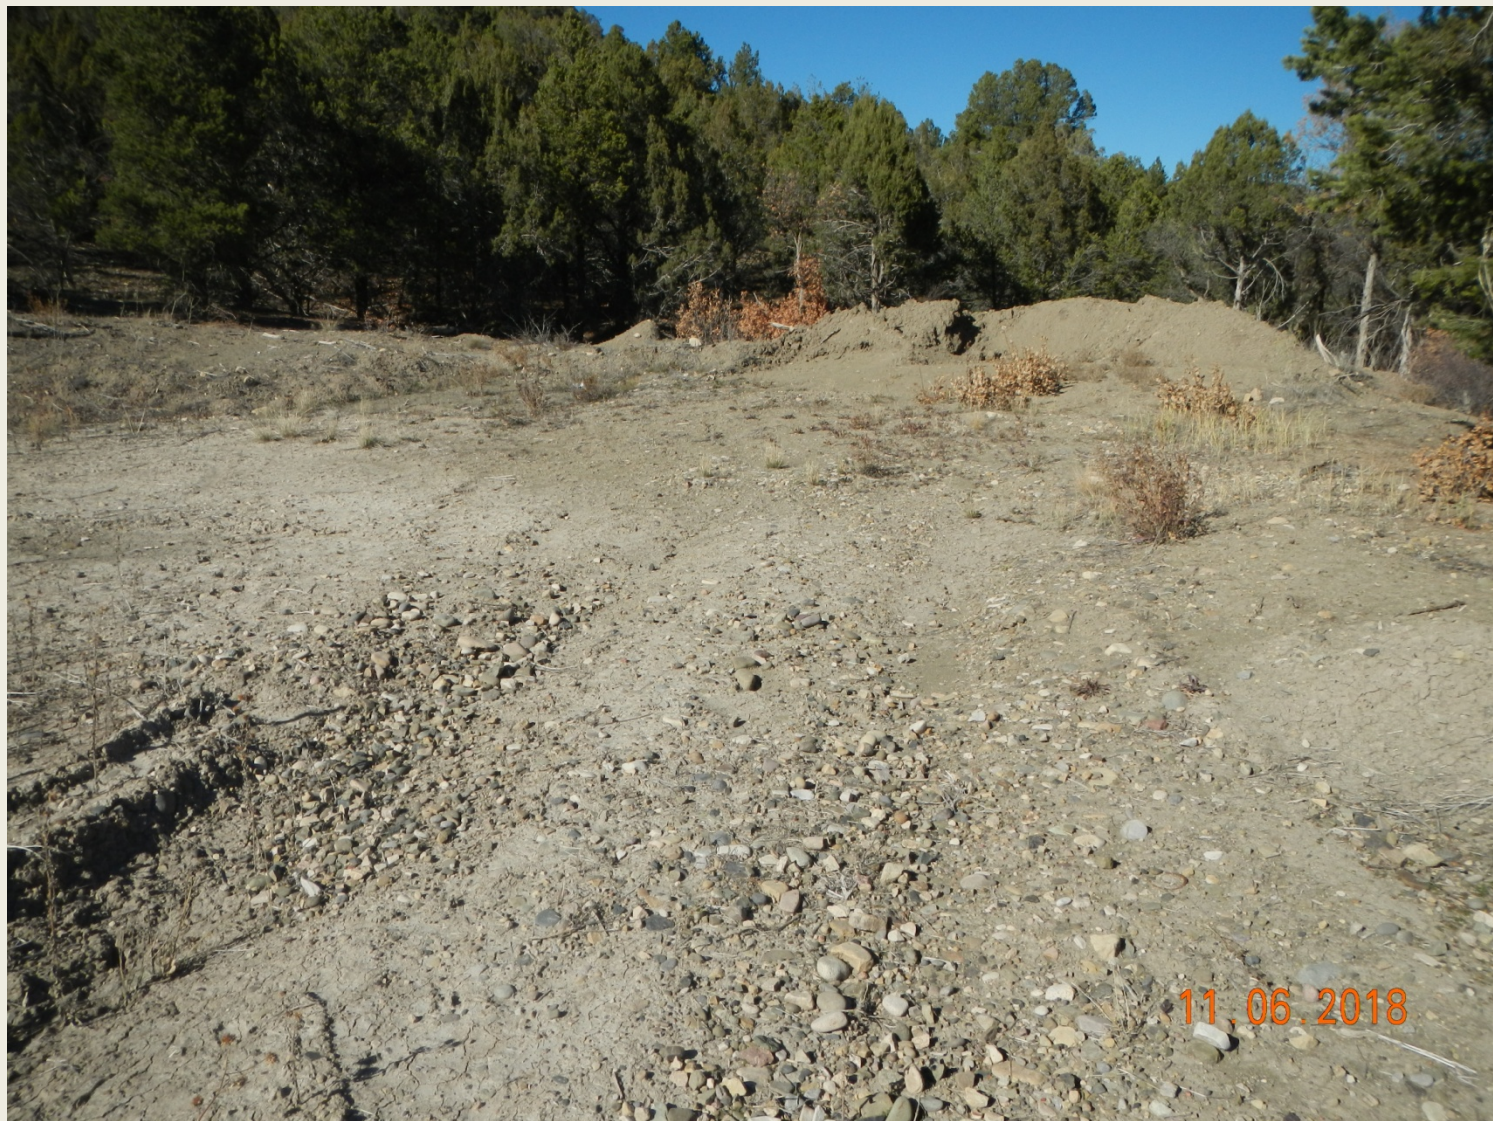
Photo 4. View of expanded disturbance in the northwestern project area. Needs reclamation.

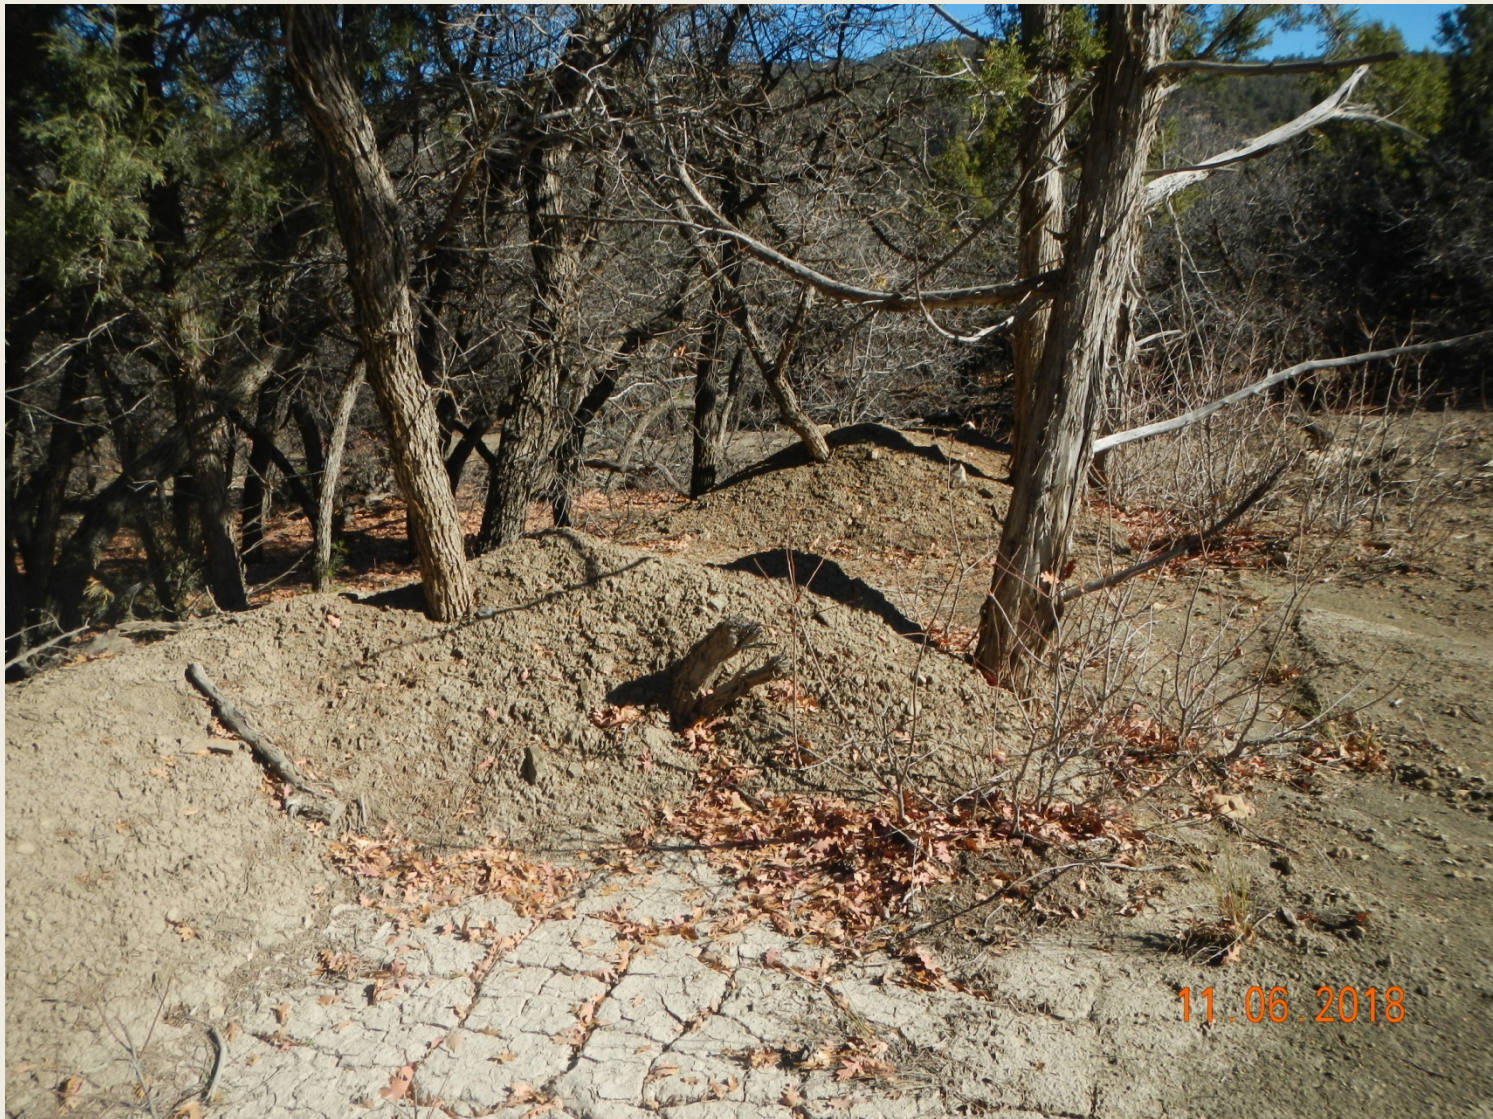
Photo 5. View of soil and sediment deposition up to 2.5 feet deep, around the base of trees from soil transport from the project area, in the northwestern project area.

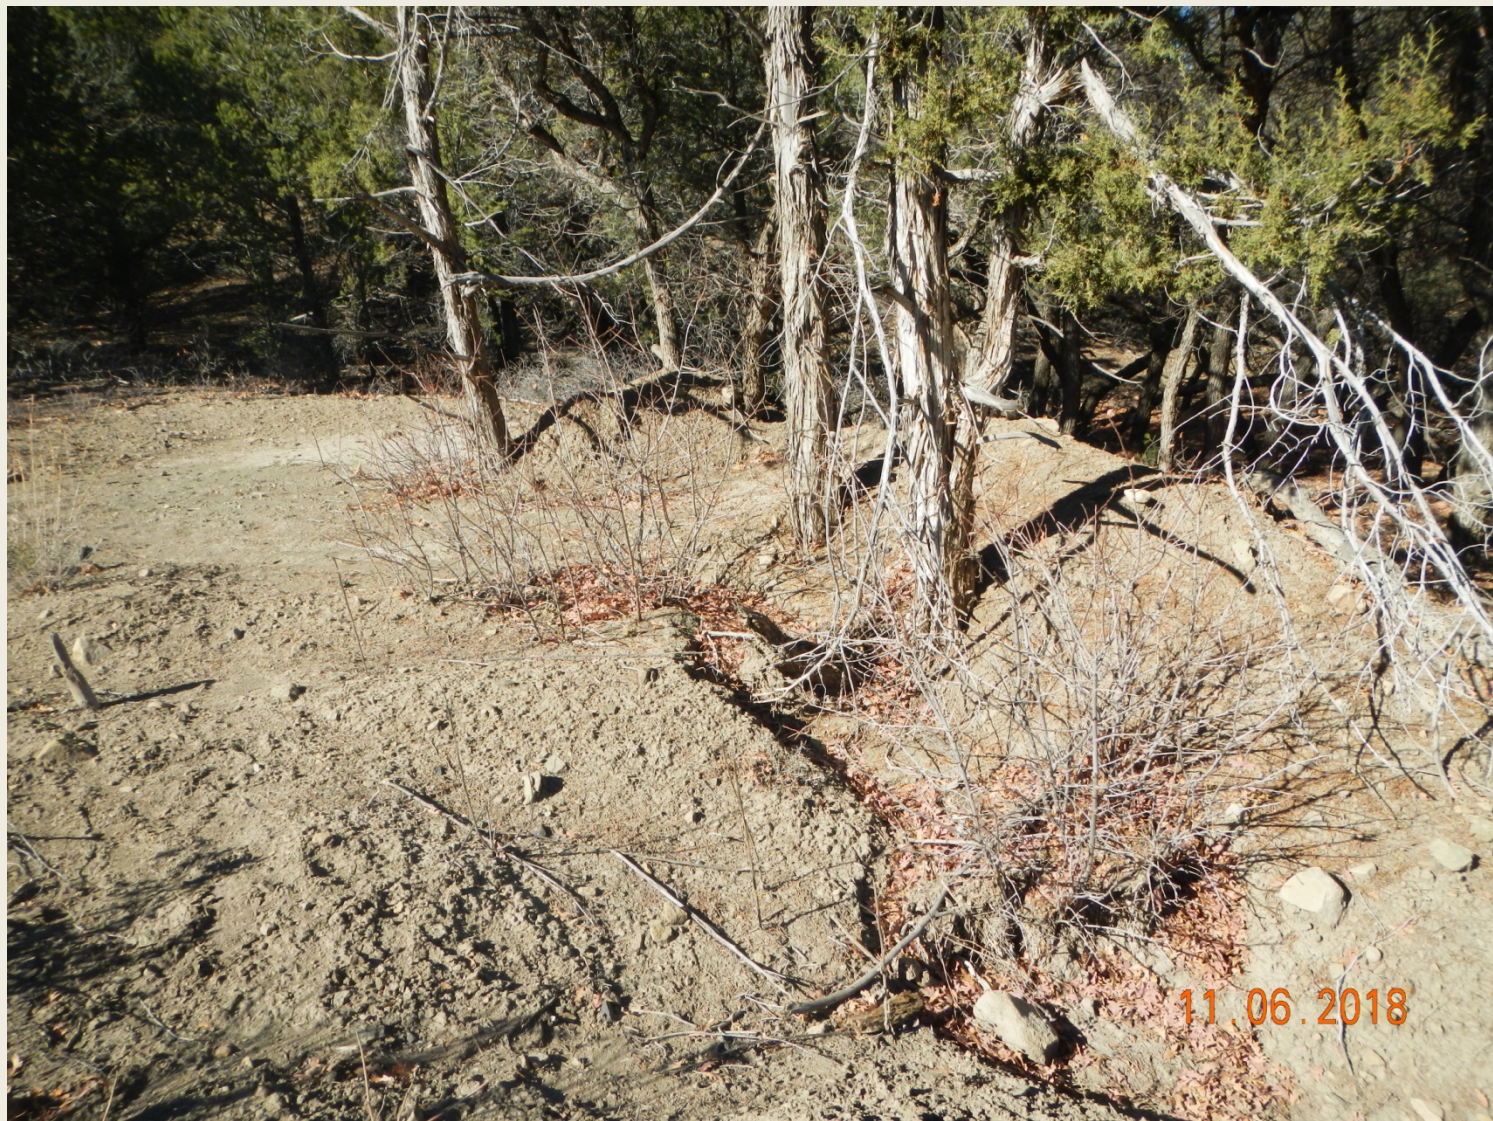
Photo 6. View of unstabilized soils and sediment deposition around trees in the northwestern project area.

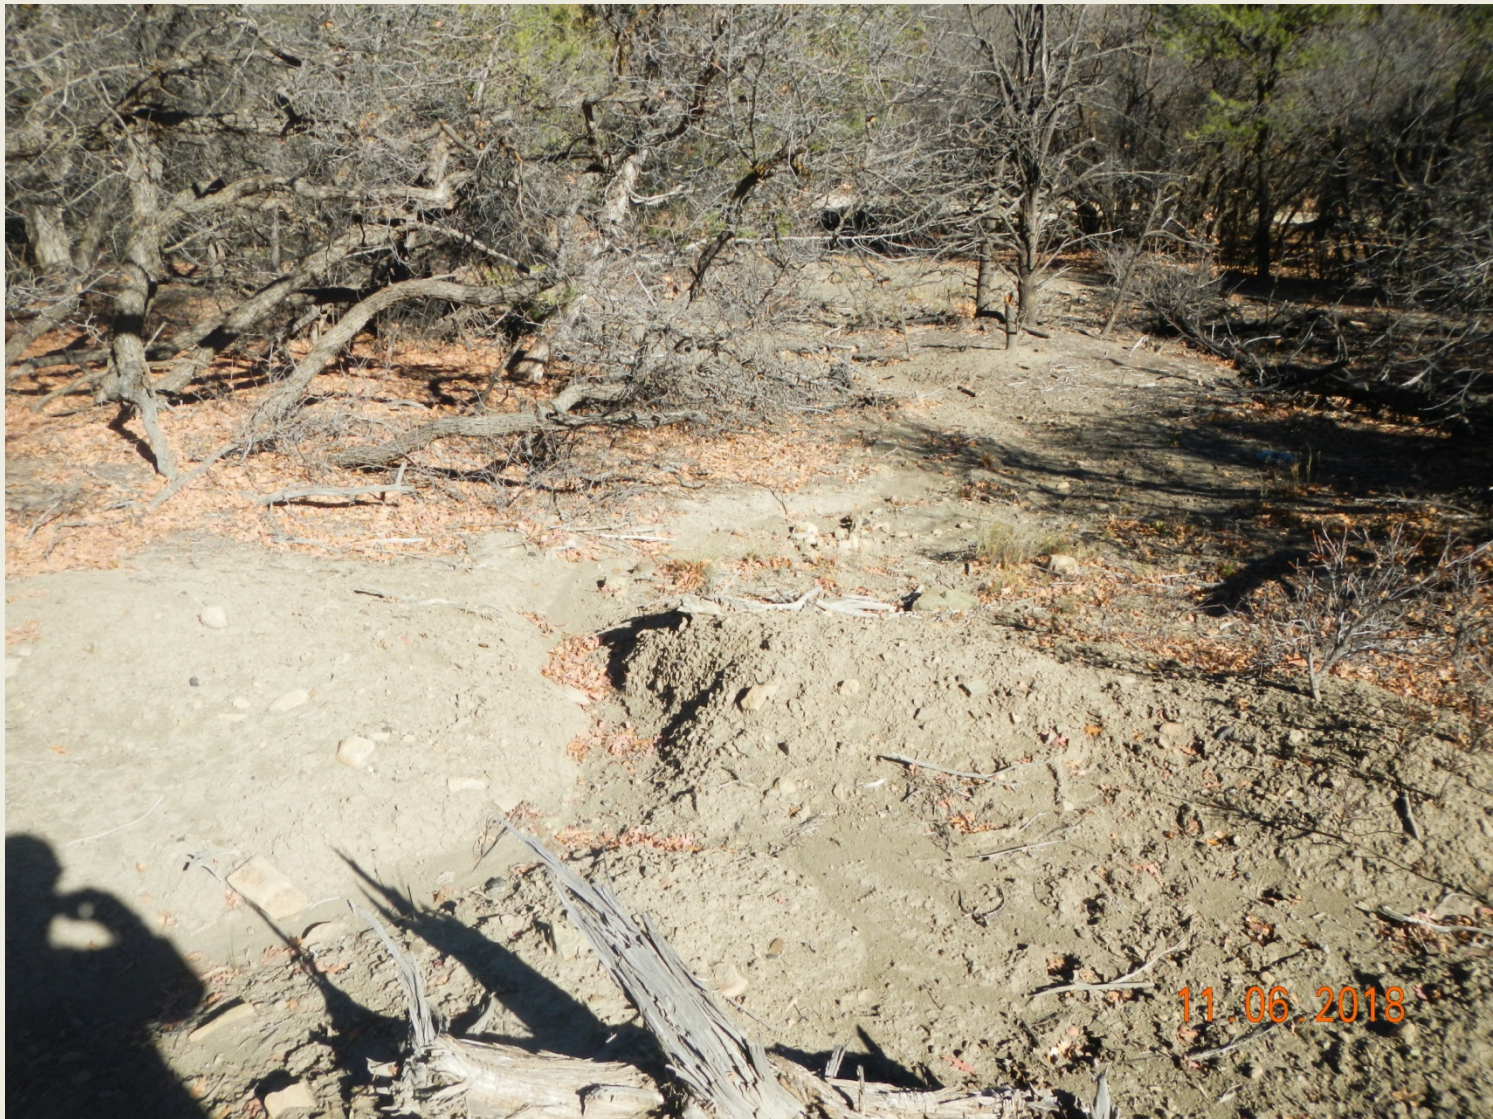
Photo 7. View of unstabilized soils, erosional channel approximately 2 feet wide and 1.5 feet deep, and sediment deposition/transport in the northwestern project area.

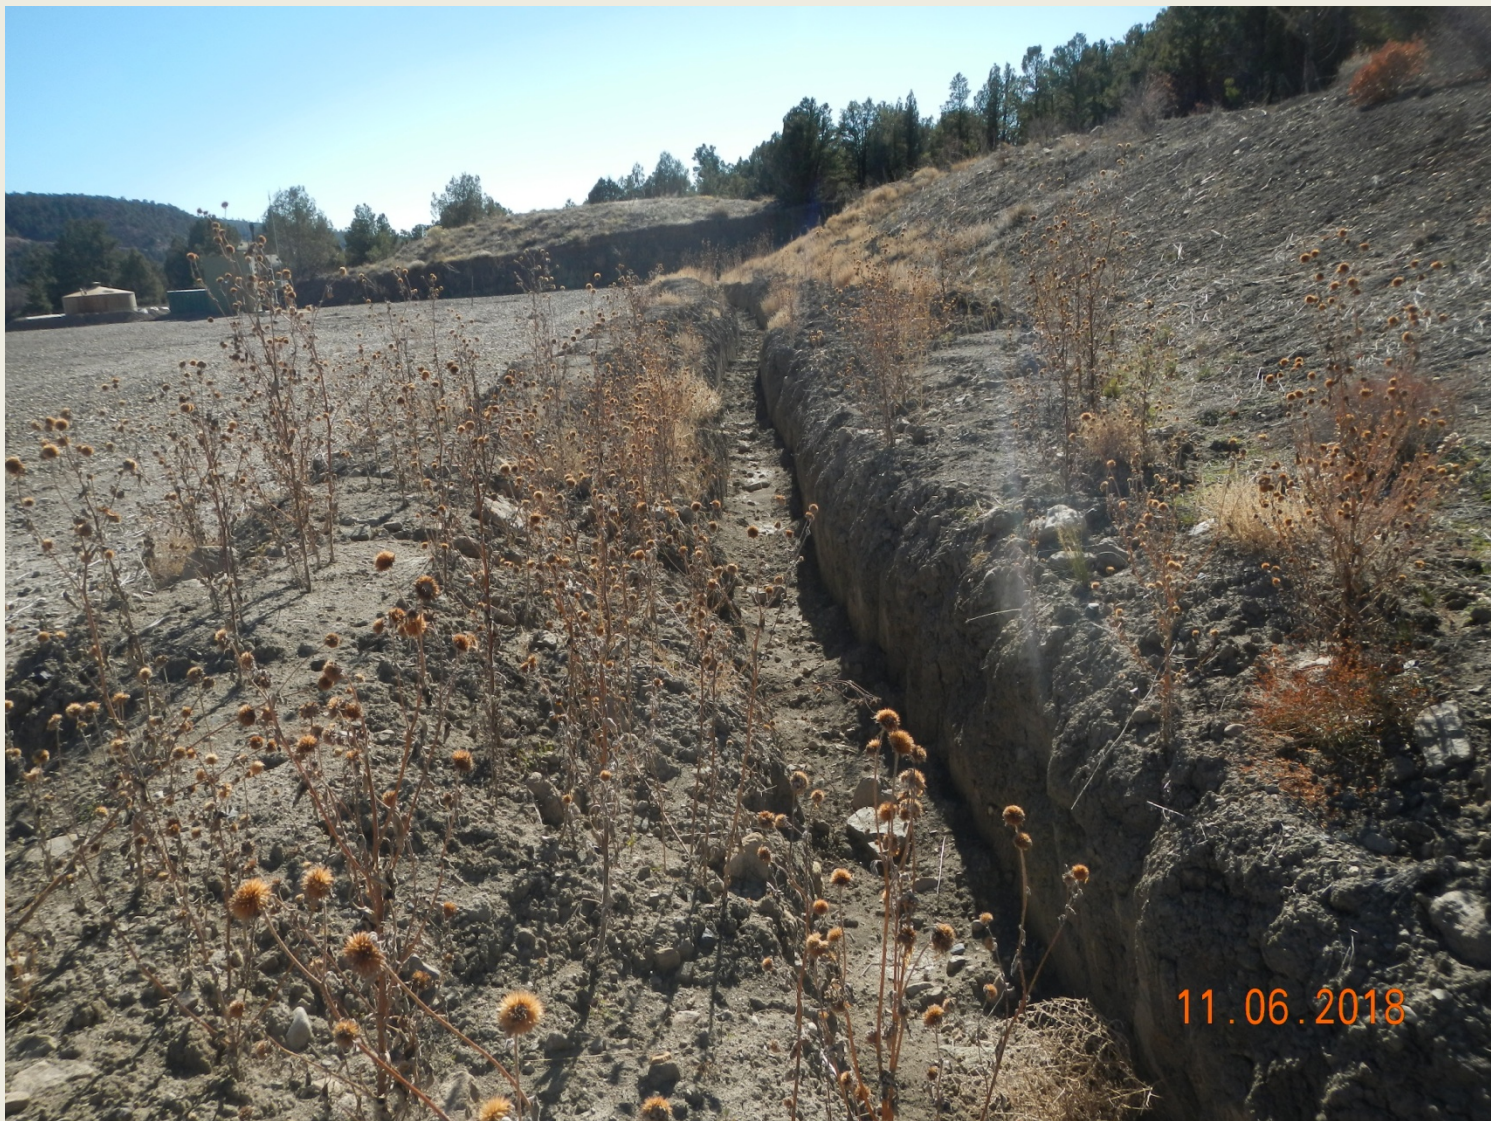
Photo 8. View of the western project area from the northwestern edge of the working area. Trench approximately 3 feet deep along the edge of the working area.

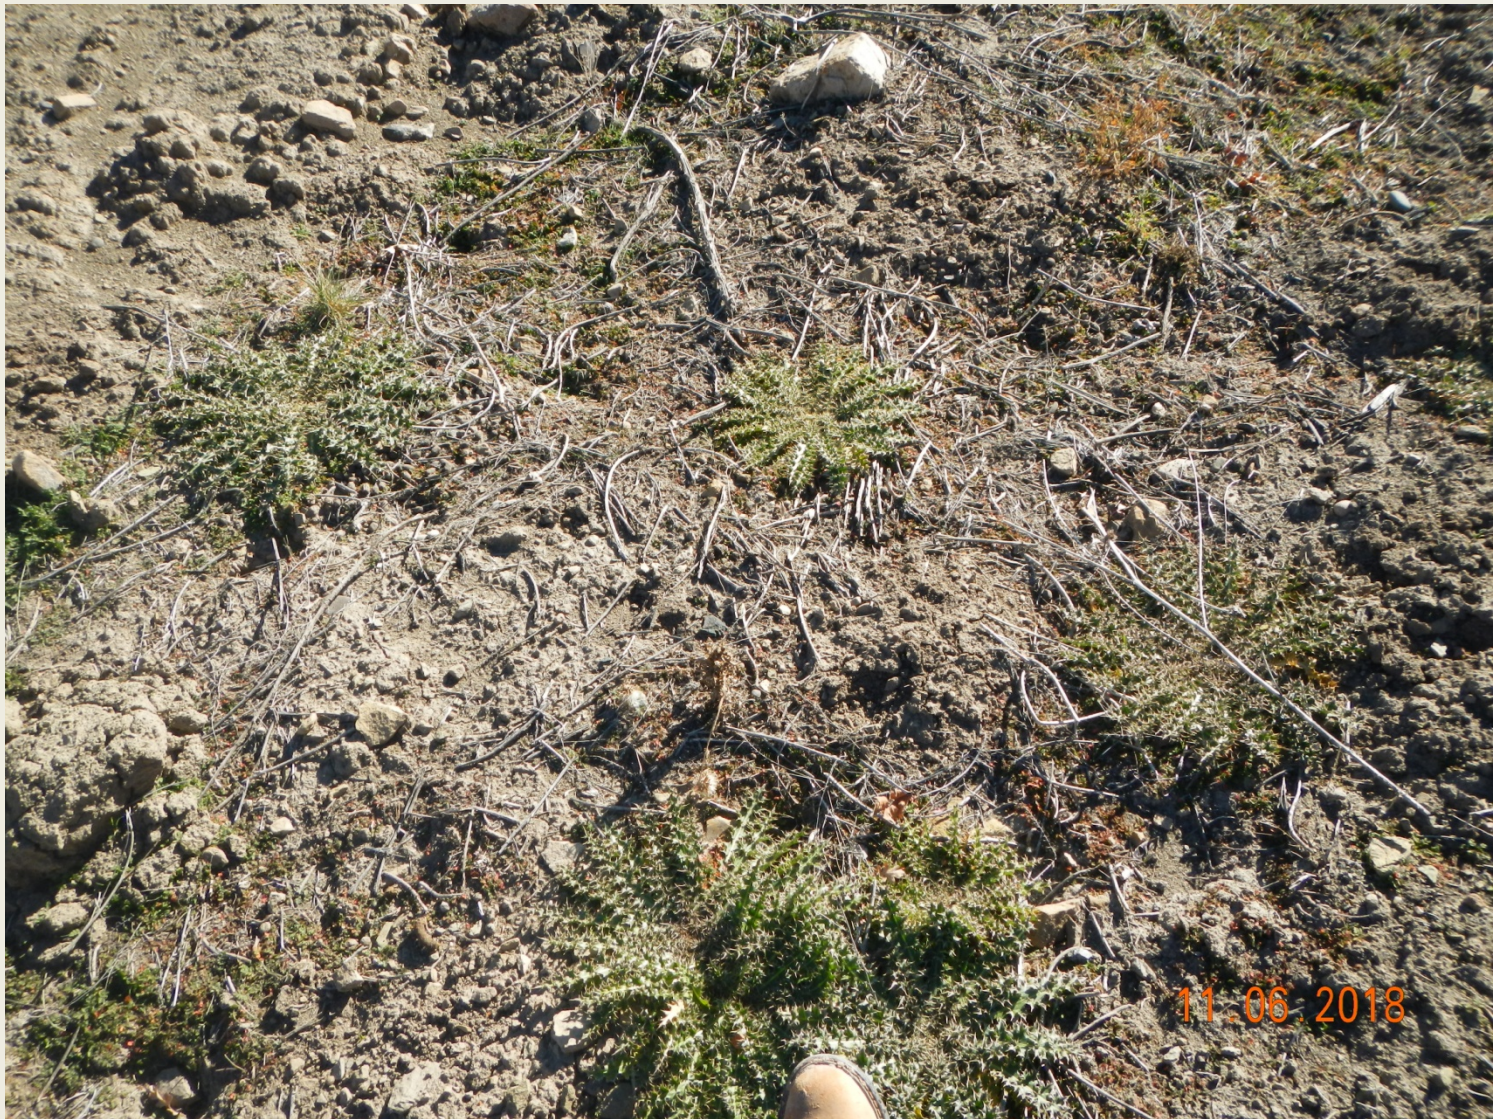
Photo 9. View of musk thistles (*Carduus nutans*) within the western project area.

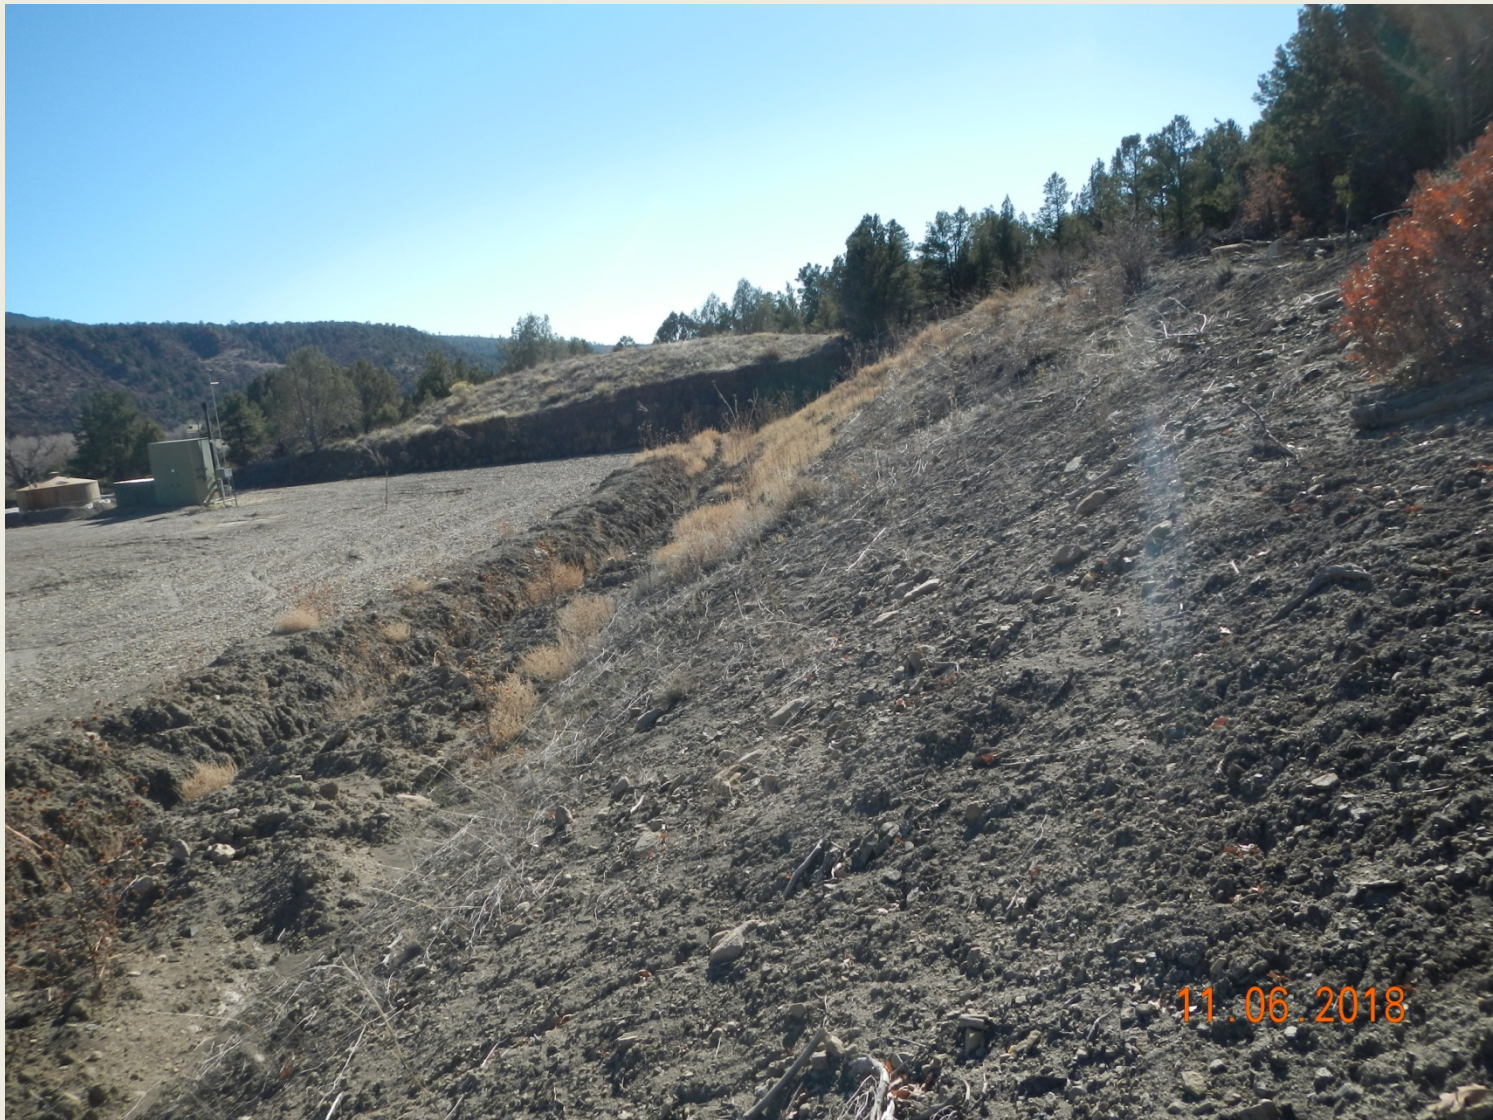
Photo 10. View of the western cut-slope from the northwestern corner facing southward.

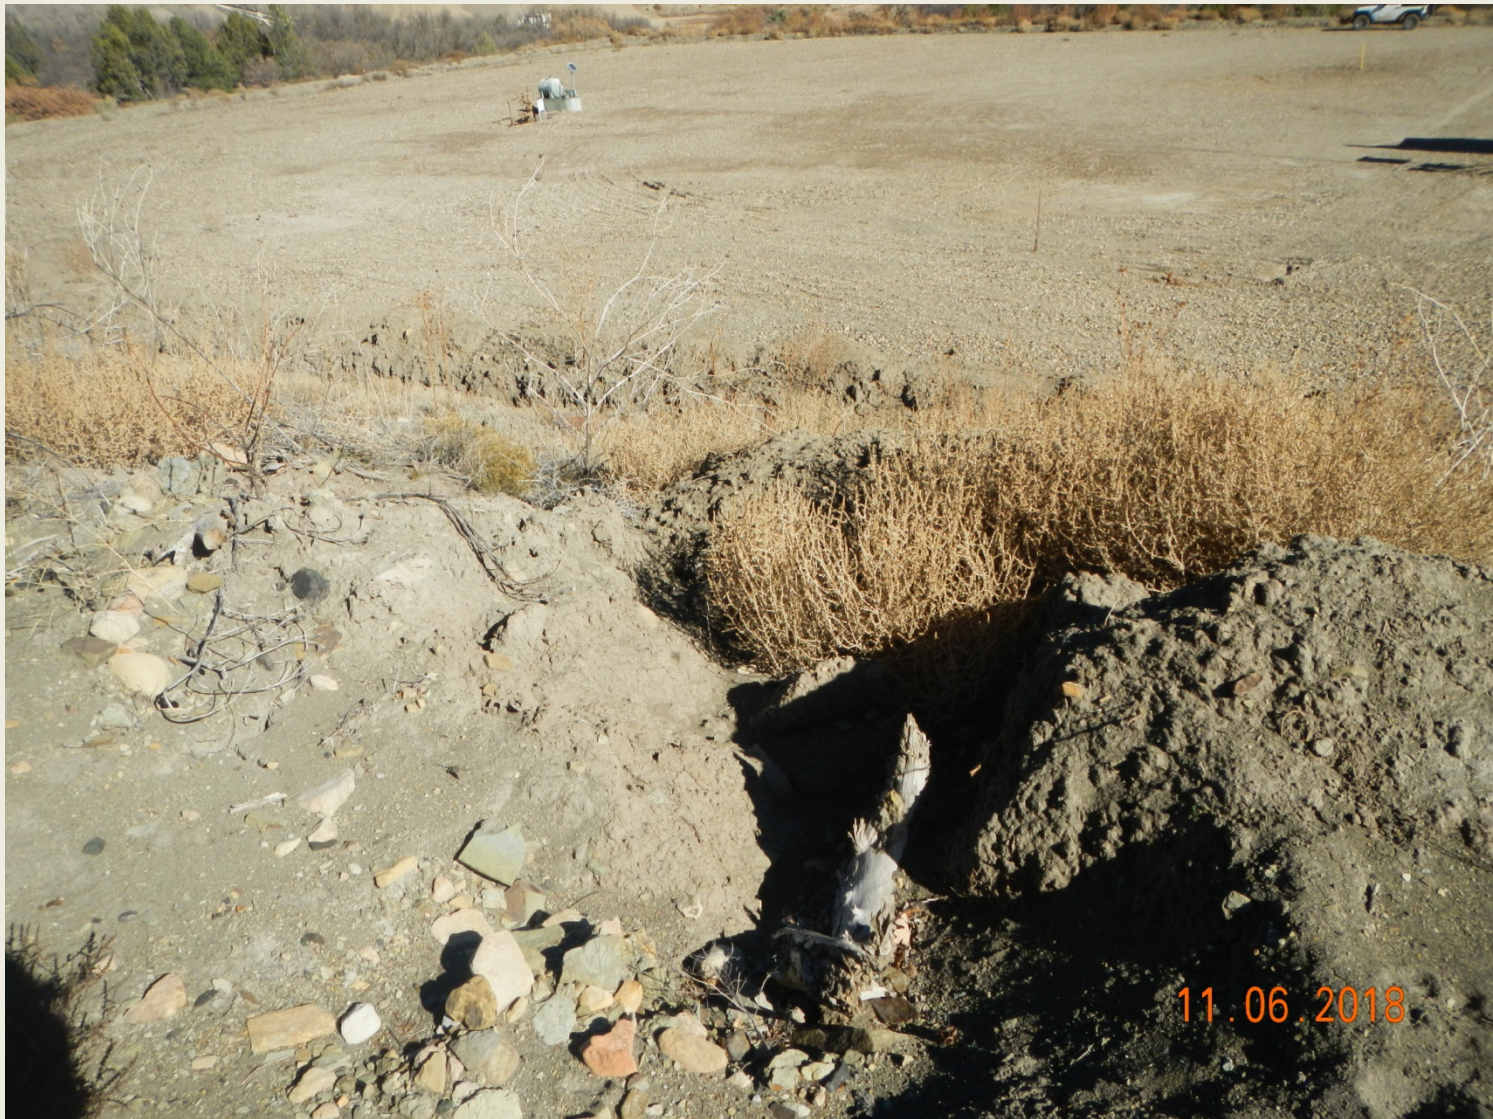
Photo 11. View of erosional channel forming from stormwater run-on within the western cut-slope.

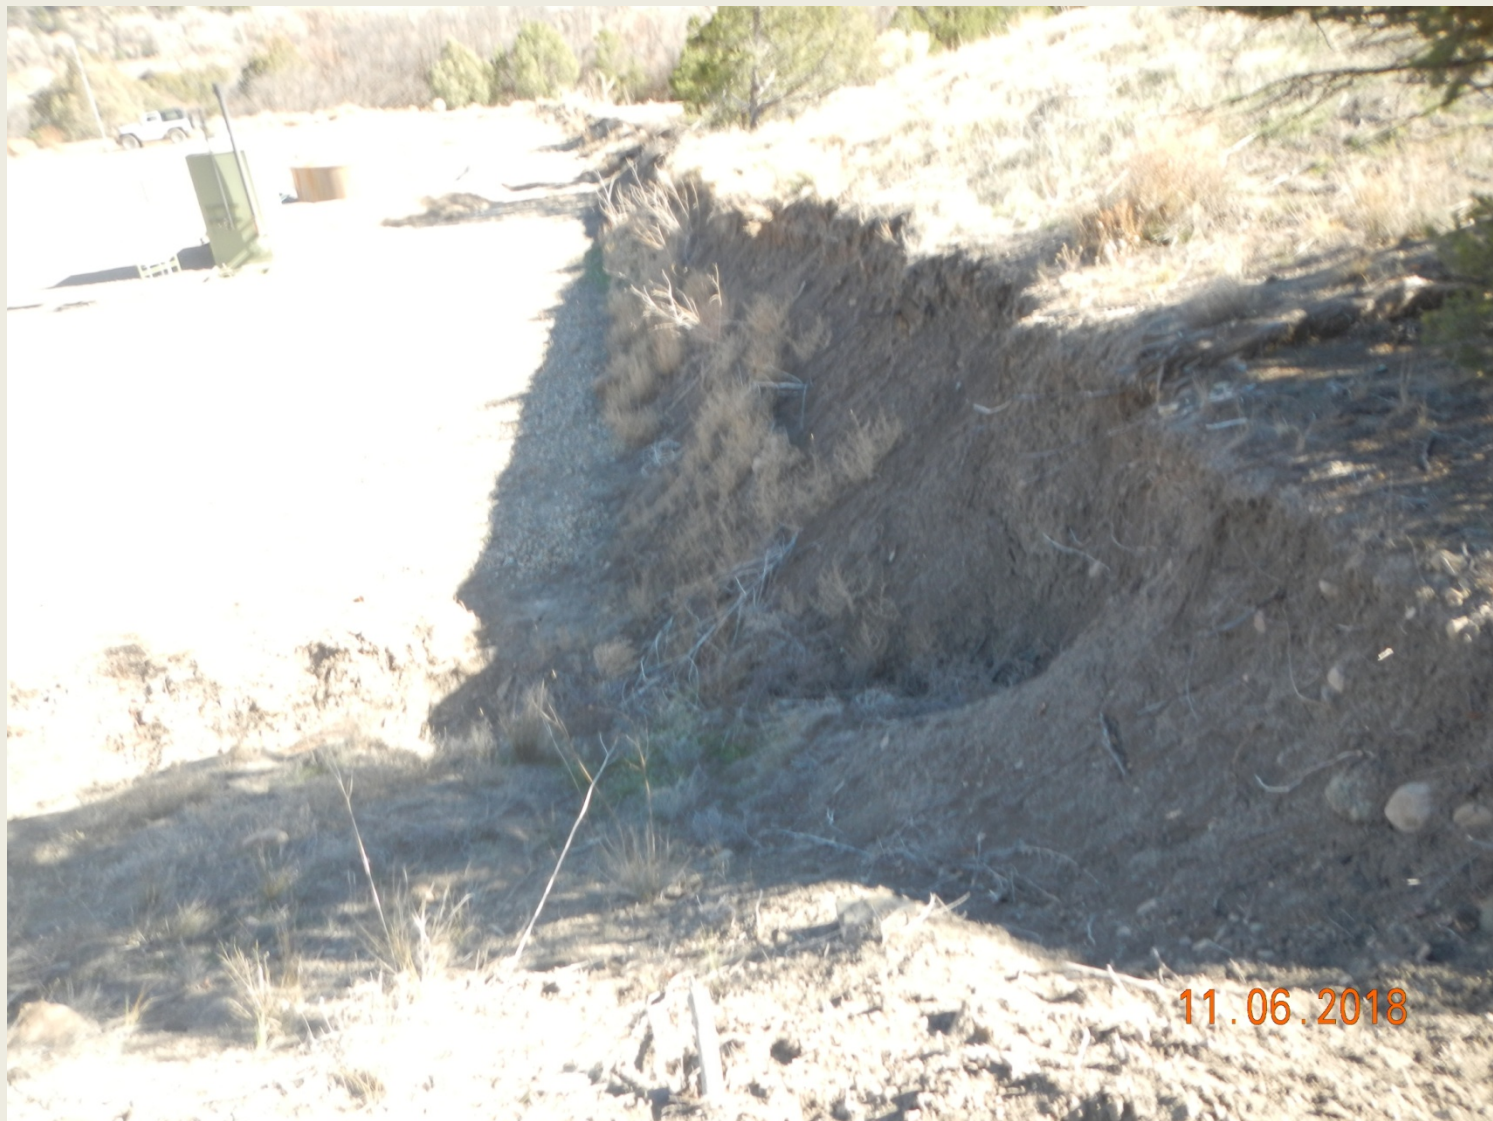
Photo 12. View of the southern project area from the southwestern corner facing eastward. Cut-slope is not stabilized.
