Interim Reclamation and Stormwater Inspection

Operator: SCHNEIDER ENERGY SERVICES INC- #76840

Location ID: 320521

Inspection Document #: 682404240

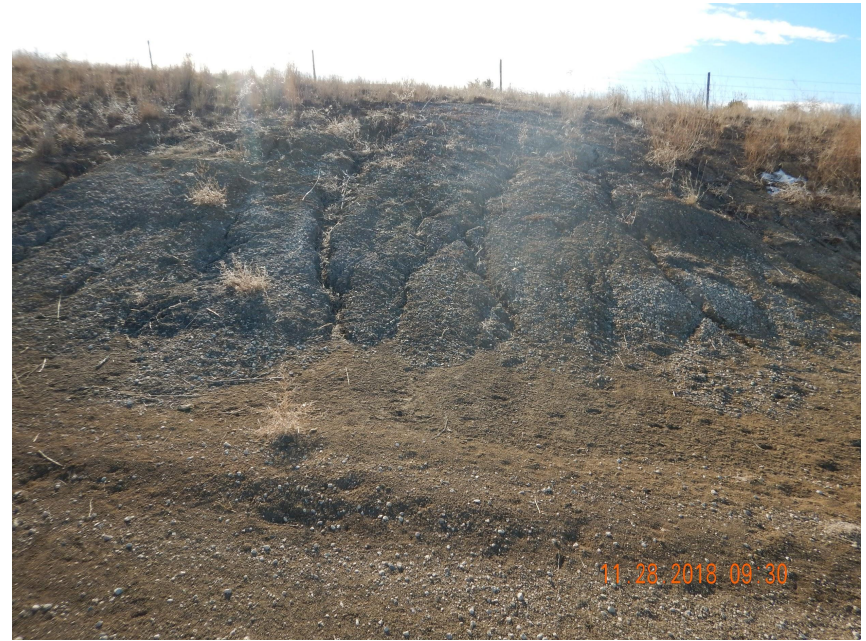
Photo 2. Photo taken from the southwestern cut slope, facing South. Photo illustrates an unstabilized cut slope with the evidence of rill erosion. The entire southern cut slope has not been properly stabilized. This location is not in compliance with Rule 1002 standards.

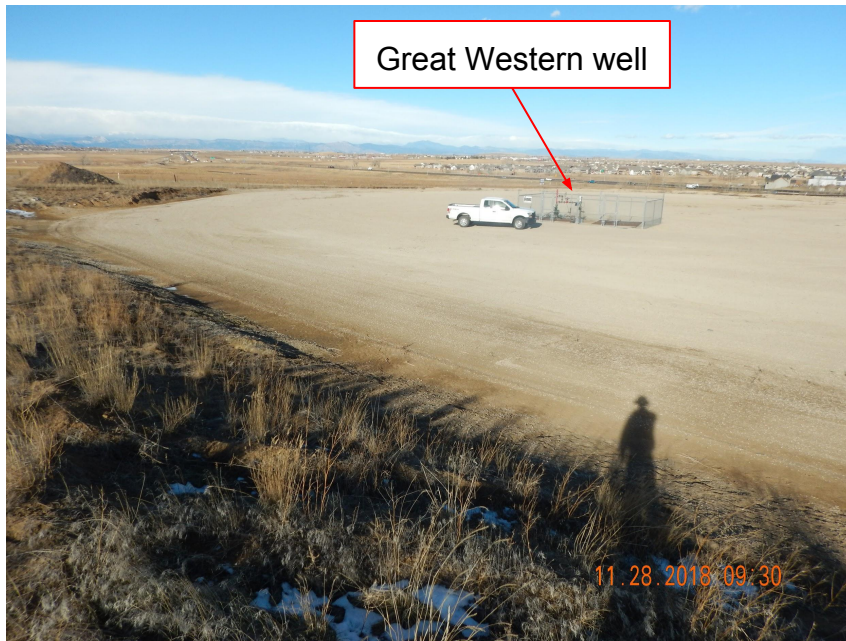
Photo 3. Photo taken from the southern perimeter of the location, facing Northwest. Photo illustrates that interim reclamation has not been performed. This location is not in compliance with Rule 1003 standards.

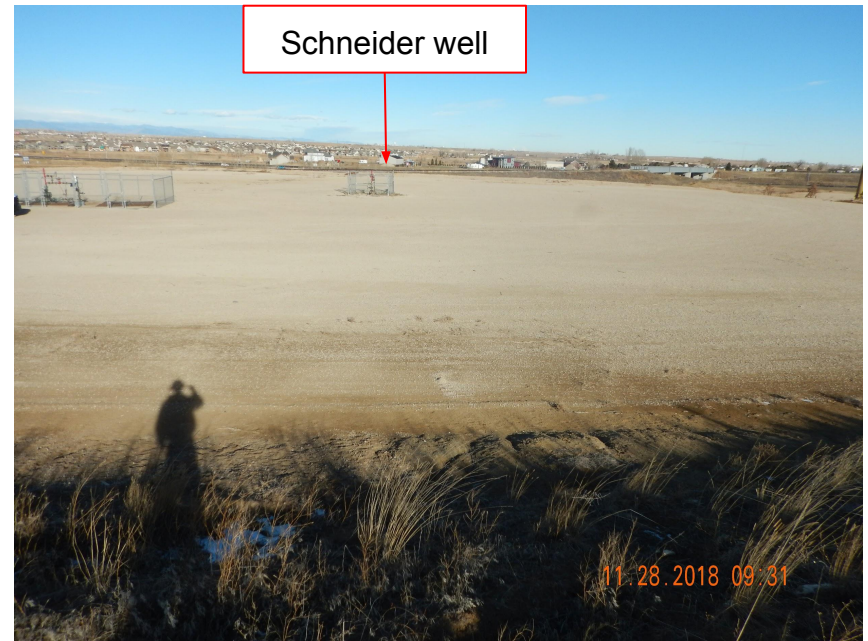
Photo 4. Photo taken from the southern perimeter of the location, facing North. See comments under Photo 3.

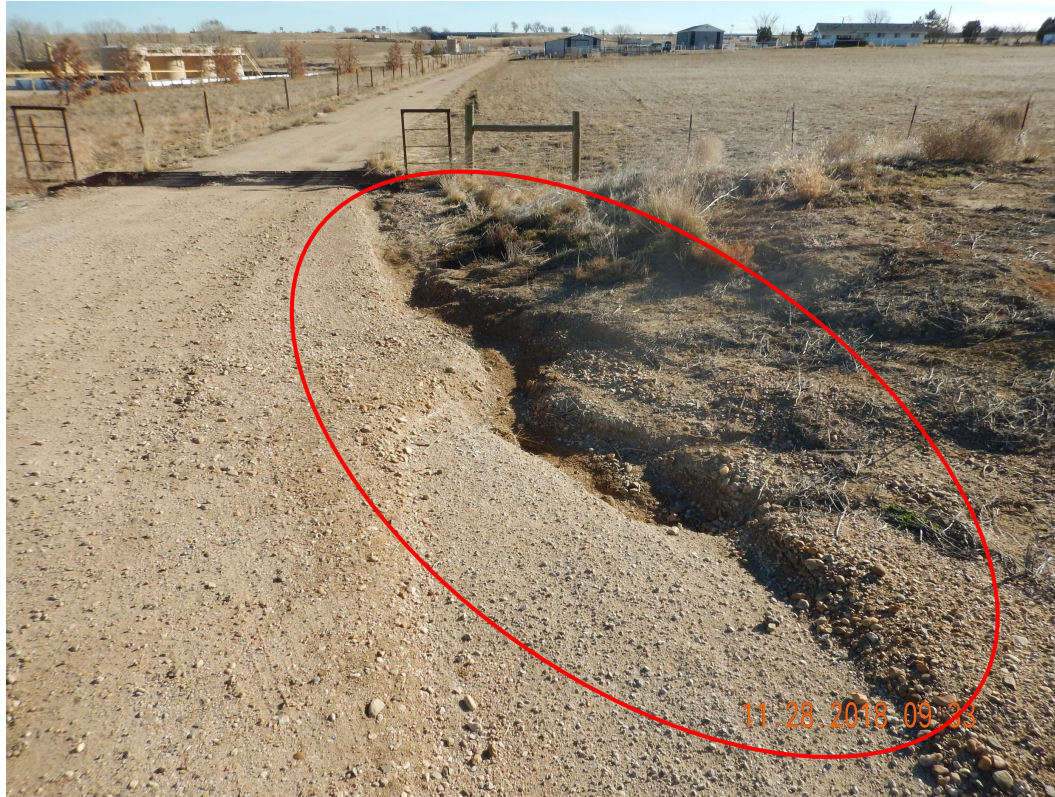
Photo 5. Photo taken from the entrance of the location, facing East. Photo illustrates stormwater erosion discharging off location. This location is not in compliance with Rule 1002 standards.

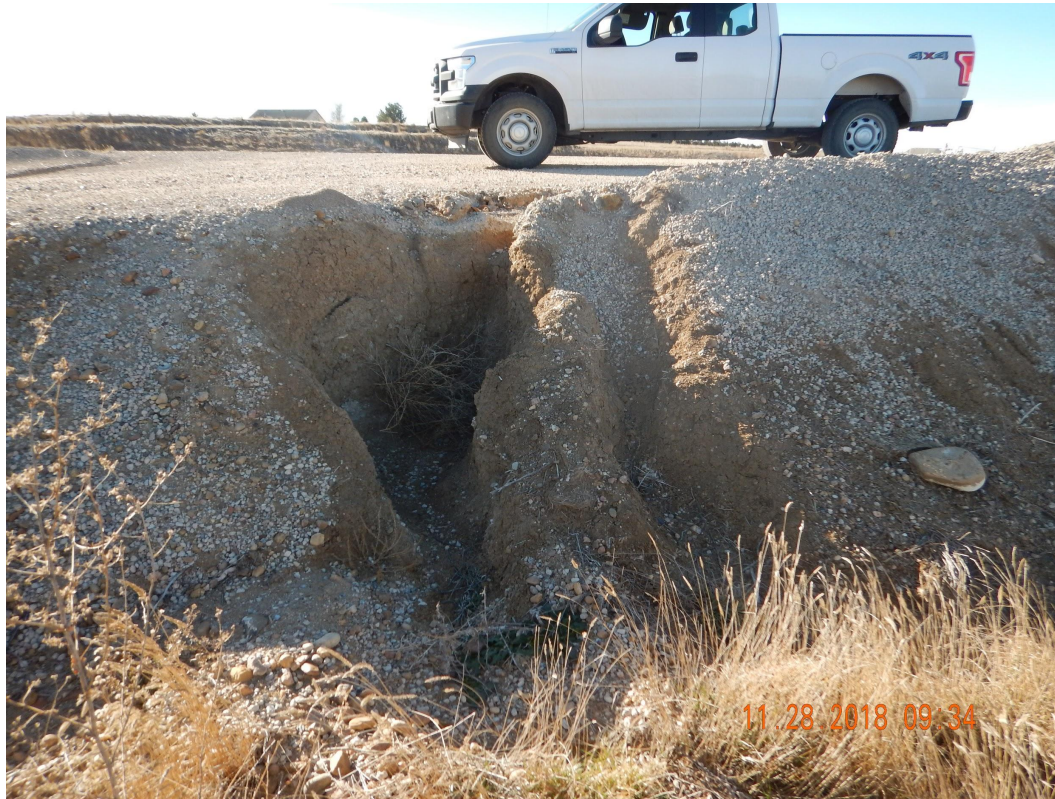
Photo 6. Photo taken from the northeastern location, facing South. Photo illustrate gully erosion off the the fill slope and is discharging off location. See comments under Photo 5.
