# Construction and Stormwater Inspection

November 28, 2018

Operator: BURLINGTON RESOURCES OIL & GAS LP- #26580

Location ID: 458787

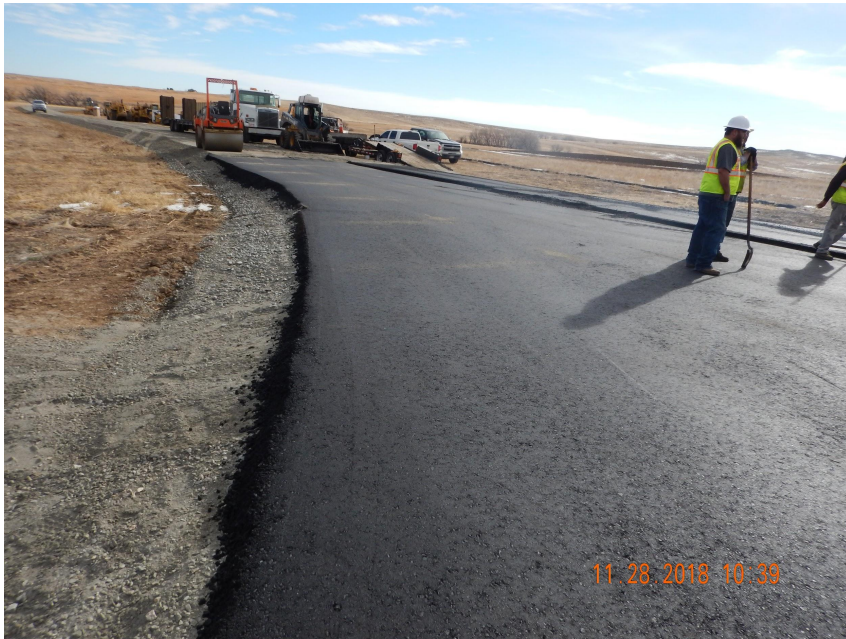
**Photo 1.** Photo taken from the entrance of the location off Watkins Road, facing Southeast. Photo illustrates paved entrance into the location. Operator in process of stabilizing the main access road- see following photo.

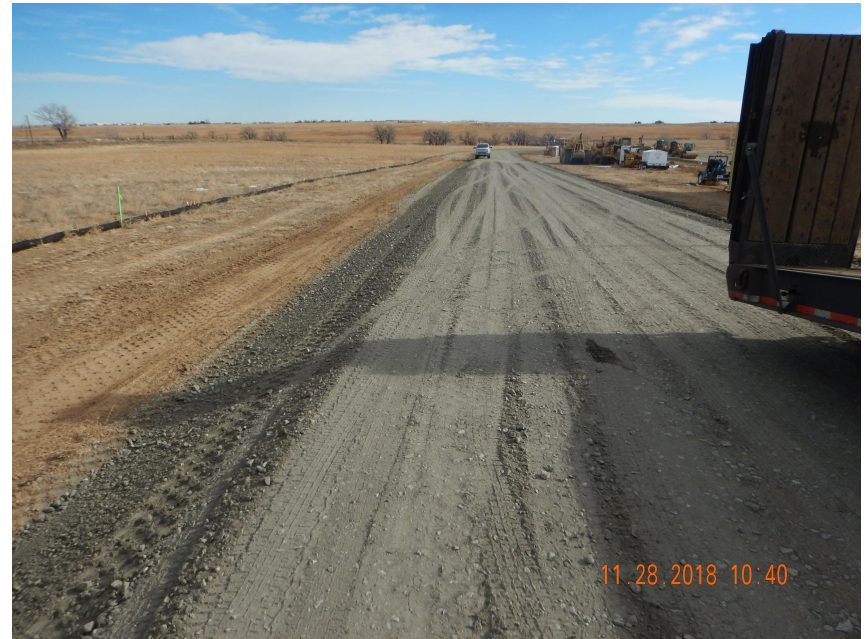
**Photo 2.** Photo taken from the entrance of the location, facing East. Photo illustrates the Operator is in process of stabilizing the main access road with road base. Filtrexx wattle BMP was observed throughout the entire perimeter of the location in conjunction with other BMPs. Note: Operator has stored equipment between the main access road and the location. Operator is responsible for reclaiming all disturbances associated with oil and gas disturbance.

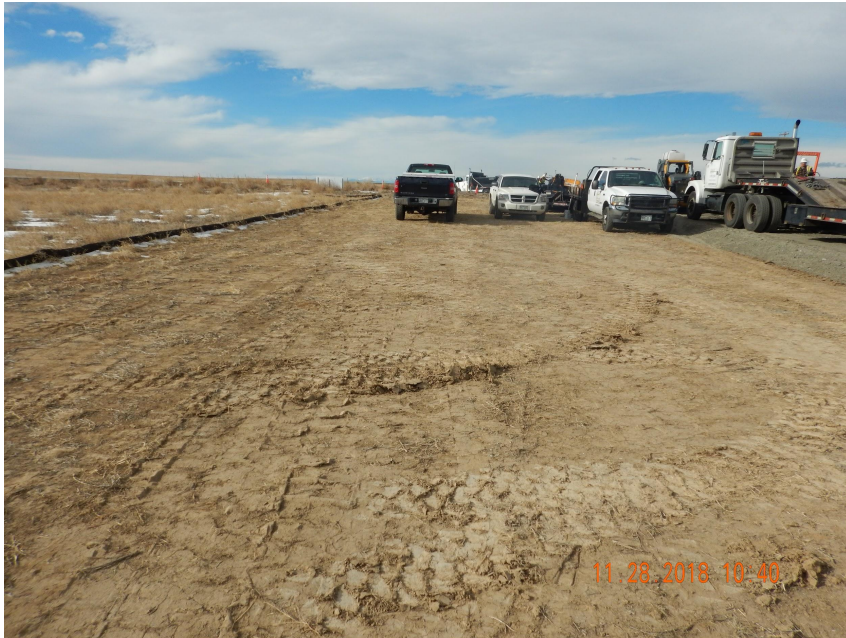
**Photo 3.** Photo taken of the disturbance area between the main access road and the location, facing West. Operator is responsible for reclaiming all disturbances associated with oil and gas disturbance.

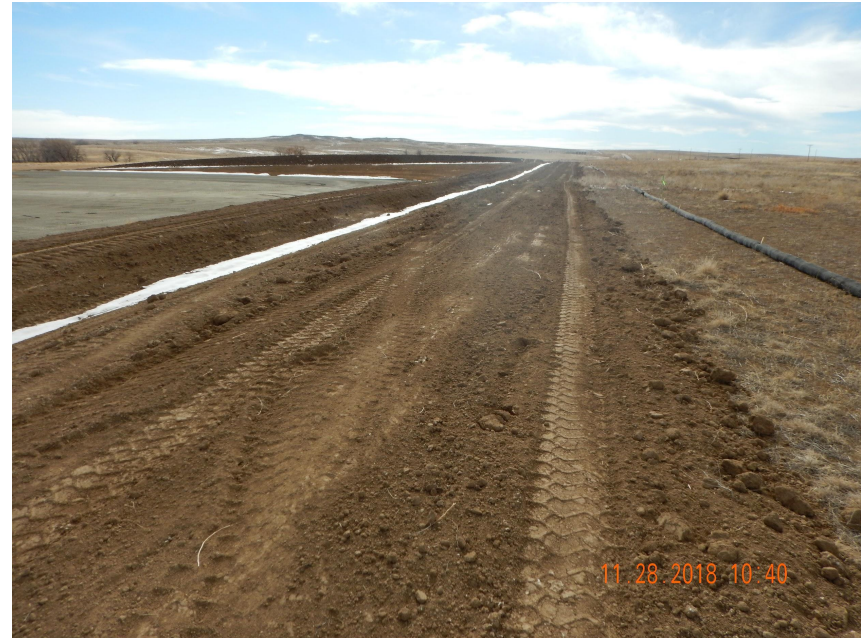
**Photo 4.** Photo taken from the northwestern perimeter of the location, facing South. Filtrexx wattle BMP has been installed throughout the entire perimeter of the location in conjunction with other BMPs.

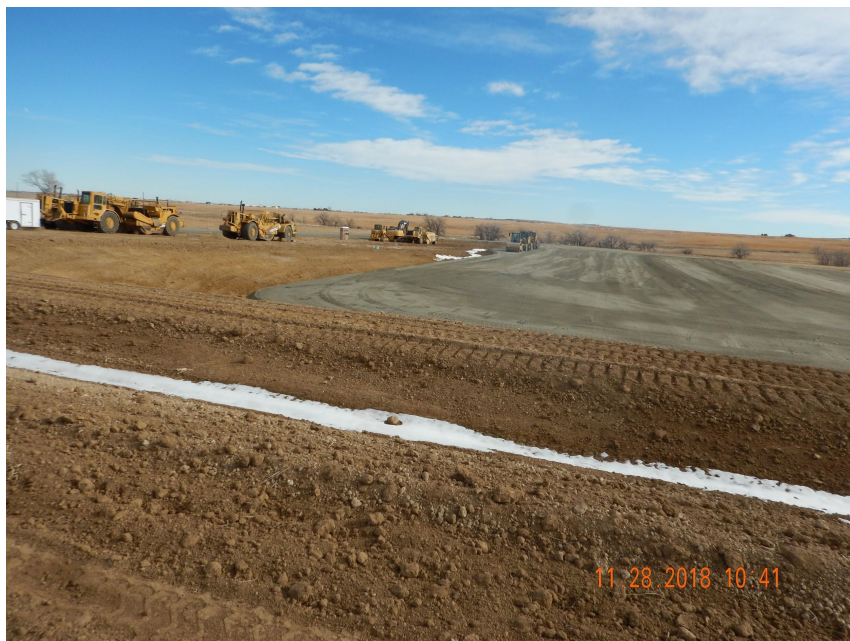
**Photo 5.** Photo taken from the northwestern perimeter of the location, facing East. Operator in process of stabilizing the well pad.

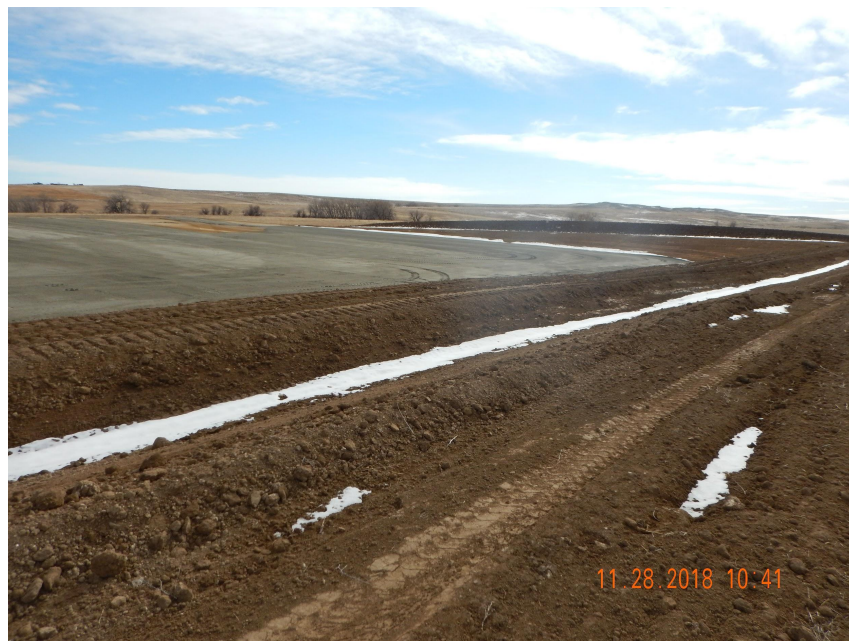
**Photo 6.** Photo taken from the northwestern perimeter of the location, facing Southeast. See comments under Photo 5.

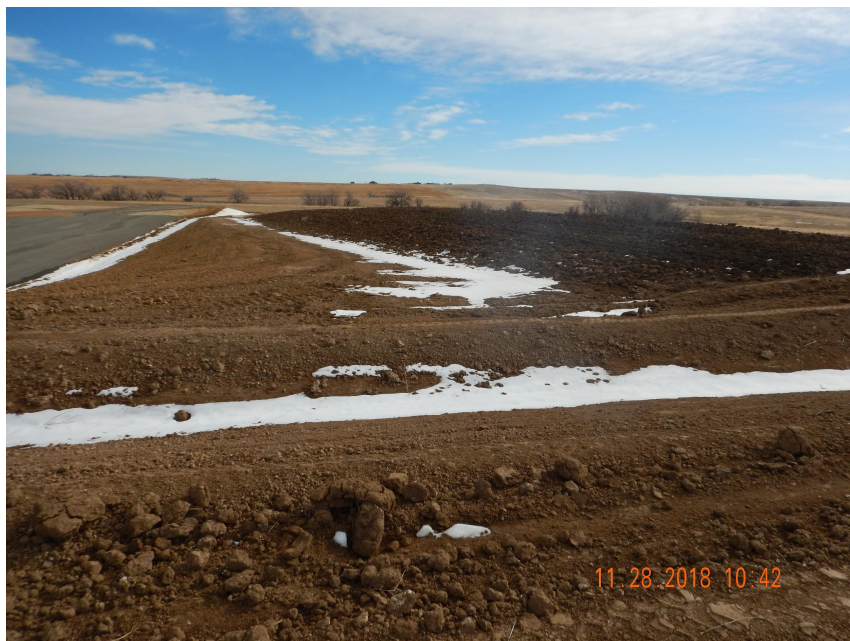
**Photo 7.** Photo taken from the southwestern perimeter of the location, facing East. Photo illustrates the topsoil stockpile that has been temporarily stabilized with equipment tracking.

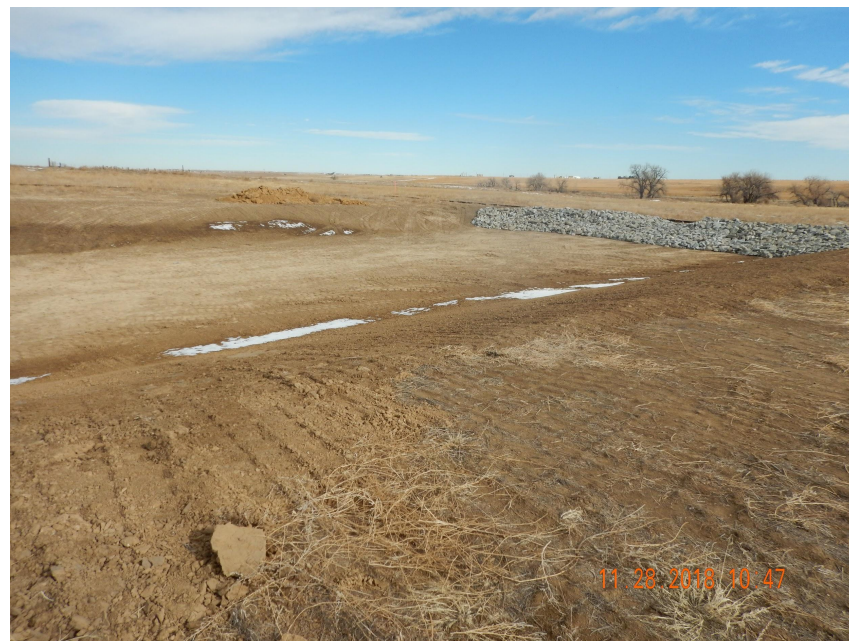
**Photo 8.** Photo taken from the northeastern perimeter of the location, facing Northeast. Photo illustrates a sediment trap installed with a stabilized outlet.

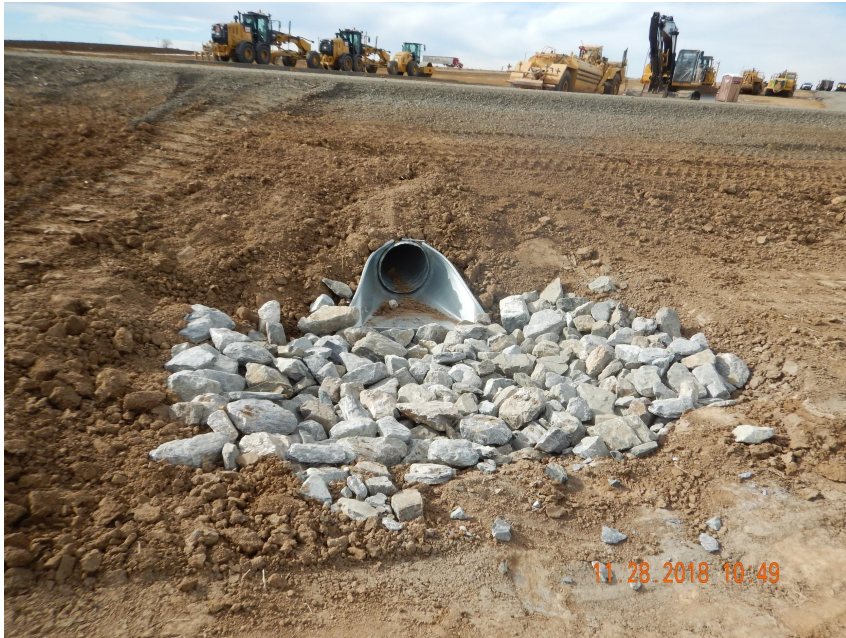
**Photo 9.** Photo taken from the outlet of a culvert, facing West. Stormwater is directed to the stabilized sediment trap.

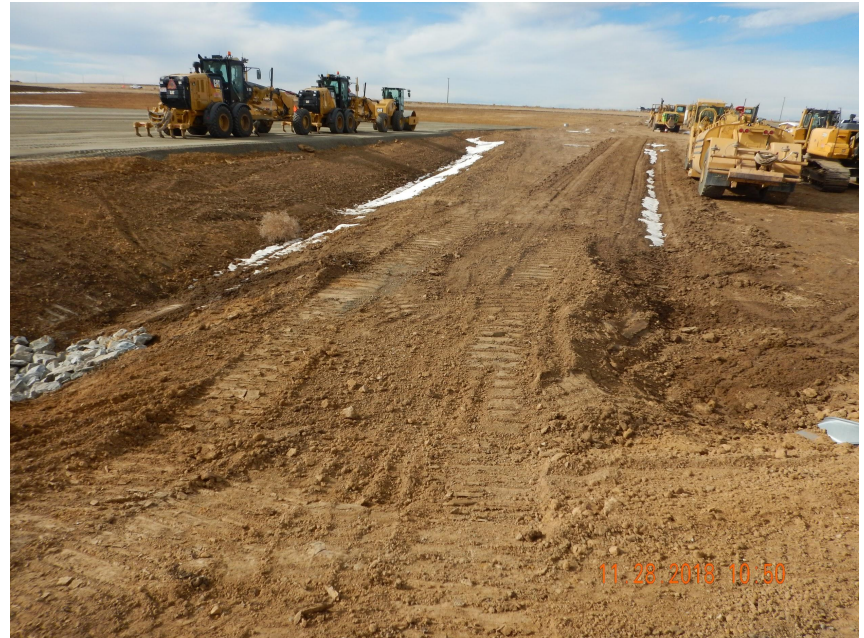
**Photo 10.** Photo taken from the northern location, facing West. Photo illustrates two sets of ditch BMPs which are directed to the stabilized outlet.
