Inspection Photos

Operator: BP Production

API: 05-067-09442

Date: 11/9/2018

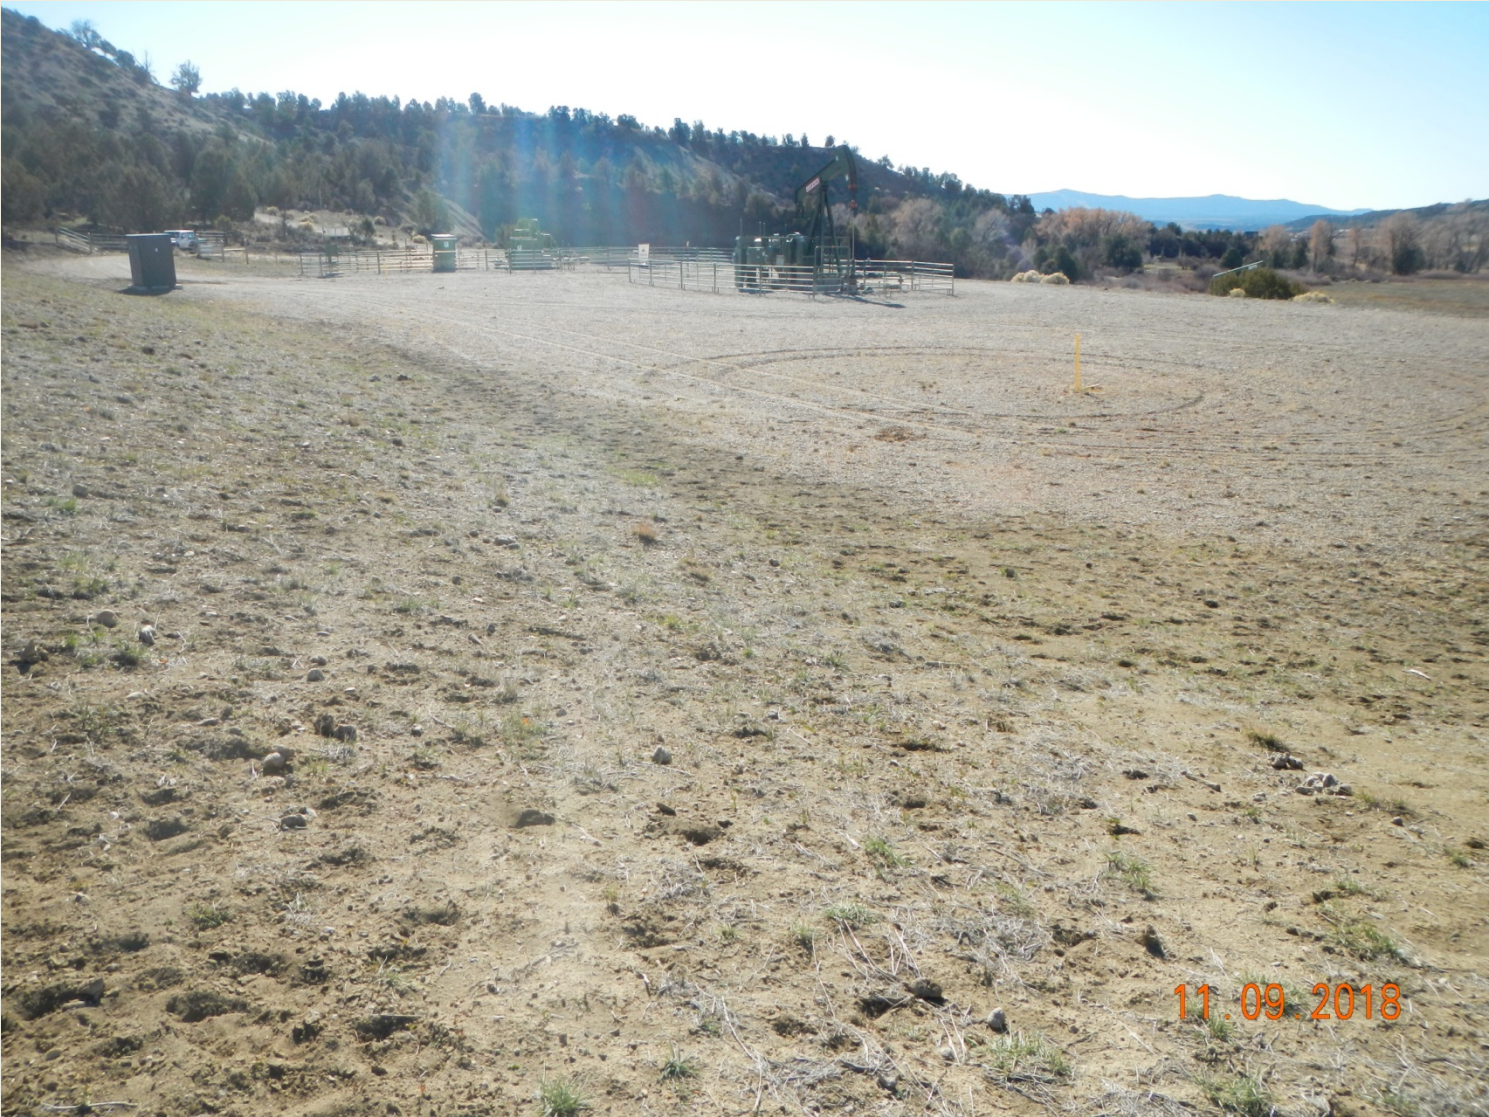
Photo 1. View of the project area from the northeastern corner facing center.

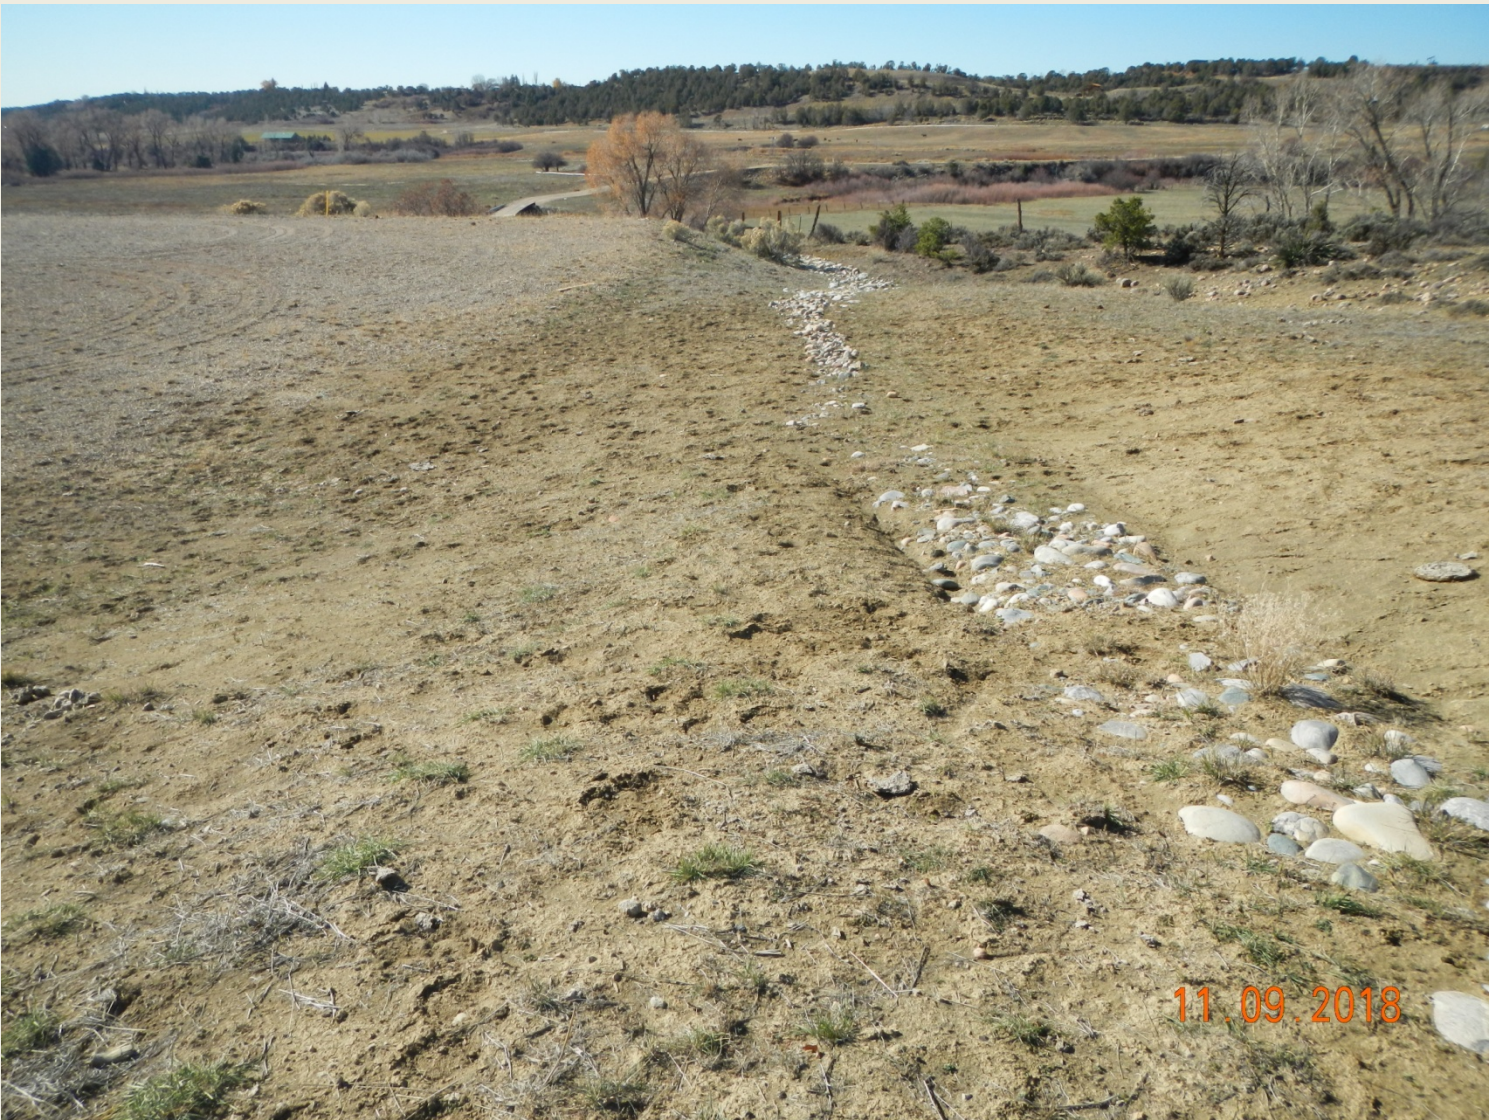
Photo 2. View of the northwestern project area from the northeastern corner facing southwestward. Revegetation is progressing with grasses such as sand dropseed (*Sporobolus cryptandrus*), western wheatgrass (*Pascopyrum smithii*), and crested wheatgrass (*Agropyron cristatum*). Cobble run-down is filling with sediment and will soon require maintenance.

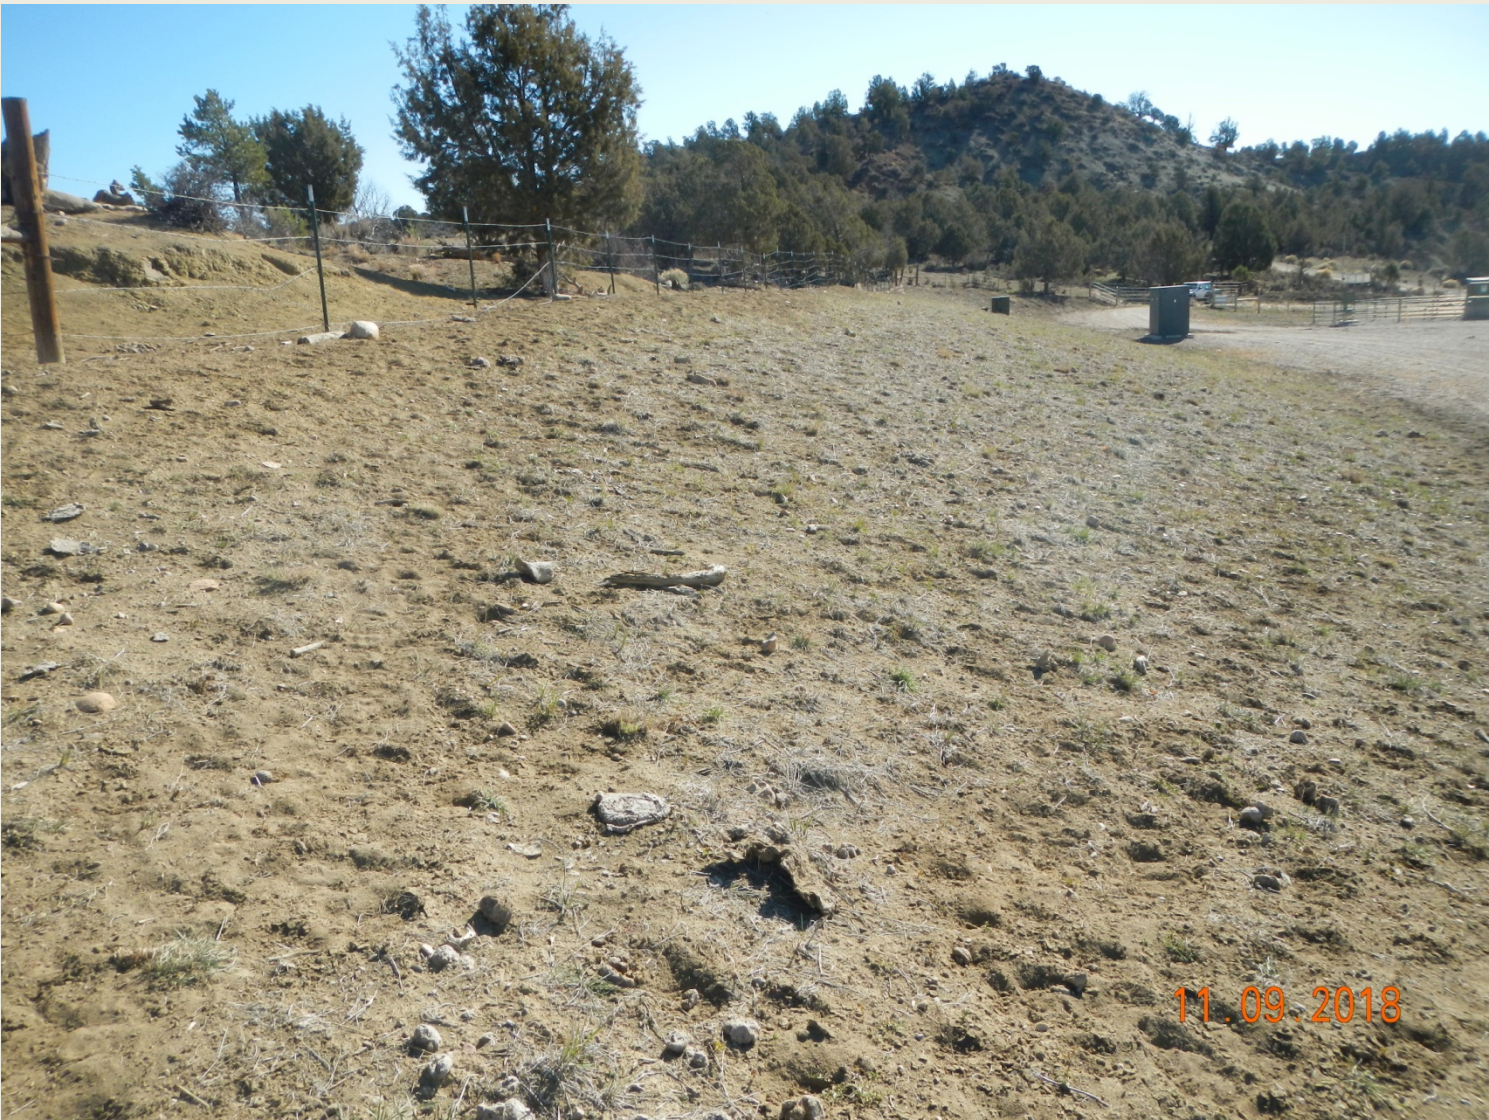
Photo 3. View of the eastern project area from the northeastern corner facing southeastward.

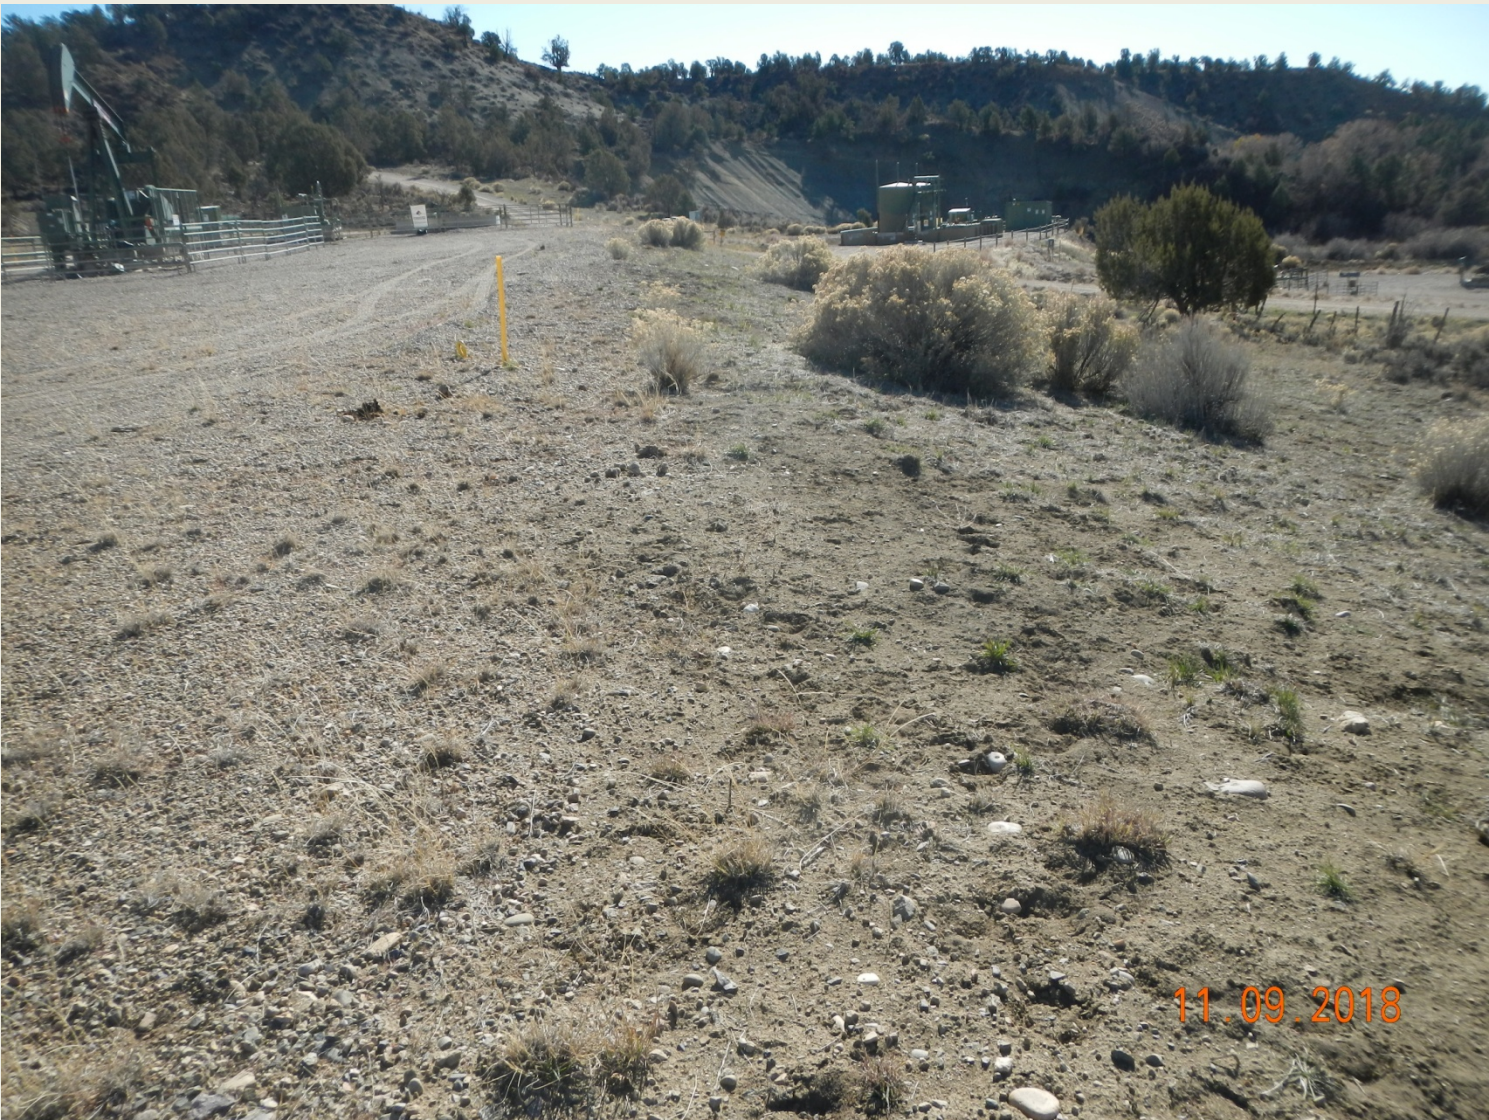
Photo 4. View of the southwestern project area from the northwestern corner facing southeastward.

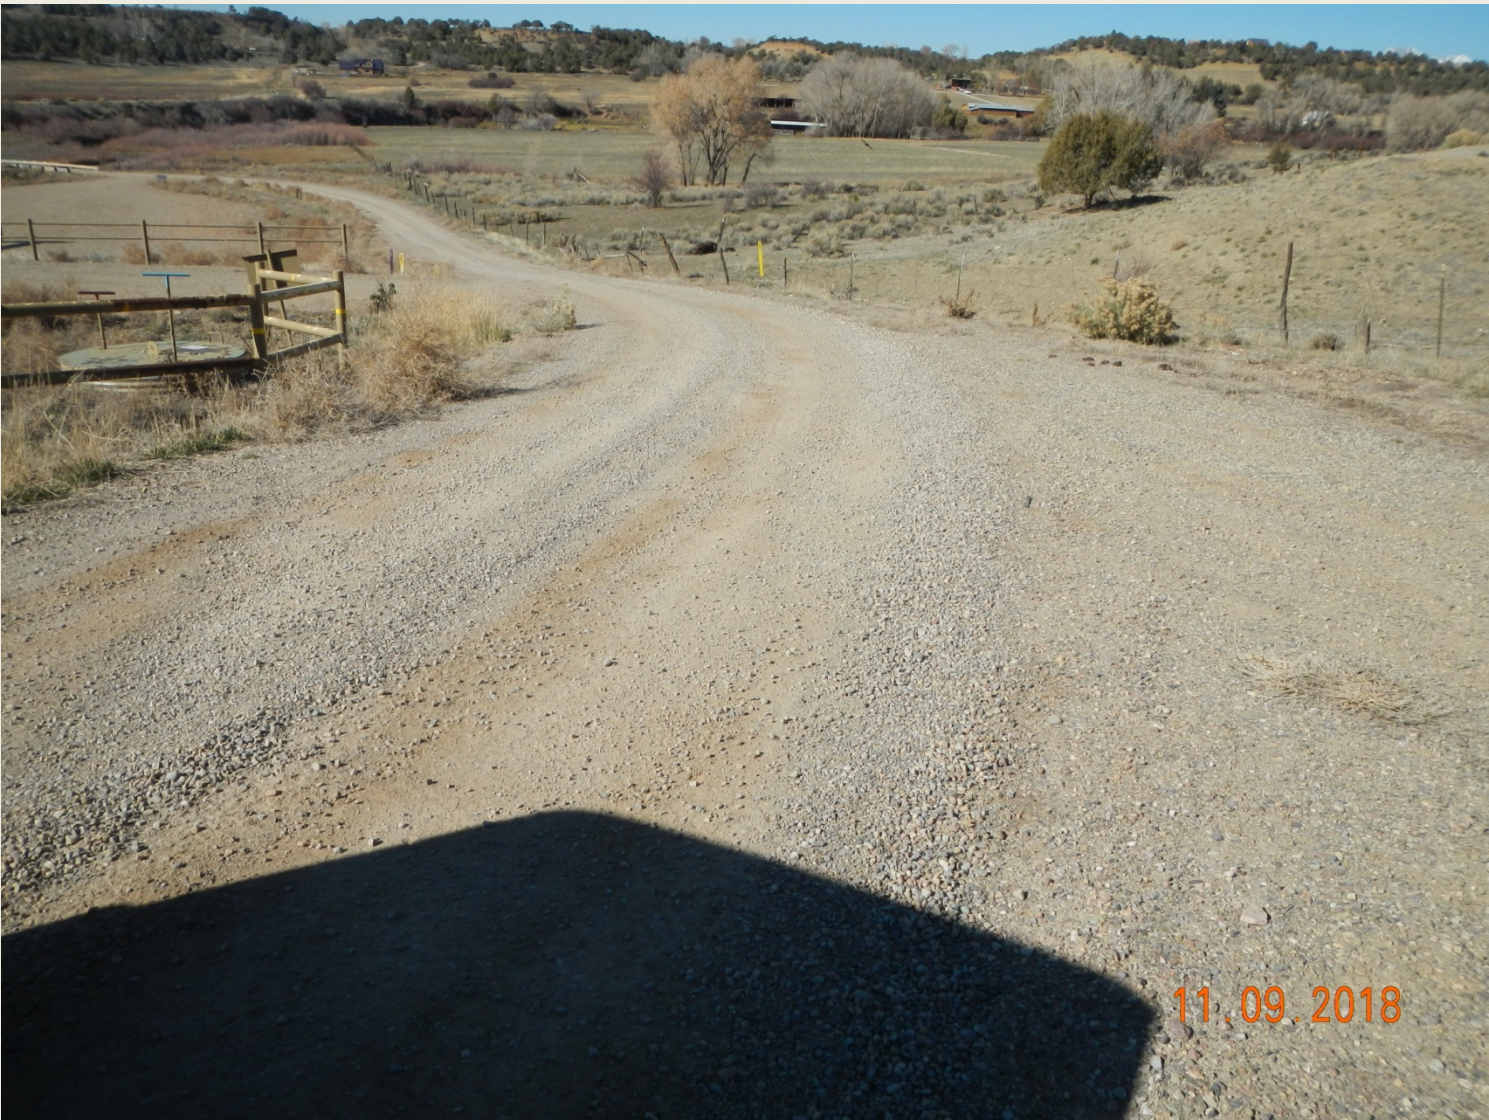
Photo 5. View of road surface maintained in good repair.
