Inspection Photos

Operator: DENVER EAST MACHINERY COMPANY
- 24040

Location ID: 390528

Inspection Doc. Number: 682504248

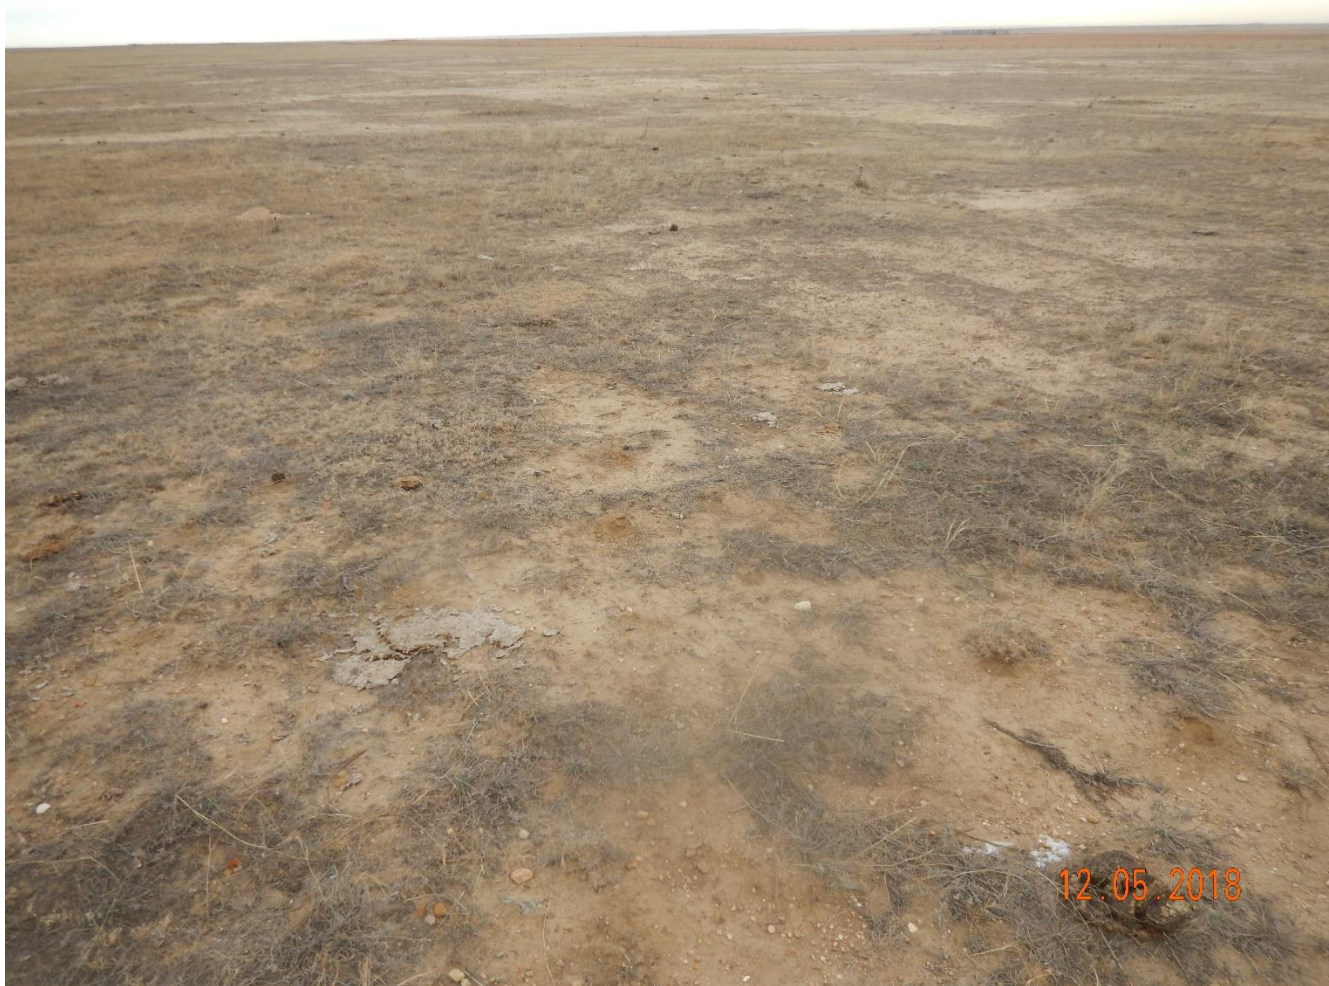
Photo 1: Photo taken from the well location, facing north. Photo shows various debris (concrete, pipe, metal, cable) appears to have been removed from the location.

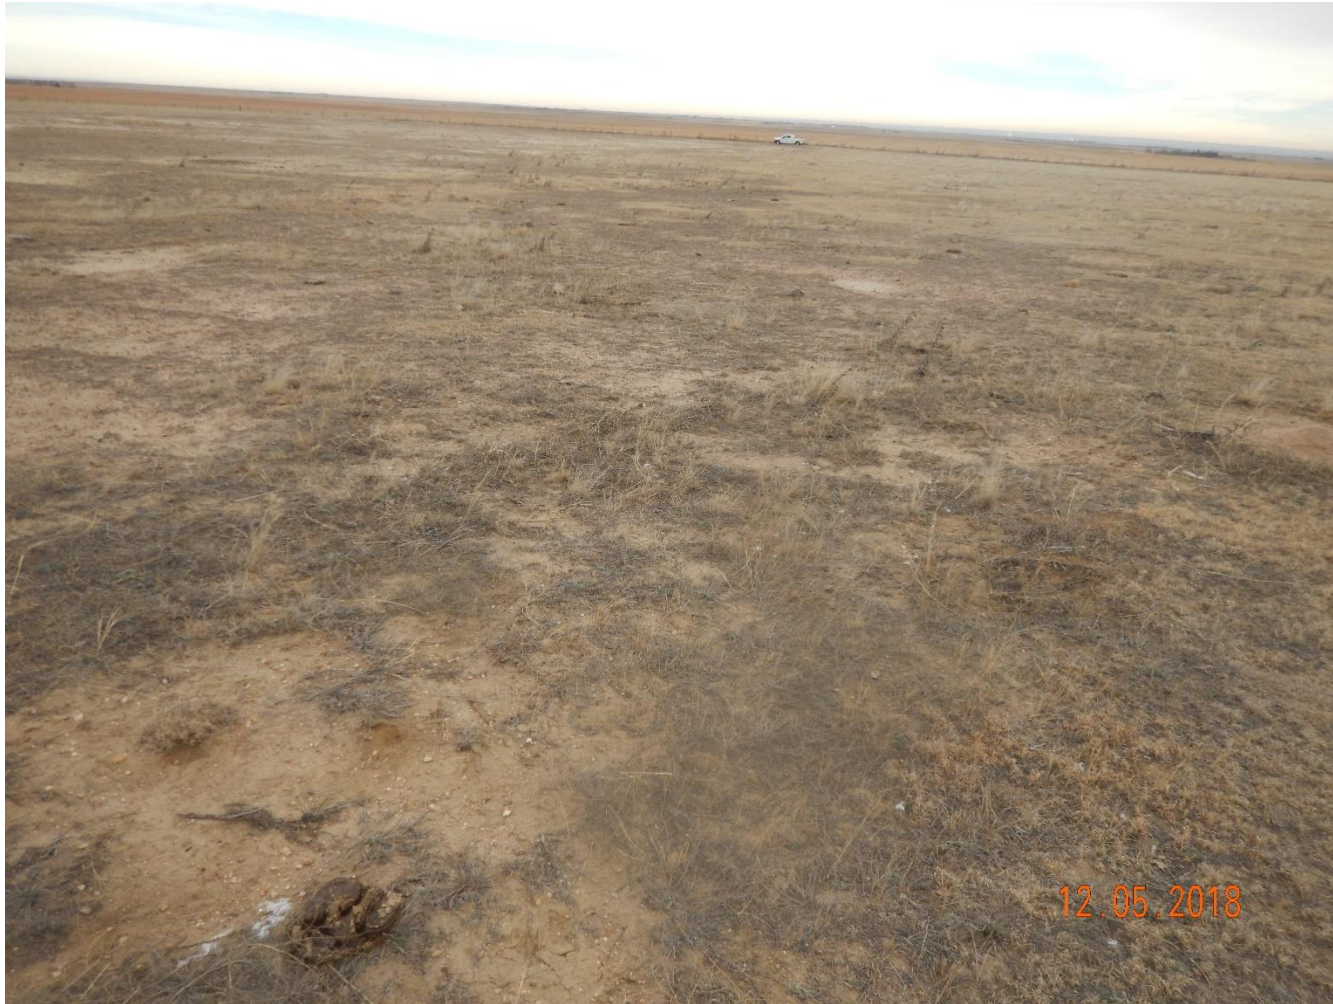
Photo 2: Photo taken from the well location, facing east. Photo shows various debris (concrete, pipe, metal, cable) appears to have been removed from the location.

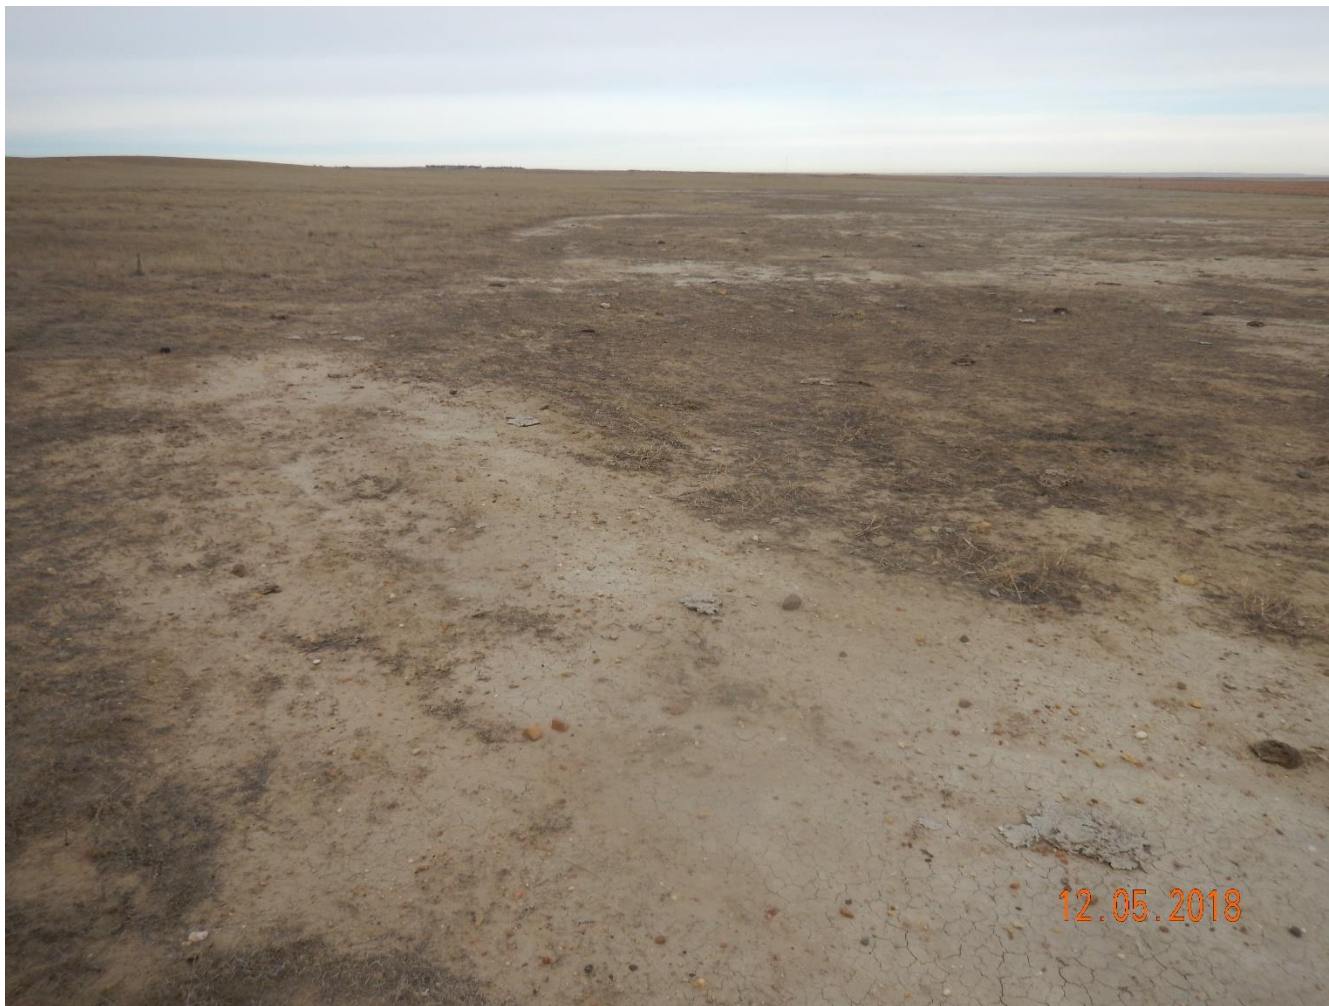
Photo 3: Photo taken from the southwest end of the disturbance area, facing north. Previous inspections that reclamation does not appear to be progressing and required operator to perform additional reclamation activities by 3/31/2018. Photos show no additional reclamation or remediation activities appear to have been conducted. The location/disturbance area remains predominantly bare and exposed soil, or undesirable weedy plant species.

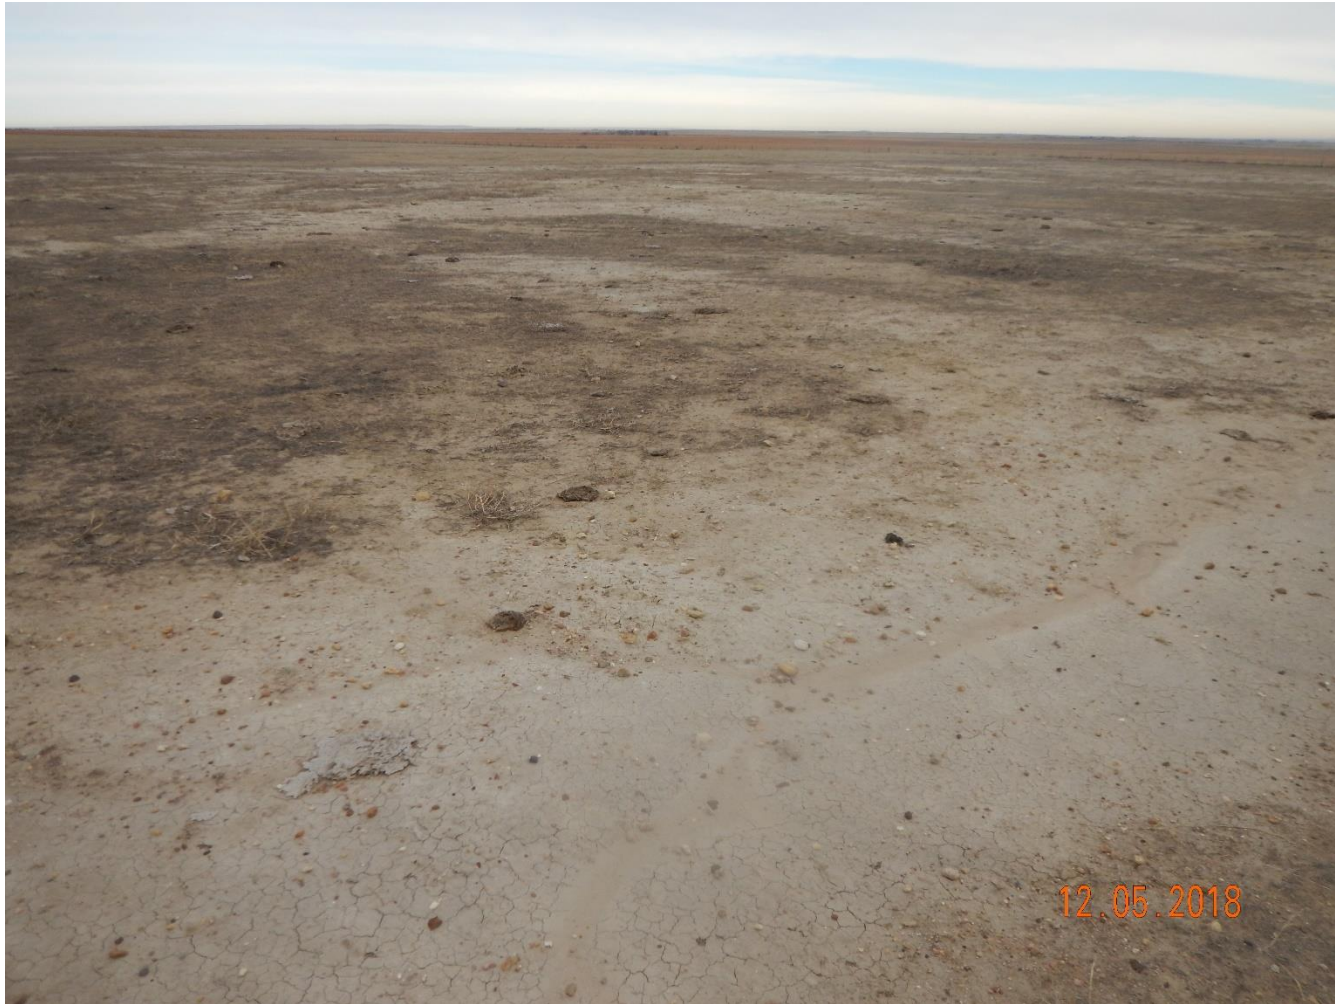
Photo 4: Photo taken from the southwest end of the disturbance area, facing northeast. See comments under photo 3.

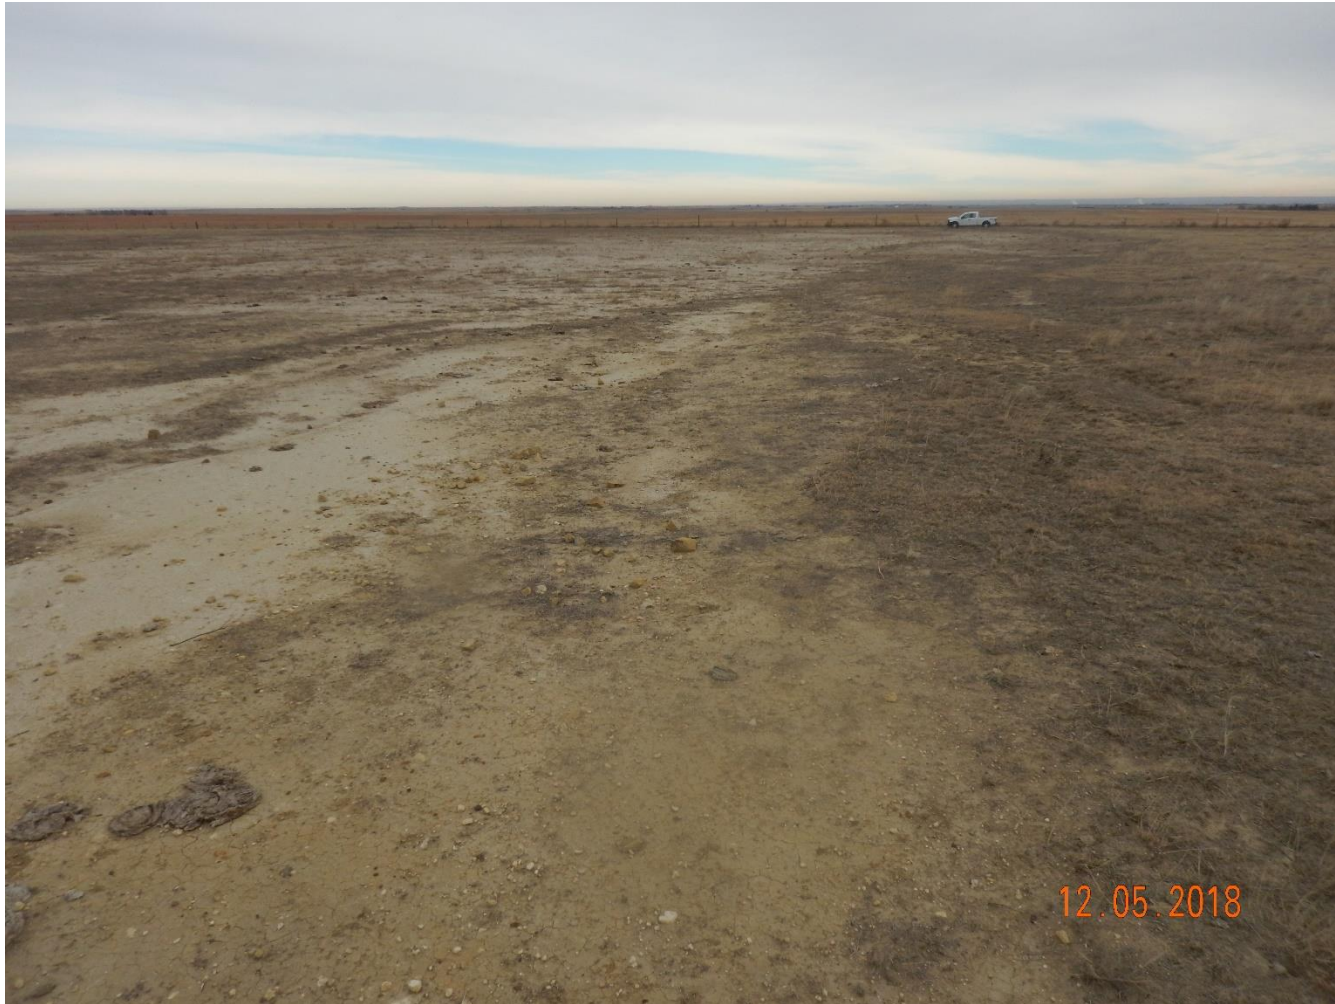
Photo 5: Photo taken from the south end of the disturbance area, facing east. See comments under photo 3.

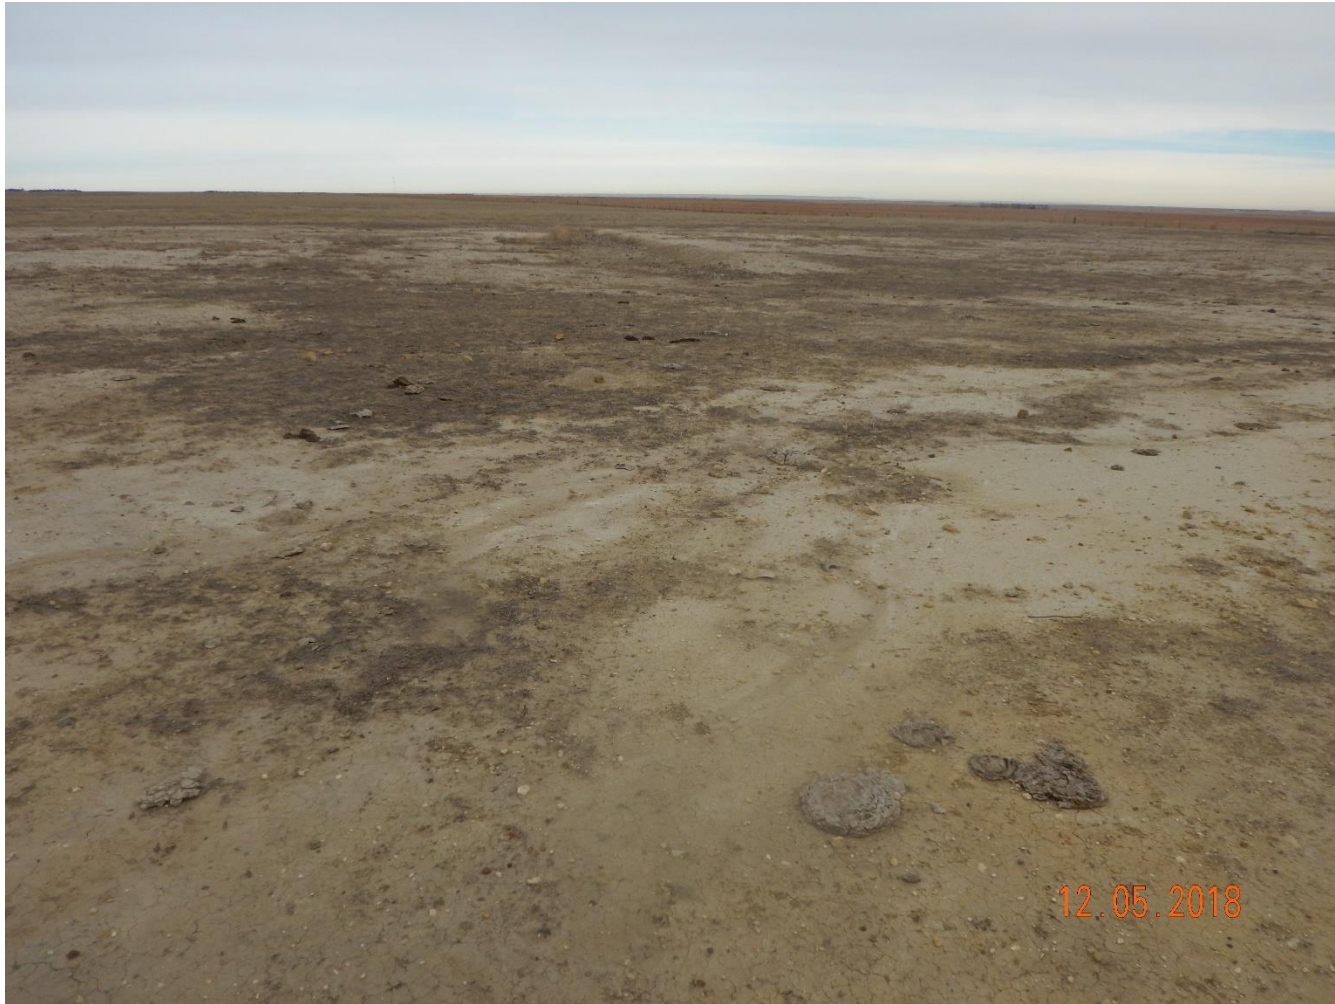
Photo 6: Photo taken from the south end of the disturbance area, facing northeast.
See comments under photo 3.

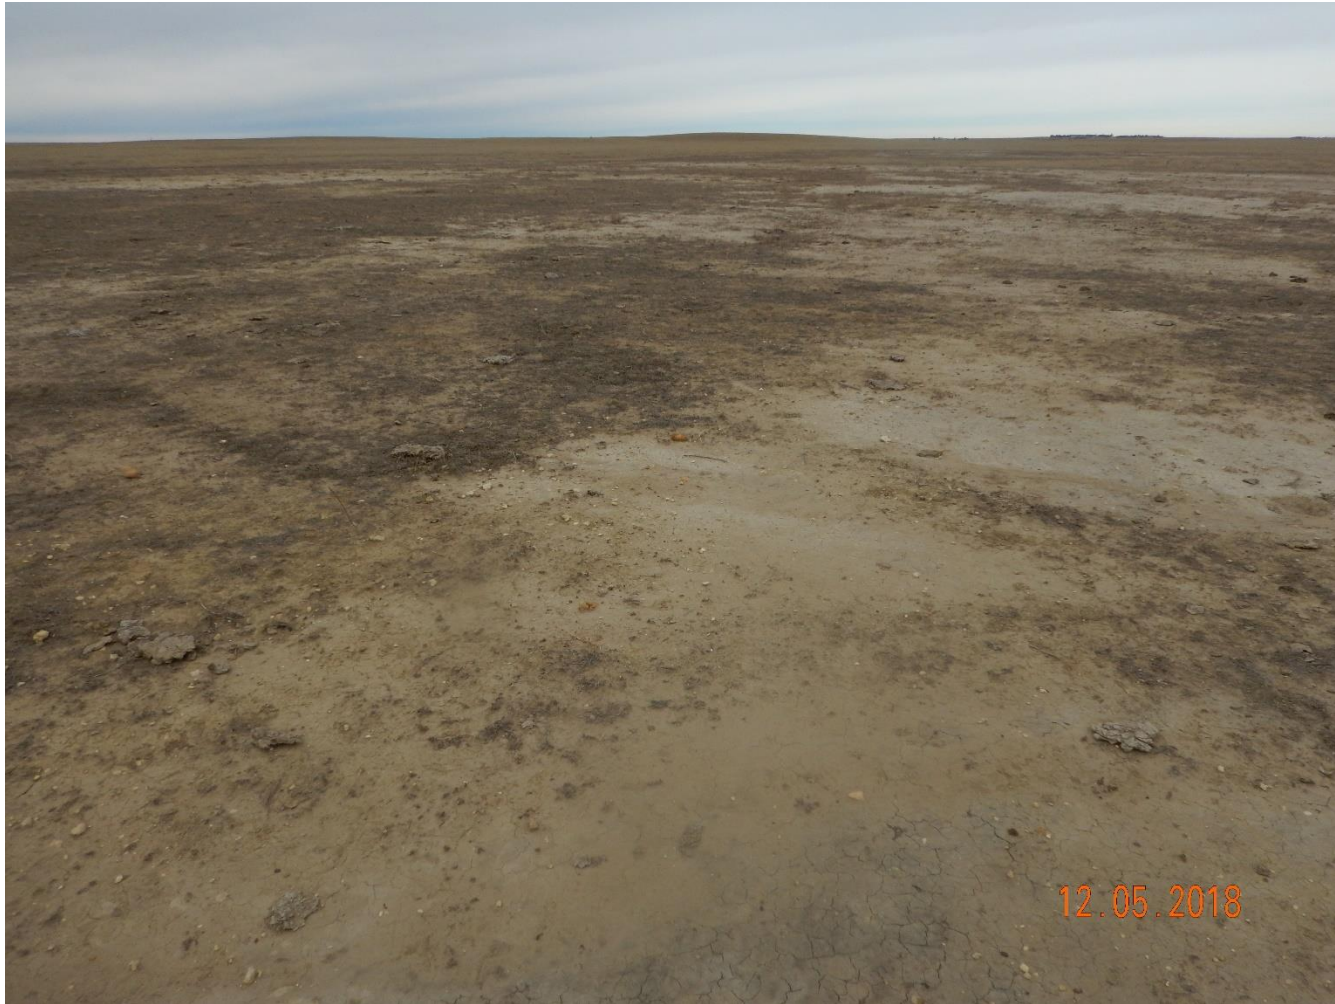
Photo 7: Photo taken from the south end of the disturbance area, facing northwest.
See comments under photo 3.

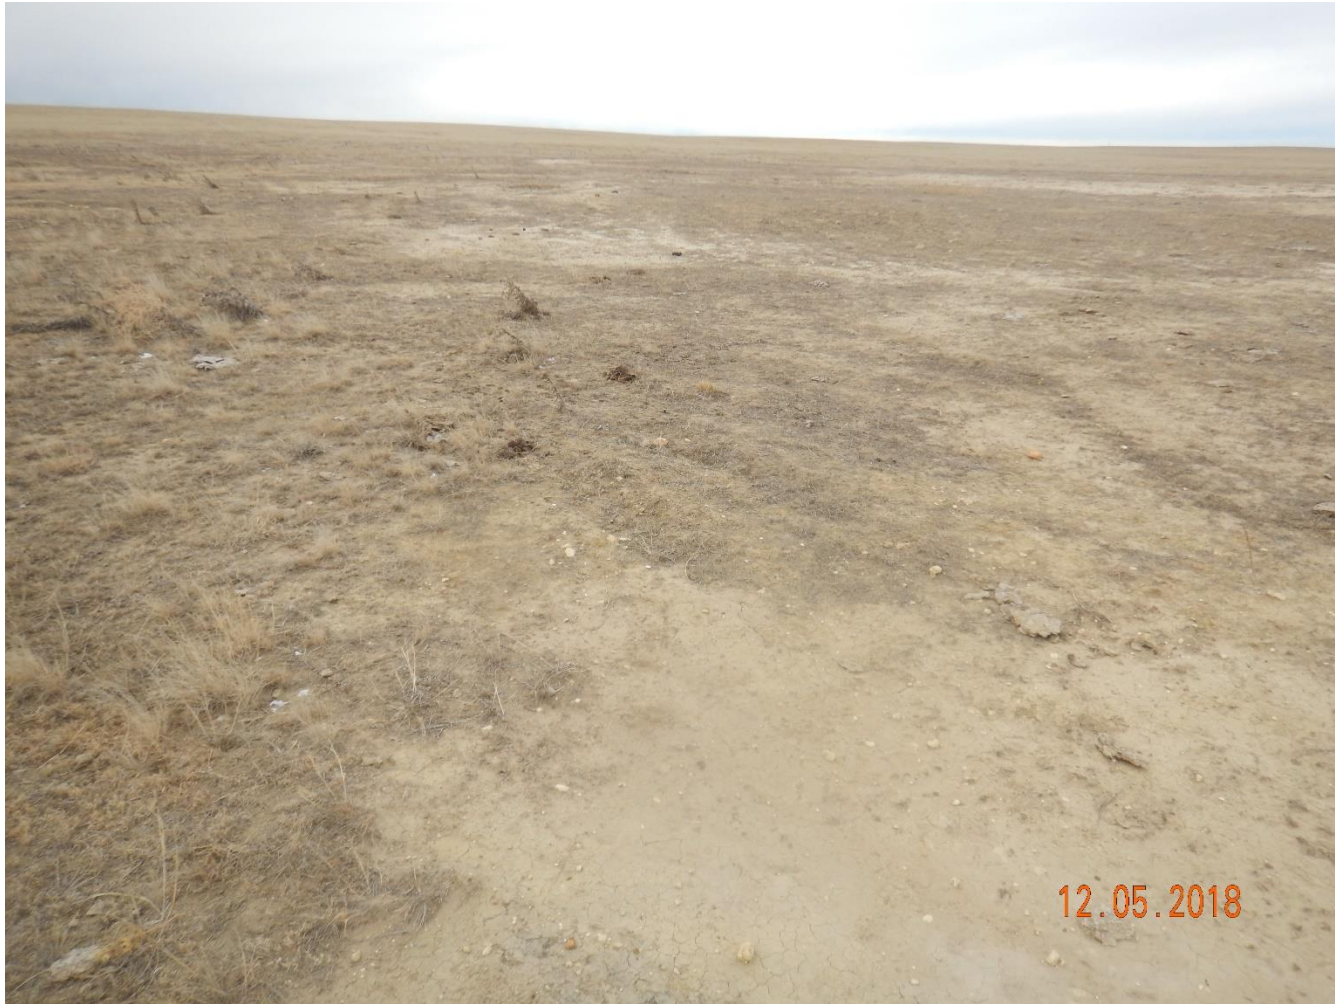
Photo 8: Photo taken from the south end of the disturbance area, facing west. See comments under photo 3.

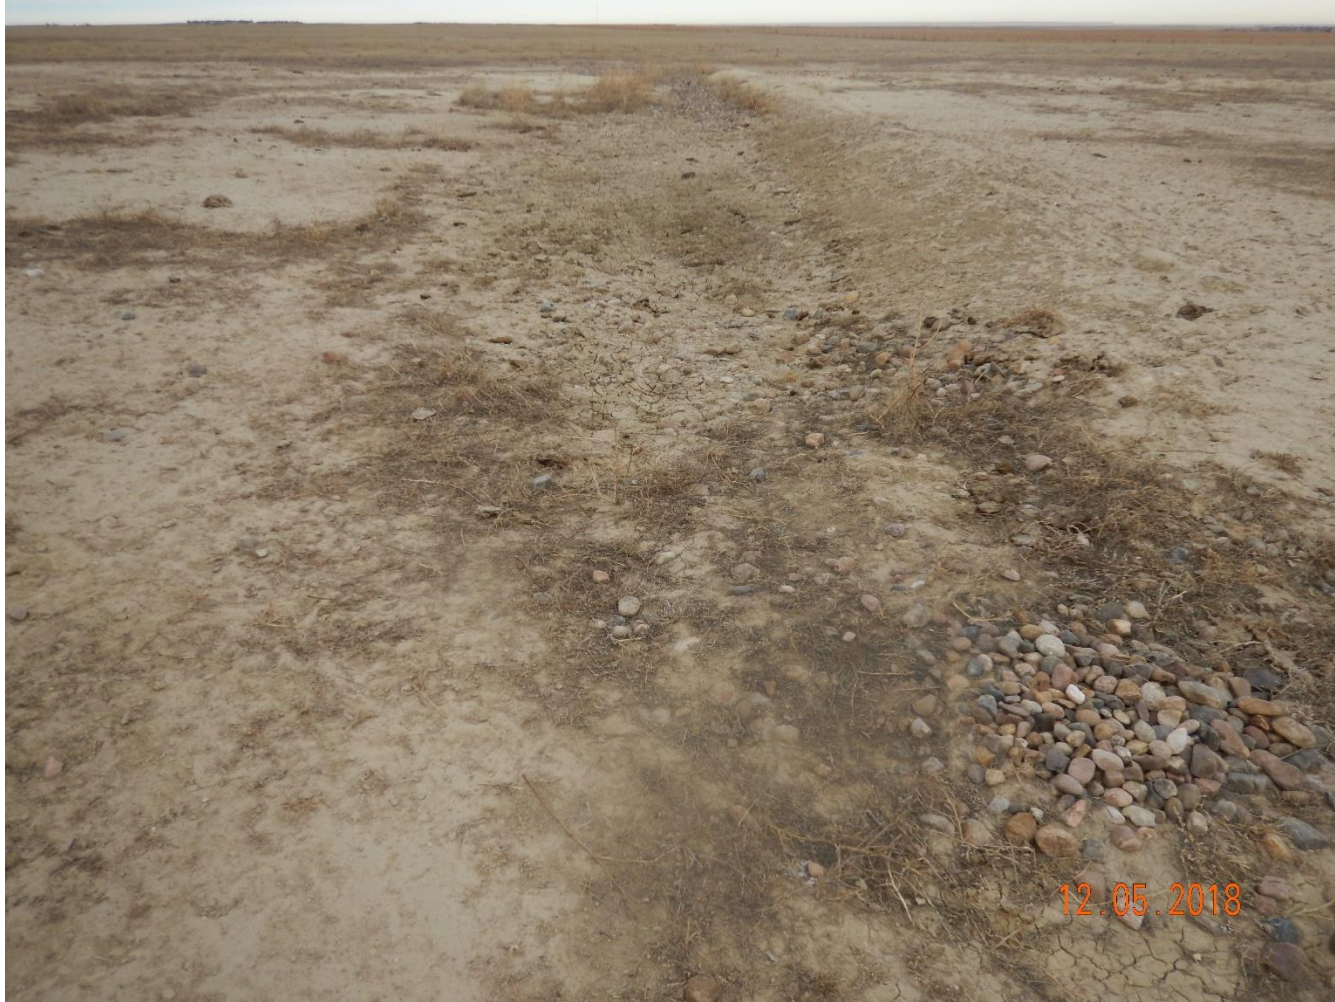
Photo 9: Photo taken from the south end of the disturbance area, facing east. Photo shows berm previously constructed for stormwater management.

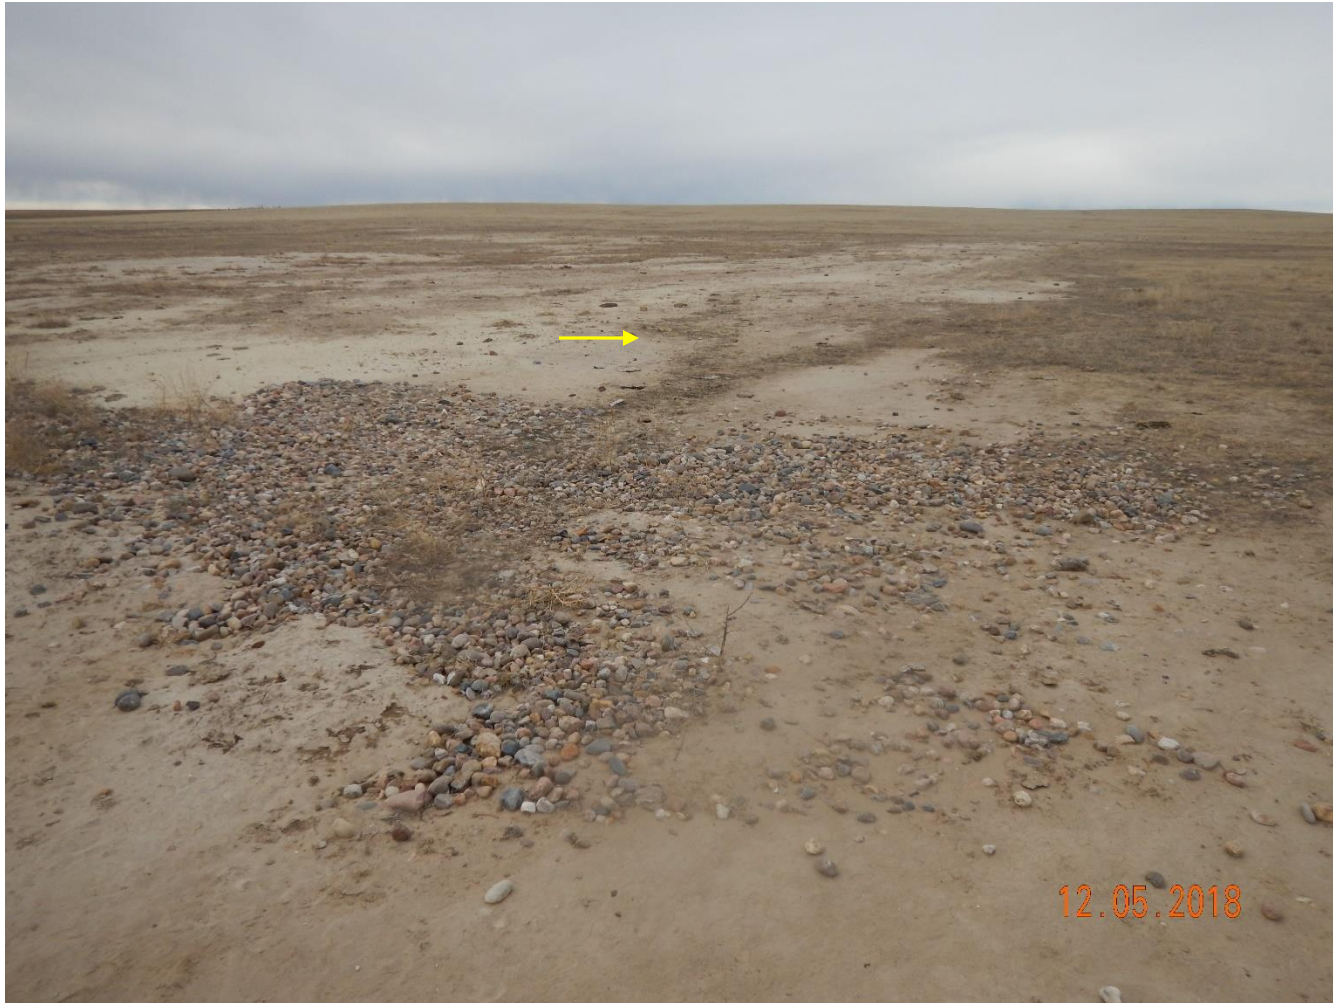
Photo 10: Photo taken from the north end of the southern berm, facing west. Photo shows stormwater erosion degradation issues remain on site and do not appear to have been addressed. Active stormwater monitoring and management does not appear to be ongoing. Location does not appear to be sufficiently stabilized to prevent erosion degradation.

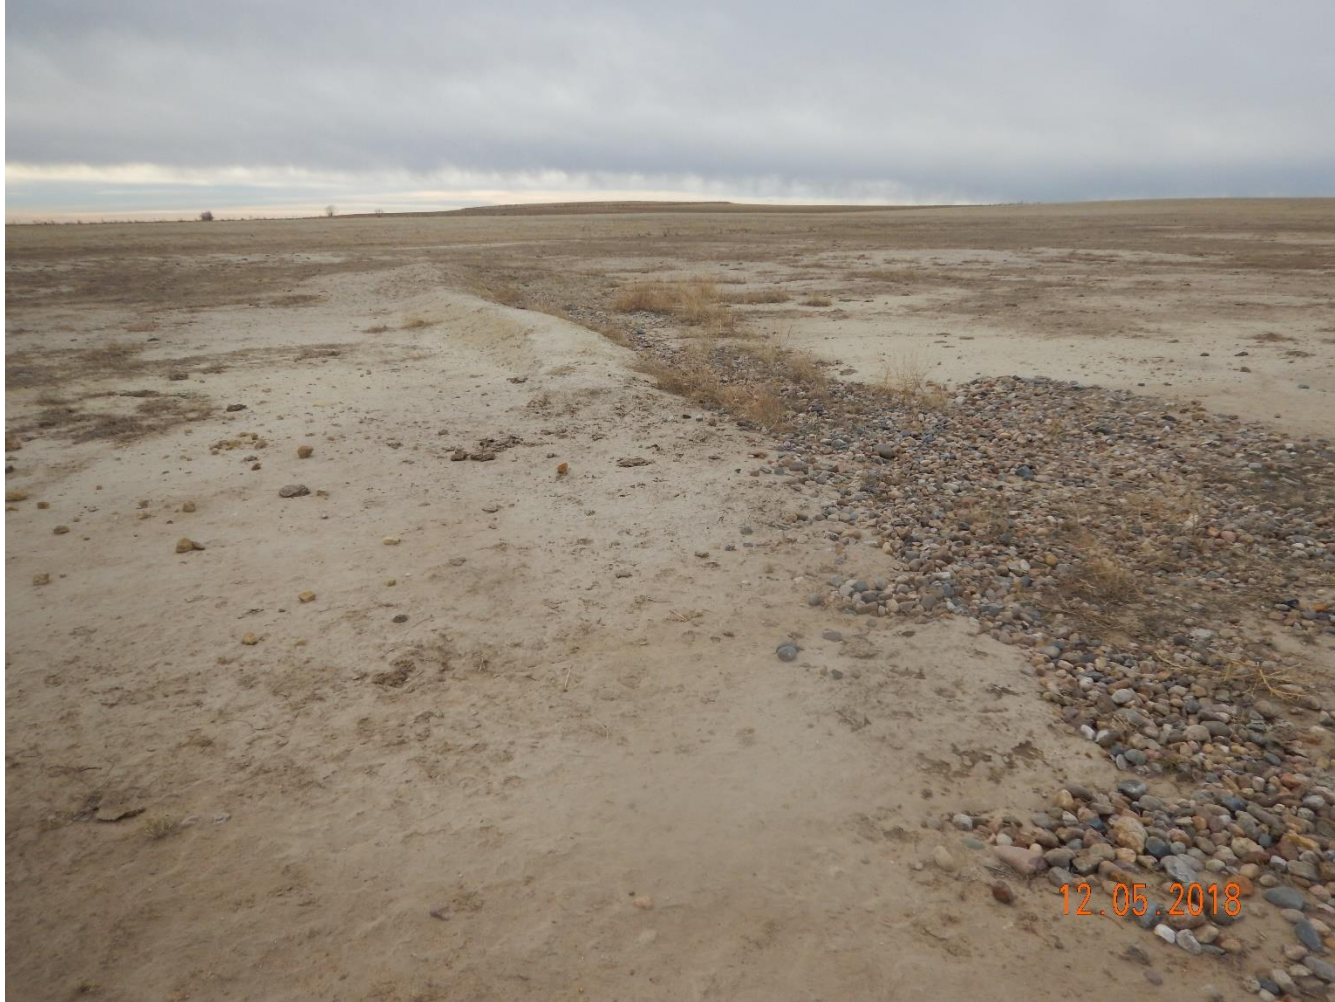
Photo 11: Photo taken from the north end of the southern berm, facing south. Photo shows berm previously constructed for stormwater management.

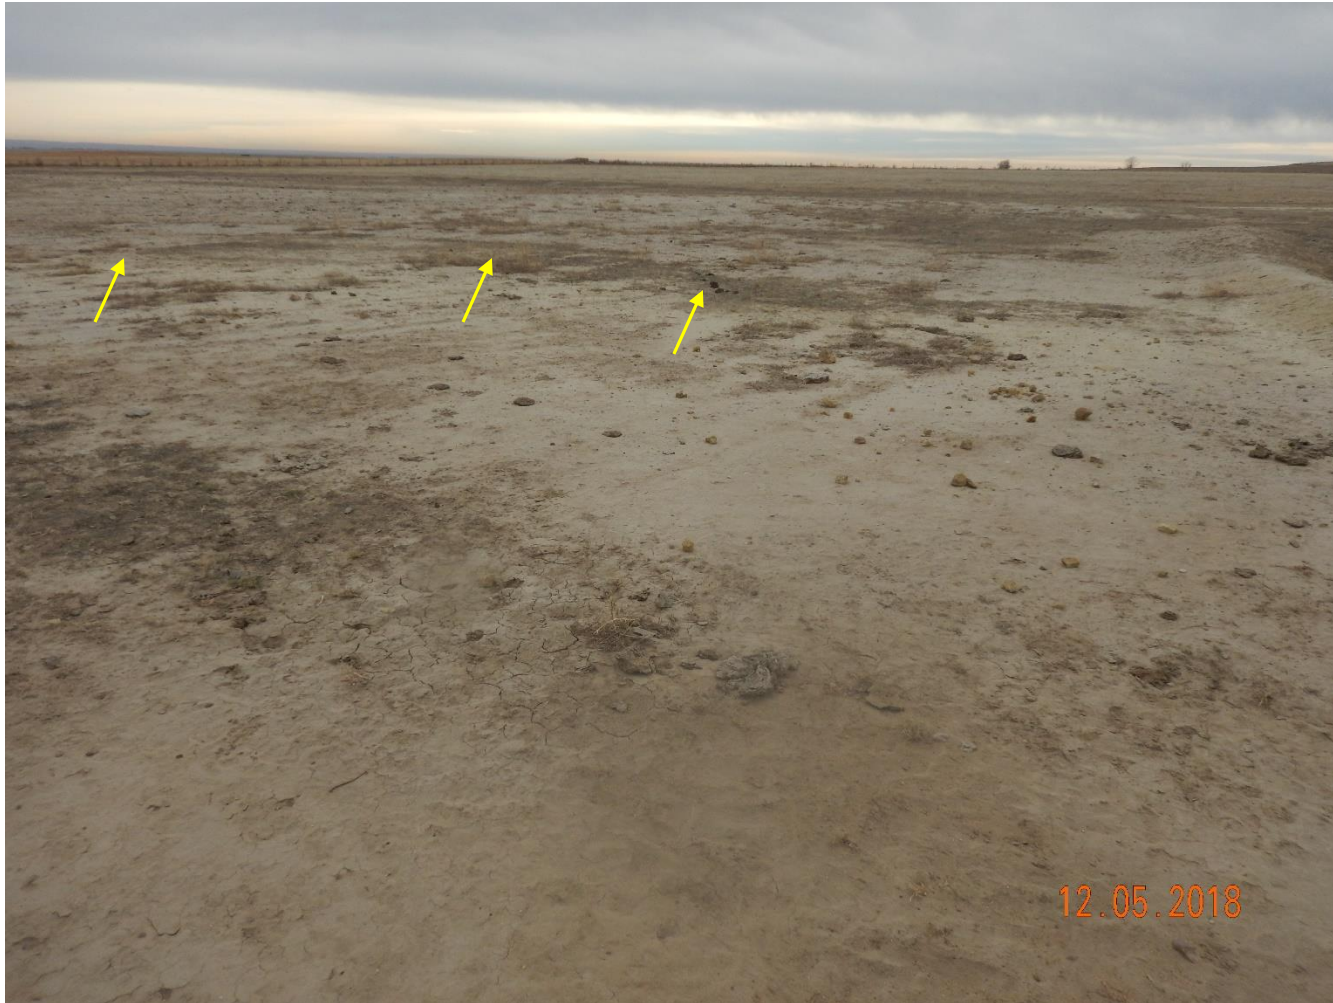
Photo 12: Photo taken from the north end of the southern berm, facing south. See comments under photo 3 regarding reclamation. See comments under photo 10 regarding stormwater.

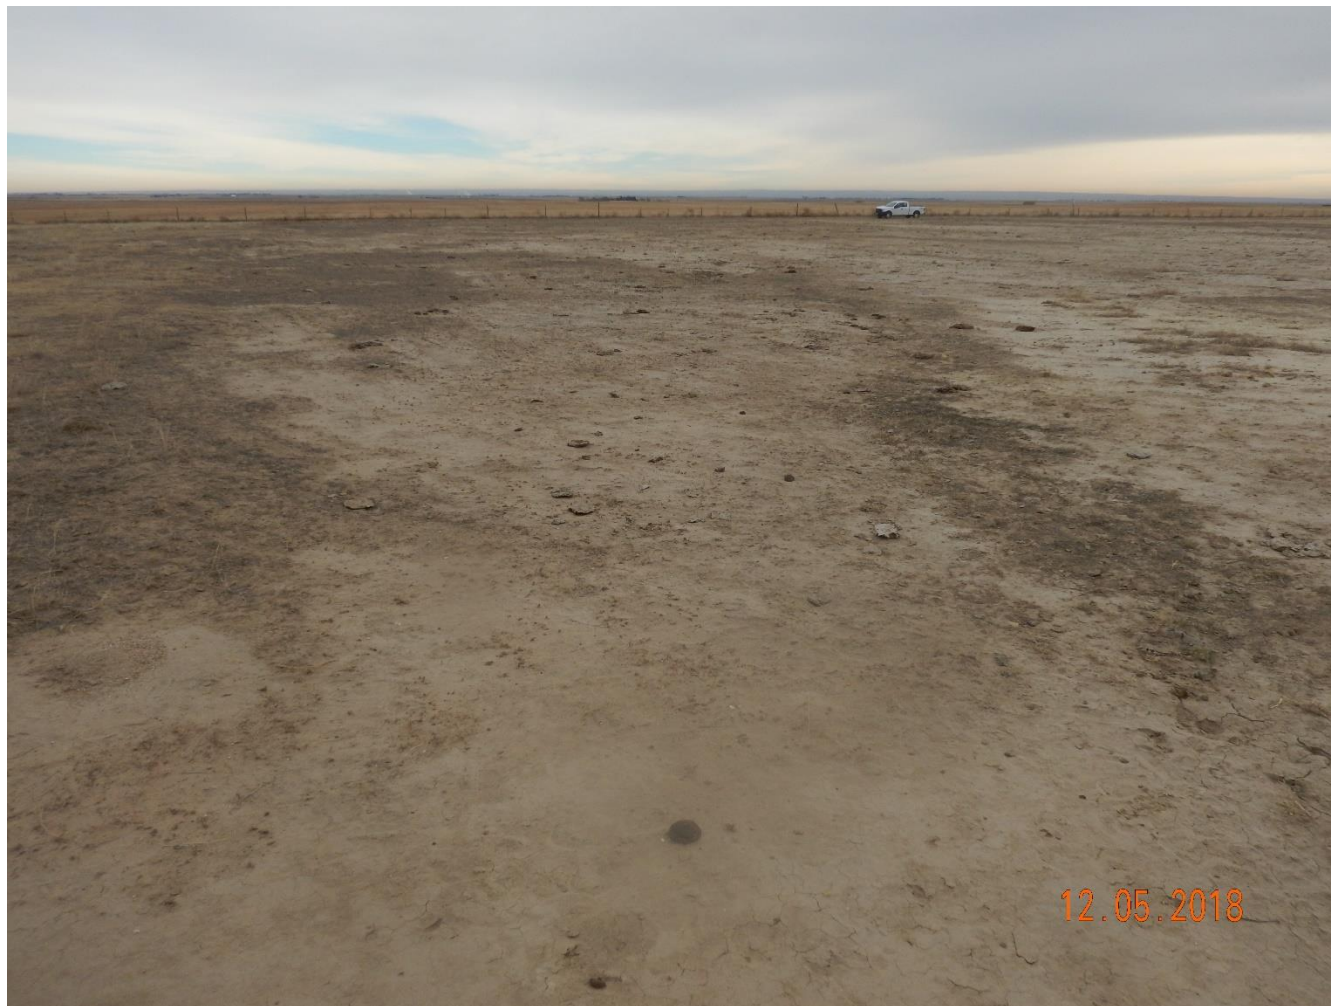
Photo 13: Photo taken from the north end of the southern berm, facing south. See comments under photo 3 regarding reclamation. See comments under photo 10 regarding stormwater.

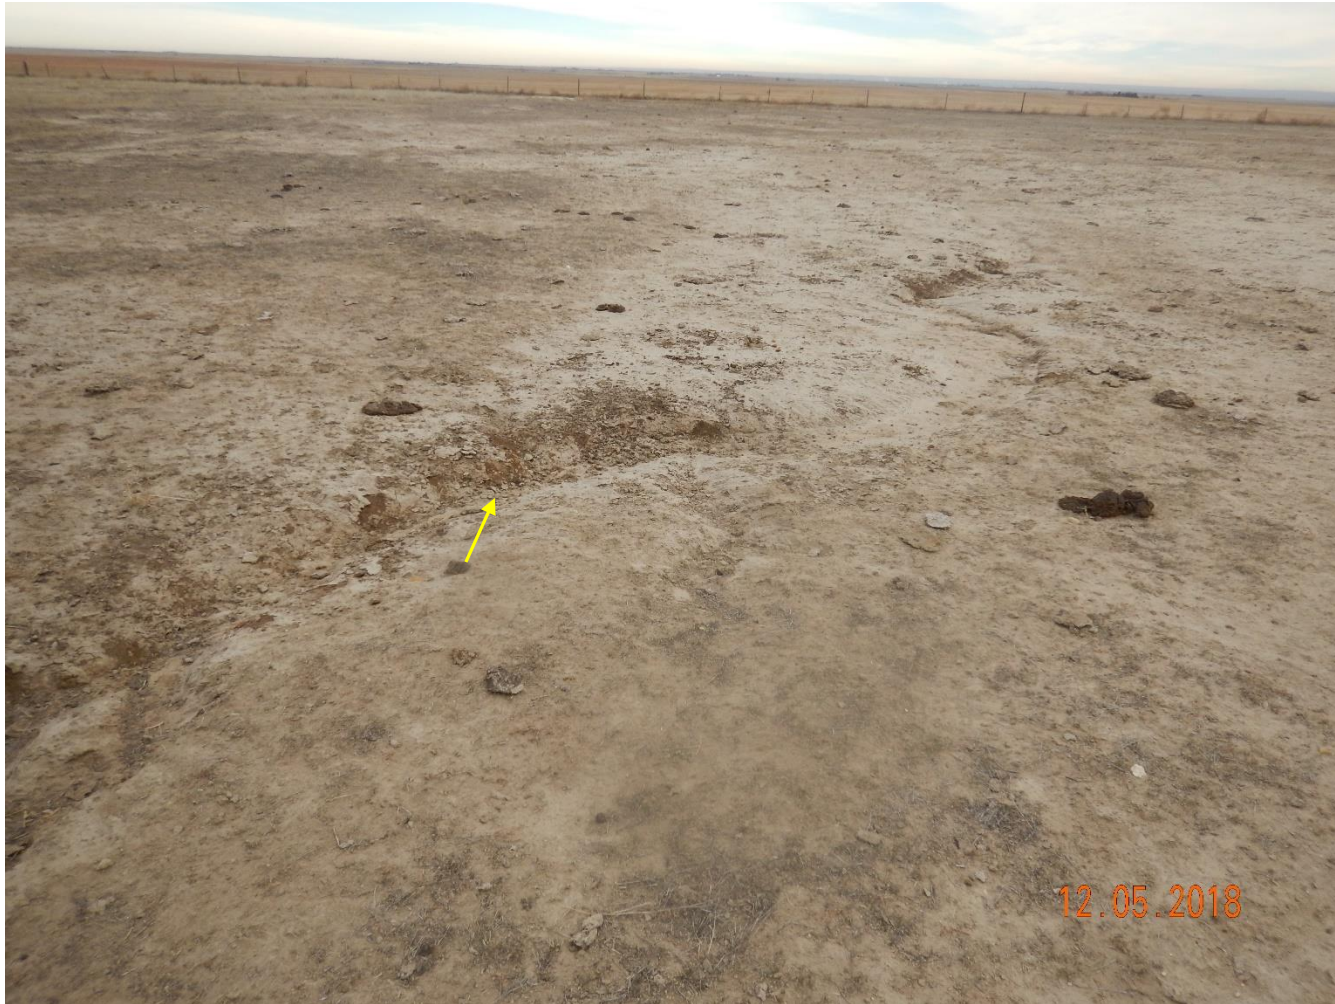
Photo 14: Photo taken from the north end of the southern degradation area, just east of the southern berm, facing east. See comments under photo 10.

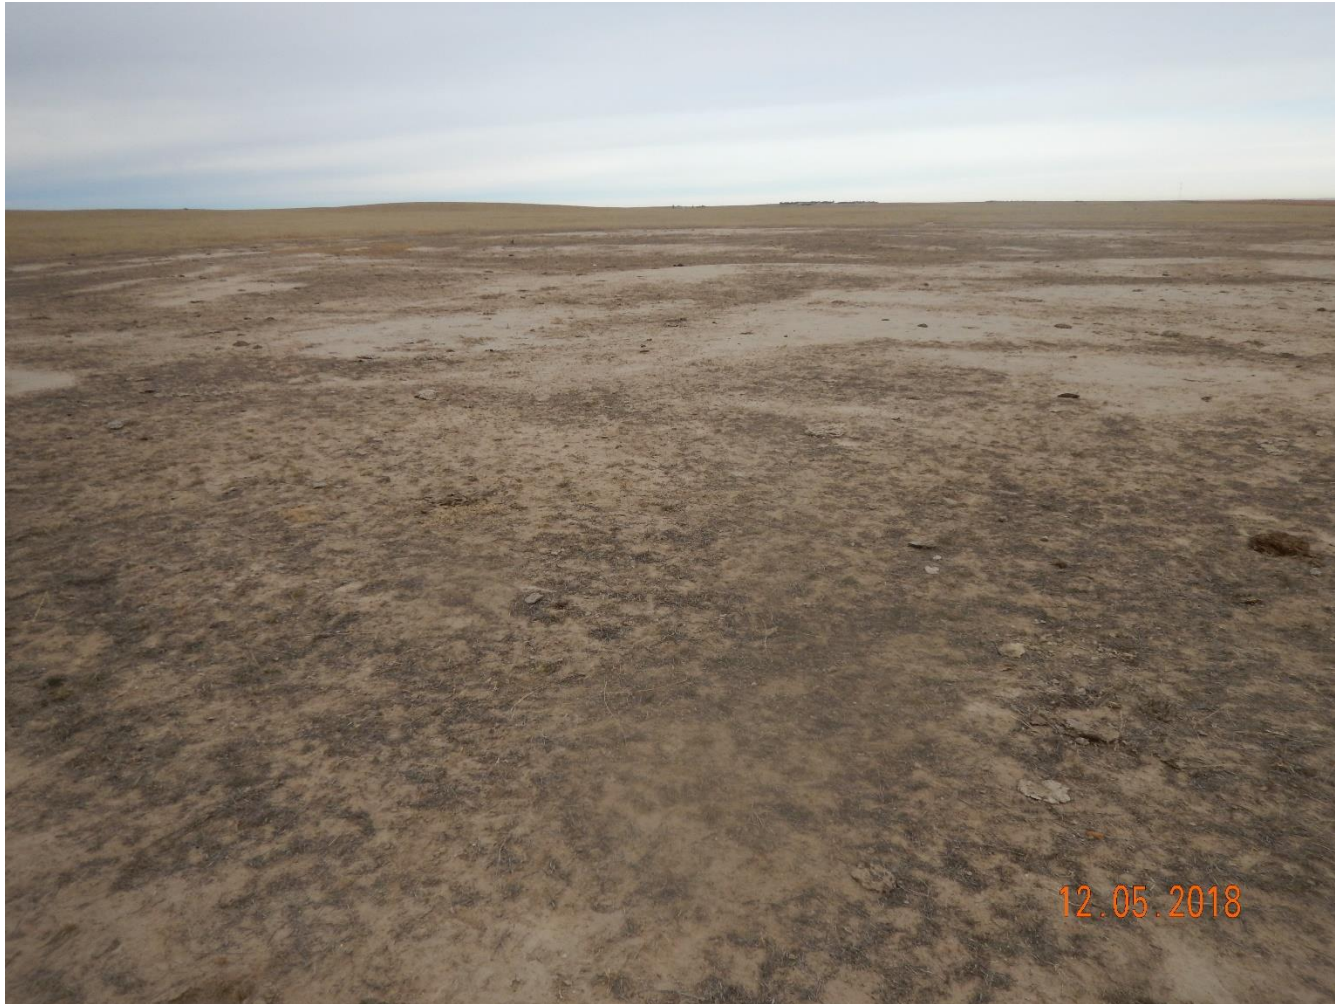
Photo 15: Photo taken from the west end of the location, facing north. See comments under photo 3.

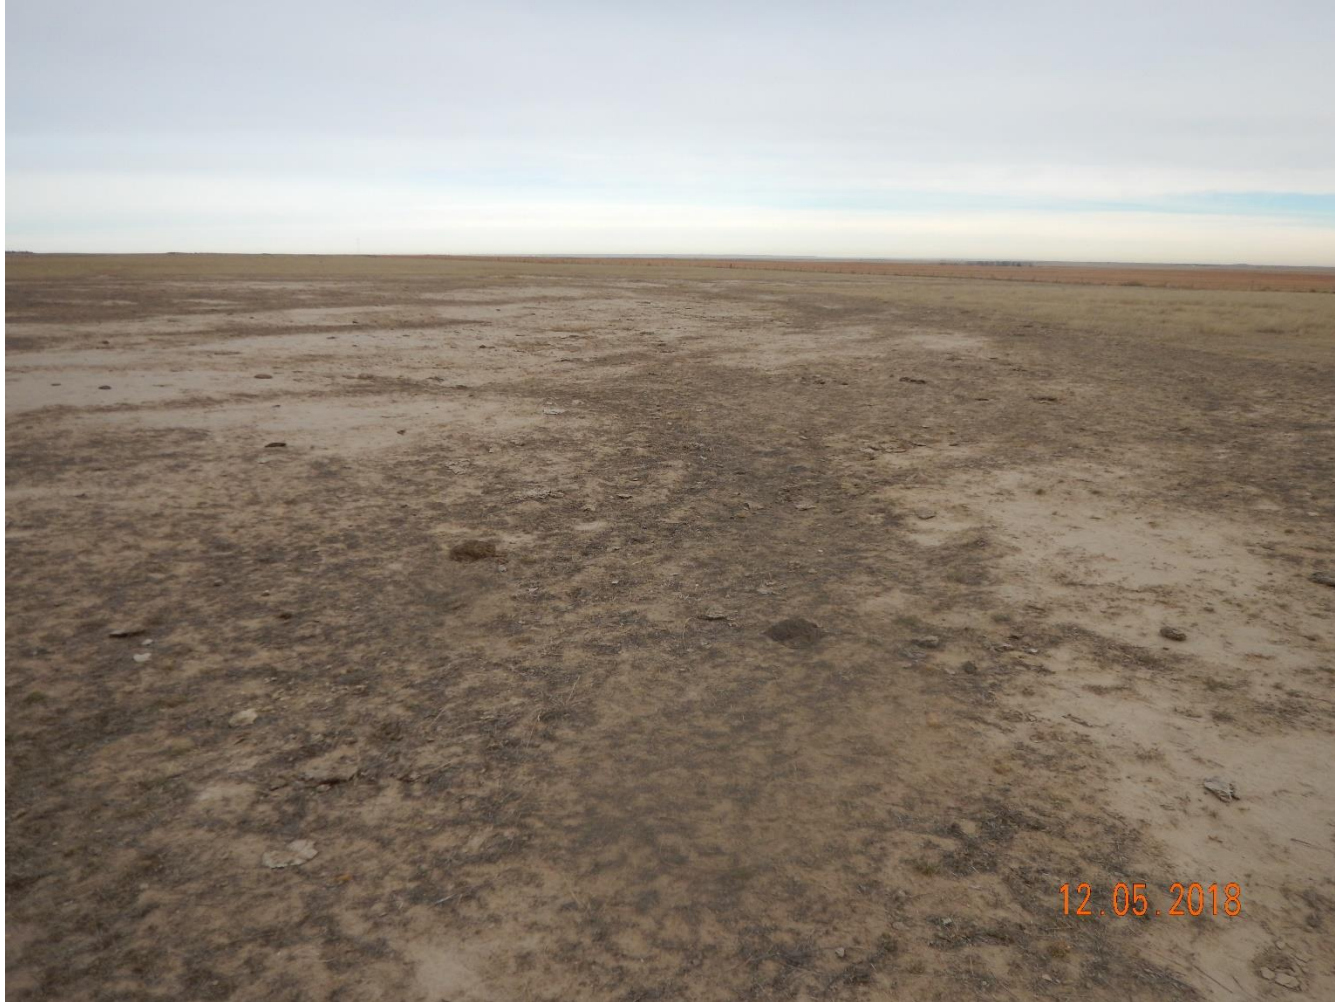
Photo 16: Photo taken from the west end of the location, facing south. See comments under photo 3.
