Inspection Photos

Operator: DENVER EAST MACHINERY COMPANY
- 24040

Location ID: 390528

Inspection Doc. Number: 682504248

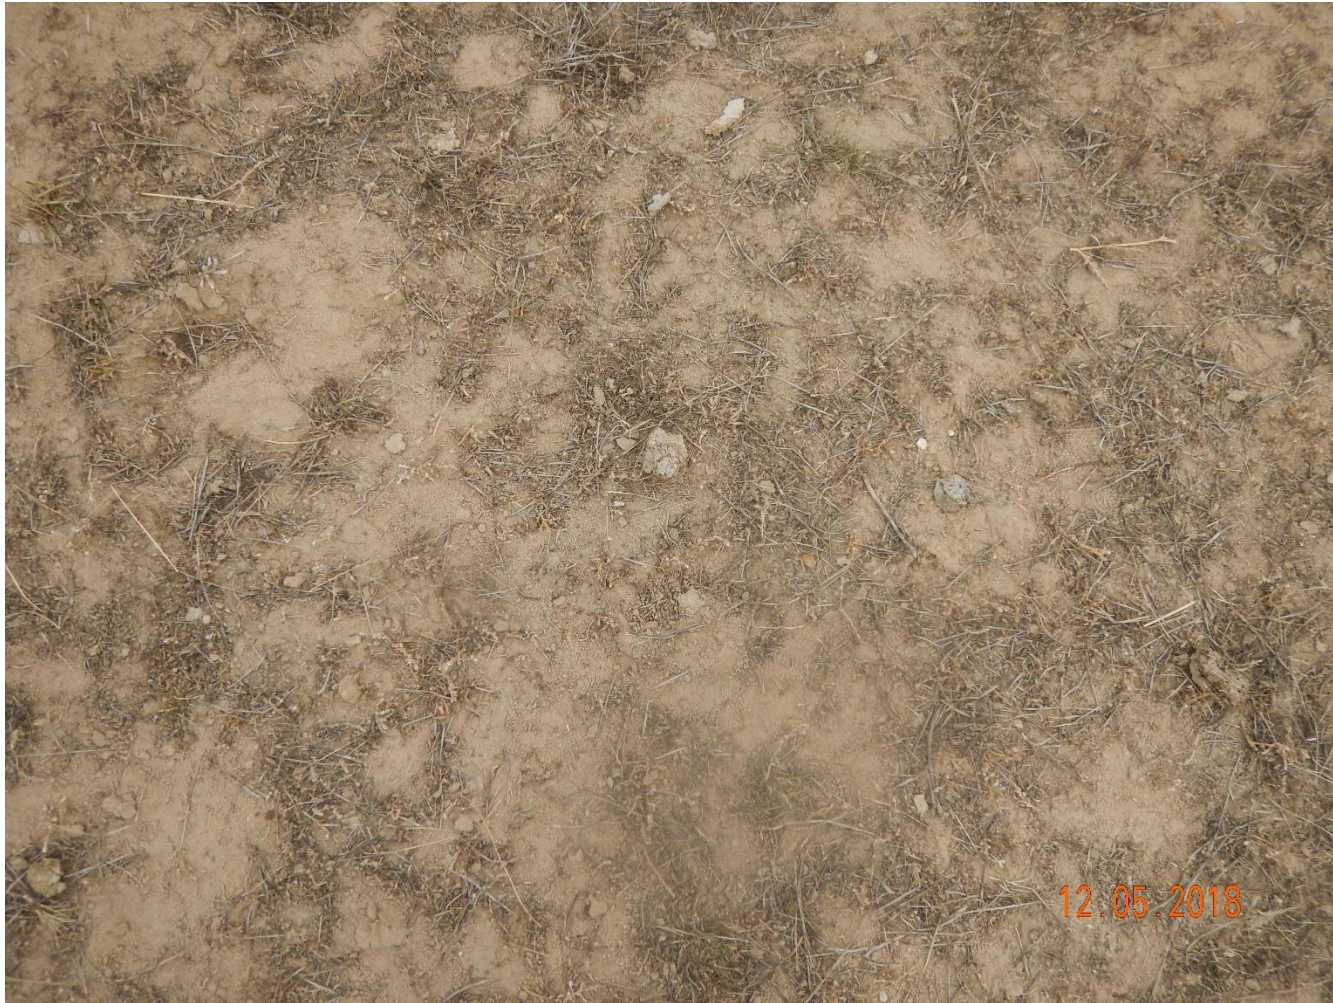
Photo 17: Photo taken from the west end of the location. Photo shows disturbance area is predominantly bare and exposed soil. What sparse vegetation that is growing is predominantly undesirable weedy plant species.

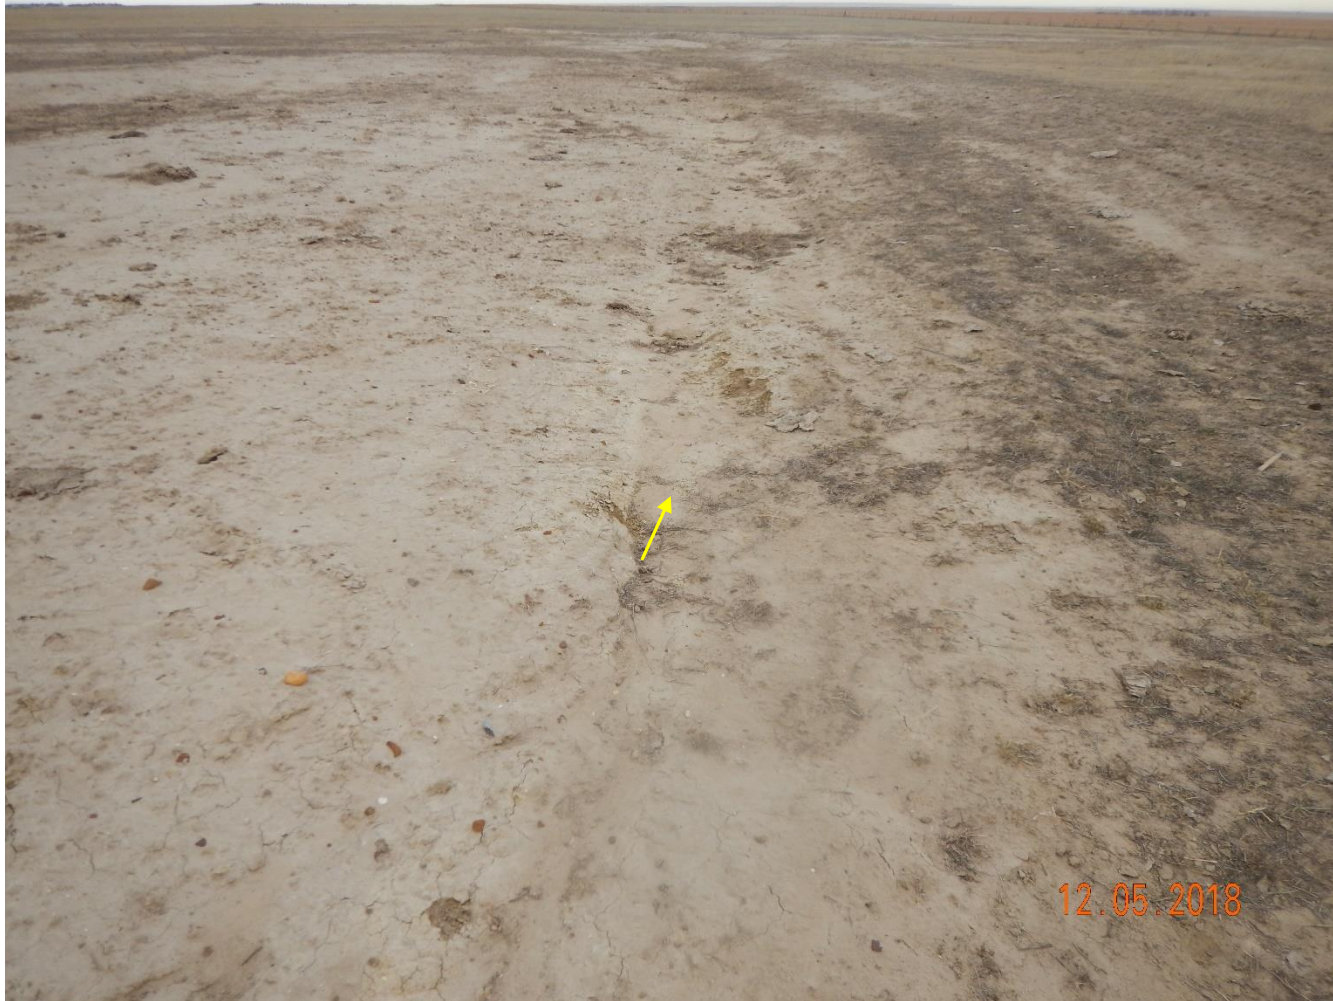
Photo 10: Photo taken from the north end of the southern berm, facing west. Photo shows stormwater erosion degradation issues remain on site and do not appear to have been addressed. Active stormwater monitoring and management does not appear to be ongoing. Location does not appear to be sufficiently stabilized to prevent erosion degradation.

Photo 18: Photo taken from the west end of the location, facing northeast. See comments under photo 10.

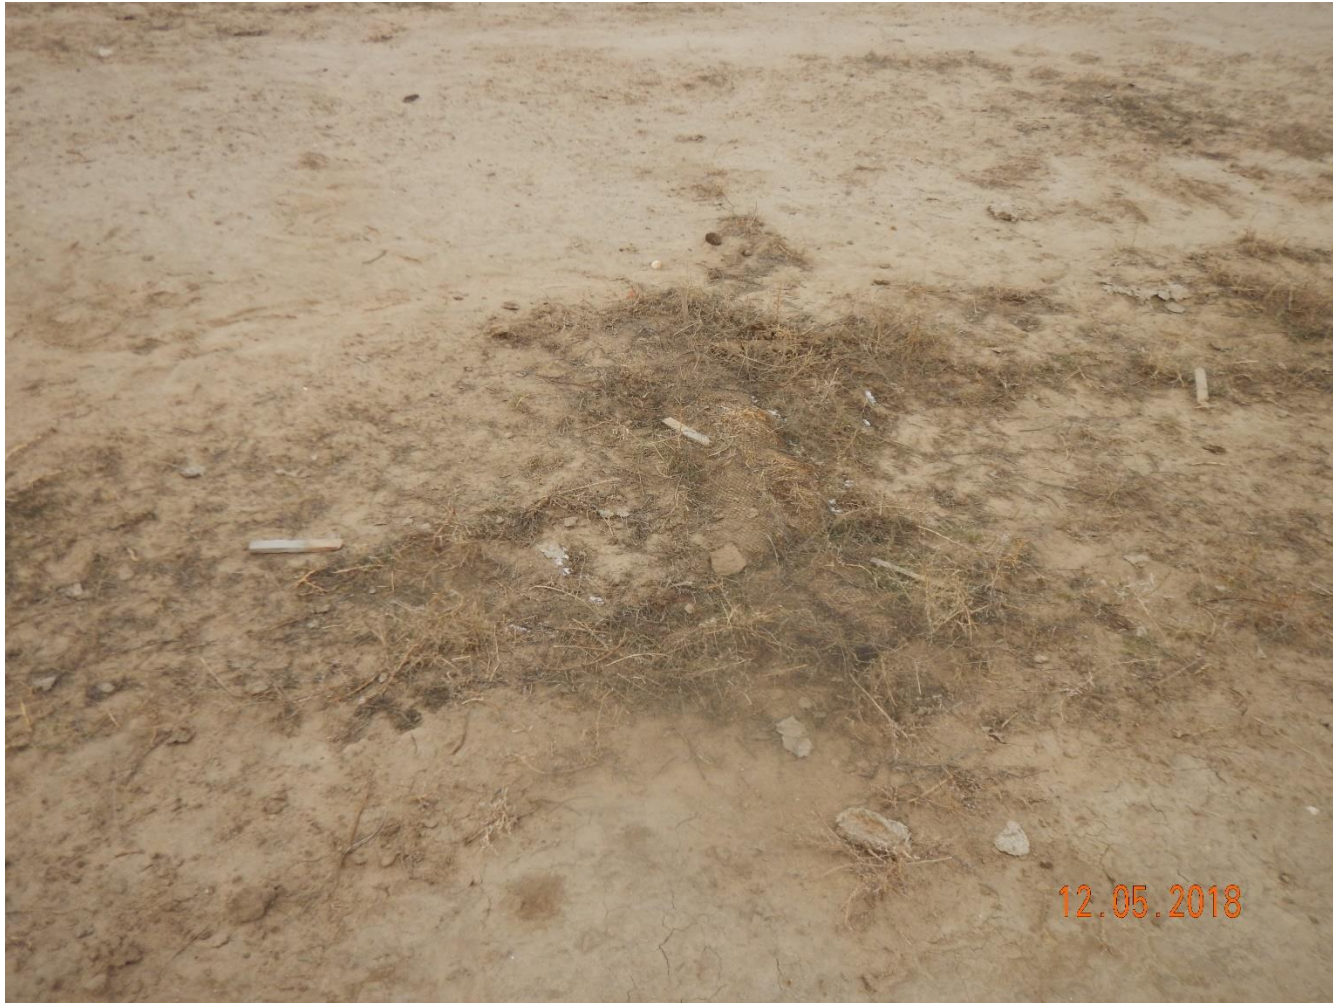
Photo 19: Photo taken from the north end of the location. Photo shows straw wattle BMP has been filled with sediment, is in disrepair, and no longer in proper functioning condition. Active stormwater monitoring and management does not appear to be ongoing.

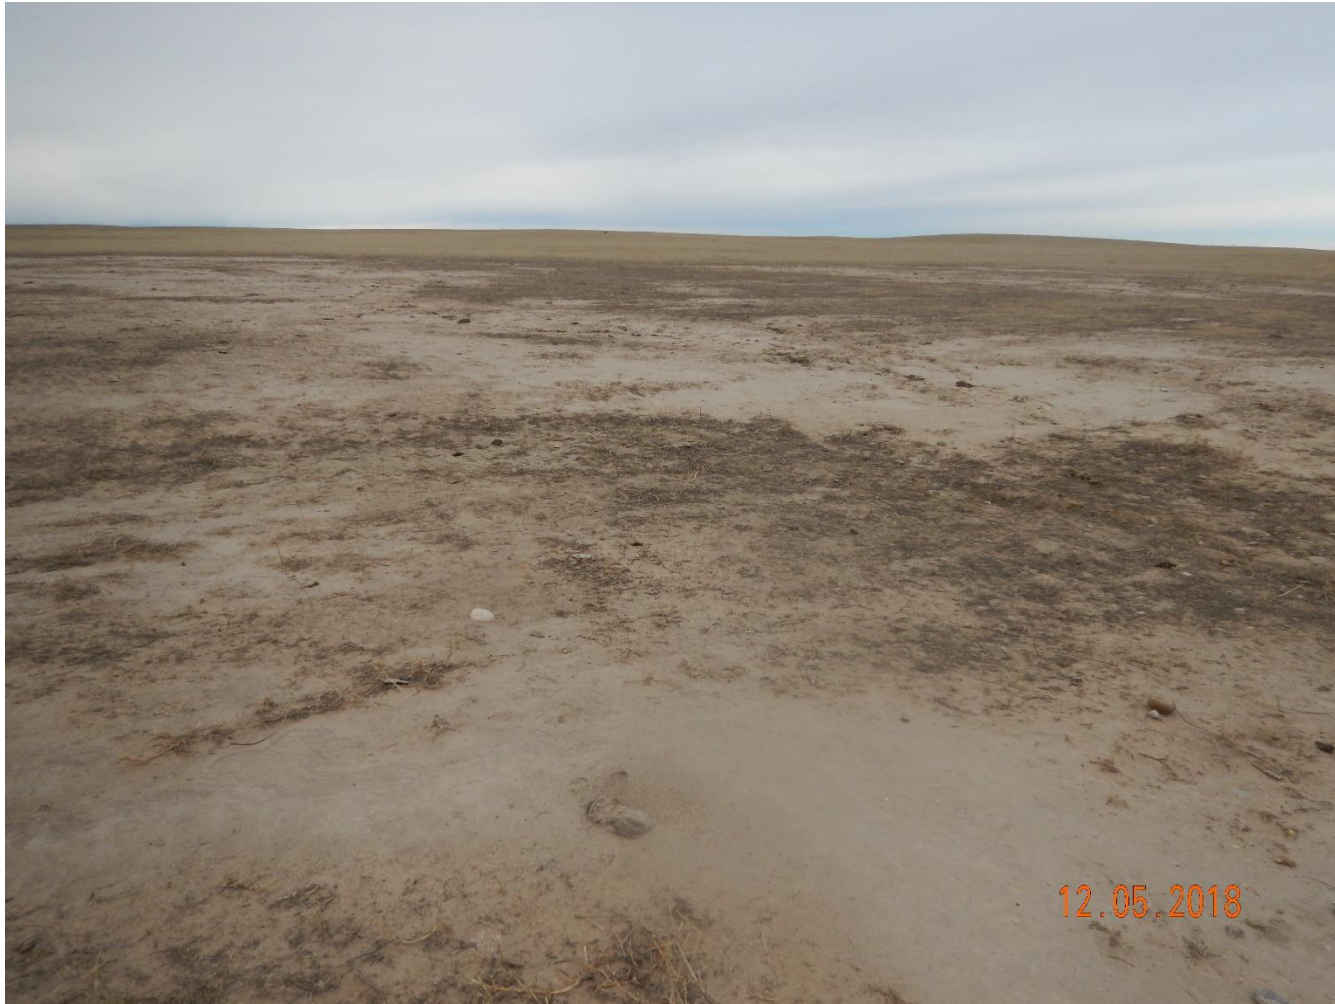
Photo 3: Photo taken from the southwest end of the disturbance area, facing north. Previous inspections that reclamation does not appear to be progressing and required operator to perform additional reclamation activities by 3/31/2018. Photos show no additional reclamation or remediation activities appear to have been conducted. The location/disturbance area remains predominantly bare and exposed soil, or undesirable weedy plant species.

Photo 20: Photo taken from the northwest end of the location, facing north. See comments under photo 3.

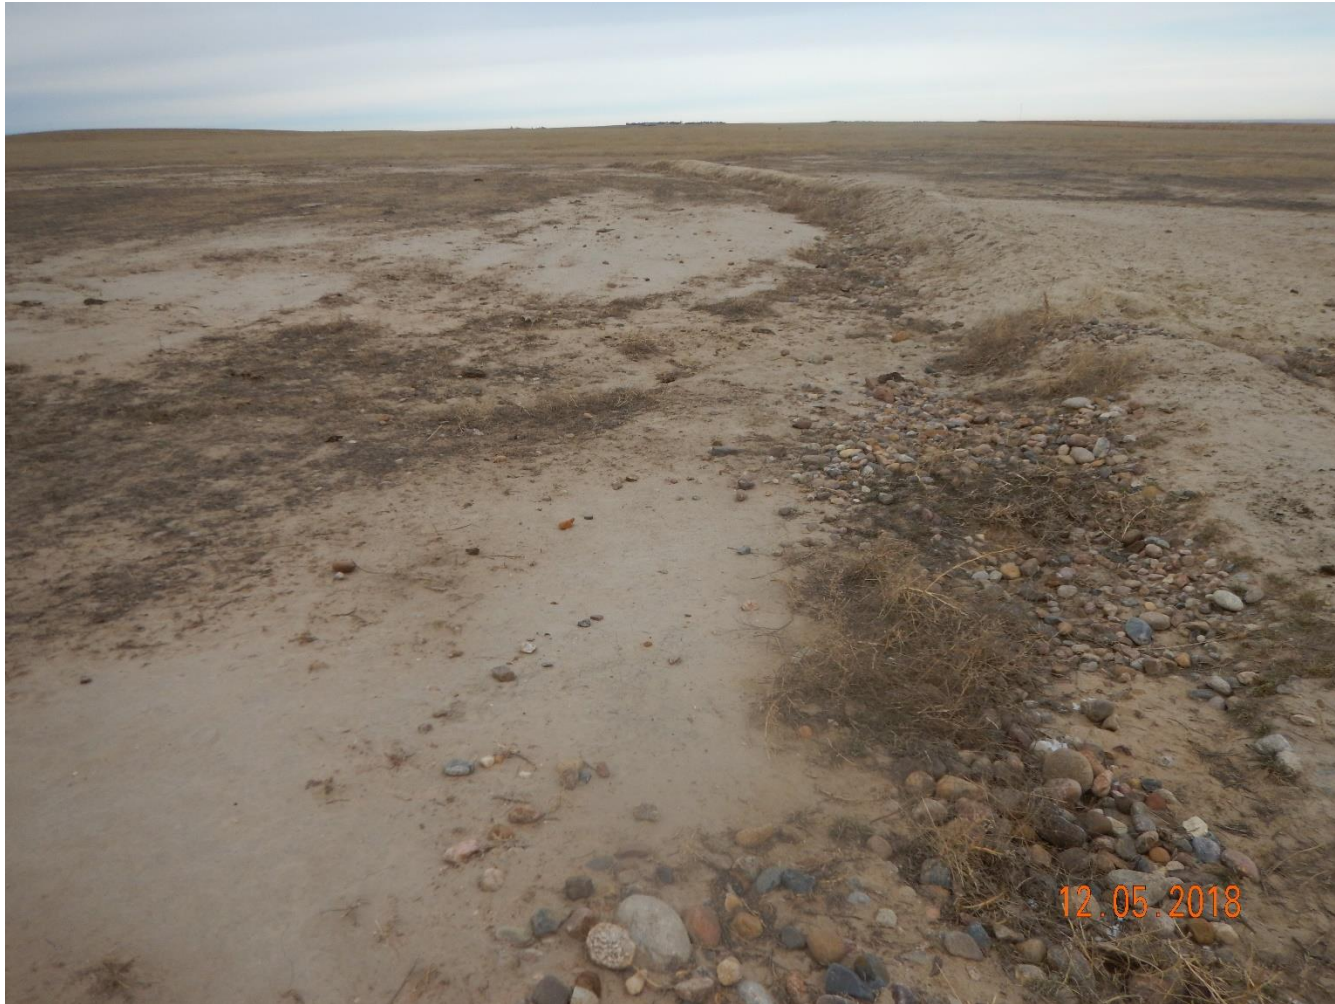
Photo 21: Photo taken from the south end of the northern berm, facing north. See comments under photo 10.

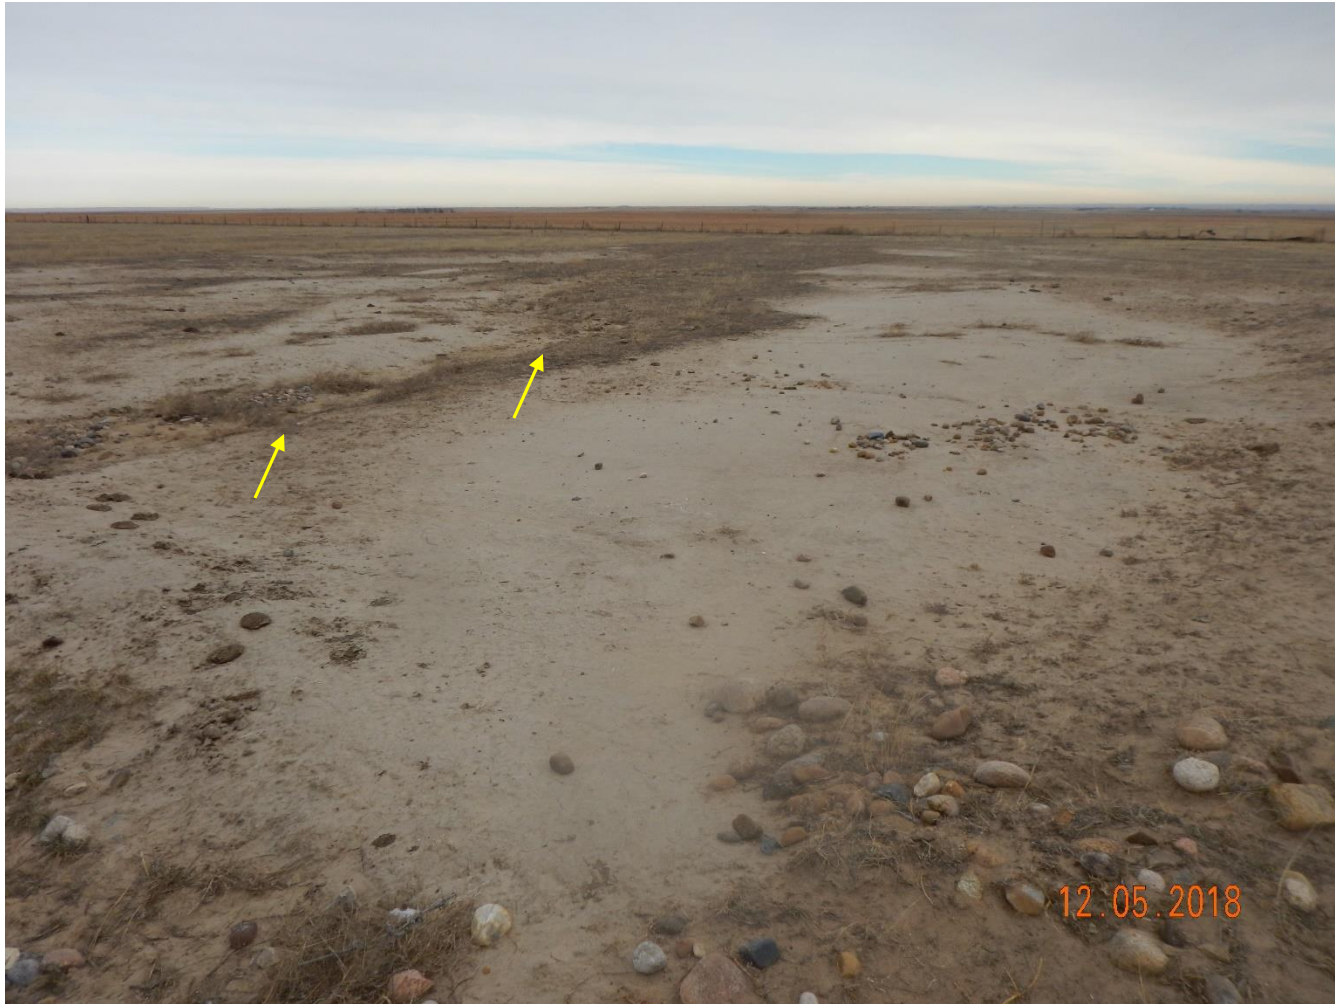
Photo 22: Photo taken from the south end of the northern berm, facing west. See comments under photo 10.

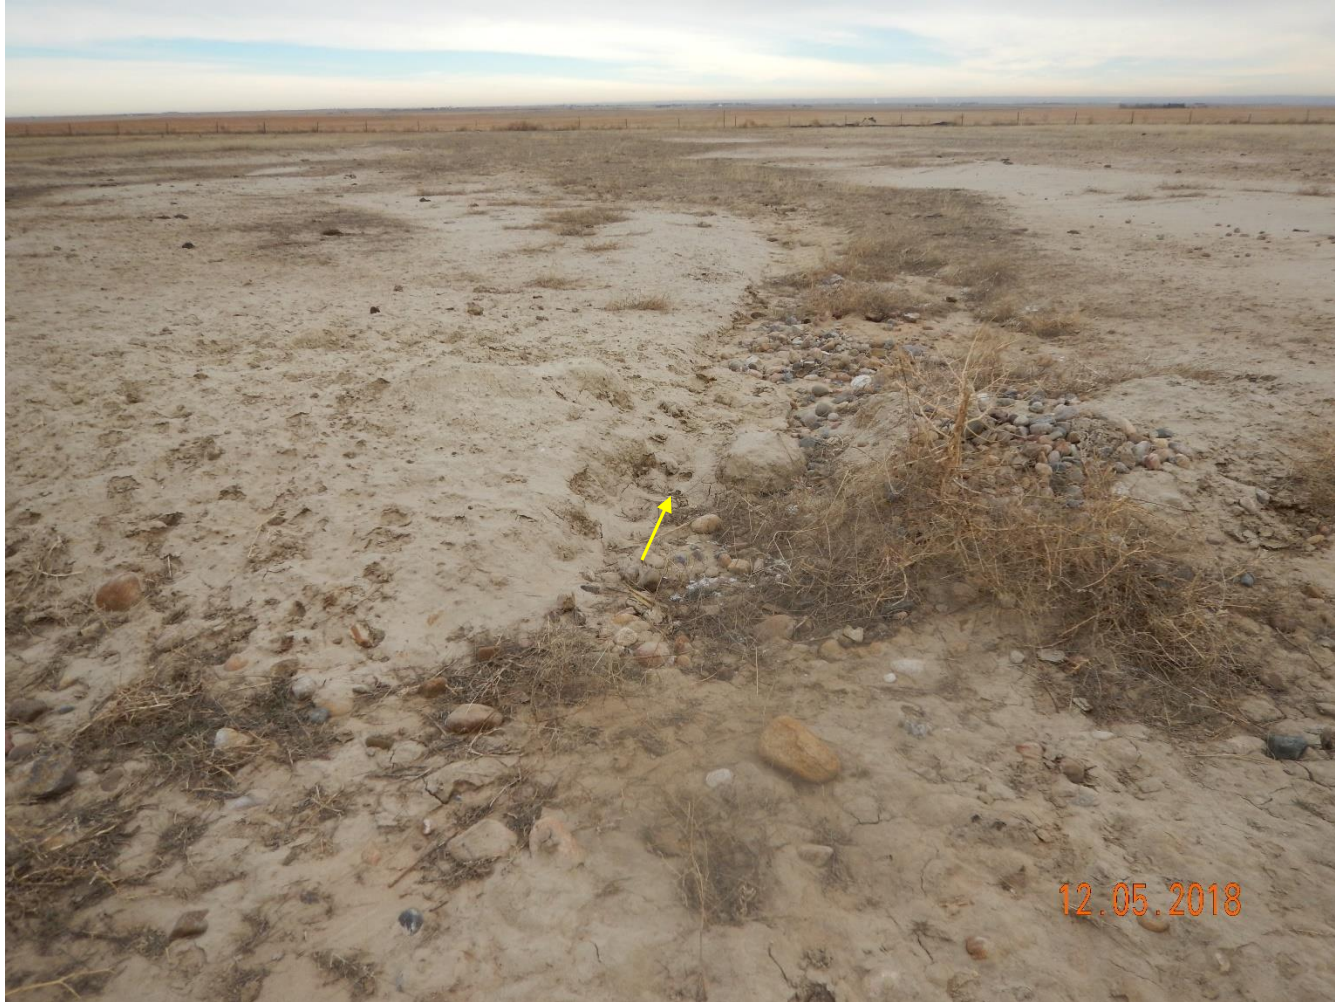
Photo 23: Photo taken from the south end of the northern berm, facing east. See comments under photo 10.

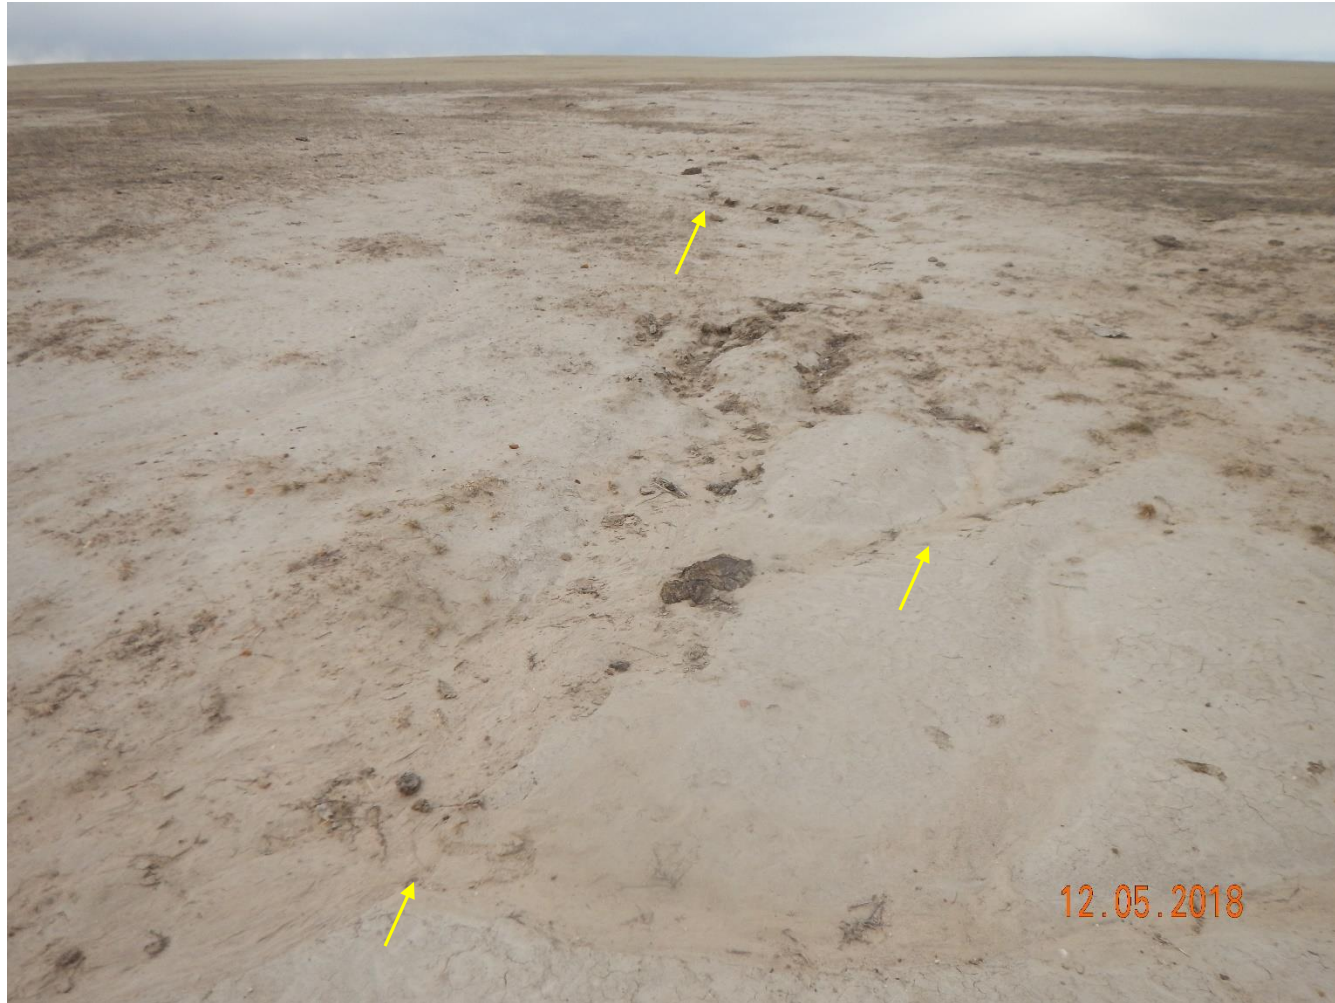
Photo 24: Photo taken from the north end of the location, facing west. See comments under photo 10.

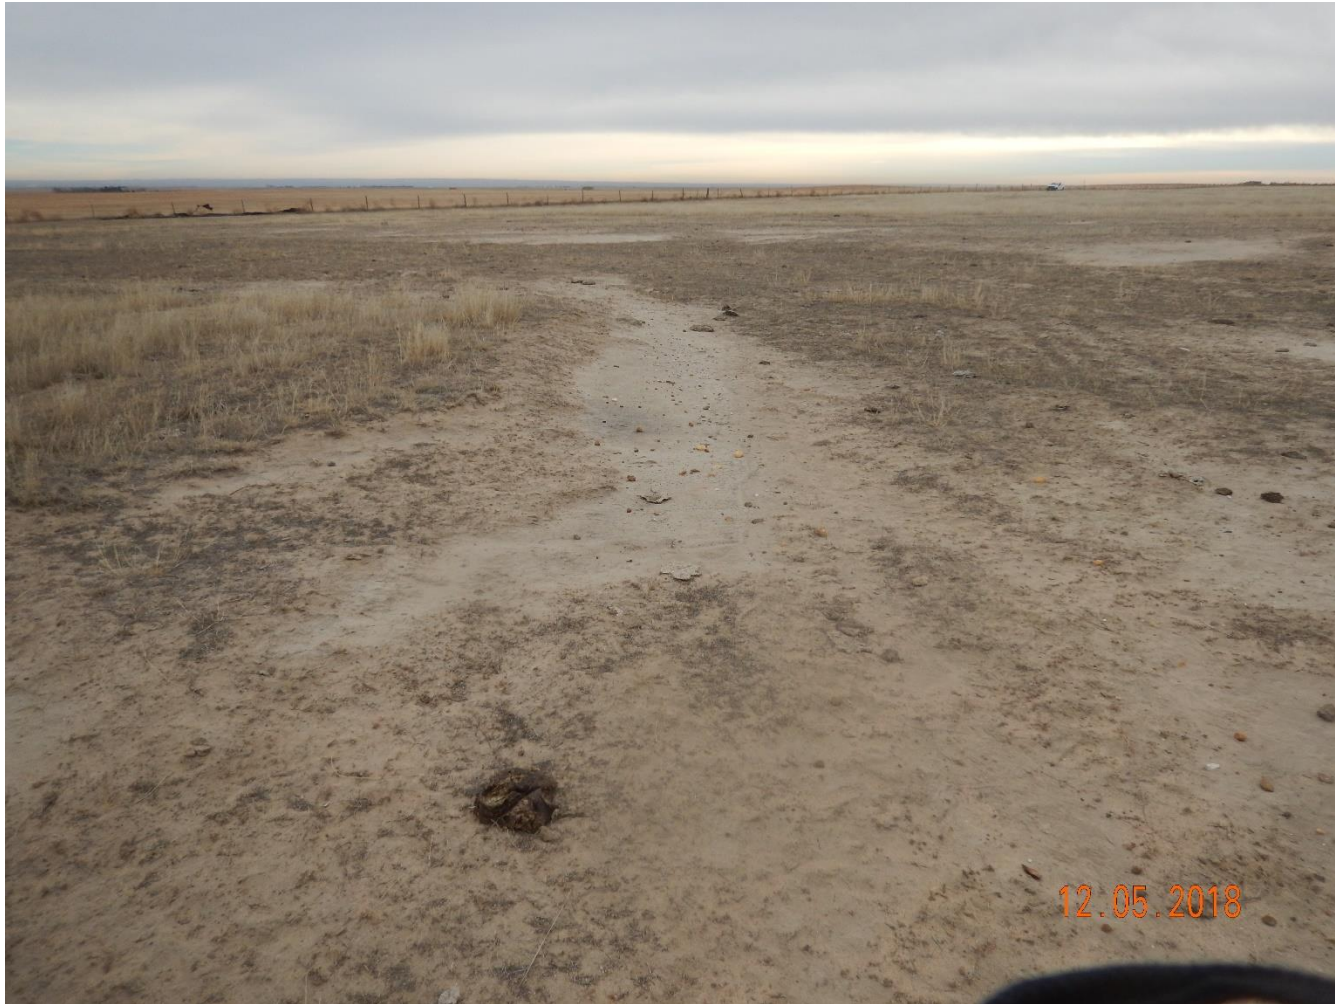
Photo 25: Photo taken from the north end of the location, facing east. See comments under photo 3.

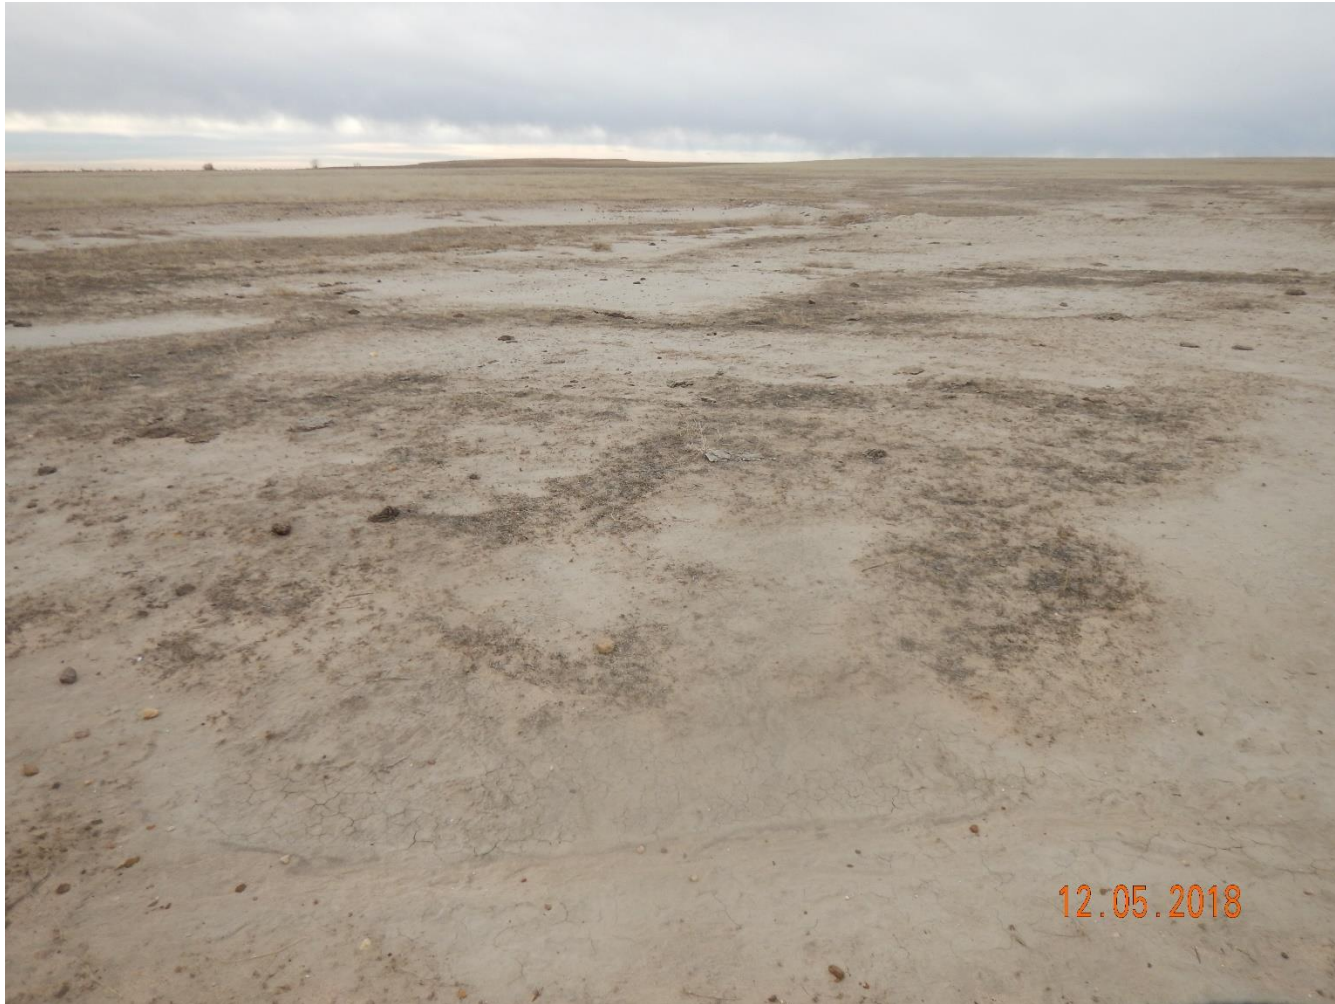
Photo 26: Photo taken from the northeast end of the location, facing south. See comments under photo 3.

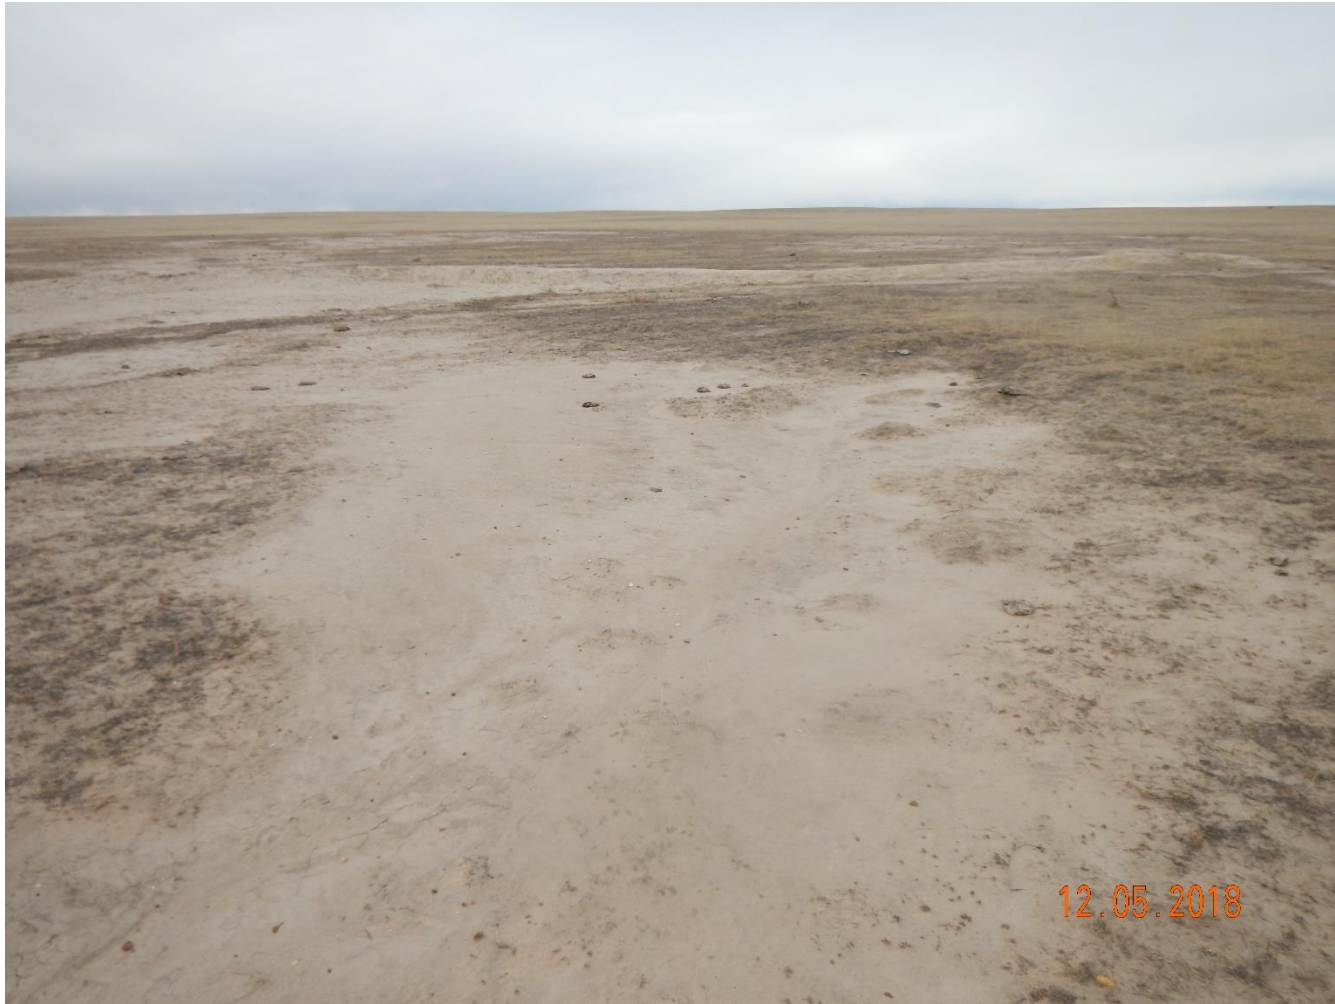
Photo 27: Photo taken from the northeast end of the location, facing west. See comments under photo 3.

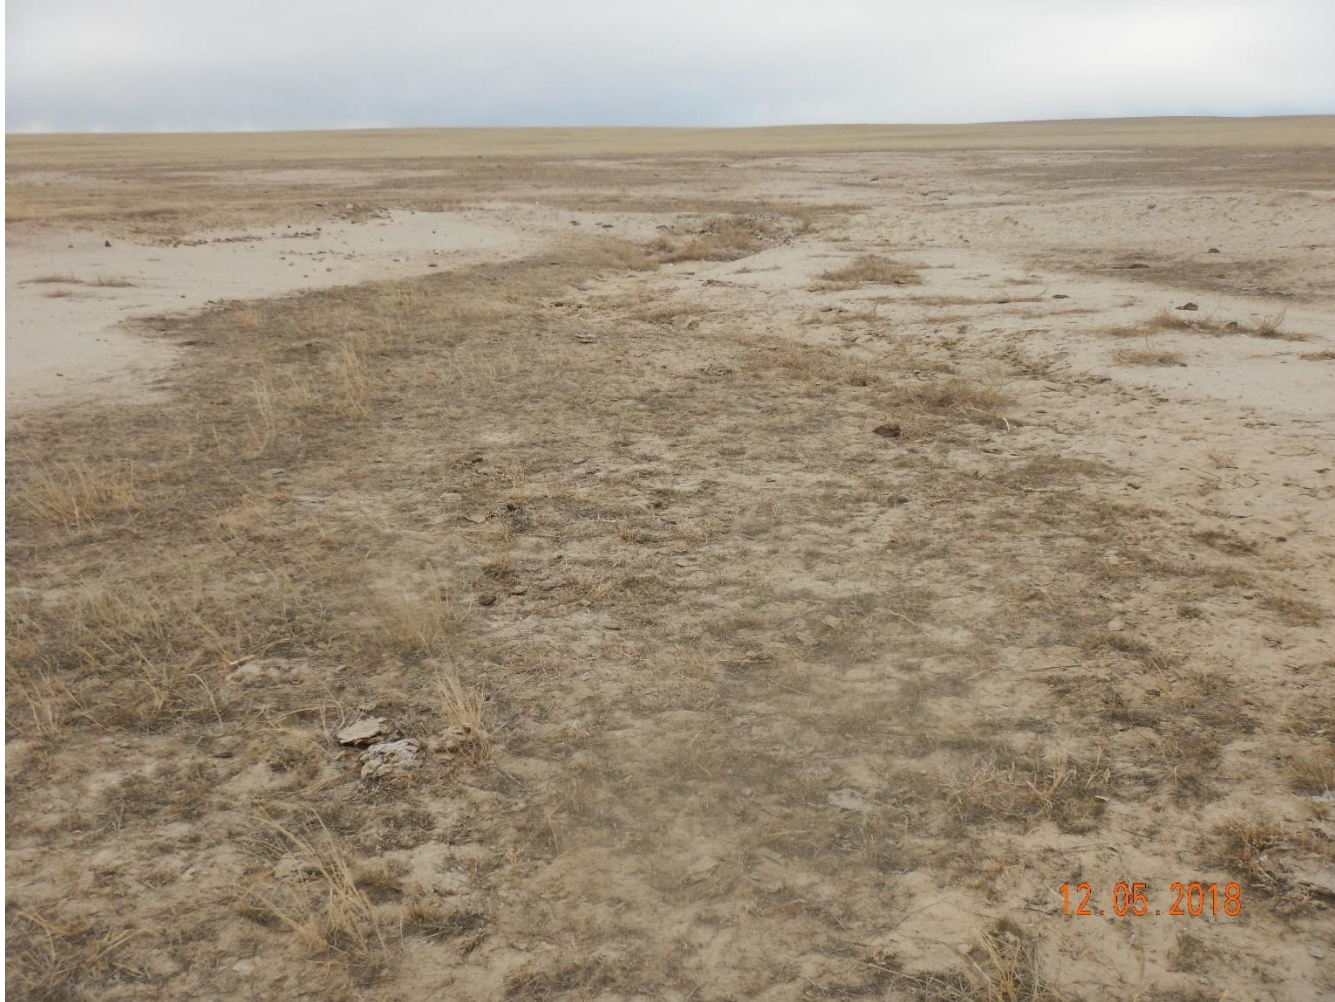
Photo 28: Photo taken from the north end of the location, facing west. See comments under photo 10.

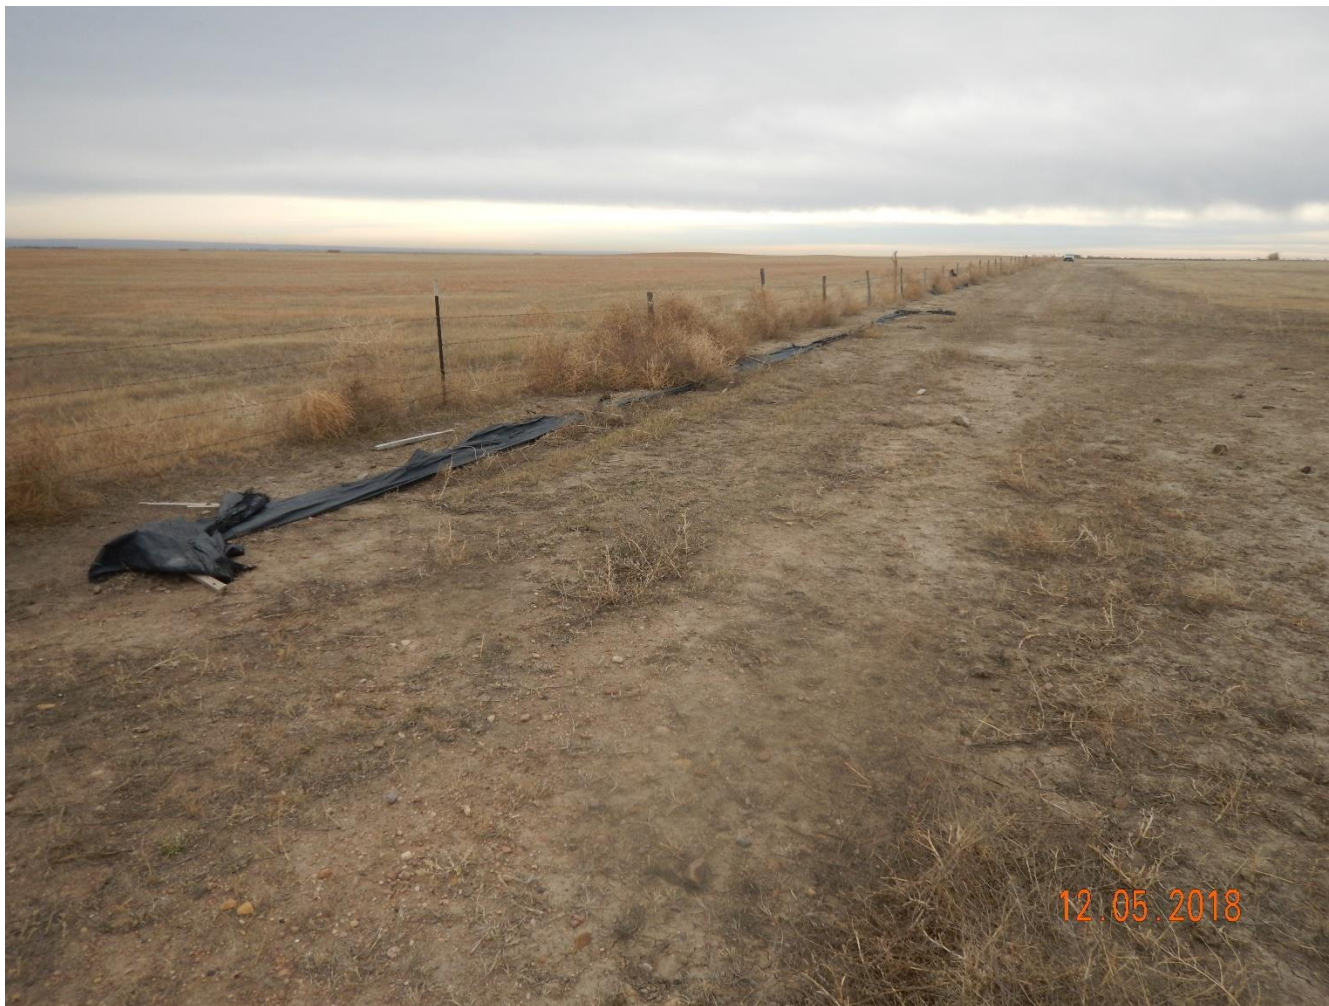
Photo 29: Photo taken from the east end of the location, facing south. Photo of silt fence. Previous inspections documented that areas of the silt fence in disrepair. Entire BMP is no longer in proper functioning condition.

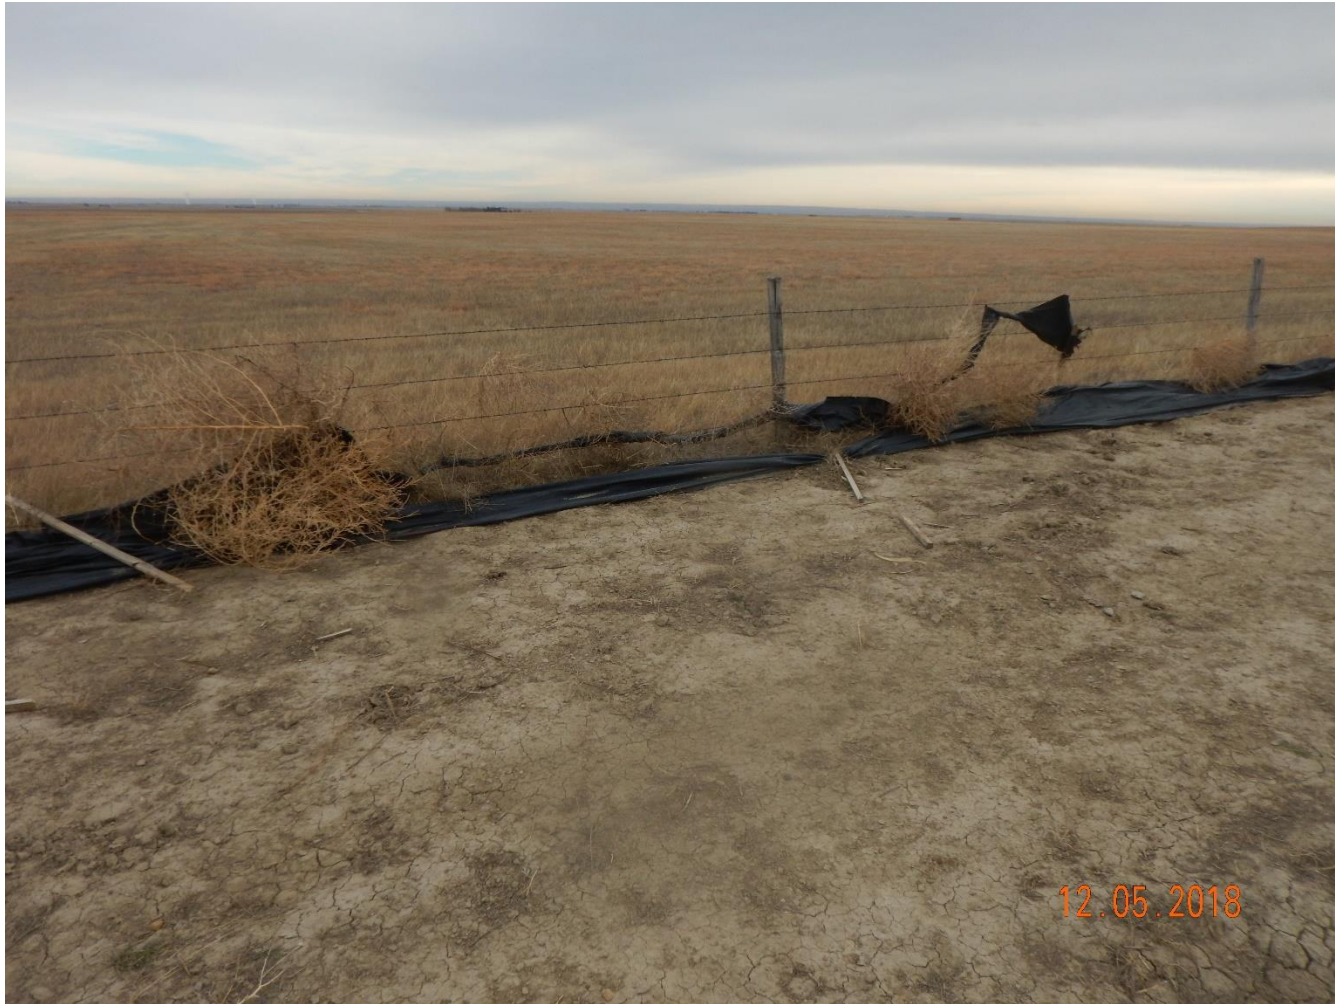
Photo 30: See comments under photo 29

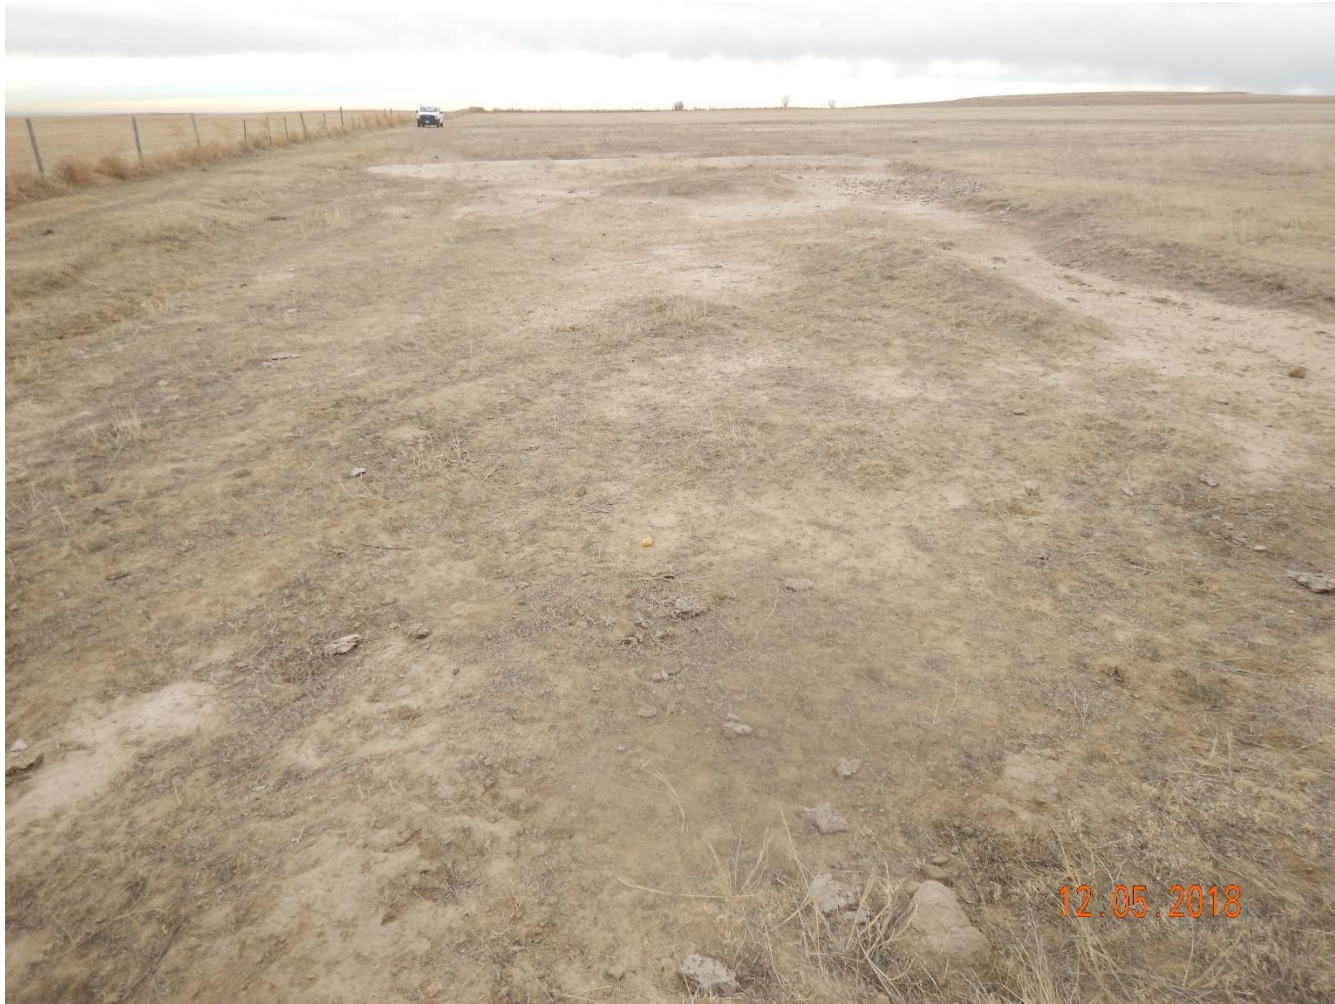
Photo 31: Photo taken from the east end of the location, facing north. See comments under photo 3.

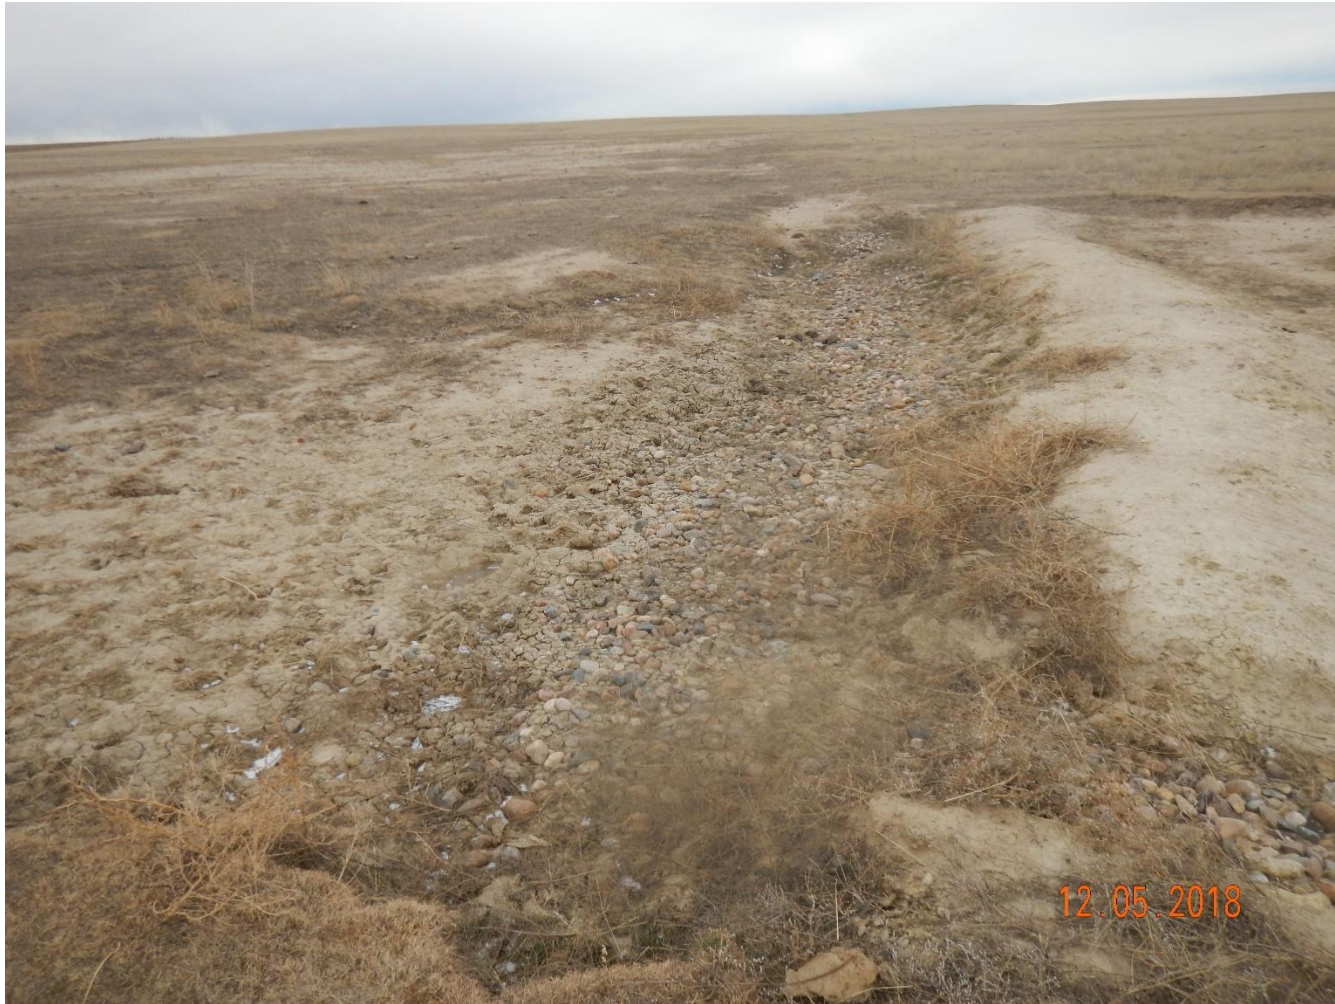
Photo 32: Photo taken from the east end of the location, facing west See comments under photo 10.
