Inspection Photos

Operator: DENVER EAST MACHINERY COMPANY
- 24040

Location ID: 390528

Inspection Doc. Number: 682504248

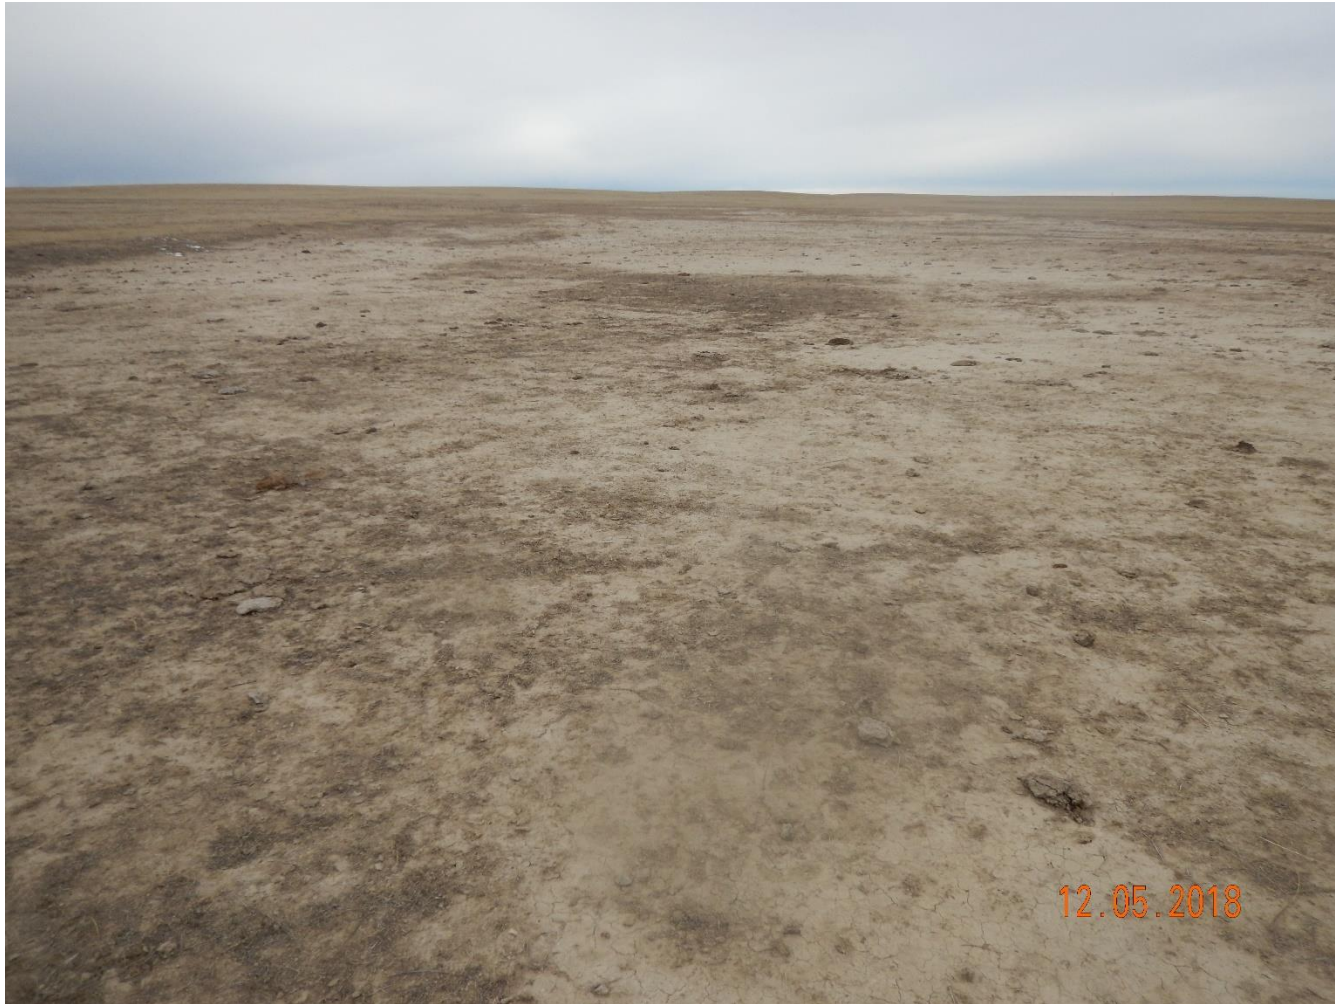
Photo 3: Photo taken from the southwest end of the disturbance area, facing north. Previous inspections that reclamation does not appear to be progressing and required operator to perform additional reclamation activities by 3/31/2018. Photos show no additional reclamation or remediation activities appear to have been conducted. The location/disturbance area remains predominantly bare and exposed soil, or undesirable weedy plant species.

Photo 33: Photo taken from the southeast end of the location, facing west. See comments under photo 3.

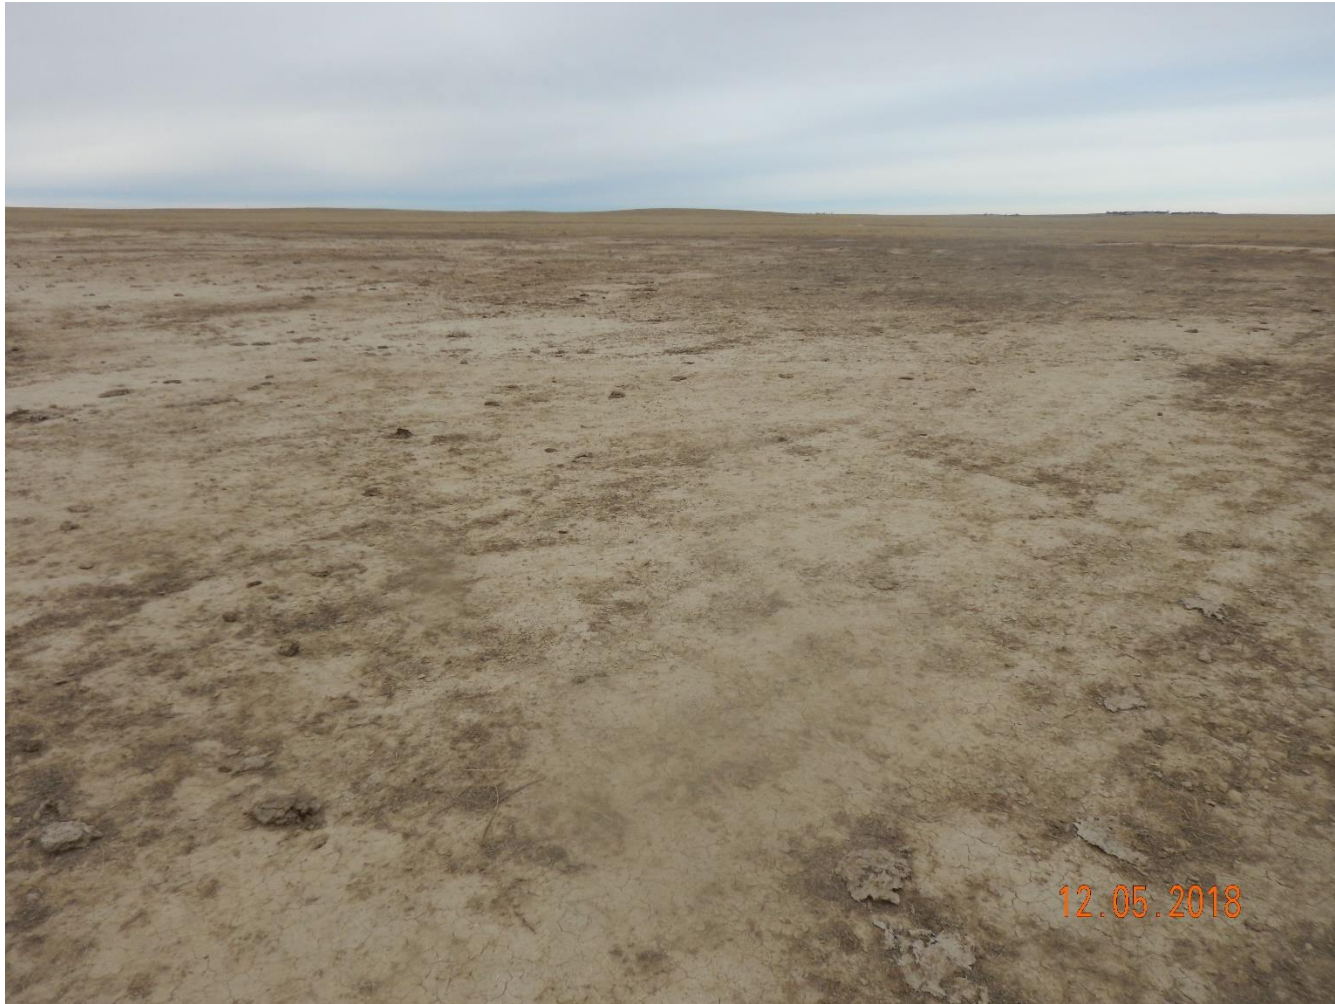
Photo 34: Photo taken from the southeast end of the location, facing northwest. See comments under photo 3.

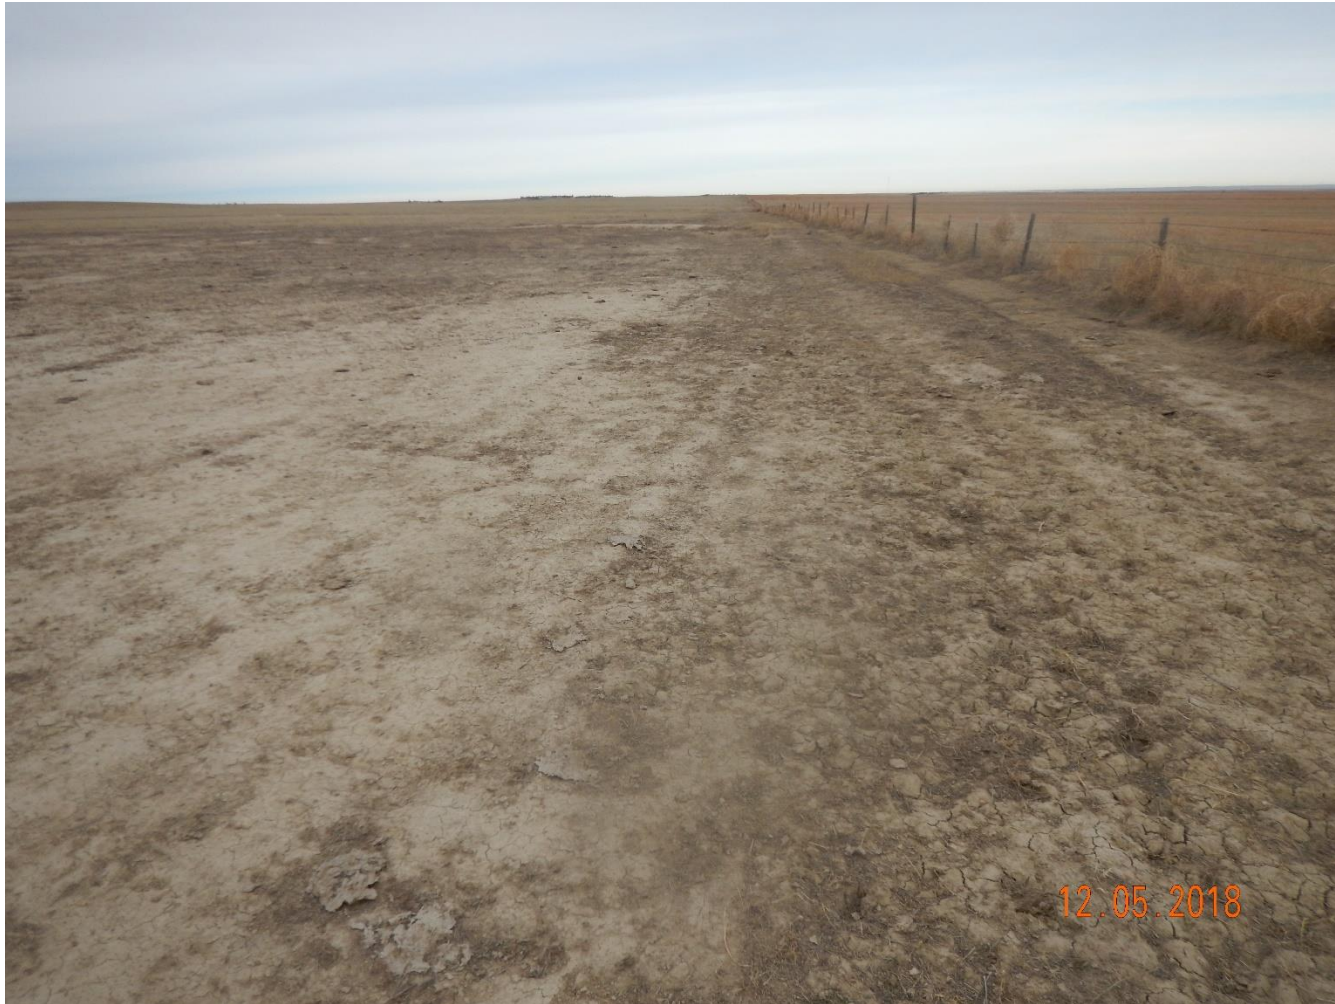
Photo 35: Photo taken from the southeast end of the location, facing north. See comments under photo 3..
