Inspection Photos

Location Name: Kinzer 23-3B, C, D Vault Removal

Facility ID: 251612

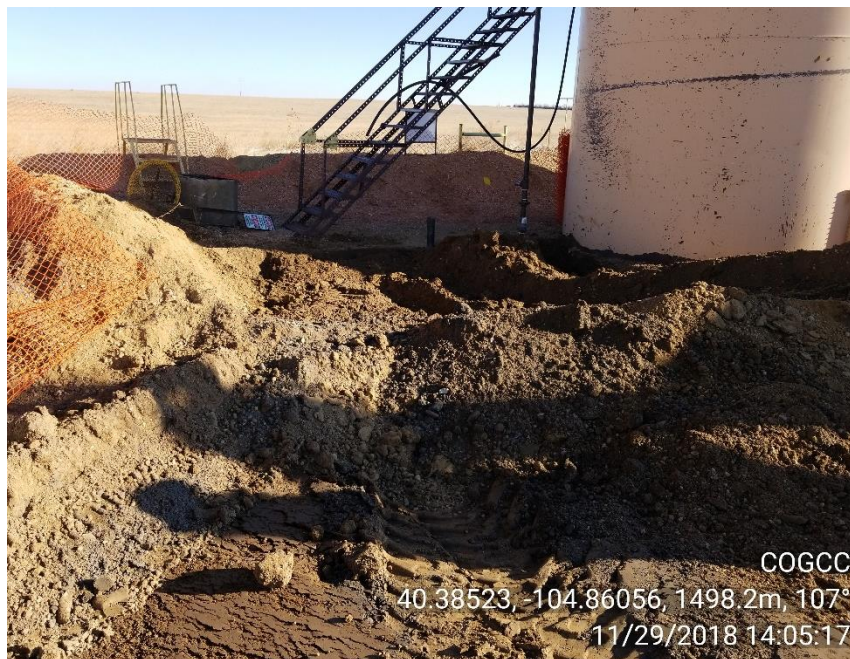
Photo 1 – Excavation area, partially backfilled after vault removal.

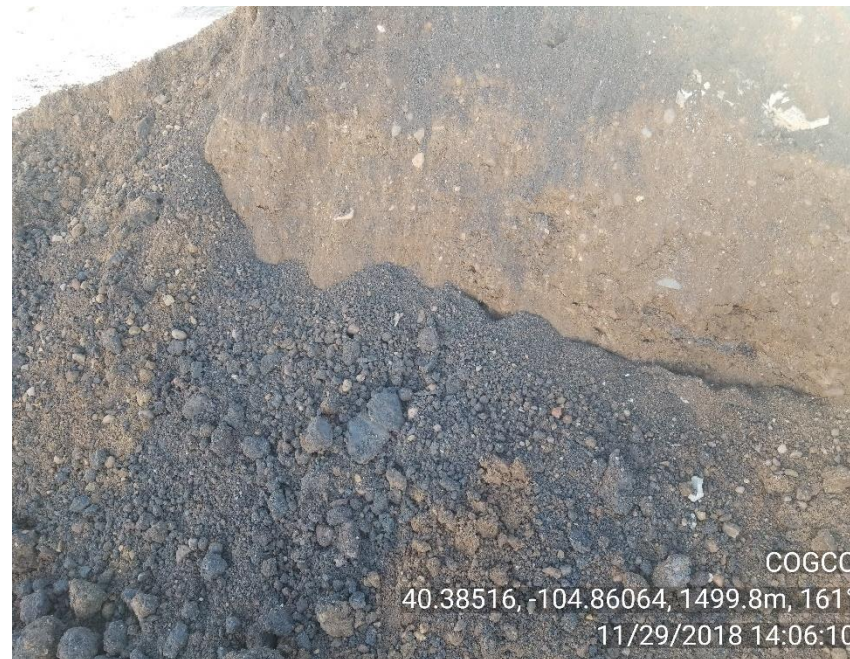
Photo 2 – Hydrocarbon impacted soil along edge of excavation.

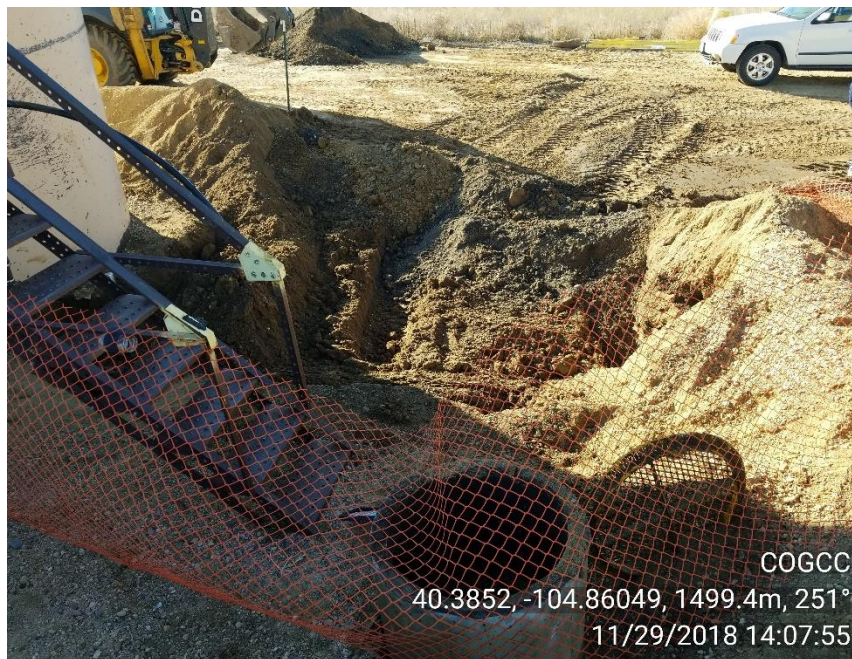
Photo 3 – Partially backfilled excavation area with impacted soils.

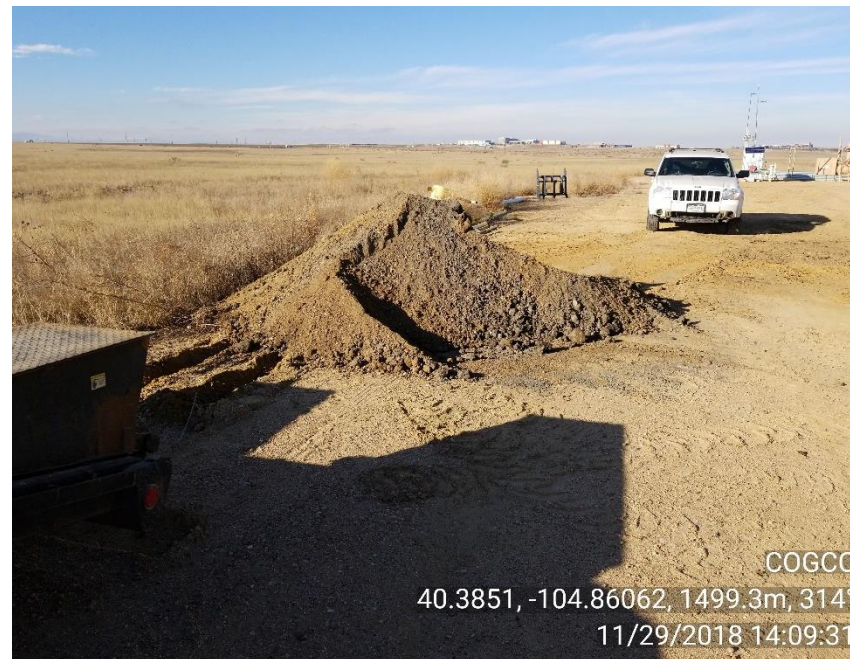
Photo 2 – Stockpiled soils on western side of facility.
