Inspection Photo (s)
Juhan Fee 26-94
API # 05-045-06023
Inspection # 689302573

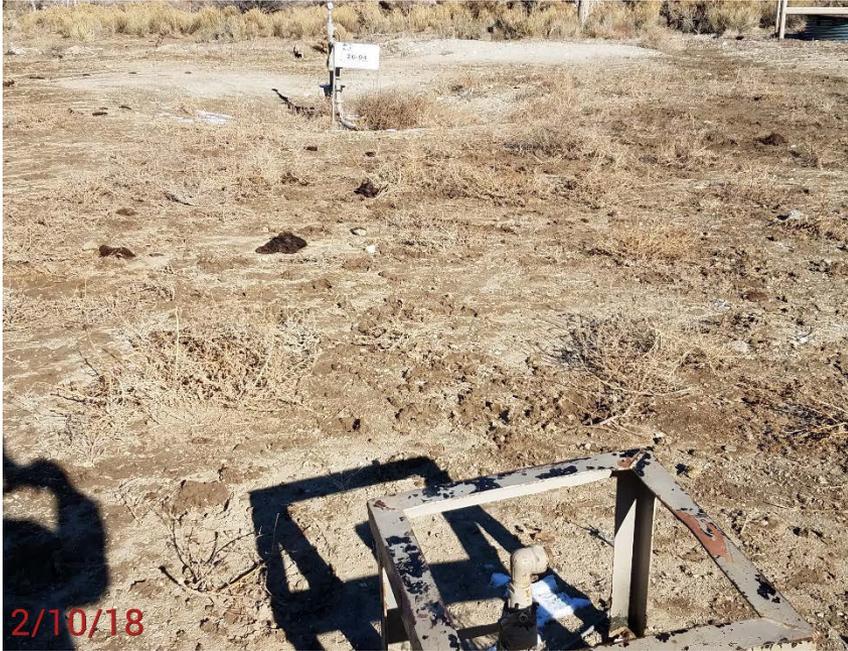
Location Photo #3 unmarked, unused flow line riser.

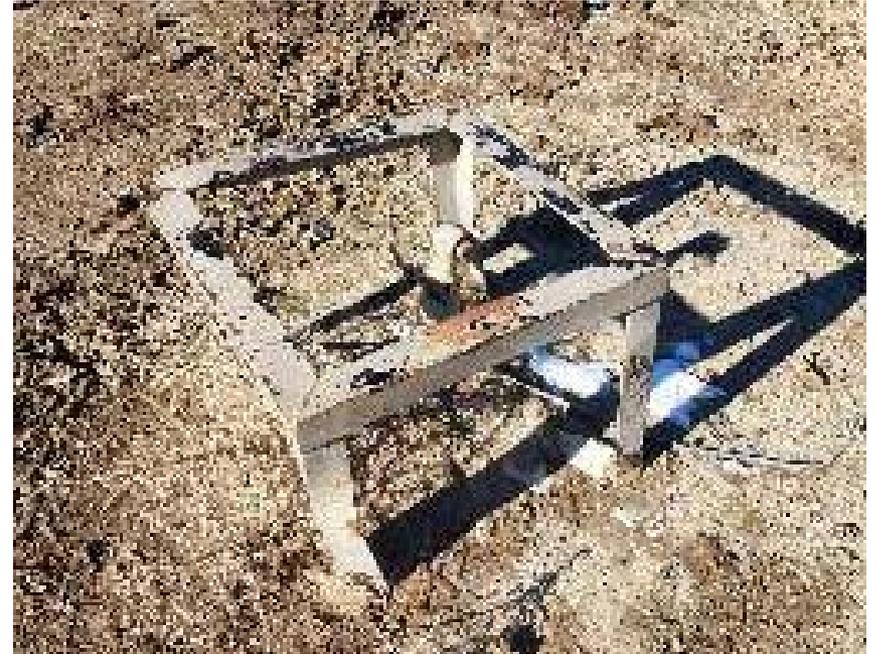
Location Photo #4, unmarked flow line riser.
