# Inspection Photos

Operator: SMITH OIL PROPERTIES INC - 79905

Location ID: 313873

Inspection Doc. Number: 682504256

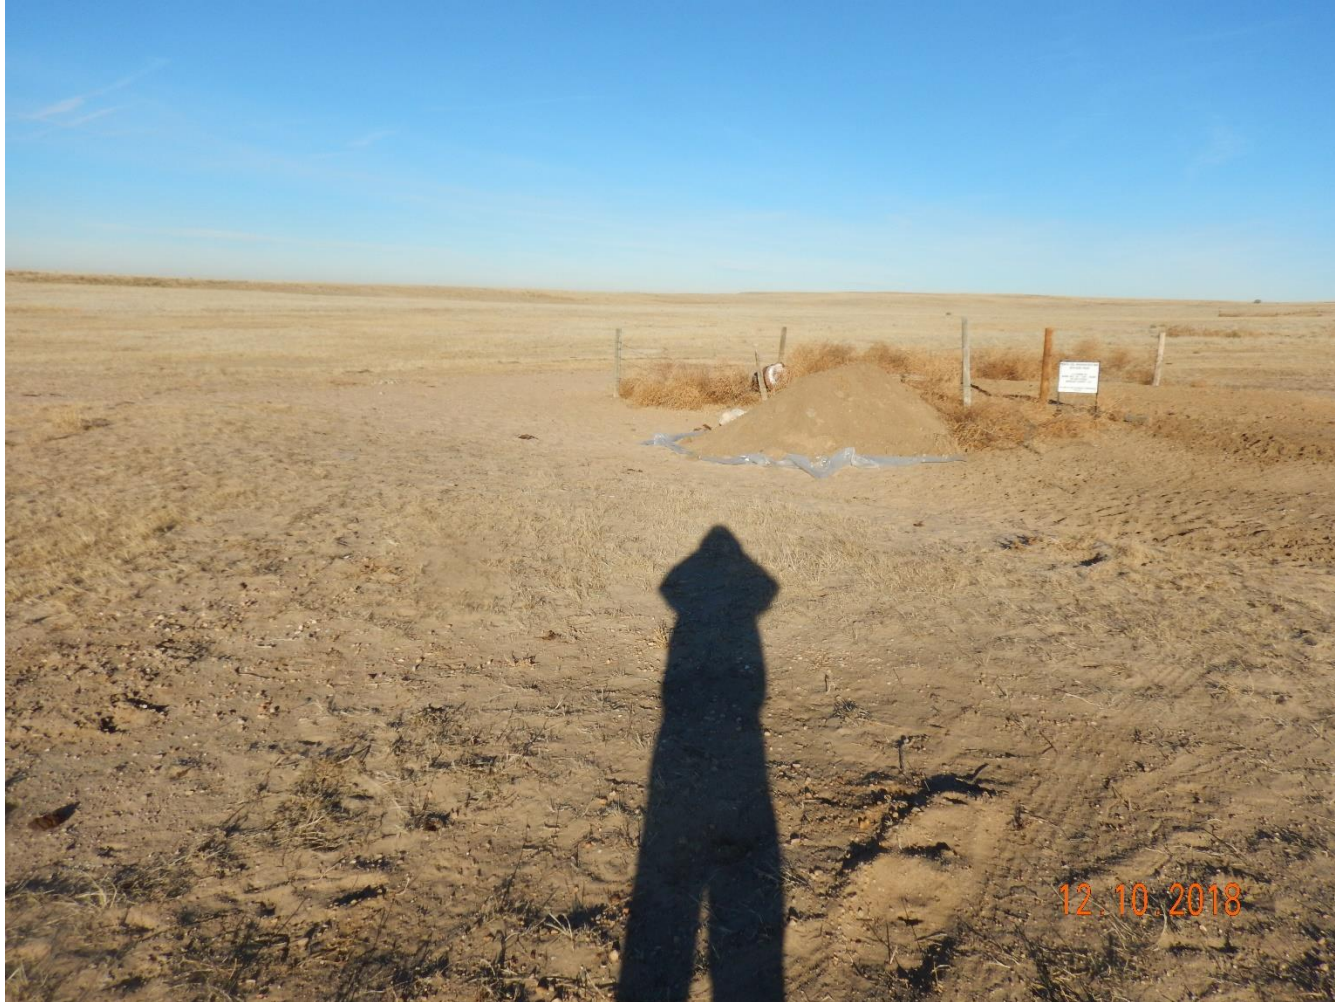
**Photo 1:** Photo taken from the south end of the well location, facing northwest. Photo shows though pump unit appear to have been removed, no additional reclamation appears to have been conducted in accordance with 1004 rules

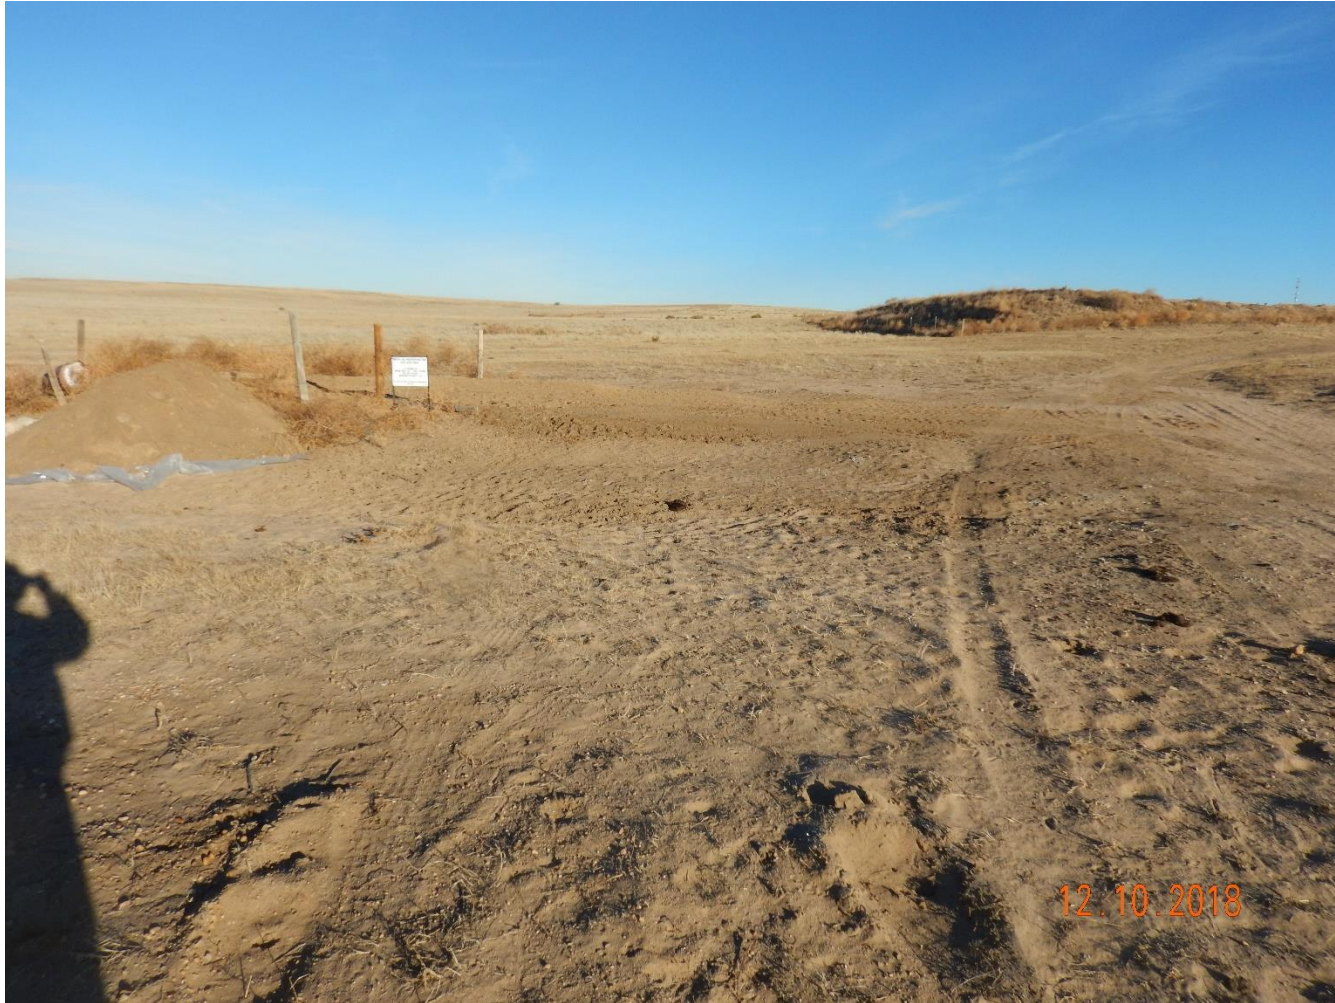
**Photo 2:** Photo taken from the south end of the well location, facing north. Photo shows though pump unit appear to have been removed, no additional reclamation appears to have been conducted in accordance with 1004 rules

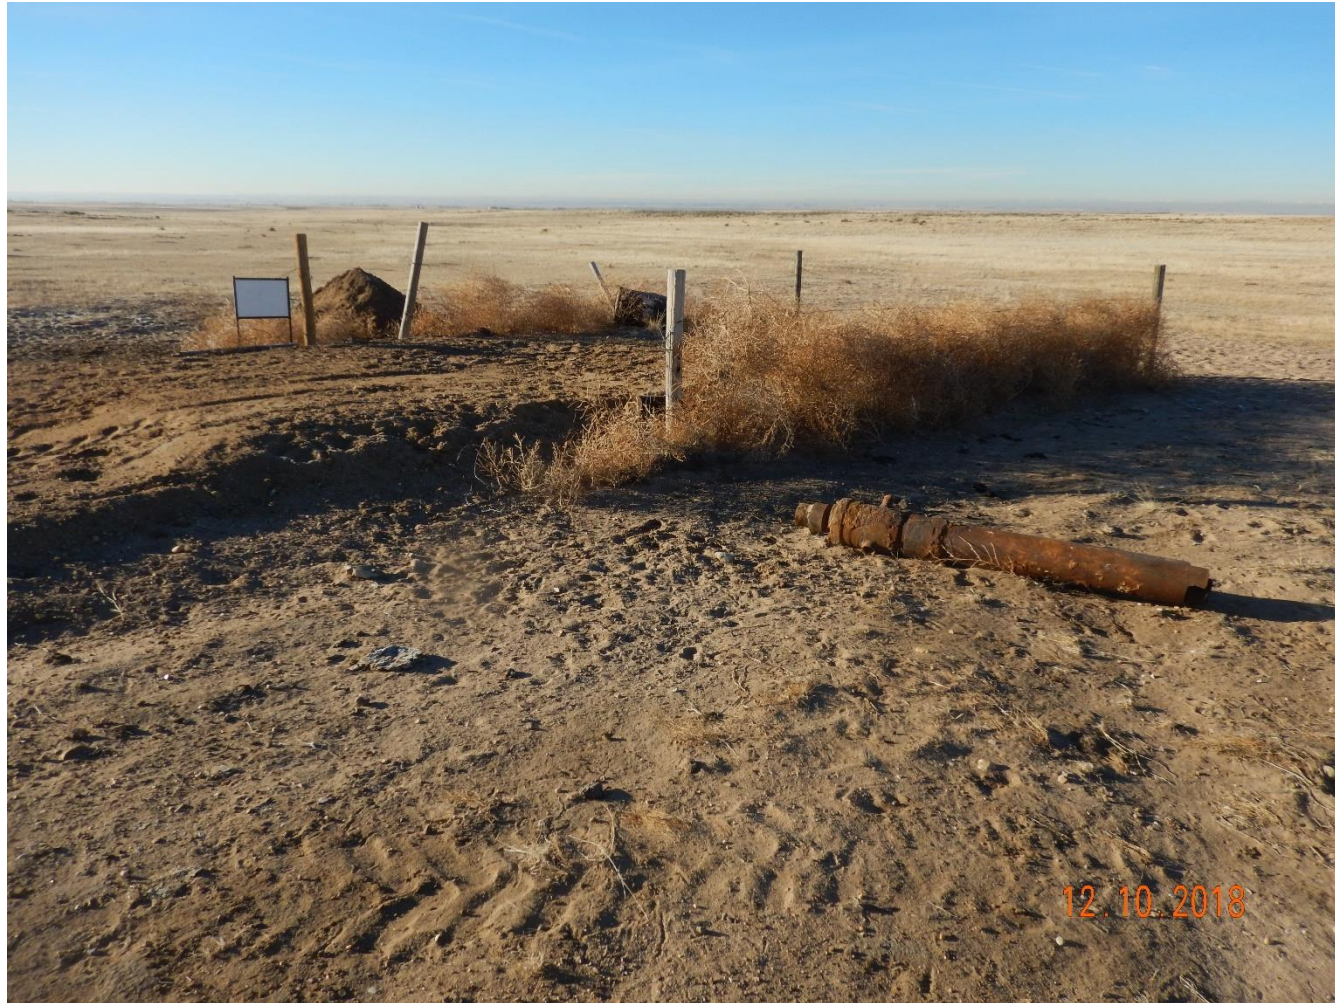
**Photo 3:** Photo taken from the north end of the well location, facing southwest. Photo shows though pump unit appear to have been removed, no additional reclamation appears to have been conducted in accordance with 1004 rules; various trash debris, equipment and fence remains.

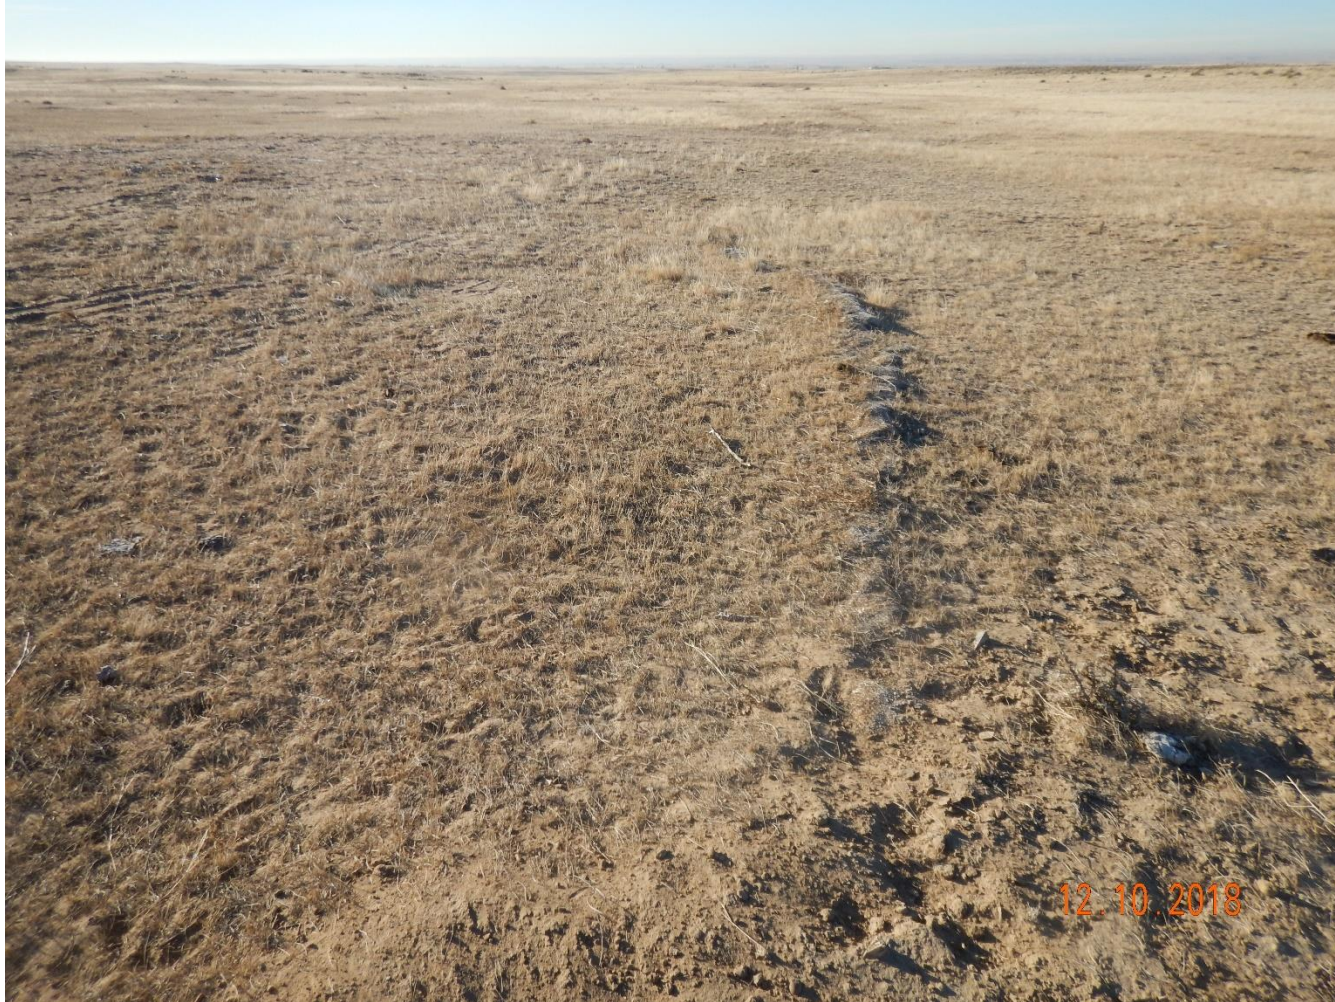
**Photo 4:** Photo taken from the west end of the well location, facing south. Photo shows straw wattle stormwater BMP previously documented remains on location and in disrepair.

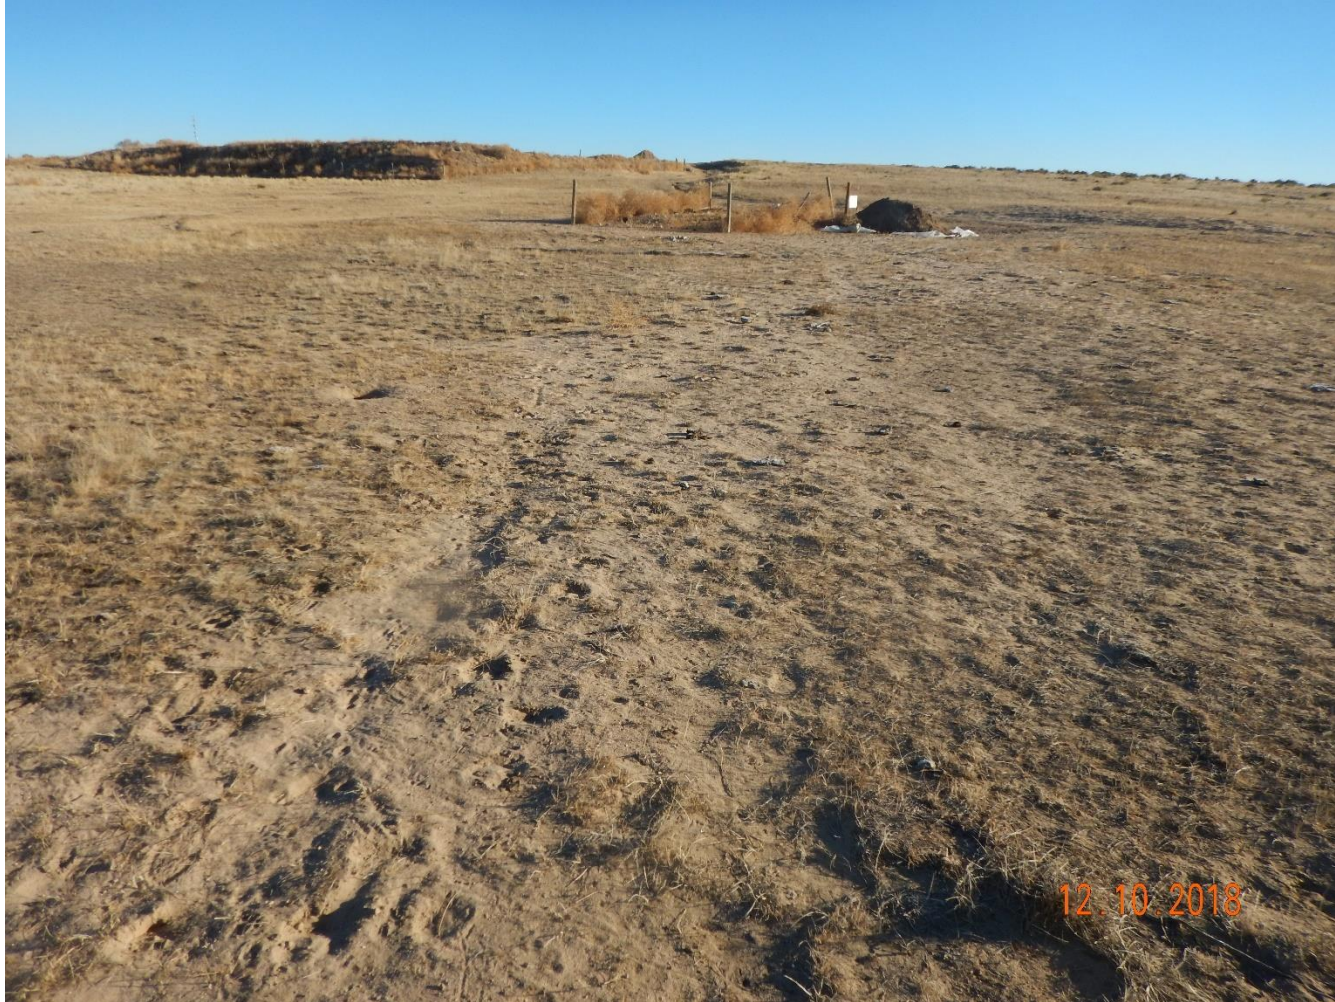
**Photo 5:** Photo taken from the west end of the well location, facing east. Photo shows no reclamation activities appear to have been conducted in accordance with 1004 rules and corrective actions.

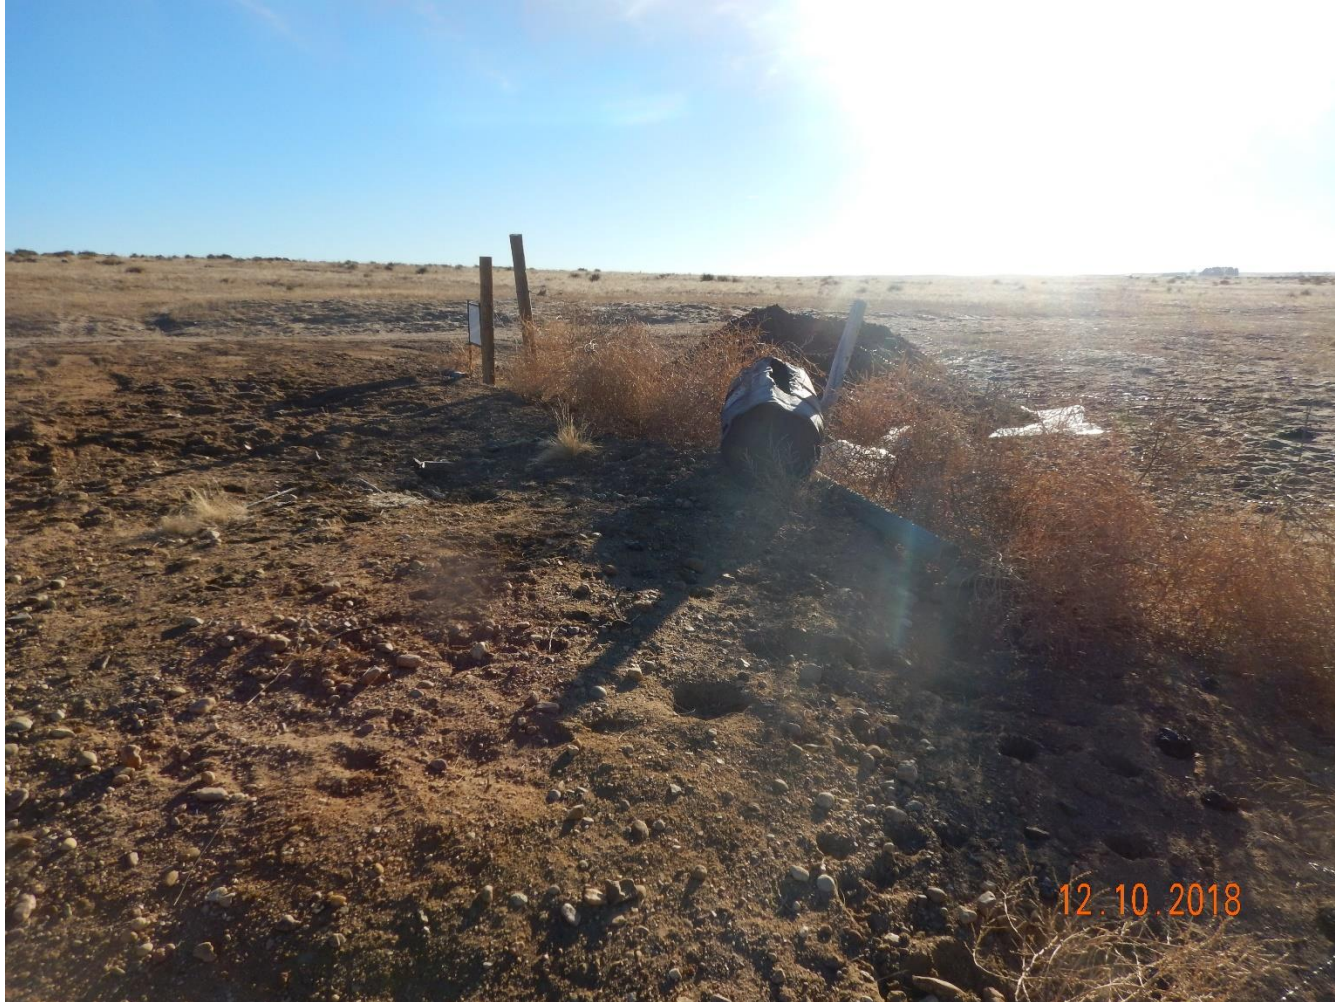
**Photo 6:** Photo taken from the west end of the well, facing east. Photo shows various trash debris, equipment and fence remaining on location.

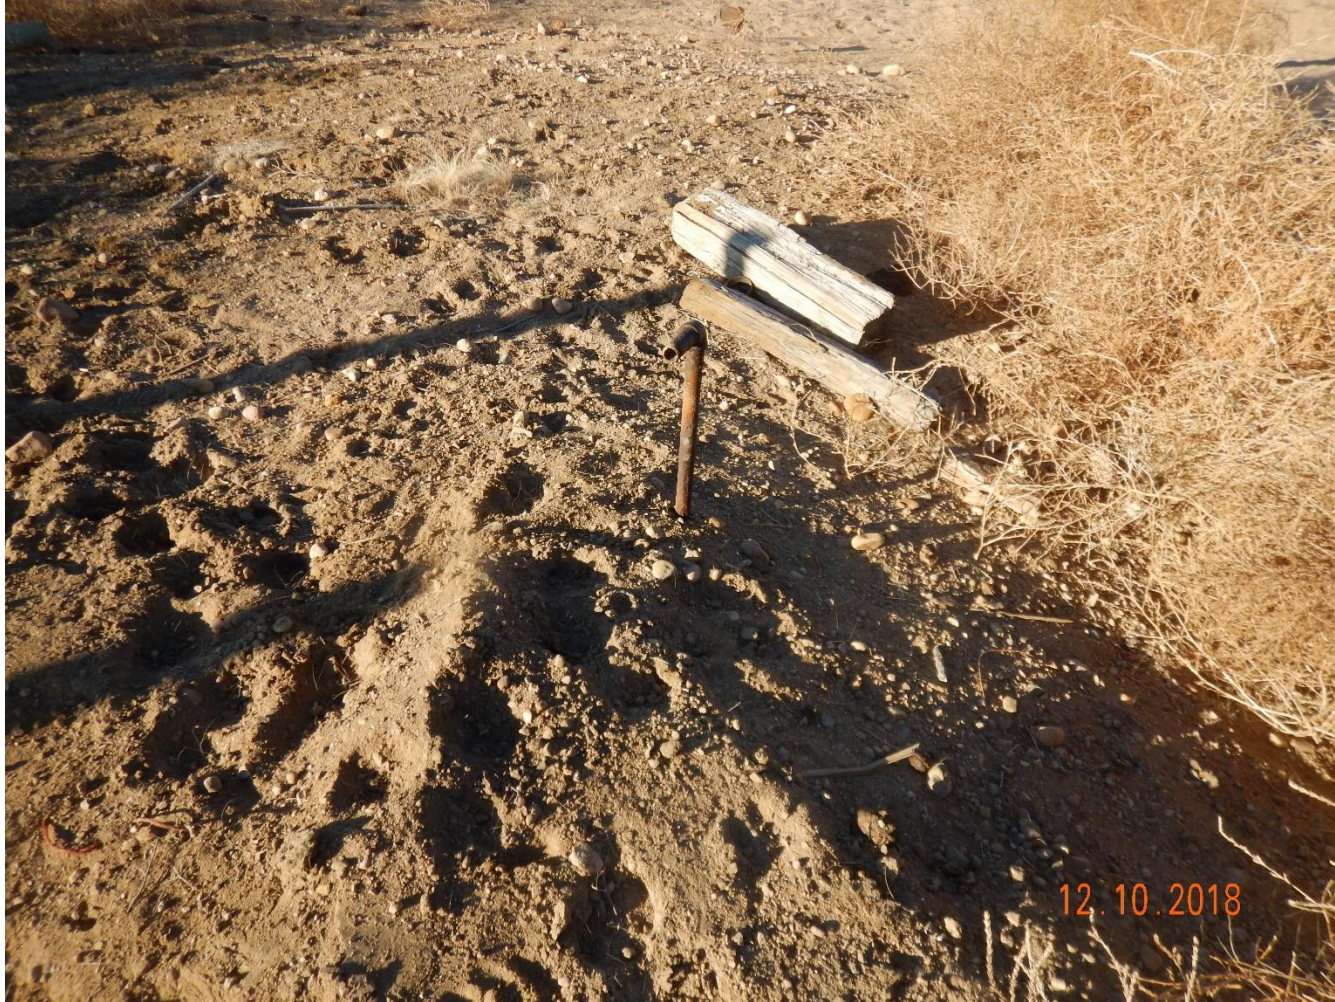
**Photo 7:** Photo taken from the well. Photo shows riser remaining on location.

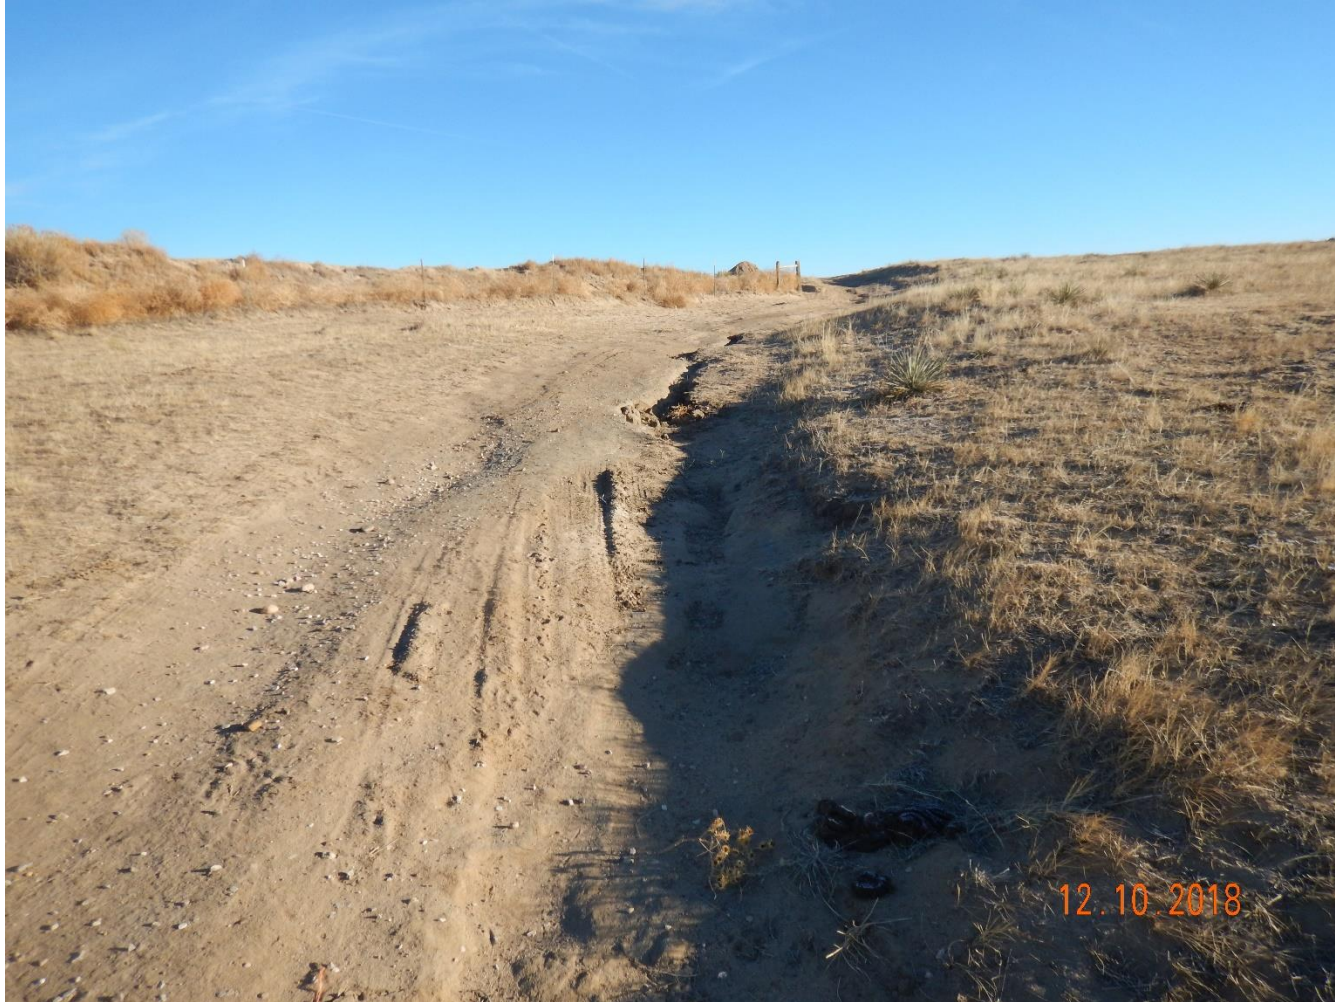
**Photo 8:** Photo taken from the access road, northeast of the well, facing northeast. Photo shows access road has not been reclaimed, and stormwater erosion degradation has been allowed to continued.

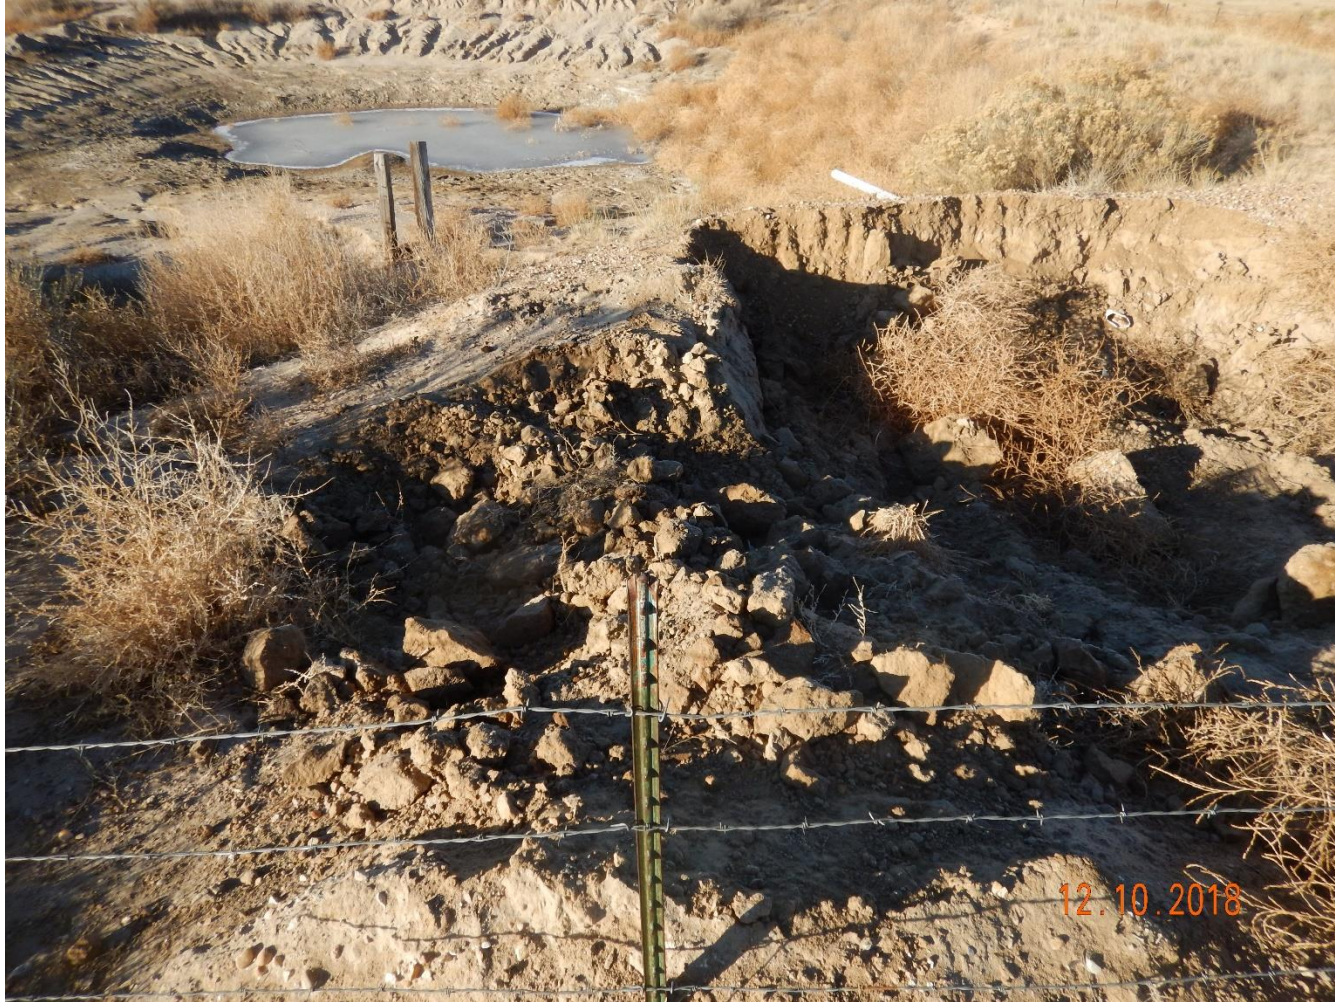
**Photo 9:** Photo taken from the east end of the pits, facing west. Photo shows pits have not been closed or reclaimed.

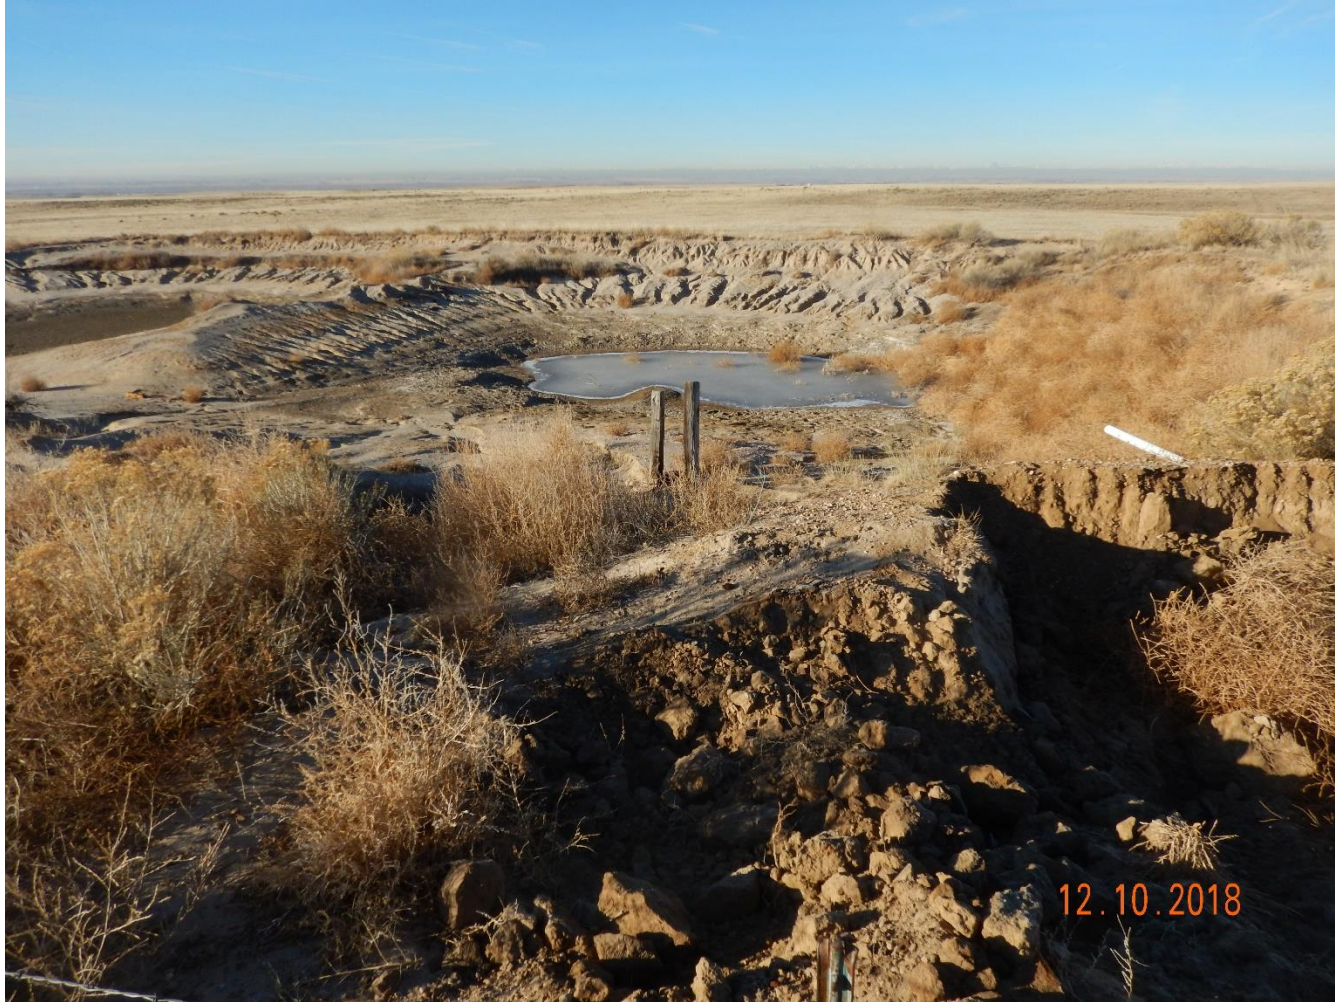
**Photo 10:** Photo taken from the east end of the pits, facing west. Photo shows pits have not been closed or reclaimed.

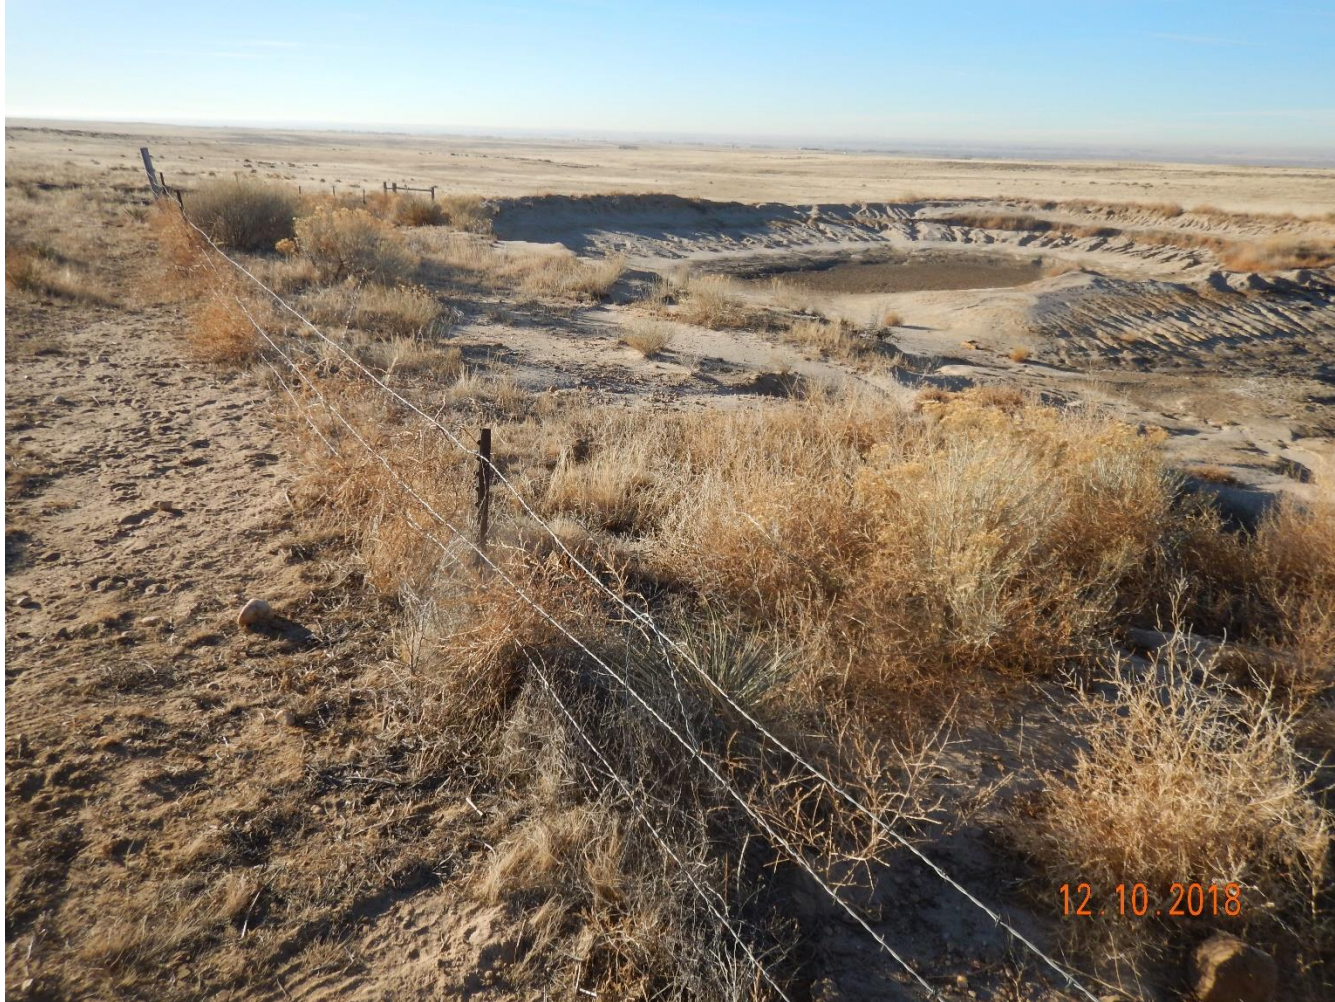
**Photo 11:** Photo taken from the east end of the pits, facing southwest. Photo shows pits have not been closed or reclaimed.

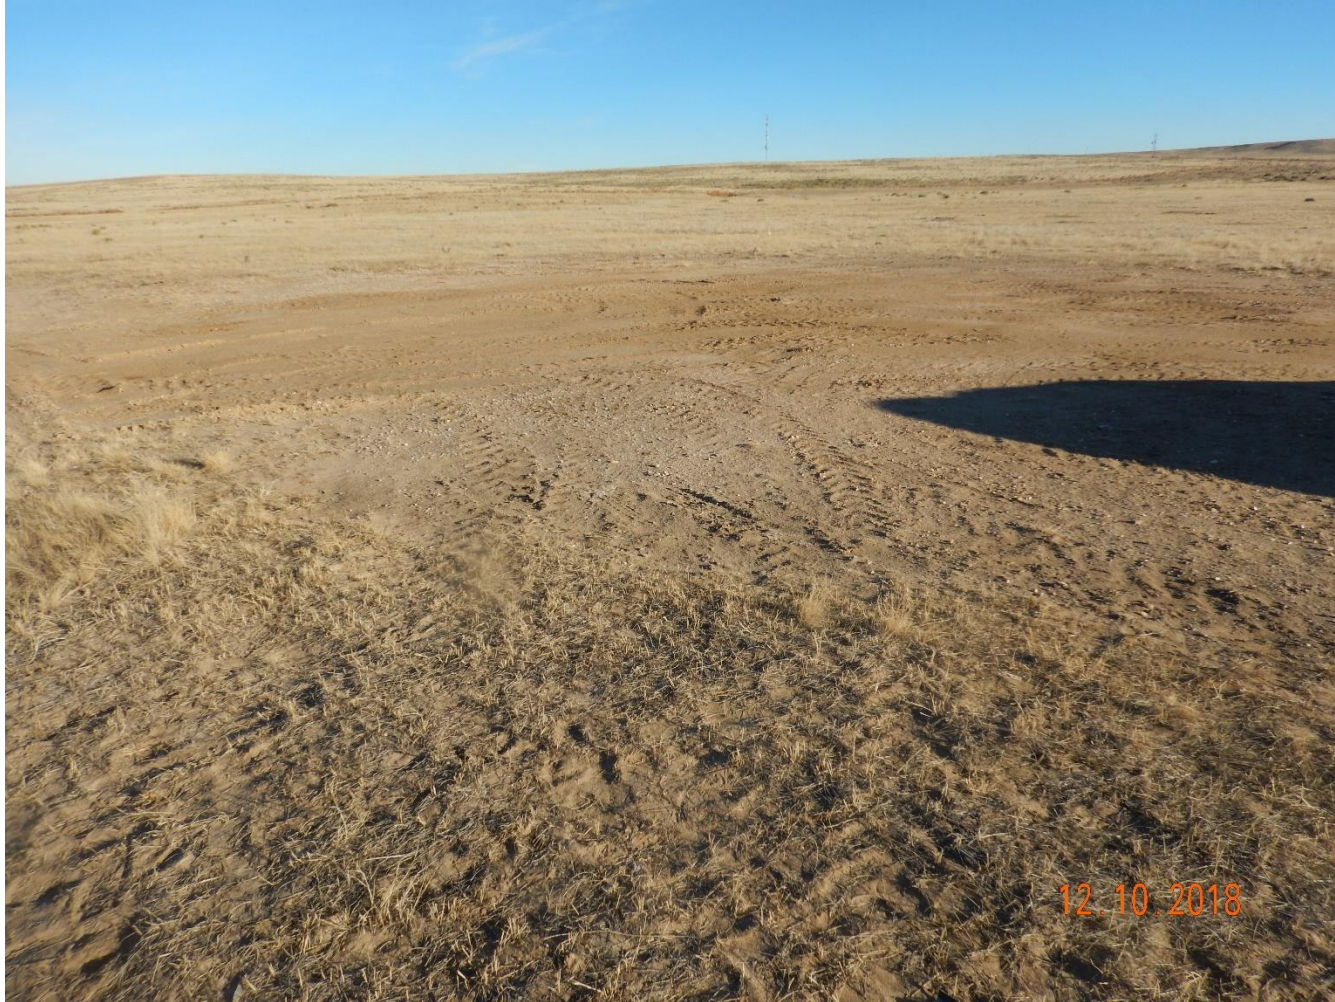
**Photo 12:** Photo taken from the west end of the battery location, facing northeast. Photo shows operator appears to have spread soil on top of the location, however, gravel has not been removed, compaction alleviation has not been conducted. Reclamation activities do not appear to have been conducted in accordance with 1004 rules and corrective actions.

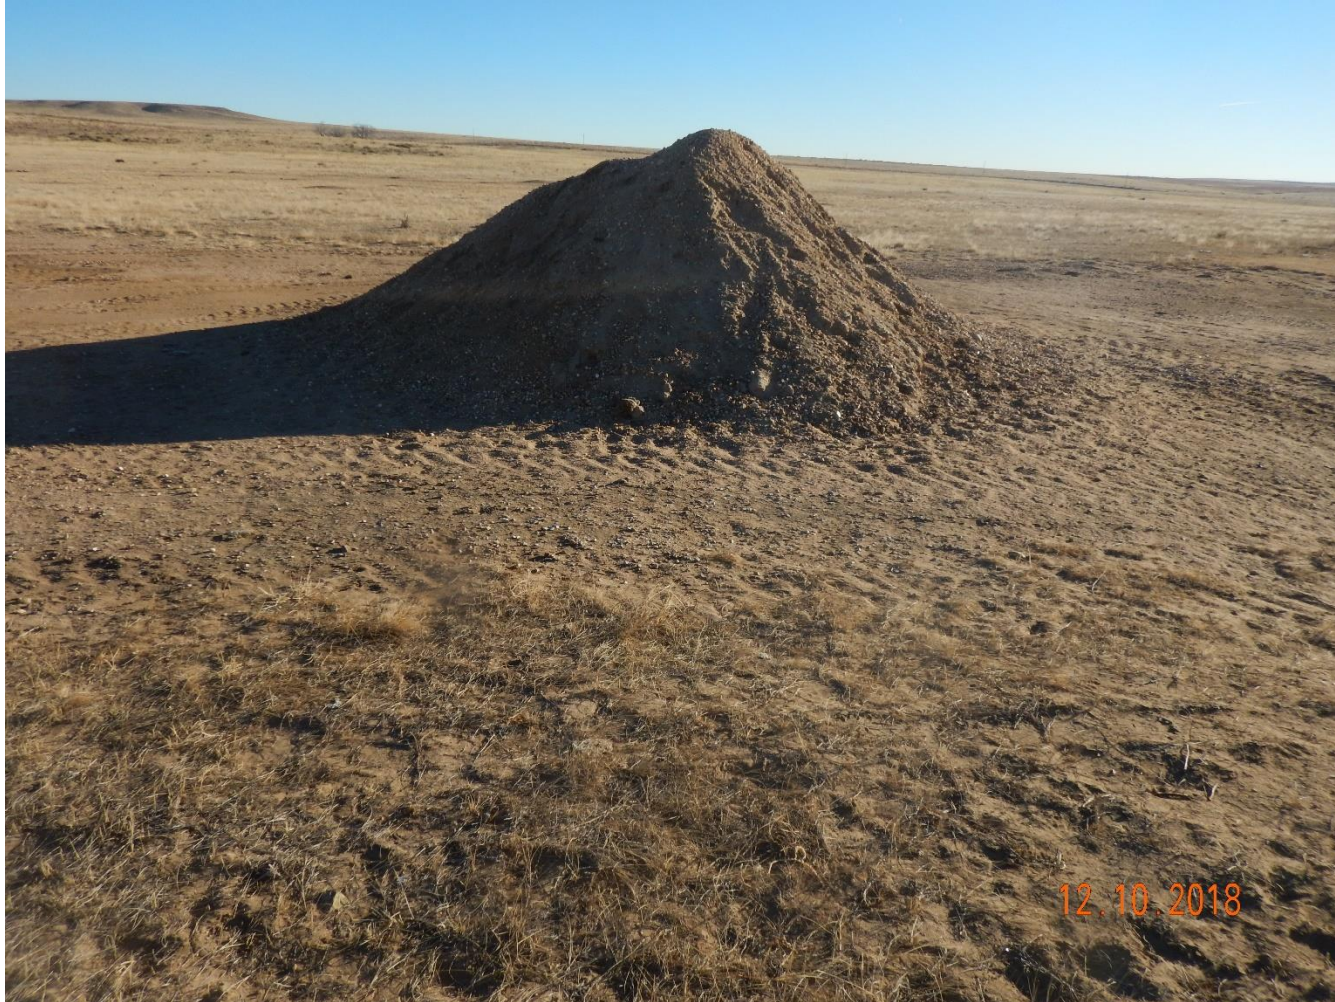
**Photo 13:** Photo taken from the west end of the battery location, facing east. See comments under photo 12.

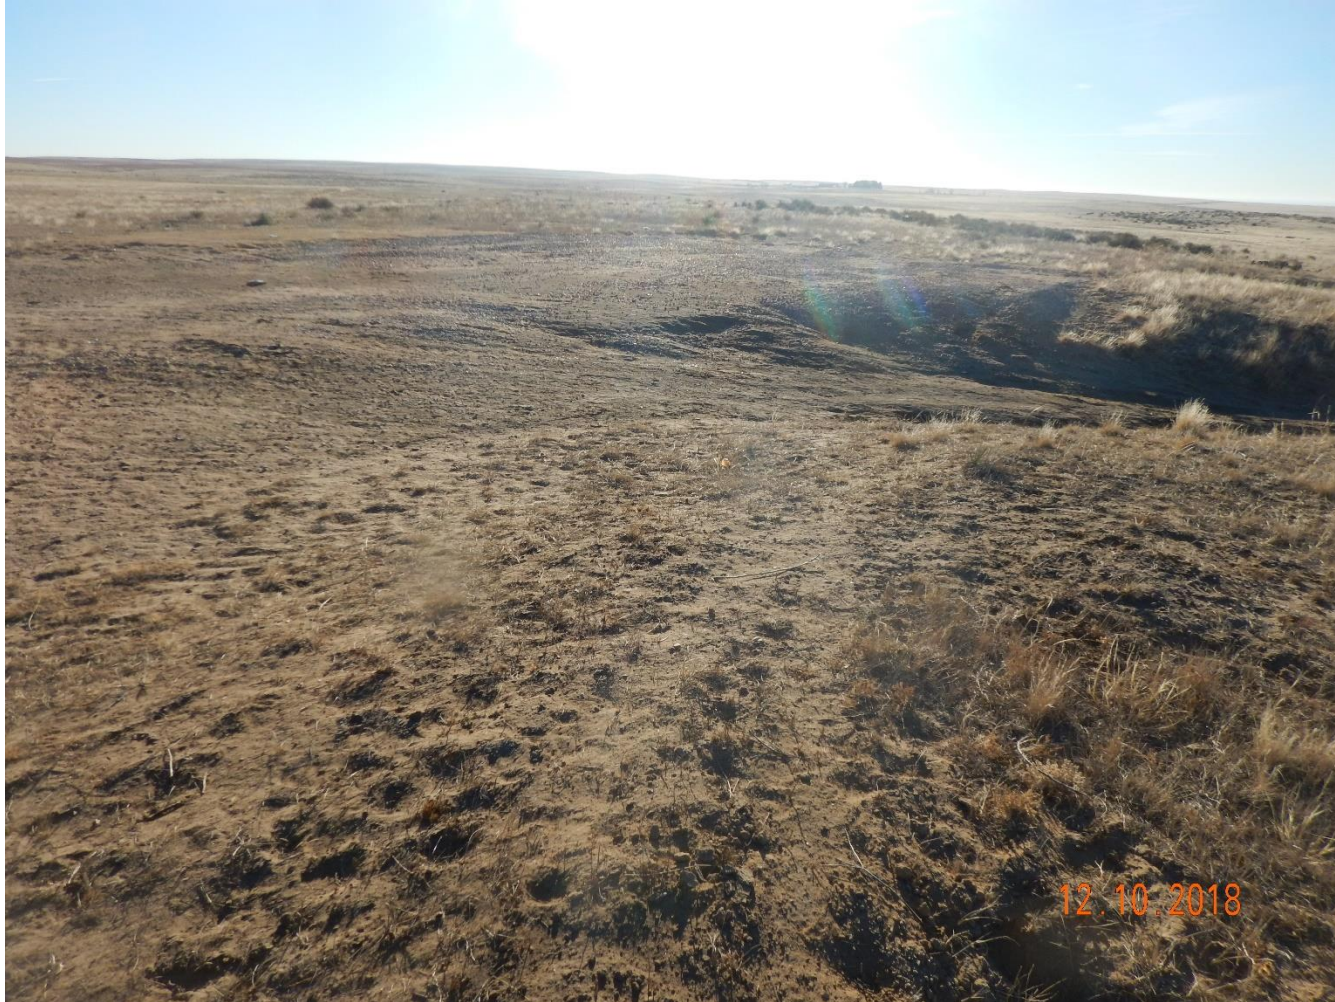
**Photo 14:** Photo taken from the west end of the battery location, facing south. See comments under photo 12.

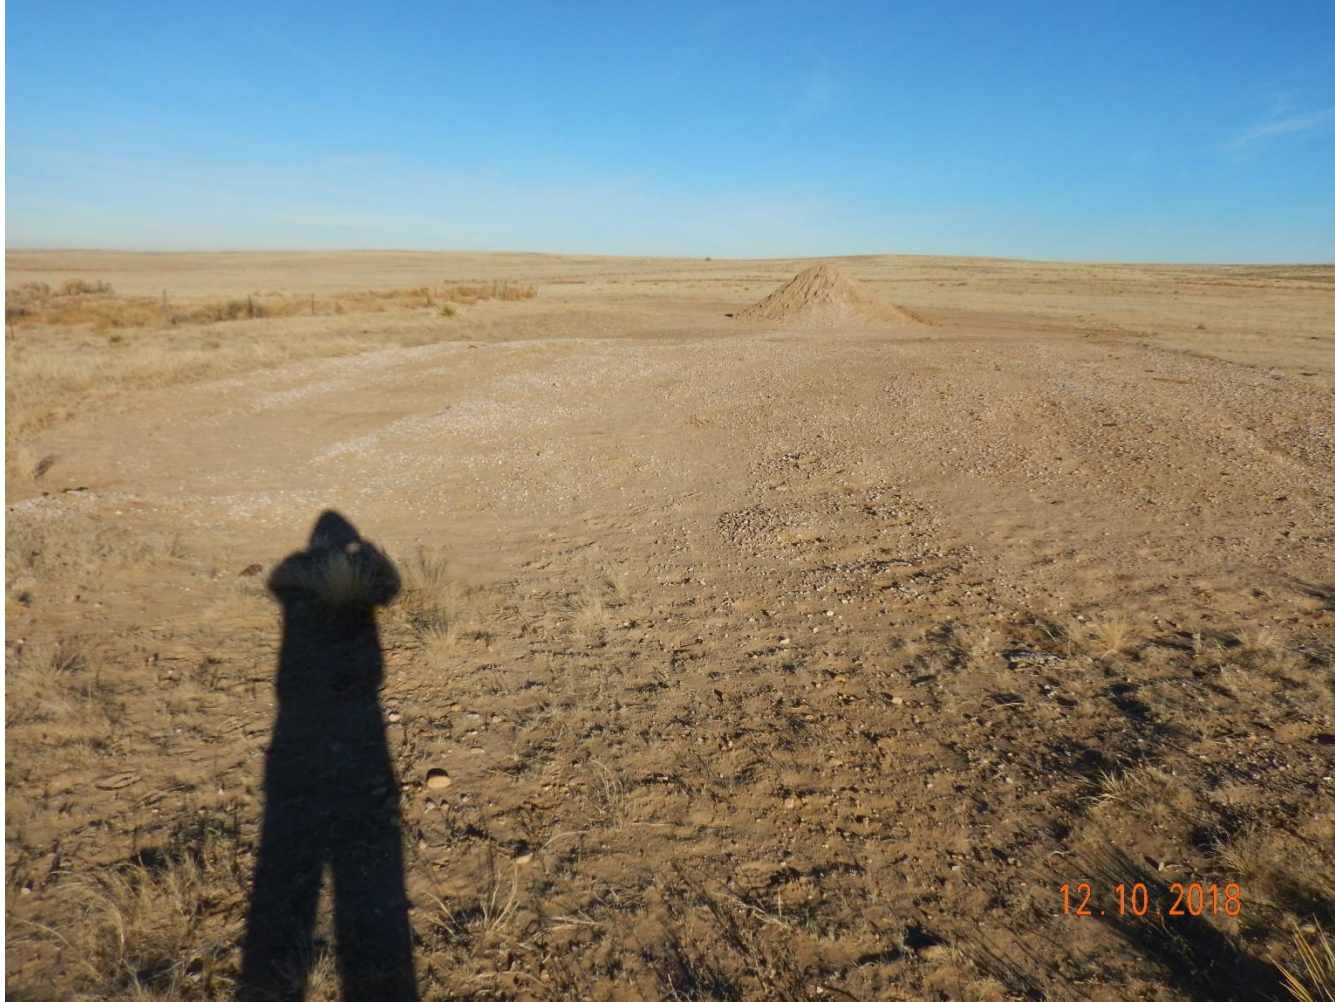
**Photo 15:** Photo taken from the south end of the battery location, facing north. See comments under photo 12.

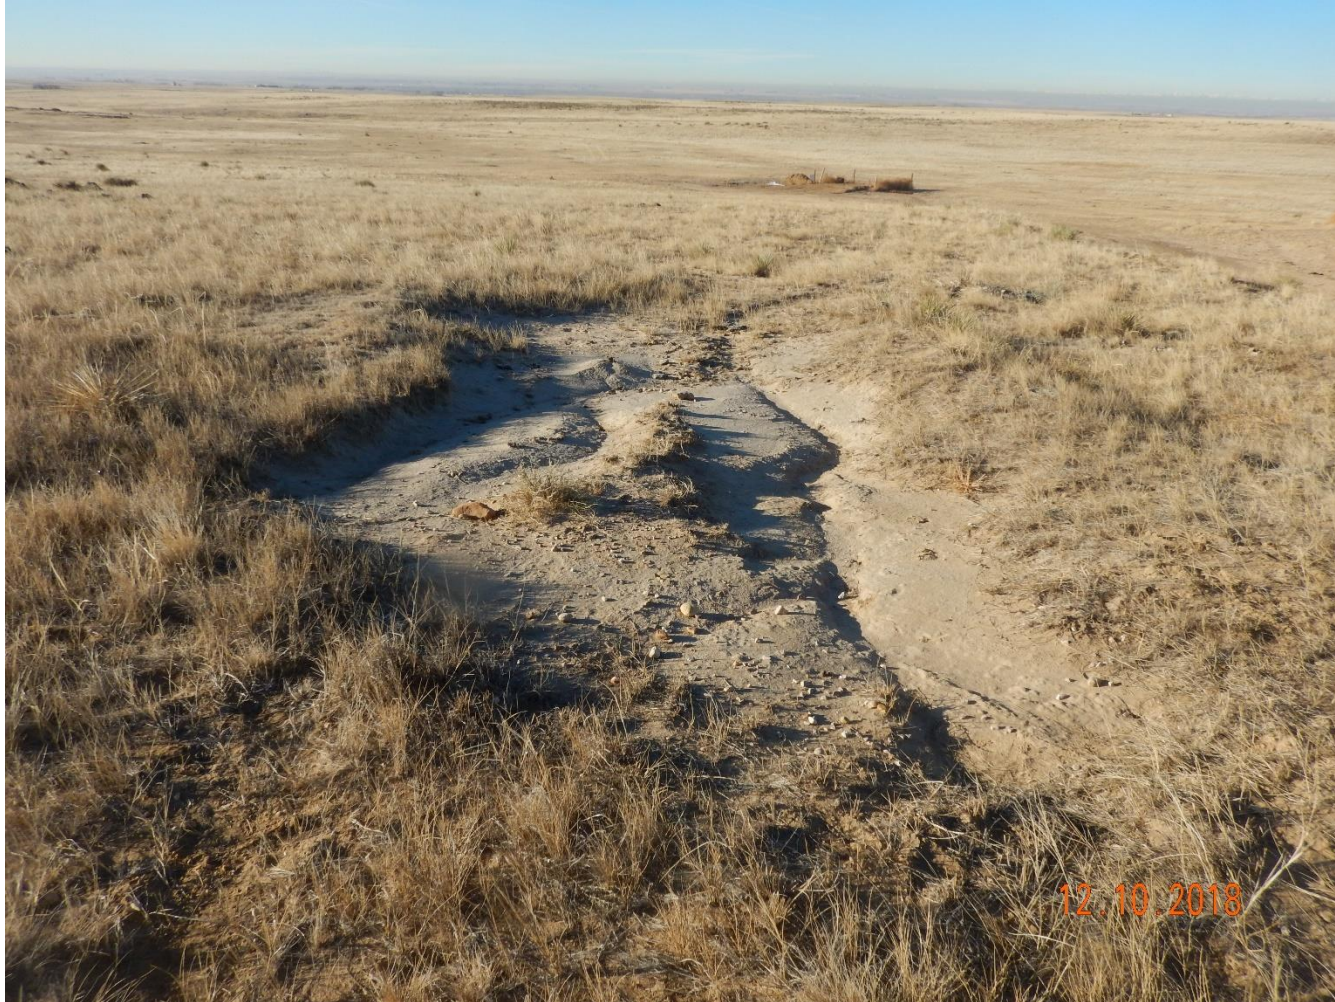
**Photo 16:** Photo taken from the south end of the battery location, facing west. Photo shows stormwater and reclamation issues have not been addressed.
