# Inspection Photos

Operator: SMITH OIL PROPERTIES INC - 79905

Location ID: 313873

Inspection Doc. Number: 682504256

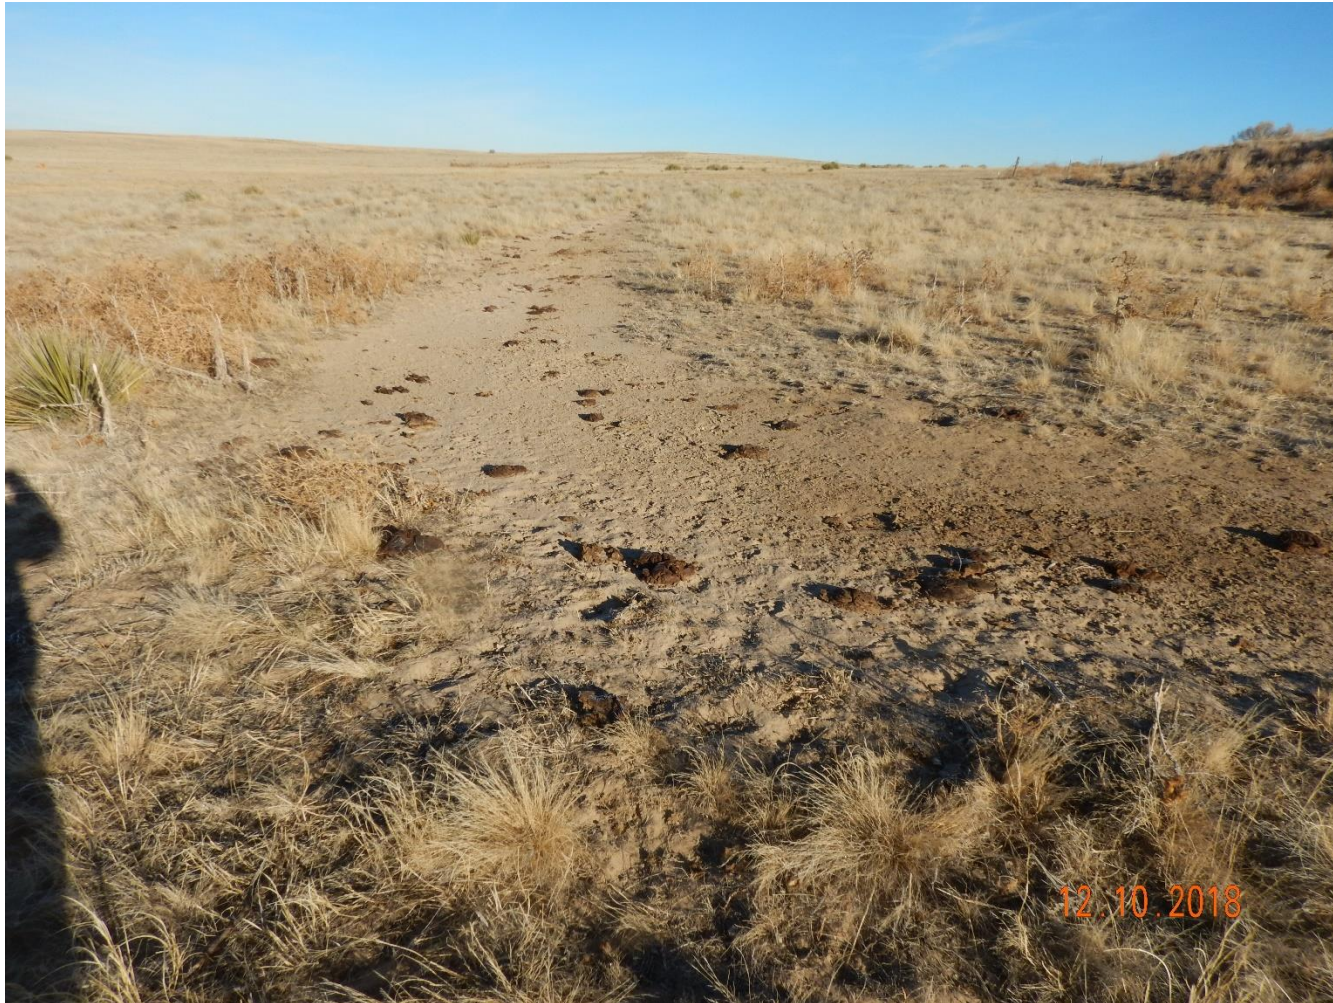
**Photo 17:** Photo taken from the west end of the open pits, facing north. Photo shows no reclamation activities appear to have been conducted in accordance with 1004 rules and corrective actions.

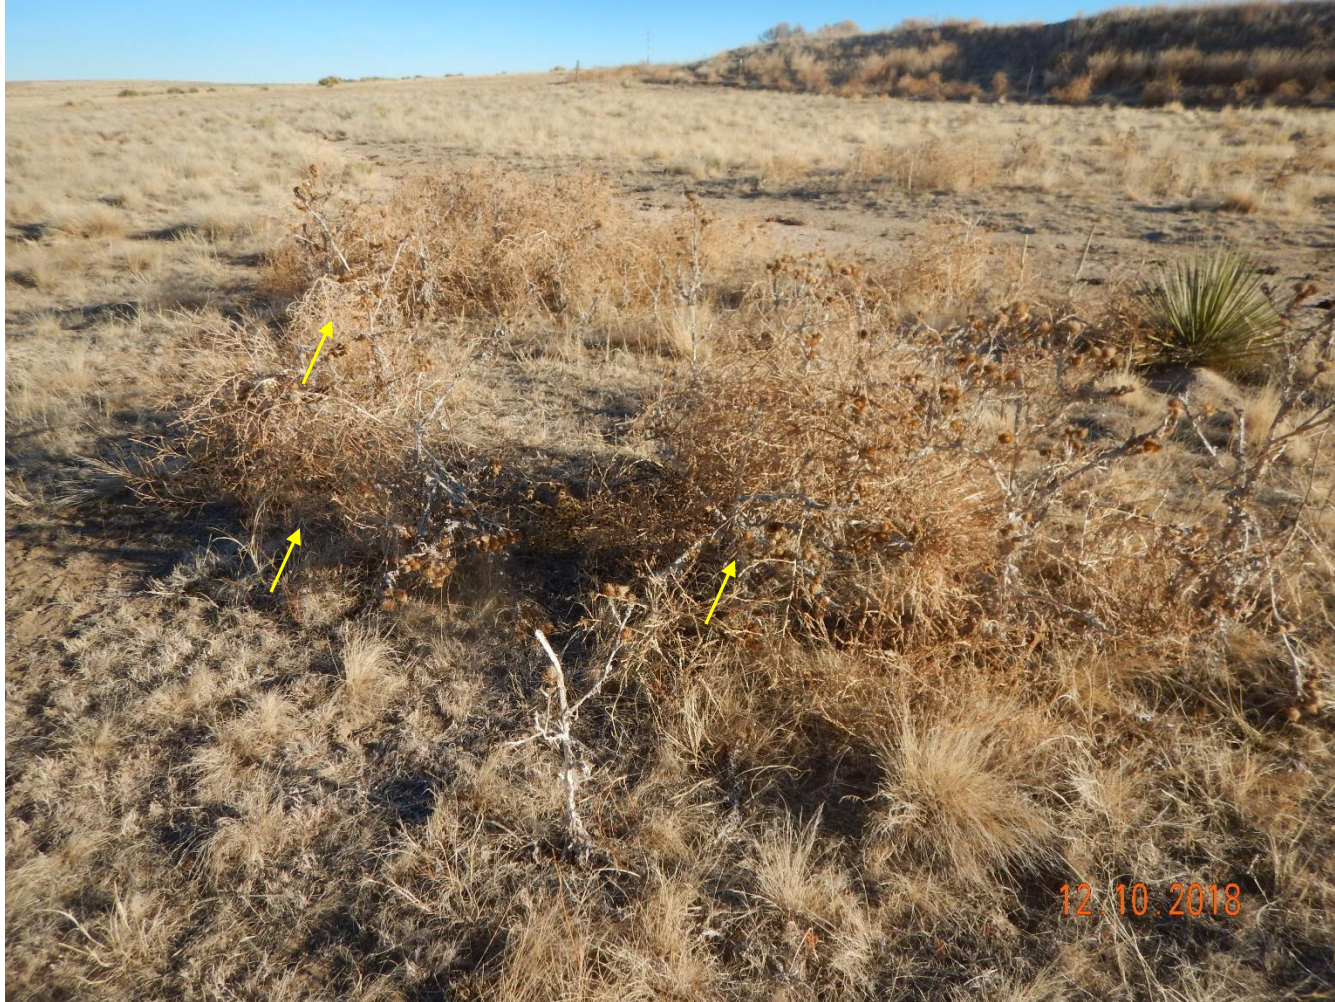
**Photo 18:** Photo taken from the west end of the open pits, facing north. Photo shows no noxious weeds (Scotch thistle) have not been managed.

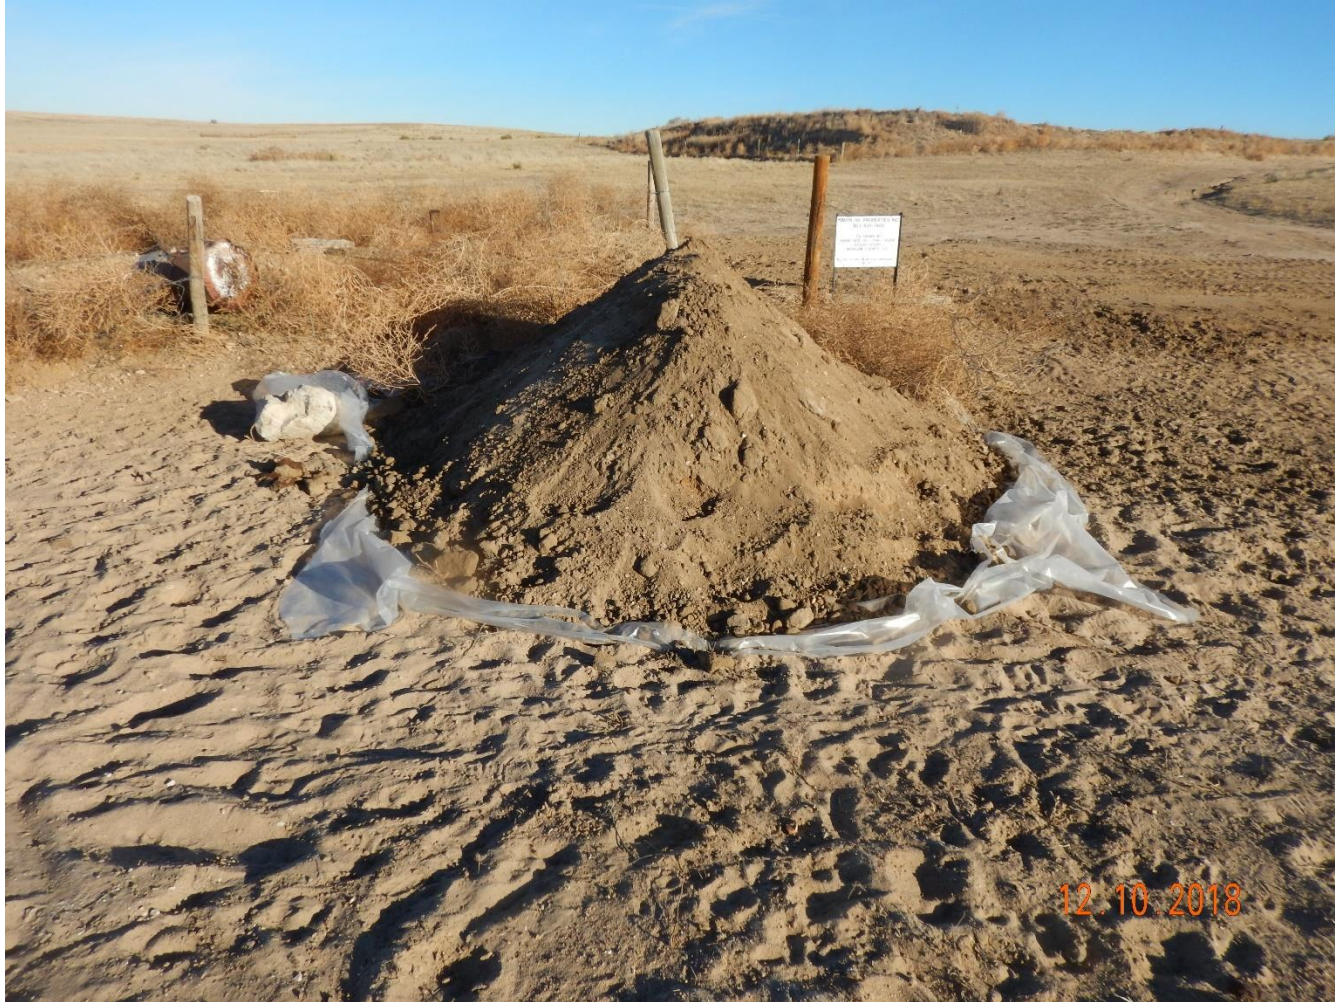
**Photo 19:** Photo taken from the south end of the well, facing north. Photo shows what appears to be contaminated soil has been stored on the south end of the well with insufficient stormwater and erosion control BMPs

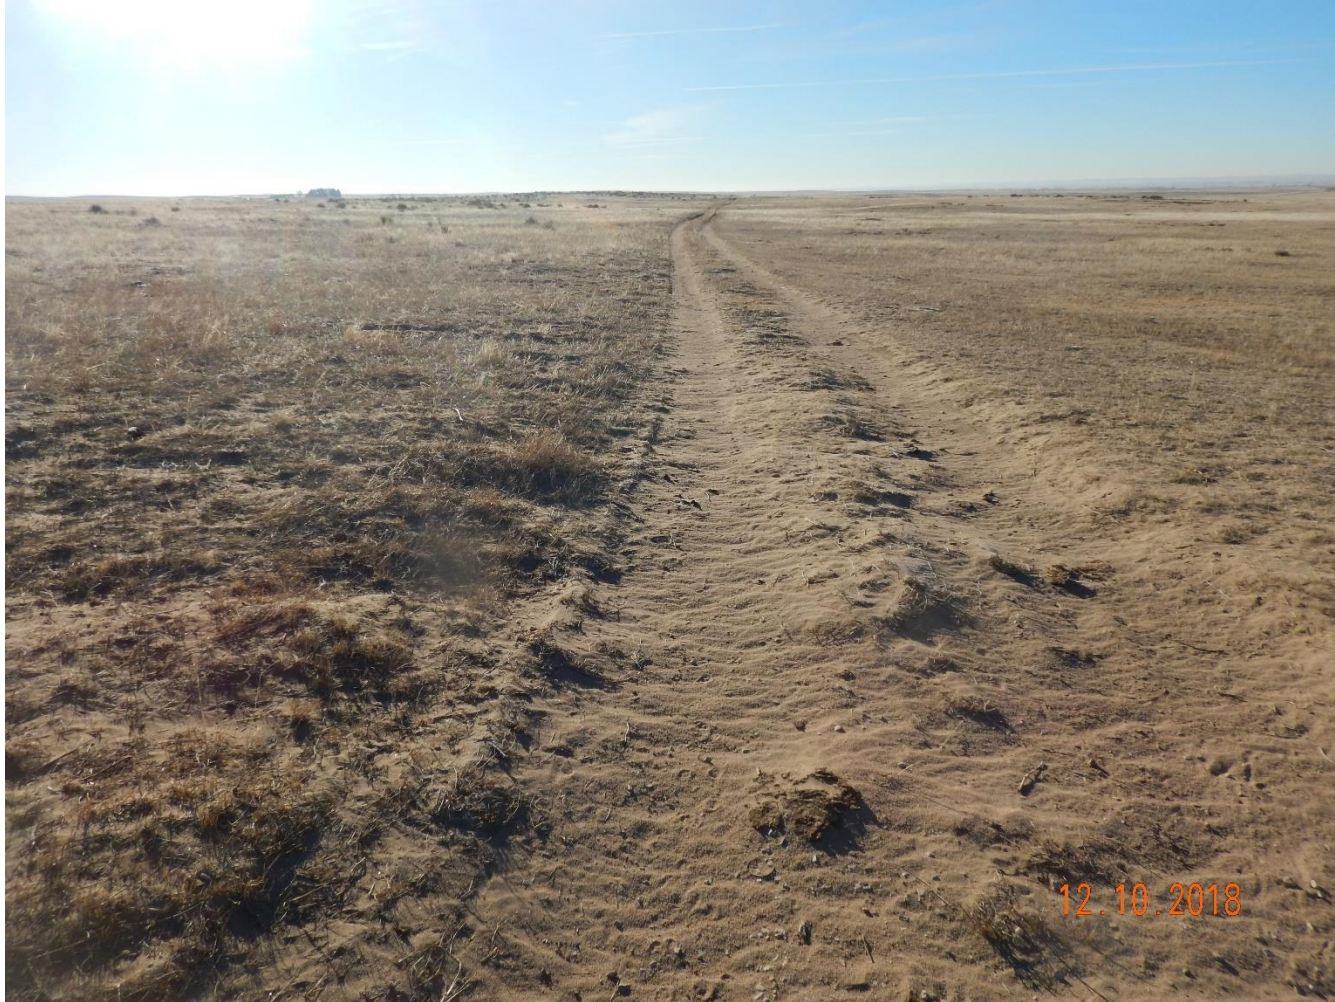
**Photo 20:** Photo taken from the access road, facing south. Photo shows no reclamation activities appear to have been conducted in accordance with 1004 rules and corrective actions.
