Construction and Stormwater Inspection

December 6, 2018

Operator: BURLINGTON RESOURCES OIL & GAS LP – 26580

Location ID: 449176

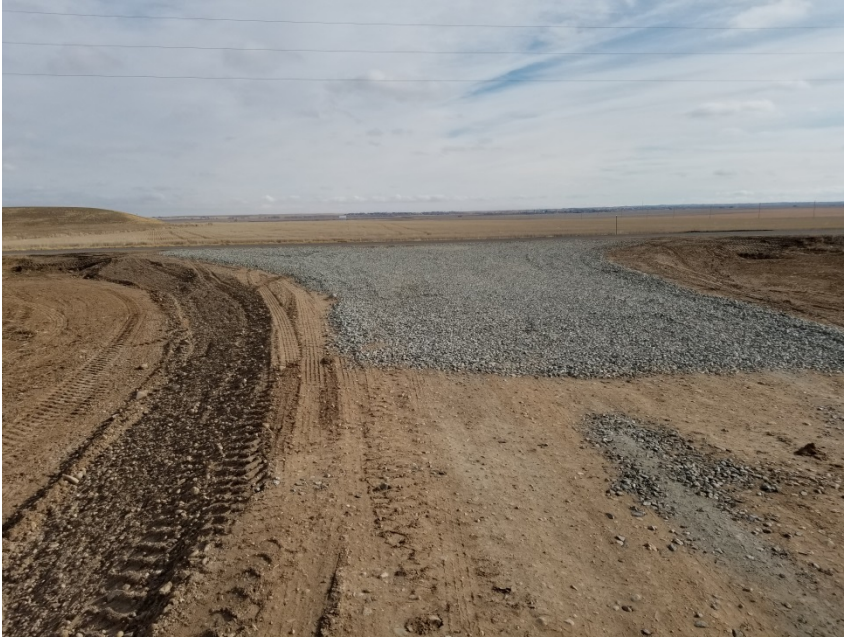
Photo 1. Photo taken from the entrance of the location off CR 21, facing North. Operator has installed vehicle tracking pad. BMPs in proper functioning condition at the time of this inspection.

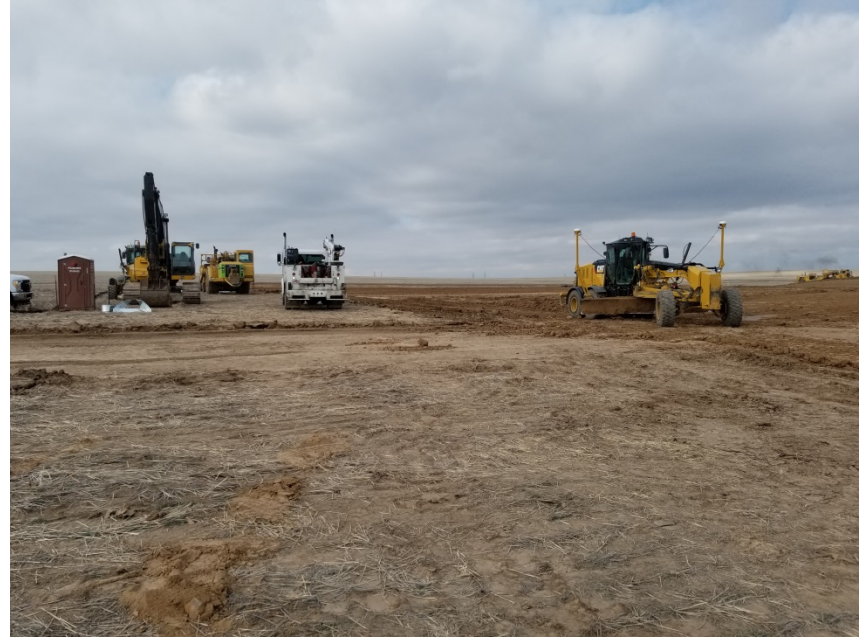
Photo 2. Photo taken from the southeastern perimeter of the location, facing North.

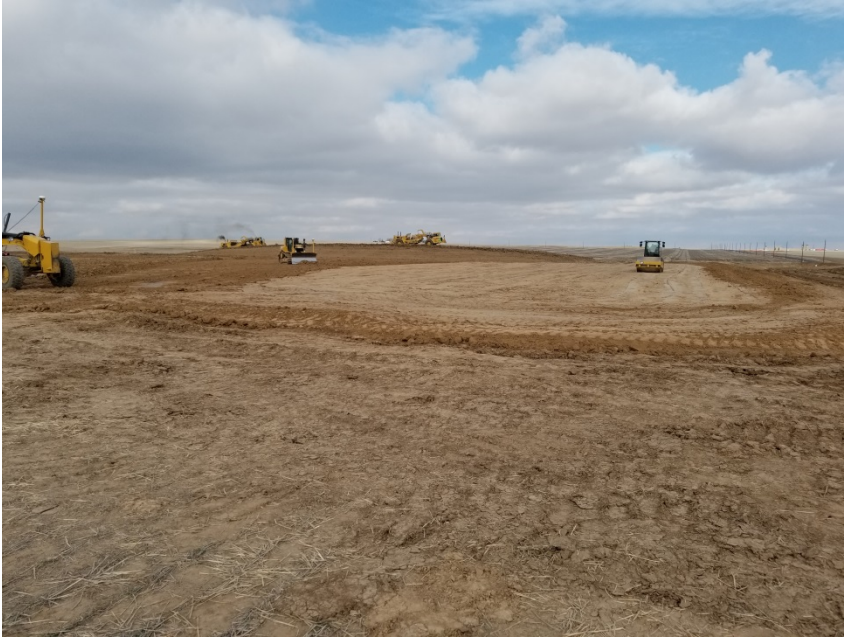
Photo 3. Photo taken from the southeastern perimeter of the location, facing North. Photo illustrates a ditch and berm BMP that has been installed around the entire perimeter of the location in conjunction with other BMPs.

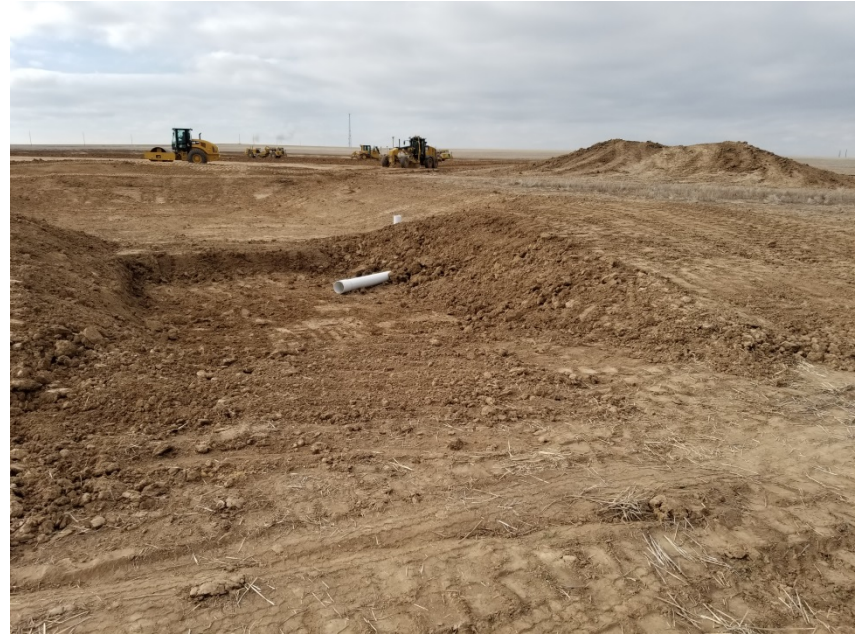
Photo 4. Photo taken from the eastern perimeter of the location, facing East. Operator is in the process of installing a sediment trap with a temporarily stabilized outlet.

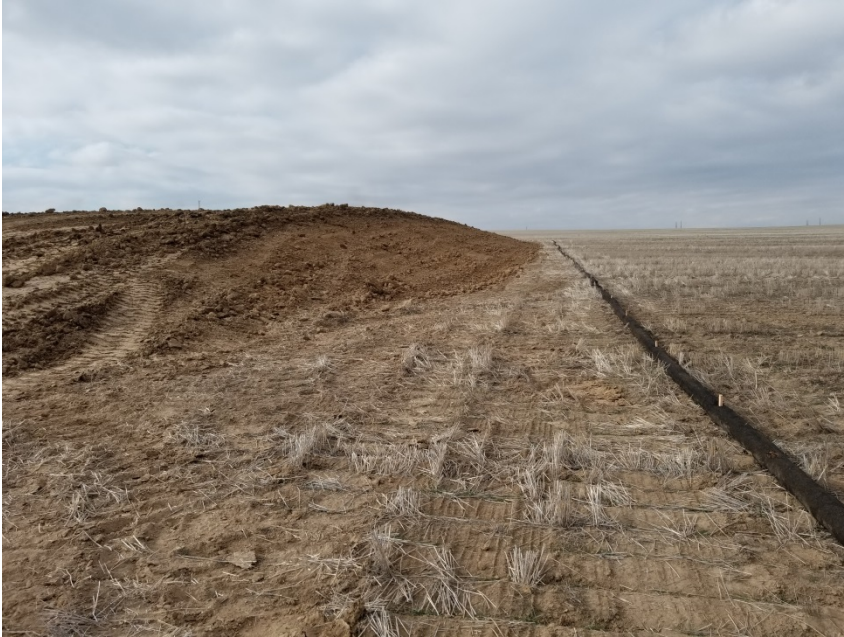
Photo 5. Photo taken from the northeastern perimeter of the location, facing West. Photo illustrates filtrex wattles along the perimeter outside of the ditch and berm. Photo also illustrates the topsoil stockpile being stored along the eastern area and has been temporarily stabilized with equipment tracking. Also See comments under Photo 2.

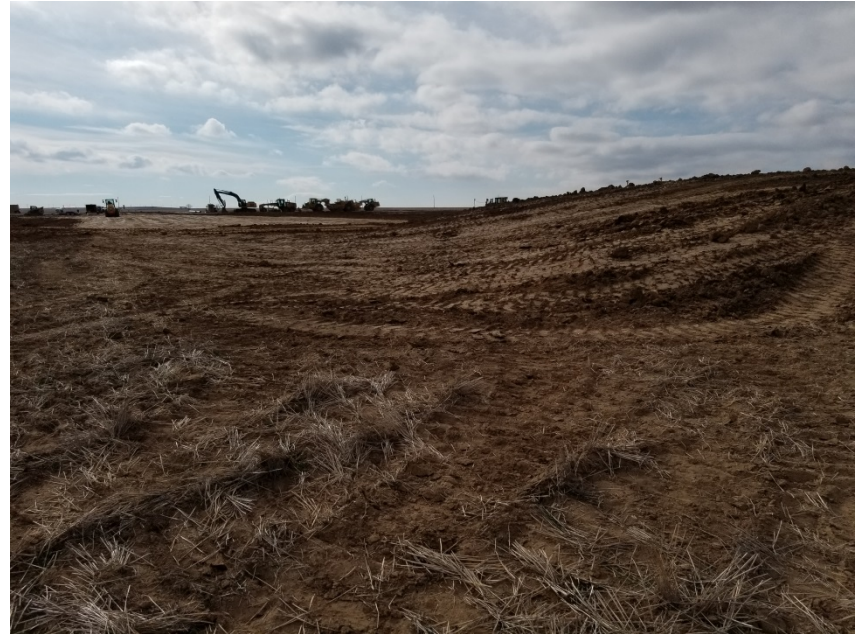
Photo 6. Photo taken from the northeastern perimeter of the location, facing South. See comments under Photo 2.

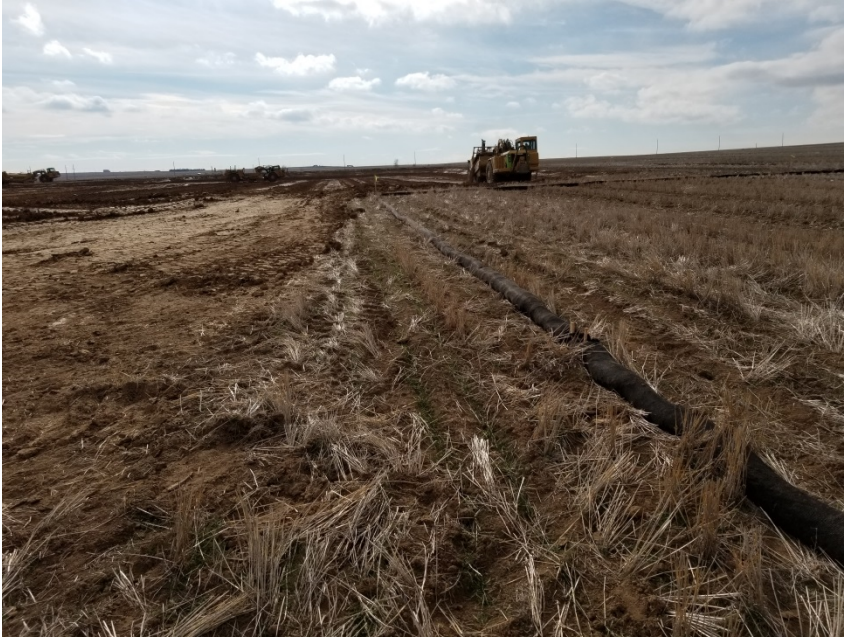
Photo 7. Photo taken from the northwestern perimeter of the location, facing South. See comments under Photos 3 and 5.

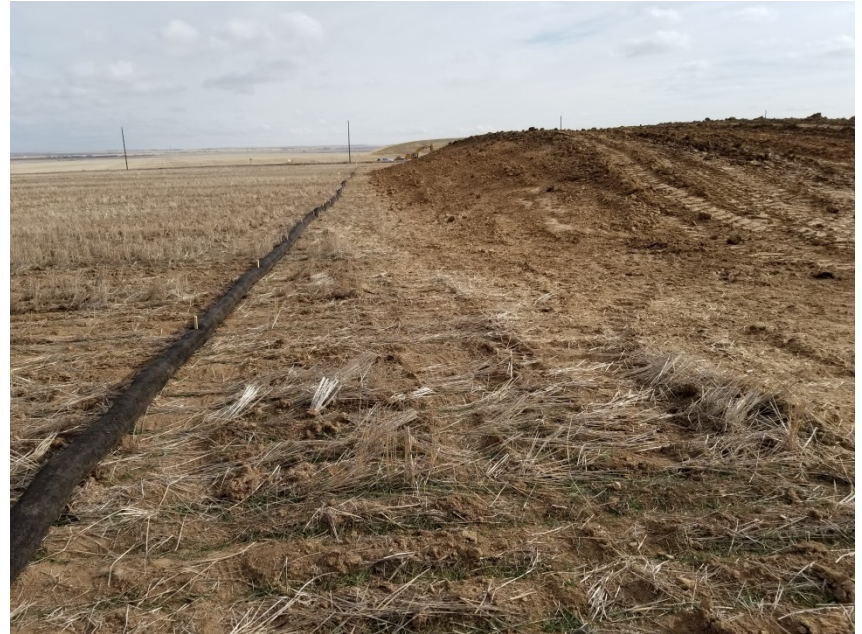
Photo 8. Photo taken from the southeastern perimeter of the location, facing East. See comments under Photos 3 and 5.

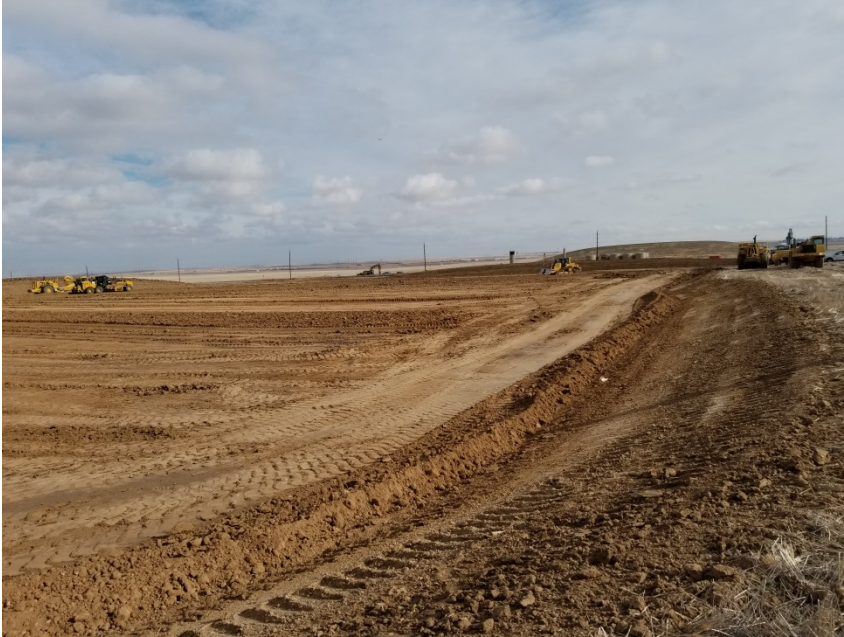
Photo 9. Photo taken from the southwestern perimeter of the location, facing East. See comments under Photos 3 and 5.

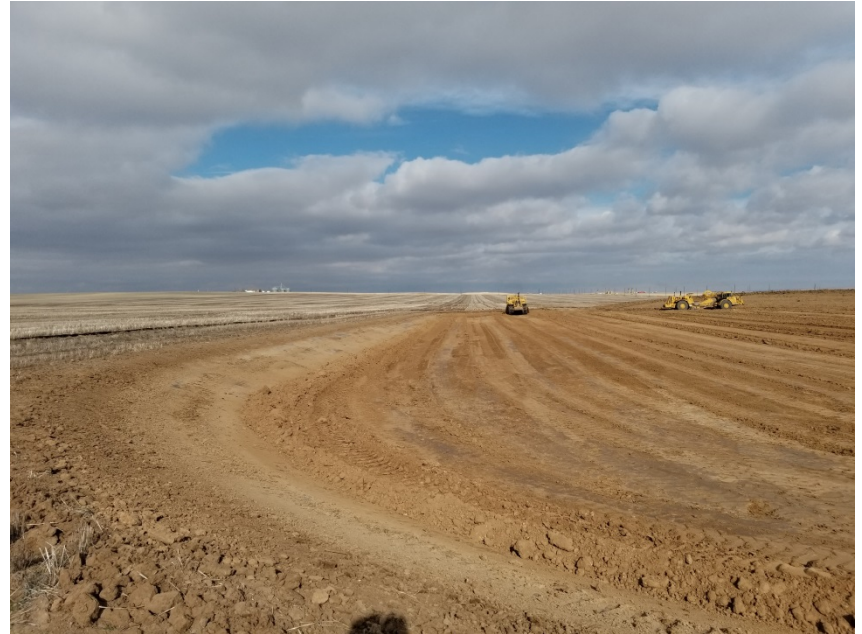
Photo 10. Photo taken from the southwestern perimeter of the location, facing North. See comments under Photos 3 and 5.

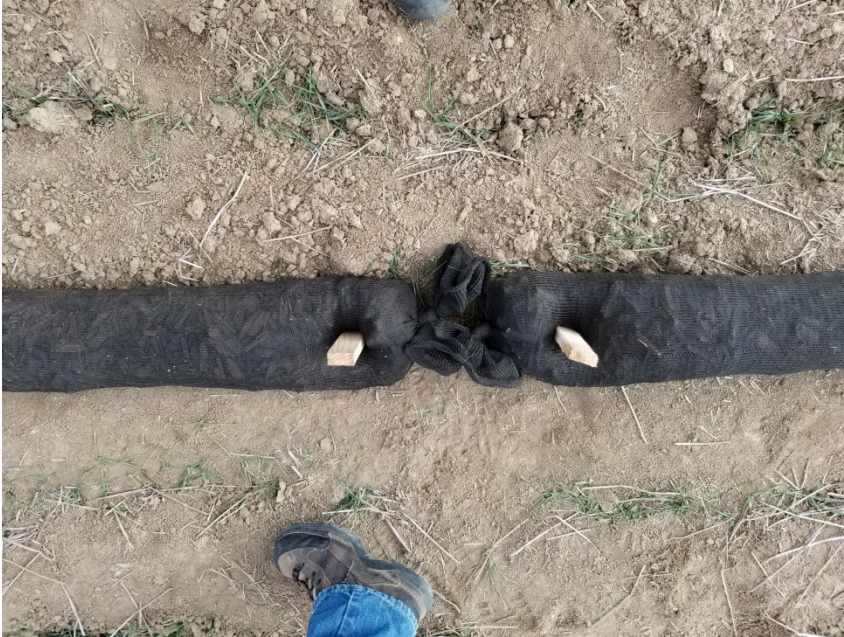
Photo 11. Photo taken from northern perimeter of the location. Photo illustrates filter wattles along the perimeter that need to be overlapped.

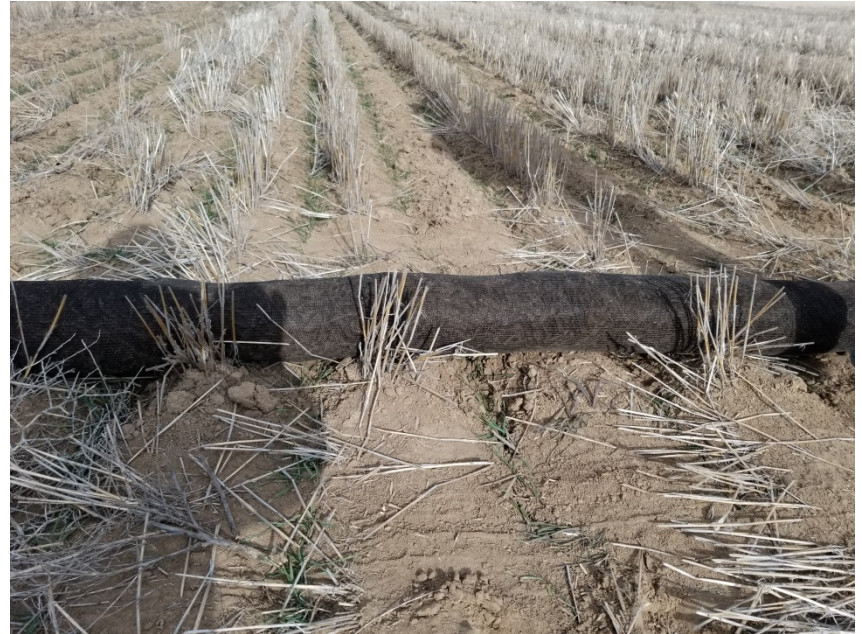
Photo 12. Photo taken from northern perimeter of the location. Photo illustrates filter wattles along the perimeter that need to be trenched in over crop rows due to daylighting underneath.
