# Inspection Photos

Operator: BP America

API: 05-067-09492

Date: 11/14/2018

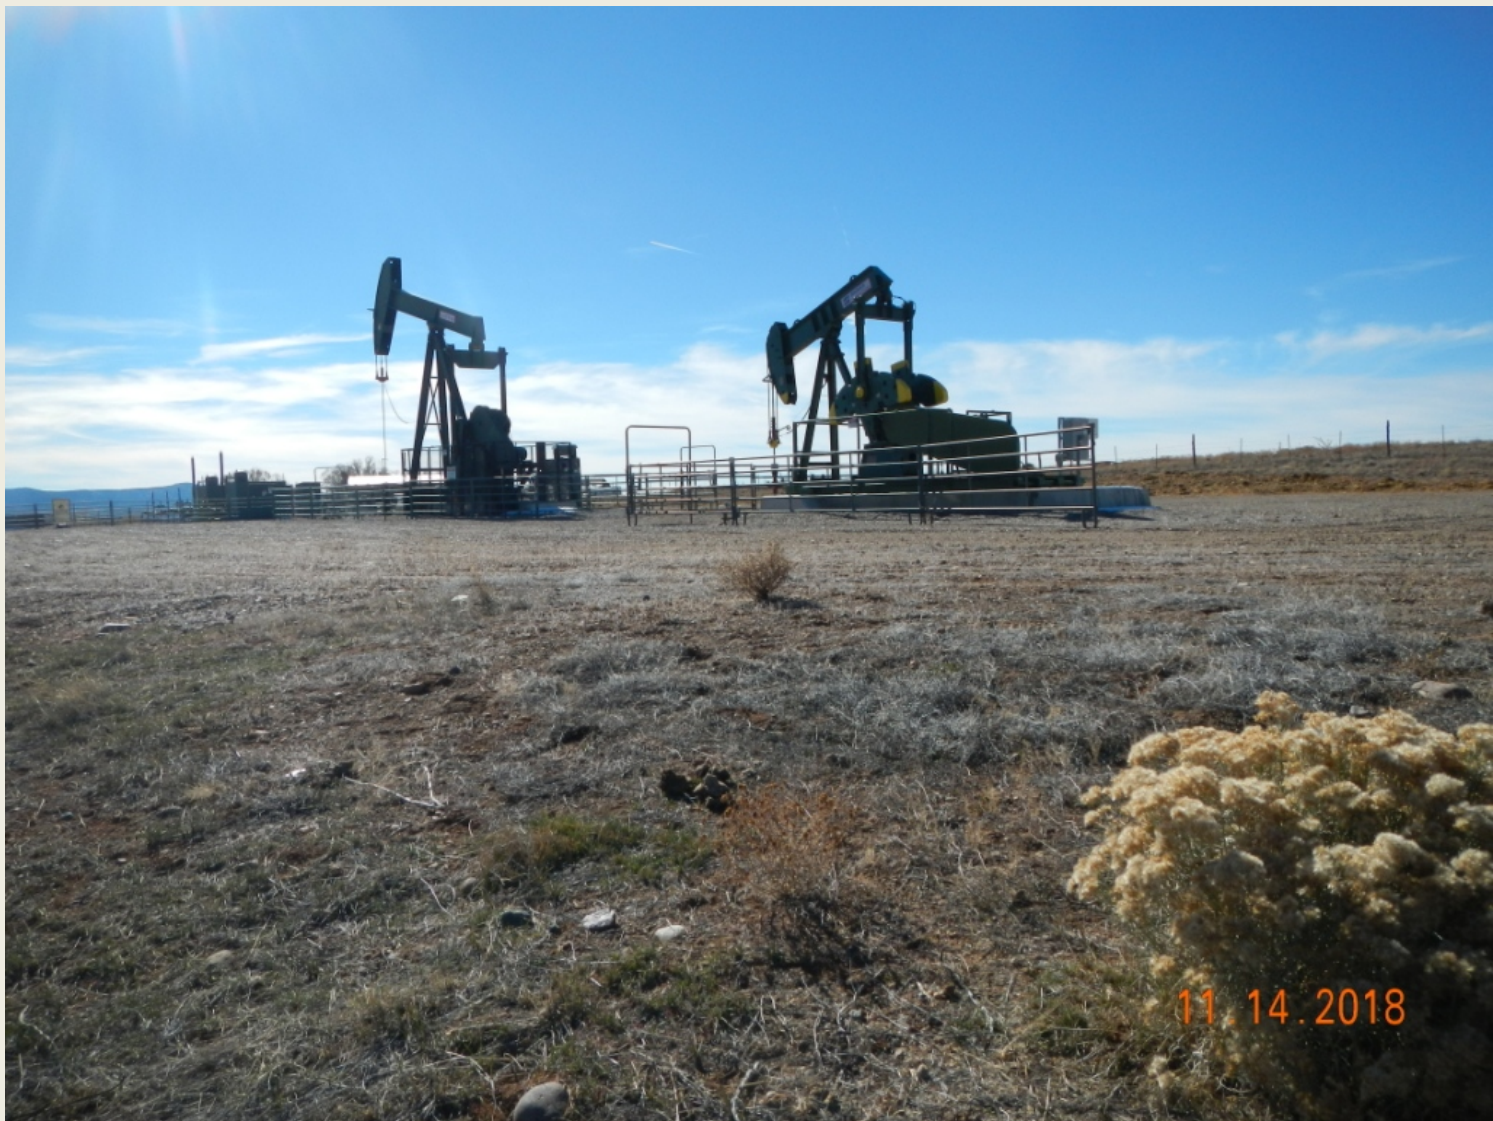
**Photo 1. View of the project area from the northeastern corner facing center.**

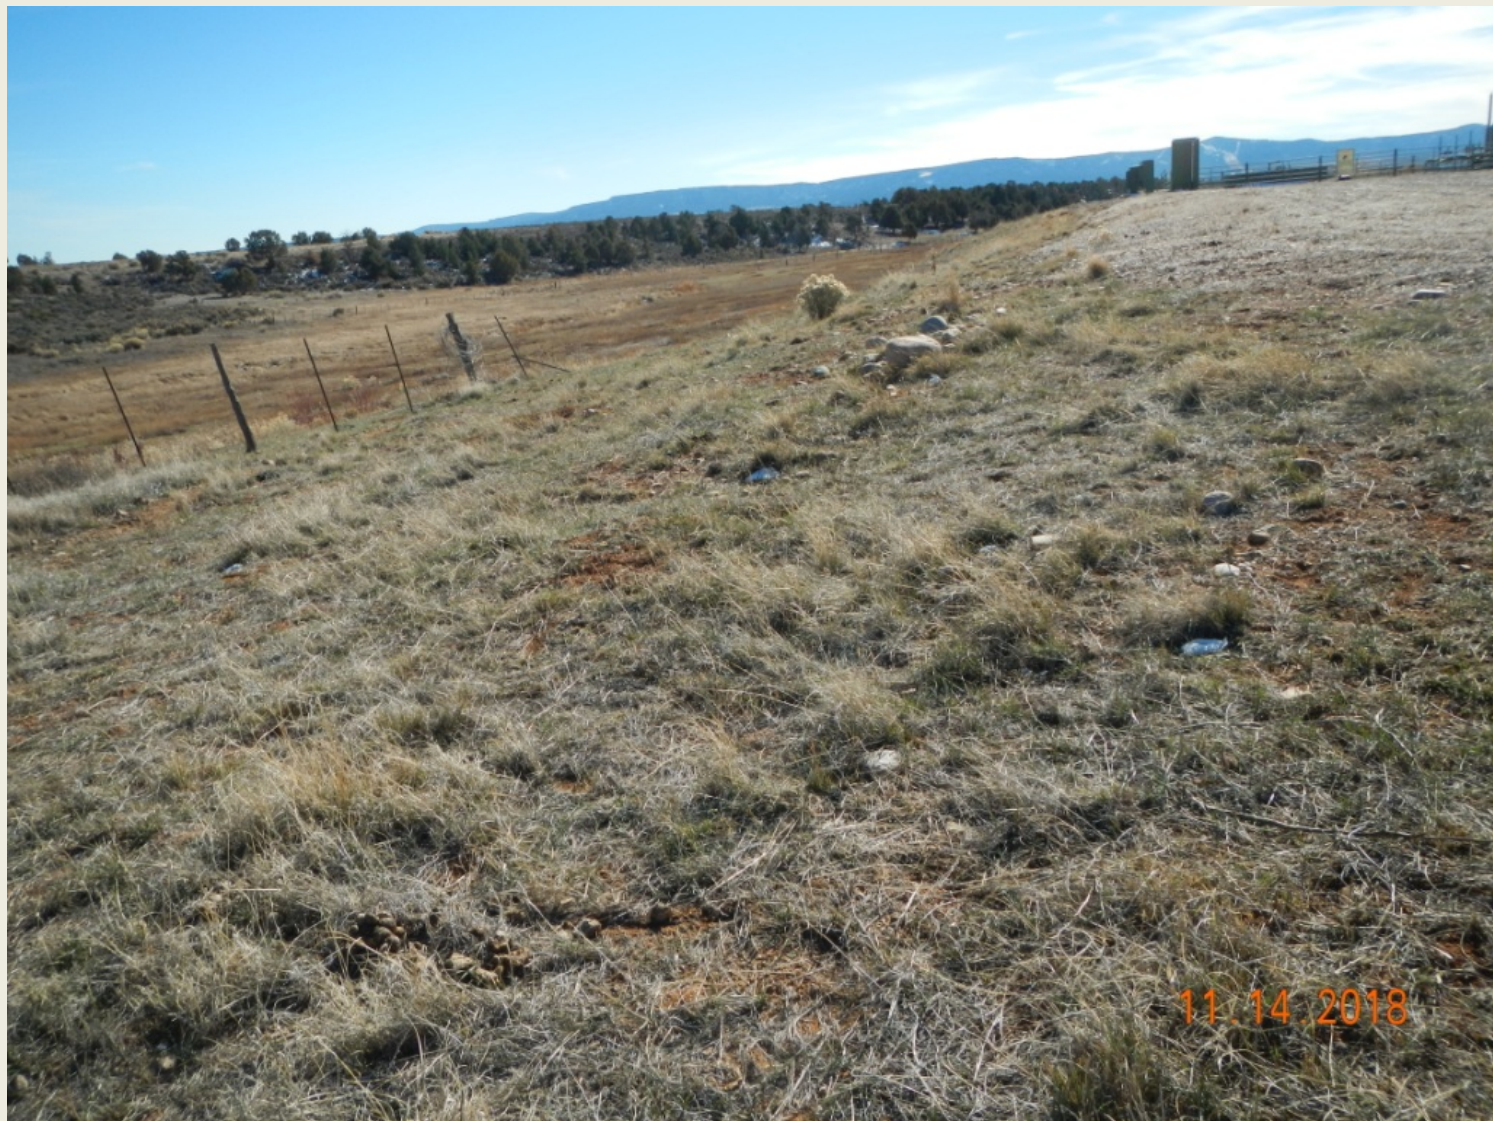
**Photo 2. View of the eastern project area from the northeastern corner facing southward. Interim reclamation area extends outside of fencing. Revegetation is progressing with grasses such as intermediate wheatgrass (*Thinopyron intermedium*), western wheatgrass (*Thinopyron intermedium*), and sand dropseed (*Sporobolus cryptandrus*).**

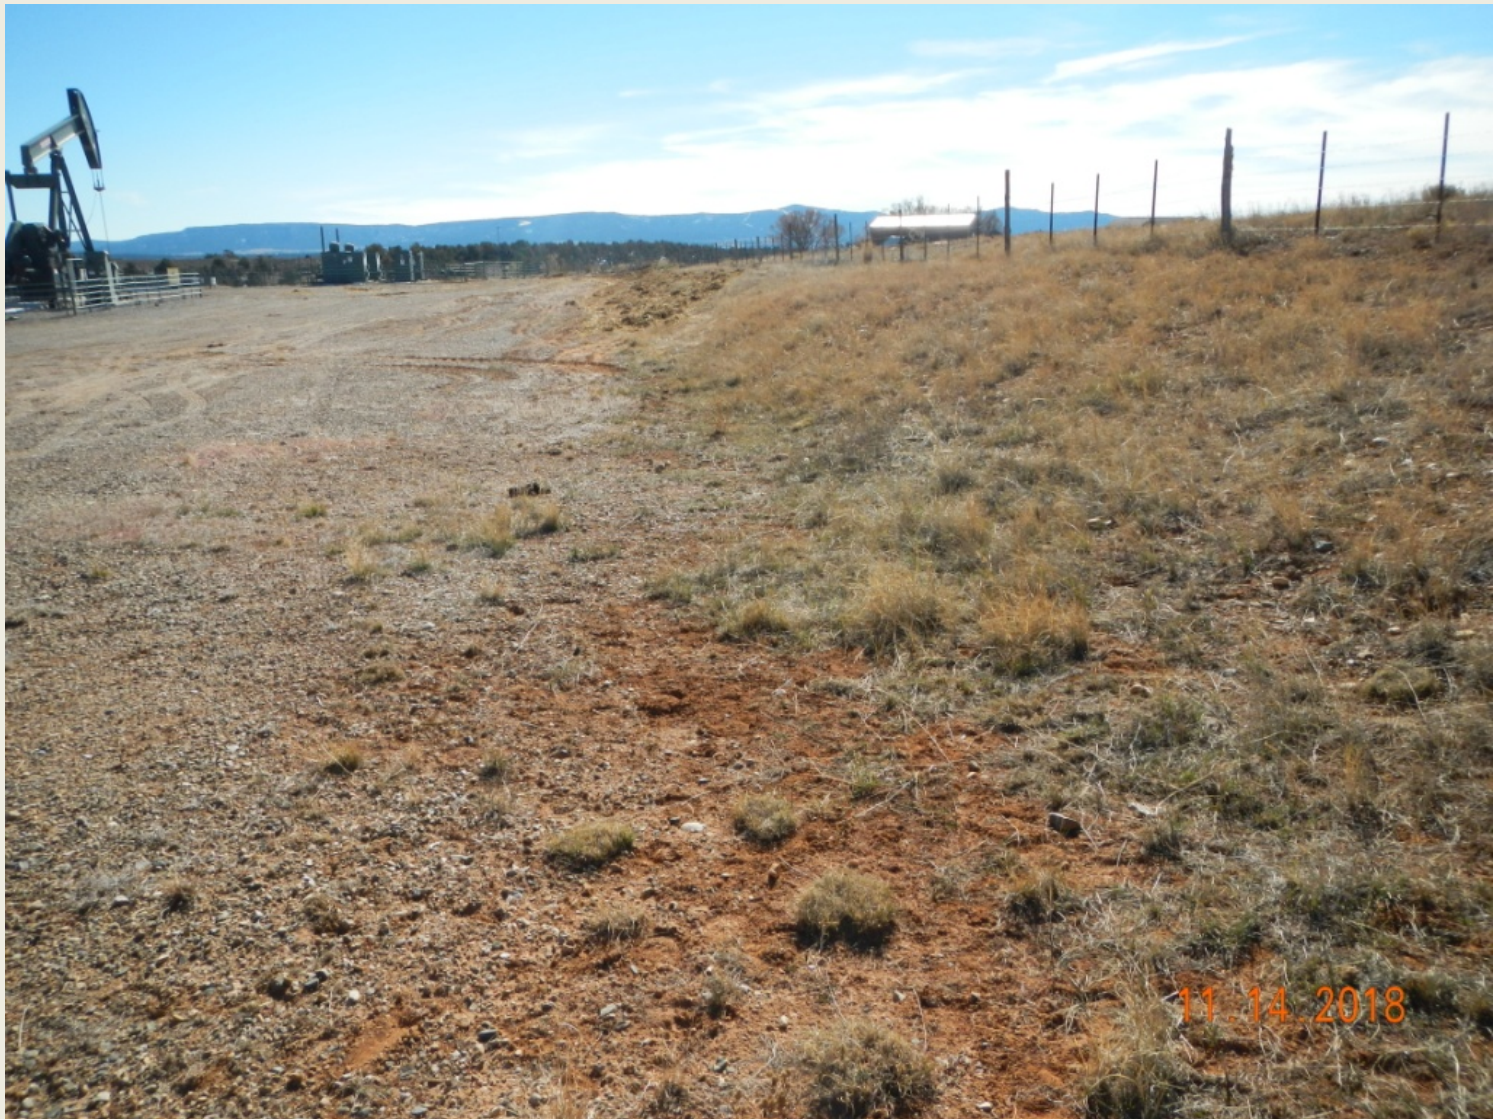
**Photo 3. View of the western project area from the northwestern corner facing southward.**

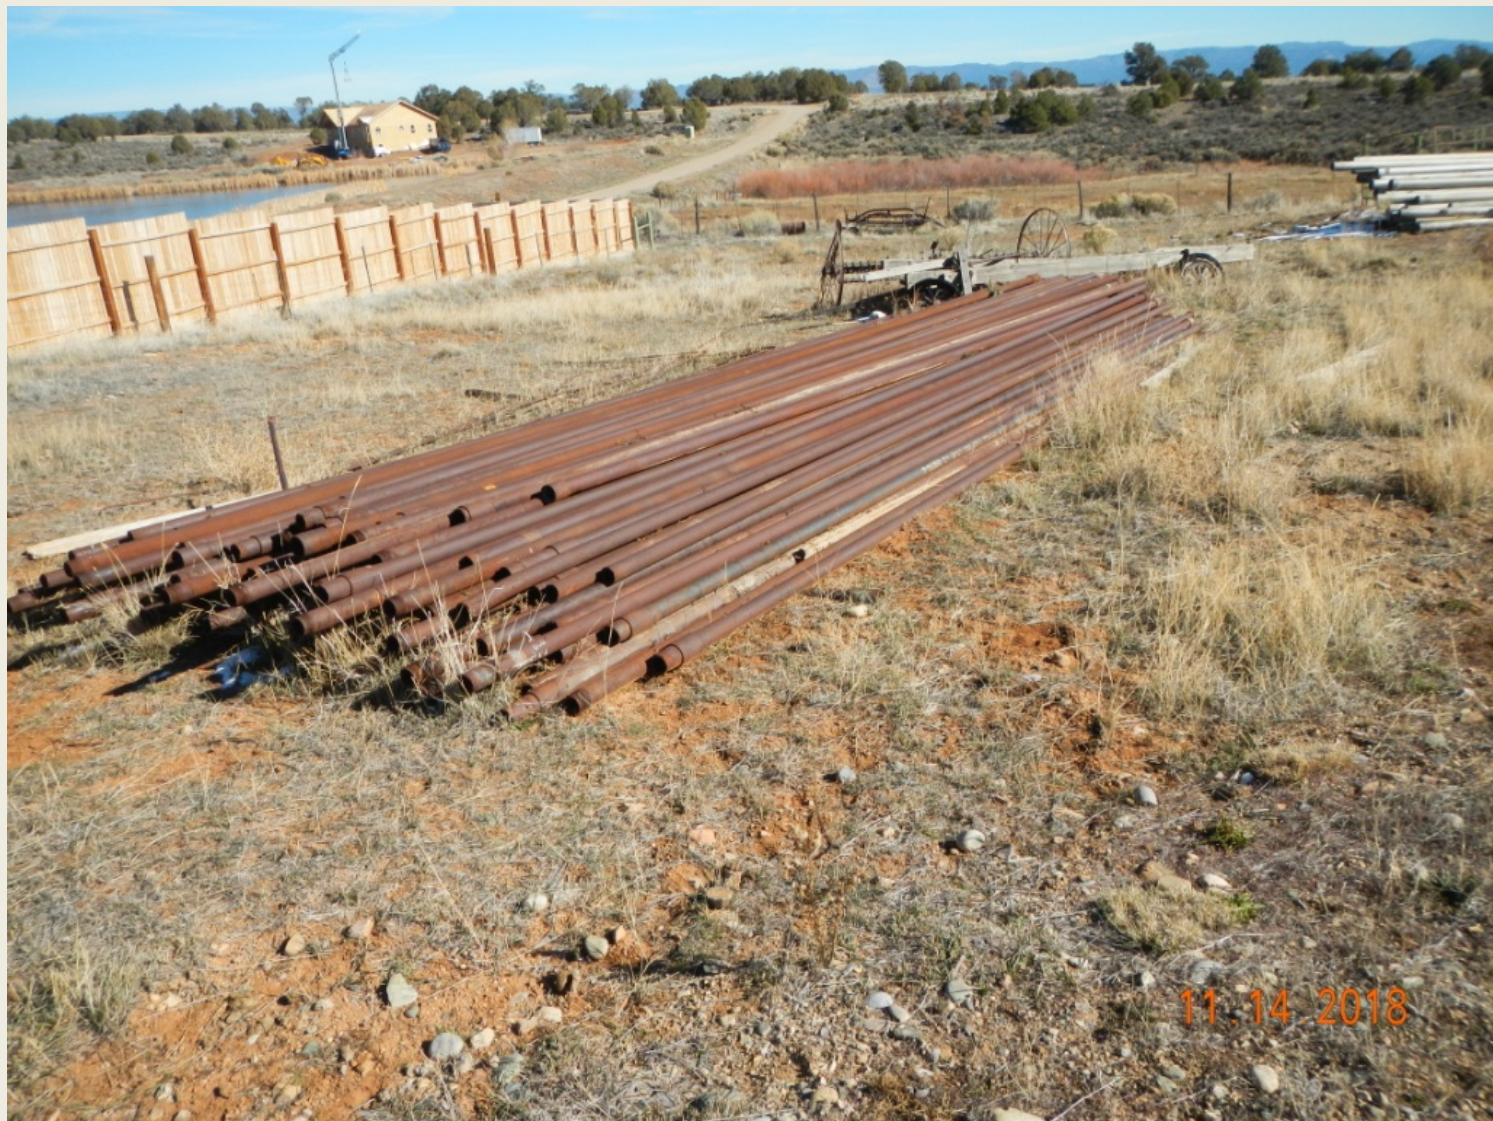
**Photo 4. View of oil and gas tubing and what appears to be surface owner debris within the northeastern project area.**

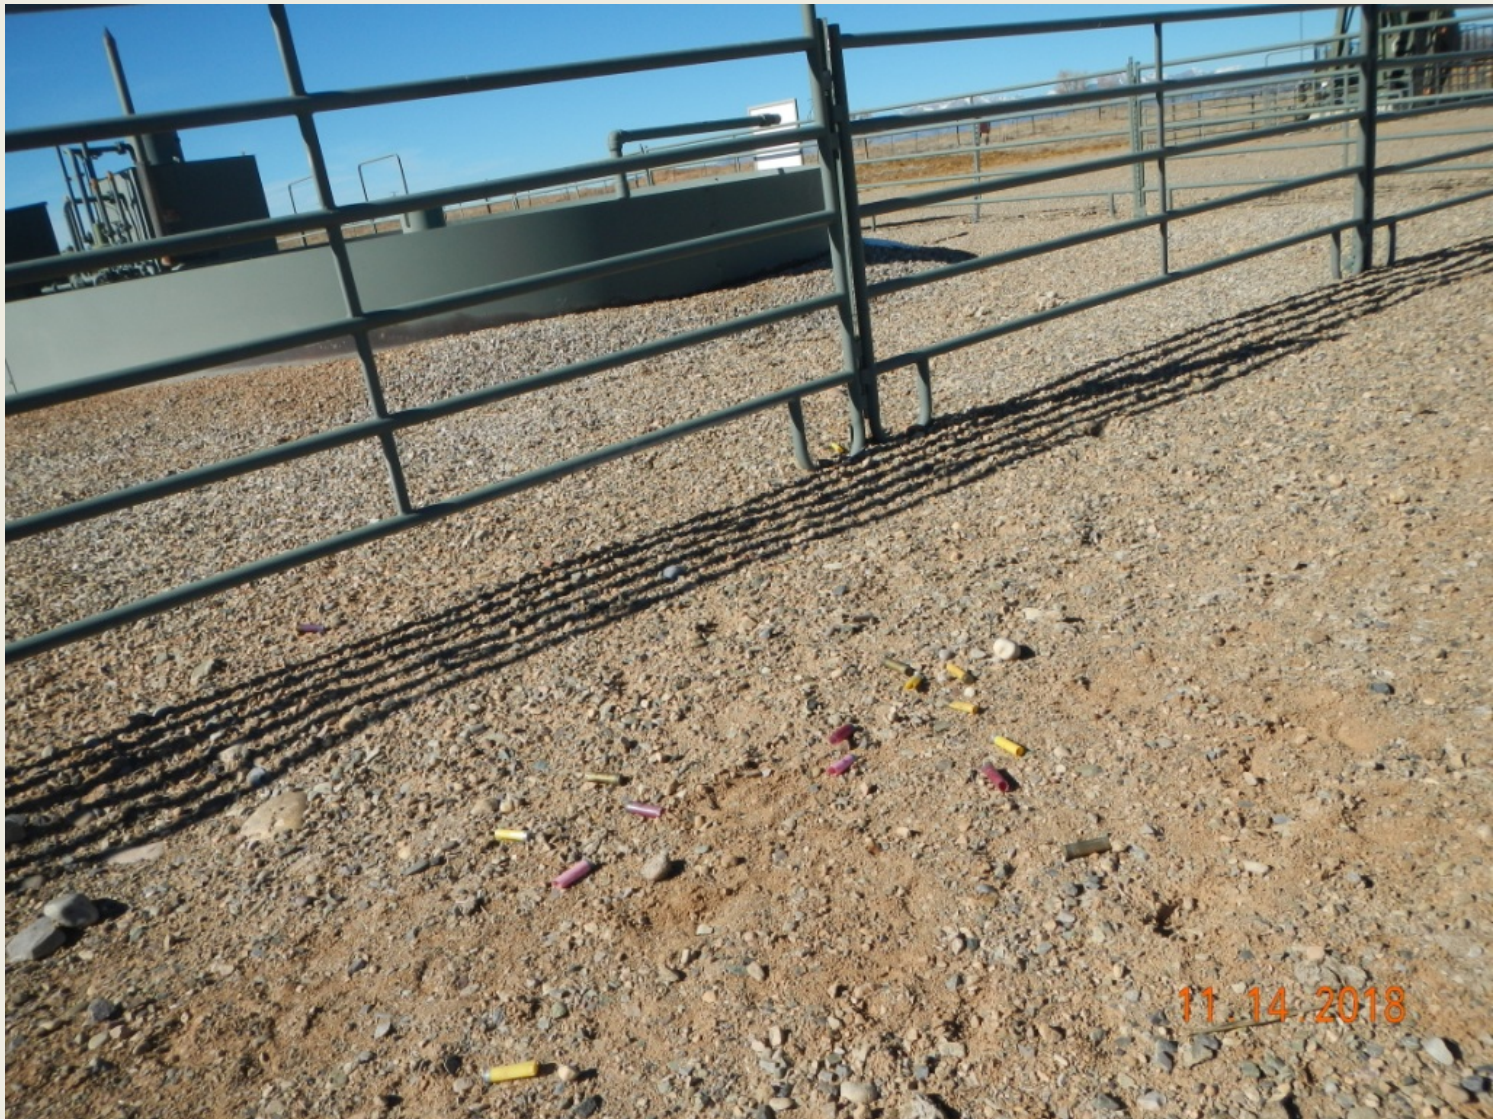
**Photo 5. View of shotgun shells next to oil and gas equipment within the eastern project area.**

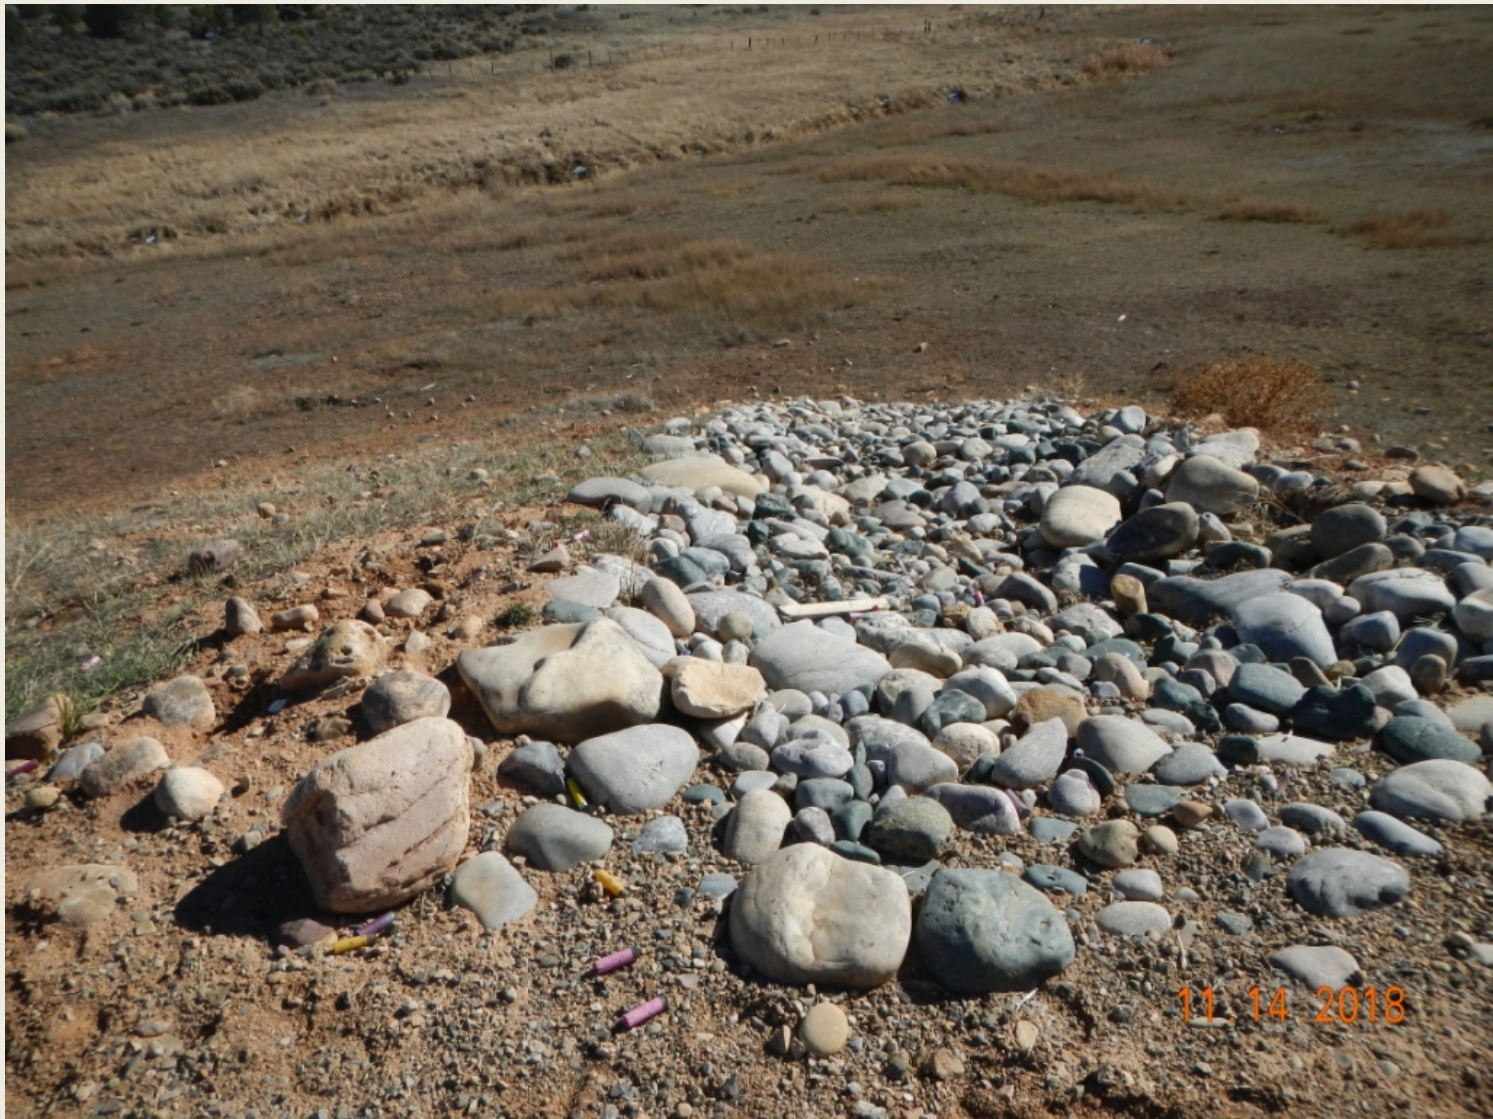
**Photo 6. View of cobble rundown within the southeastern project area. More shotgun shells are present in the foreground.**

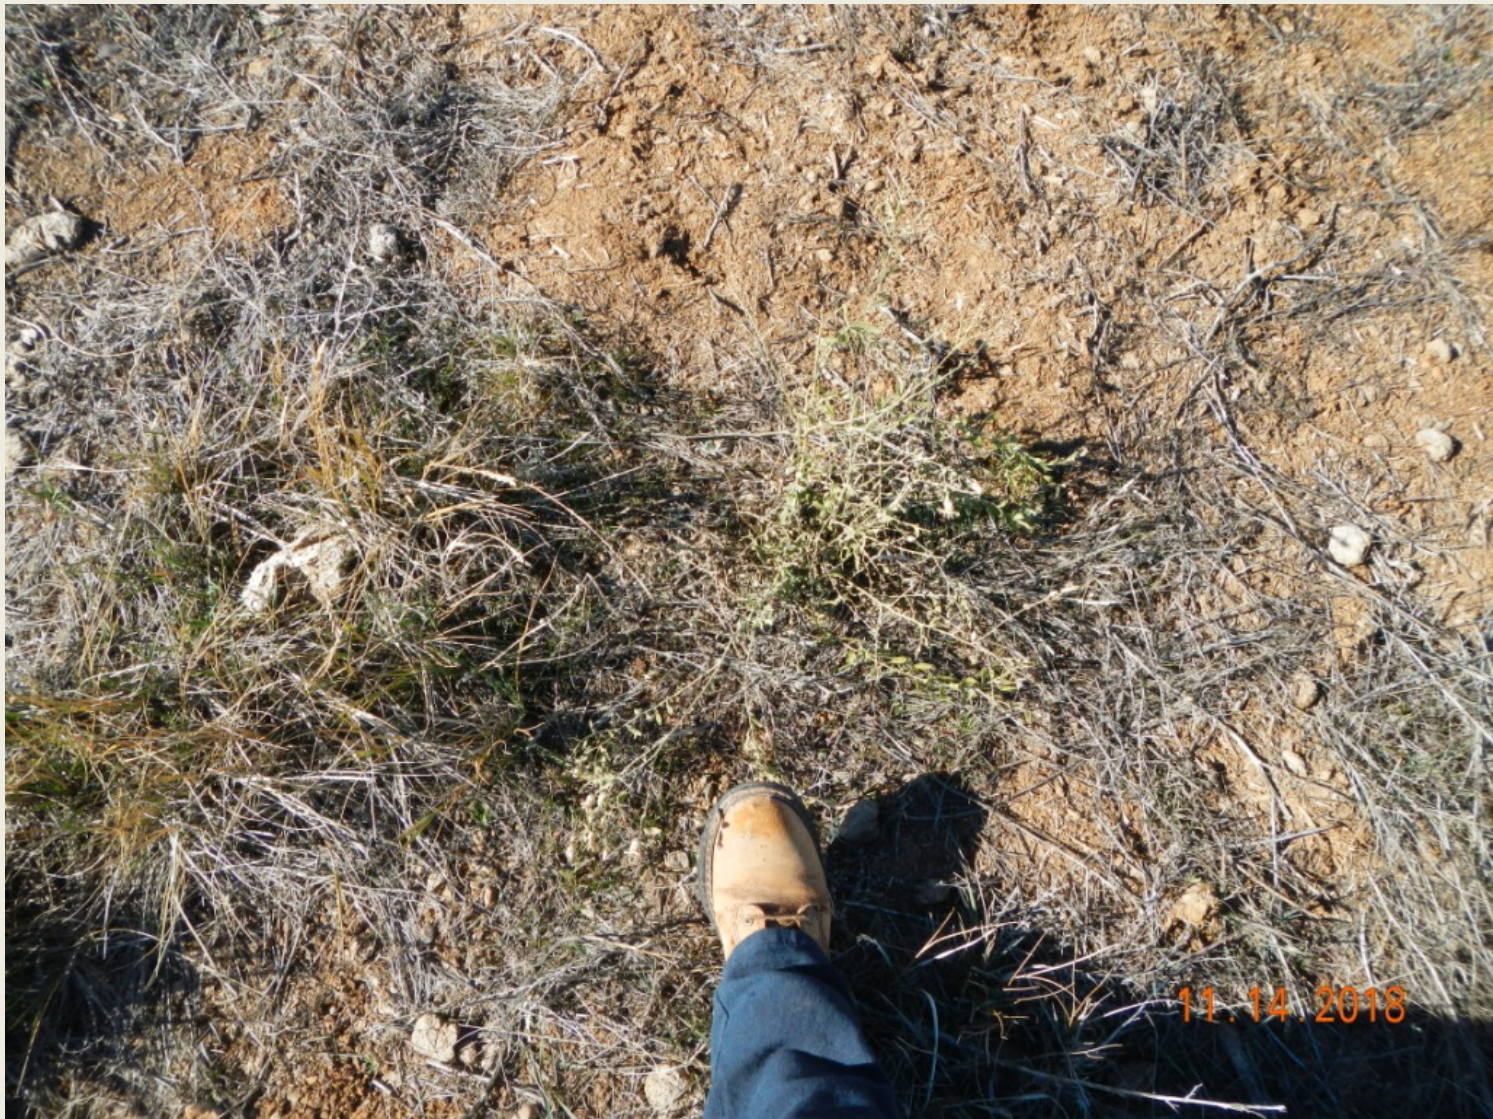
**Photo 7. View of Russian knapweed (*Rhaponticum repens*) within the eastern project area.**

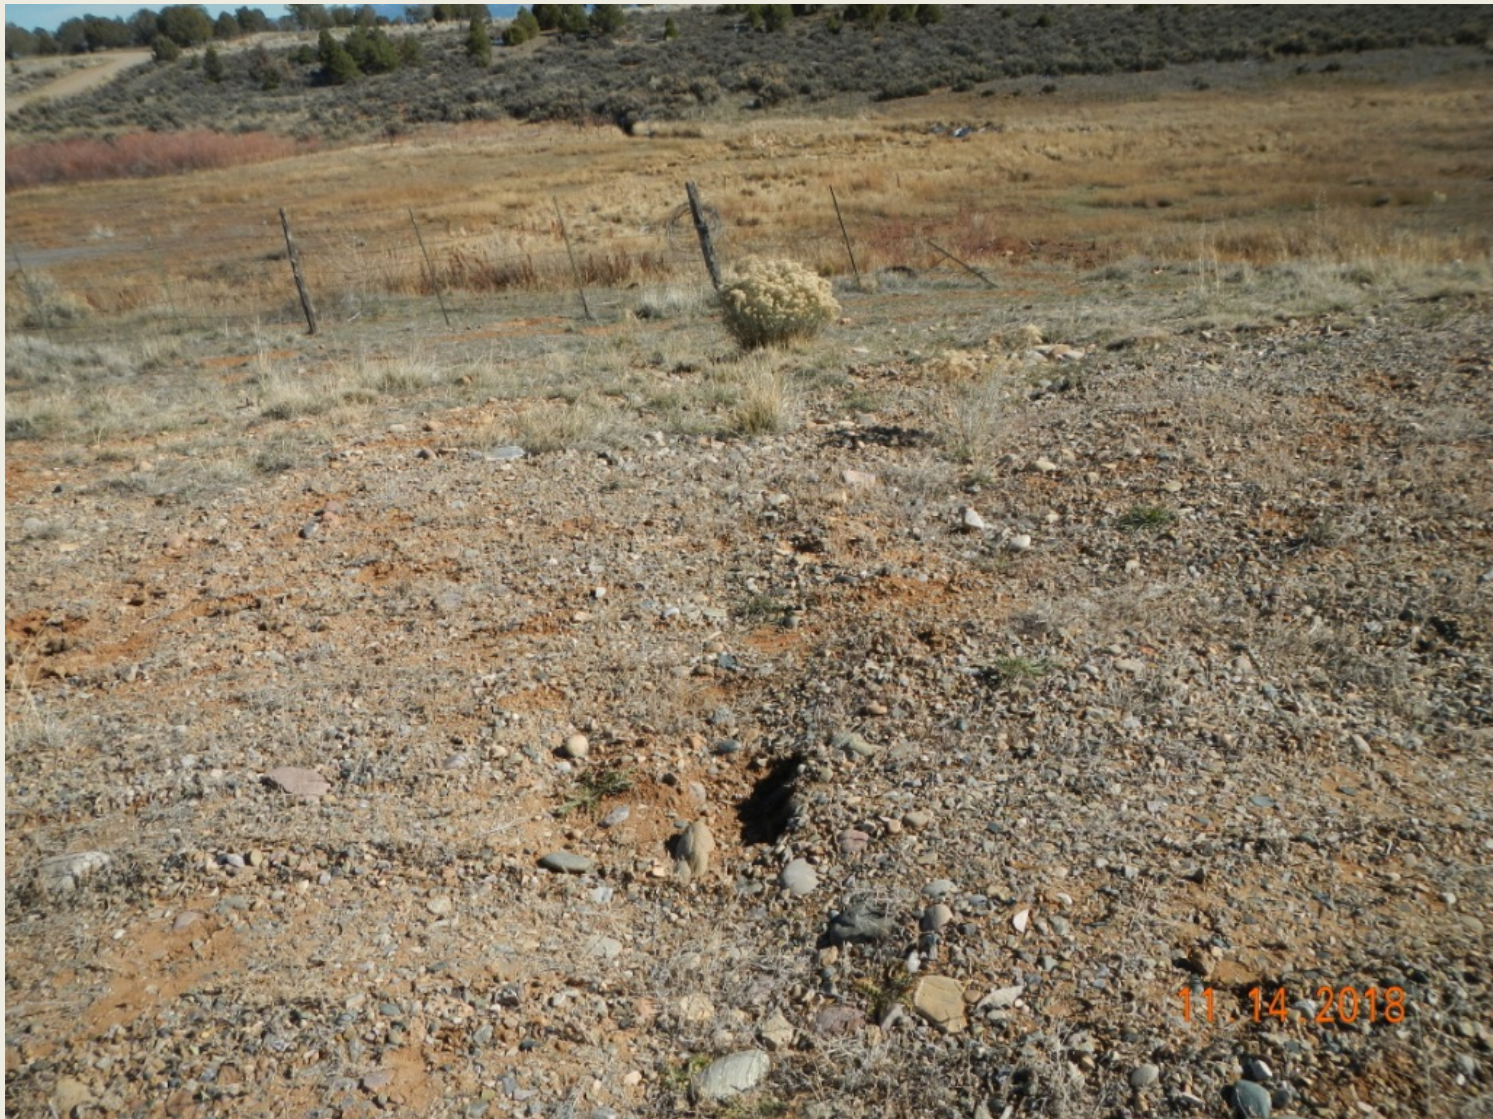
**Photo 8. View of rilling within the eastern project area.**
