Inspection Photos
Location Name: USA-Clark – Millison 1
API: 05-081-07006

Inspection Photos
Location Name: Powder Wash Federal 28-7
API: 05-081-06605

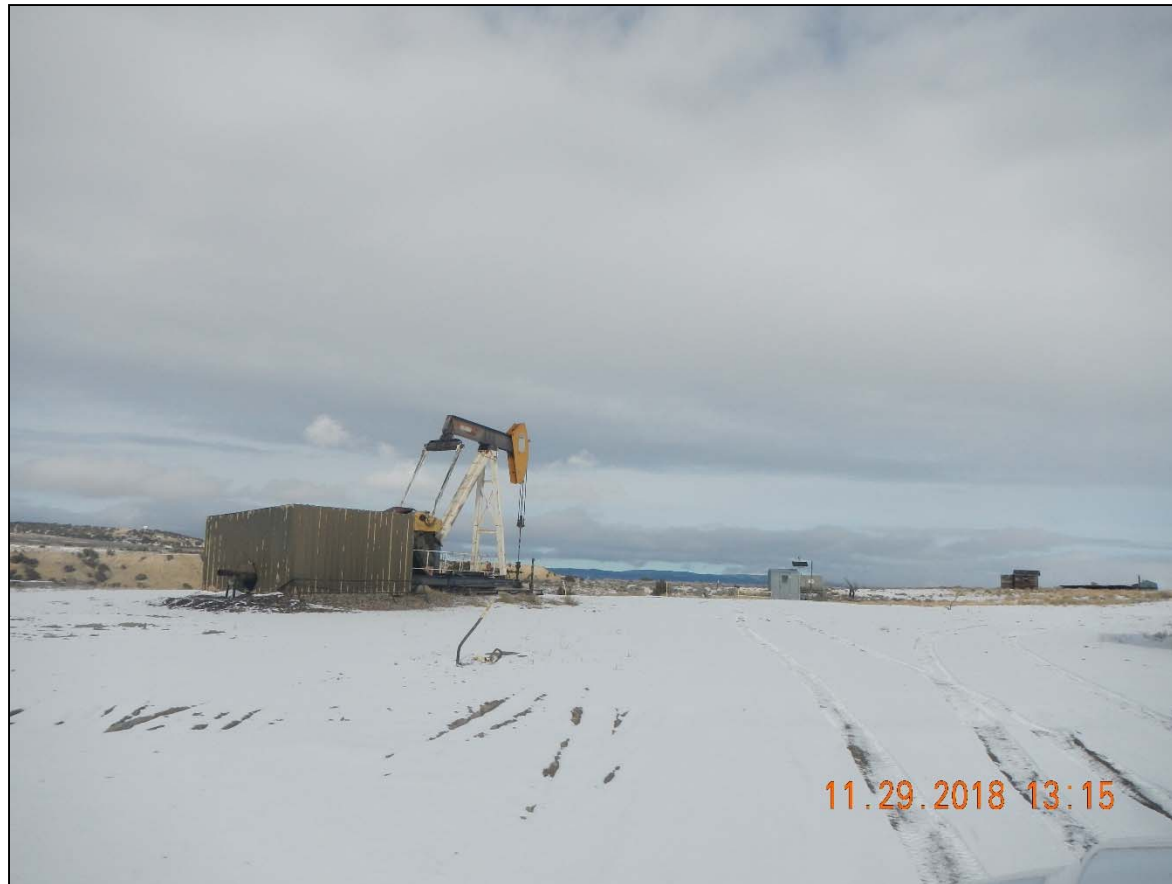
Photo 1. Overview of location taken at entrance facing northeast.
