Inspection Photos
Location Name: USA-Joyce Wolf 2
API: 05-081-06297

Inspection Photos
Location Name: Powder Wash Federal 28-7
API: 05-081-06605

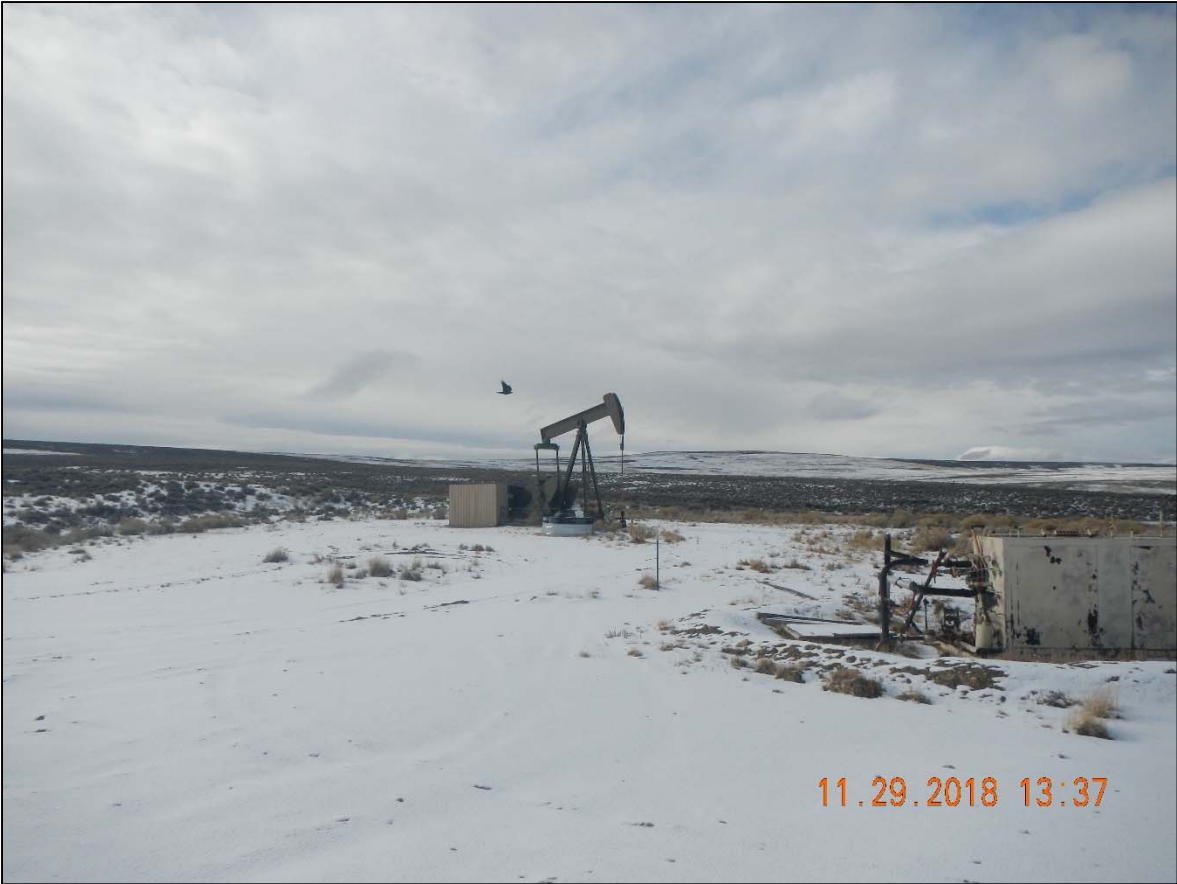
Photo 1. Overview of location taken at entrance facing west.
