Inspection Photos
Location Name: USA-Joyce Wolf 1
API: 05-081-07012

Inspection Photos
Location Name: Powder Wash Federal 28-7
API: 05-081-06605

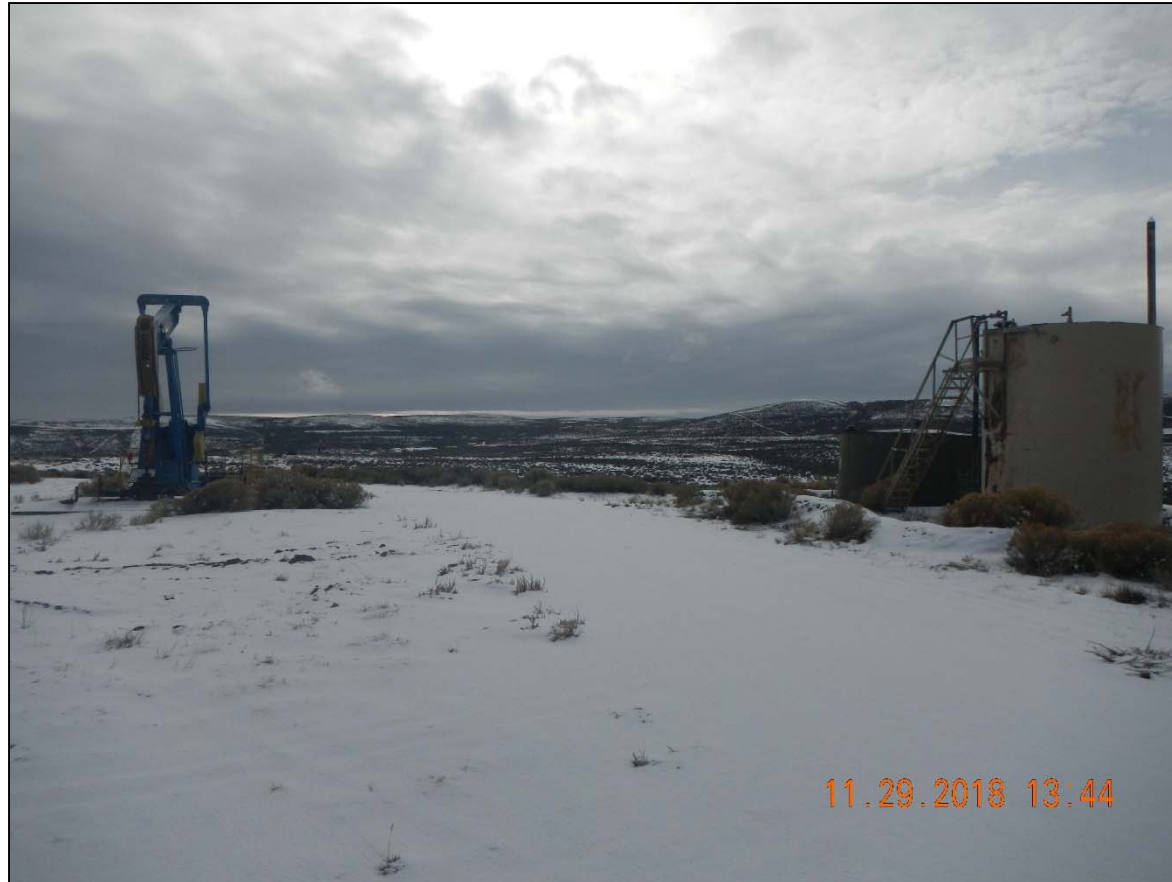
Photo 1. Overview of location taken at entrance facing southwest.

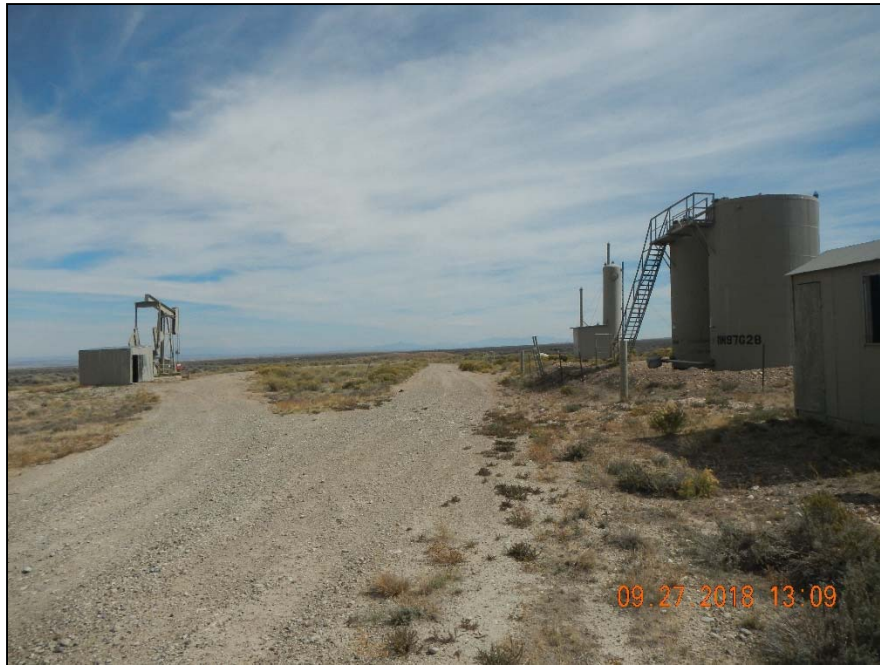
Photo 1. Overview of location taken at entrance facing east.

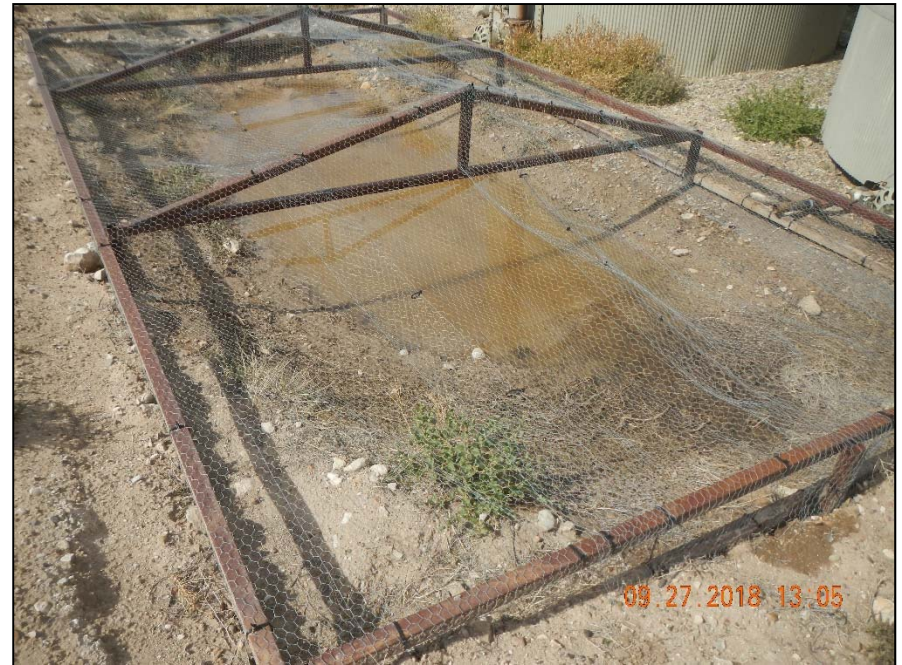
Photo 2. Pit in tank battery.

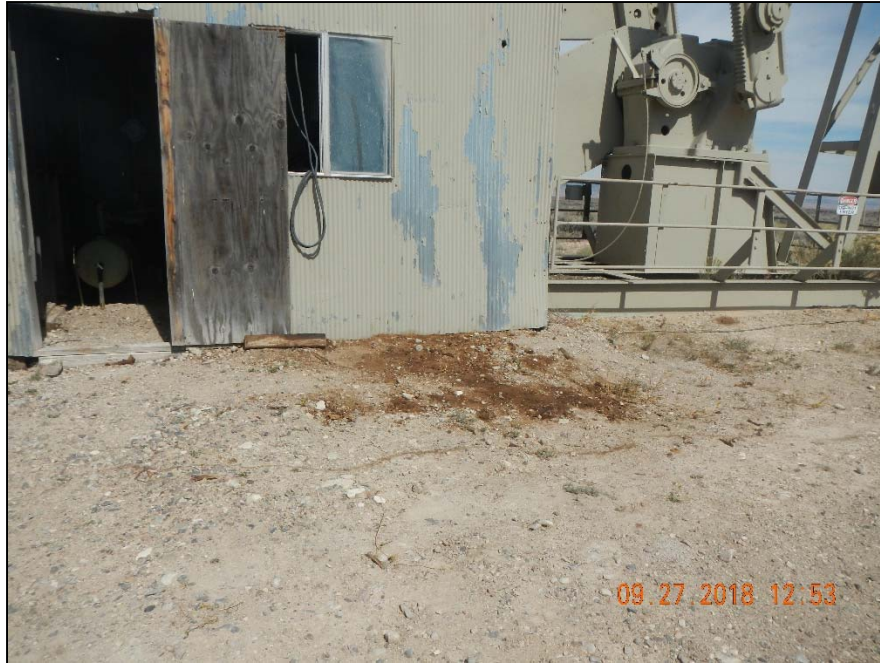
Photo 3. Stained soil at pump jack motor shed.

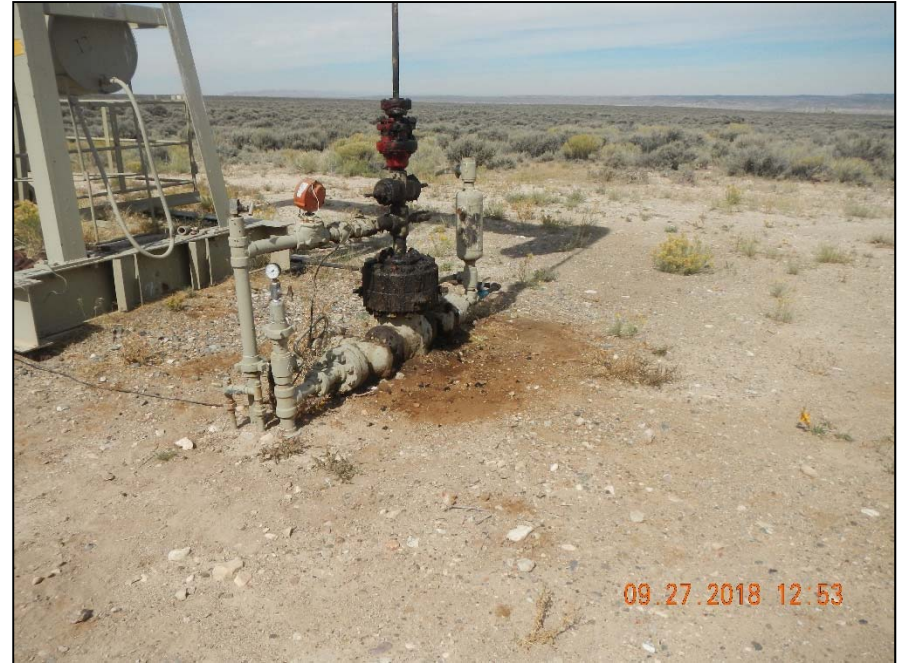
Photo 4. Stained soil at wellhead.

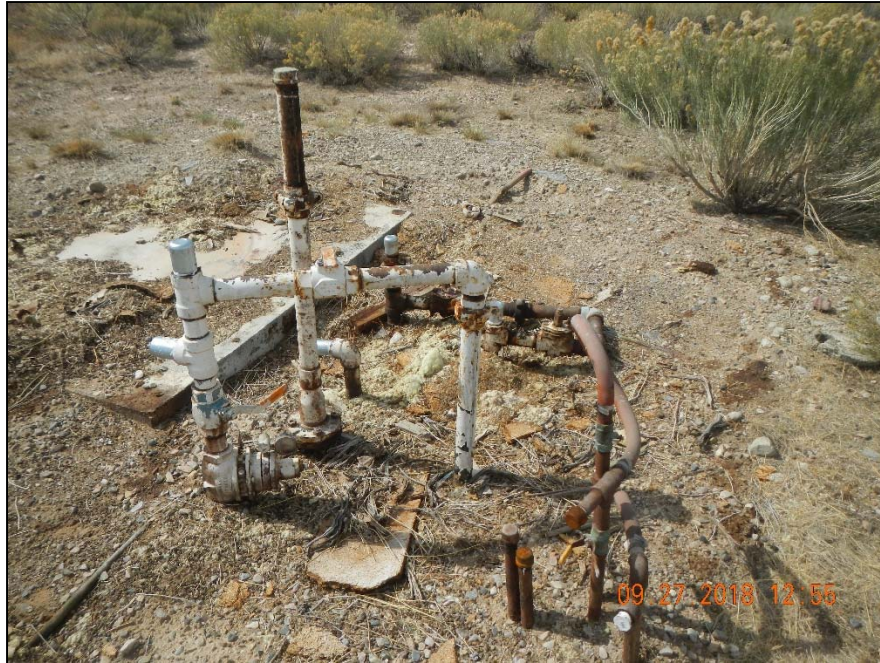
Photo 5. Unmarked risers.

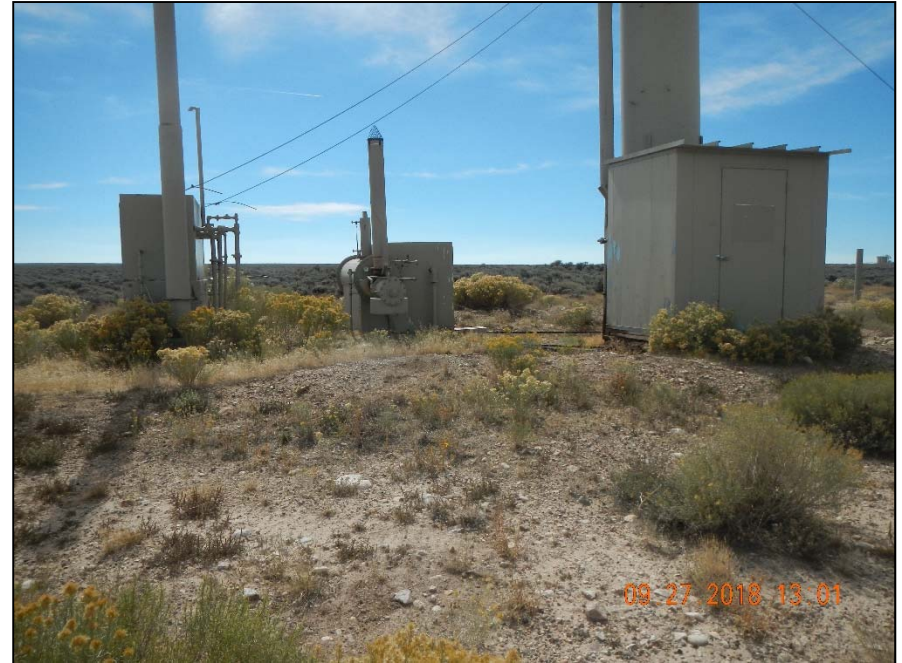
Photo 6. Weeds and vegetation around fired equipment.
