Inspection Photos
Location Name: McWilliams 4-31
API: 05-081-06521

Inspection Photos
Location Name: Powder Wash Federal 28-7
API: 05-081-06605

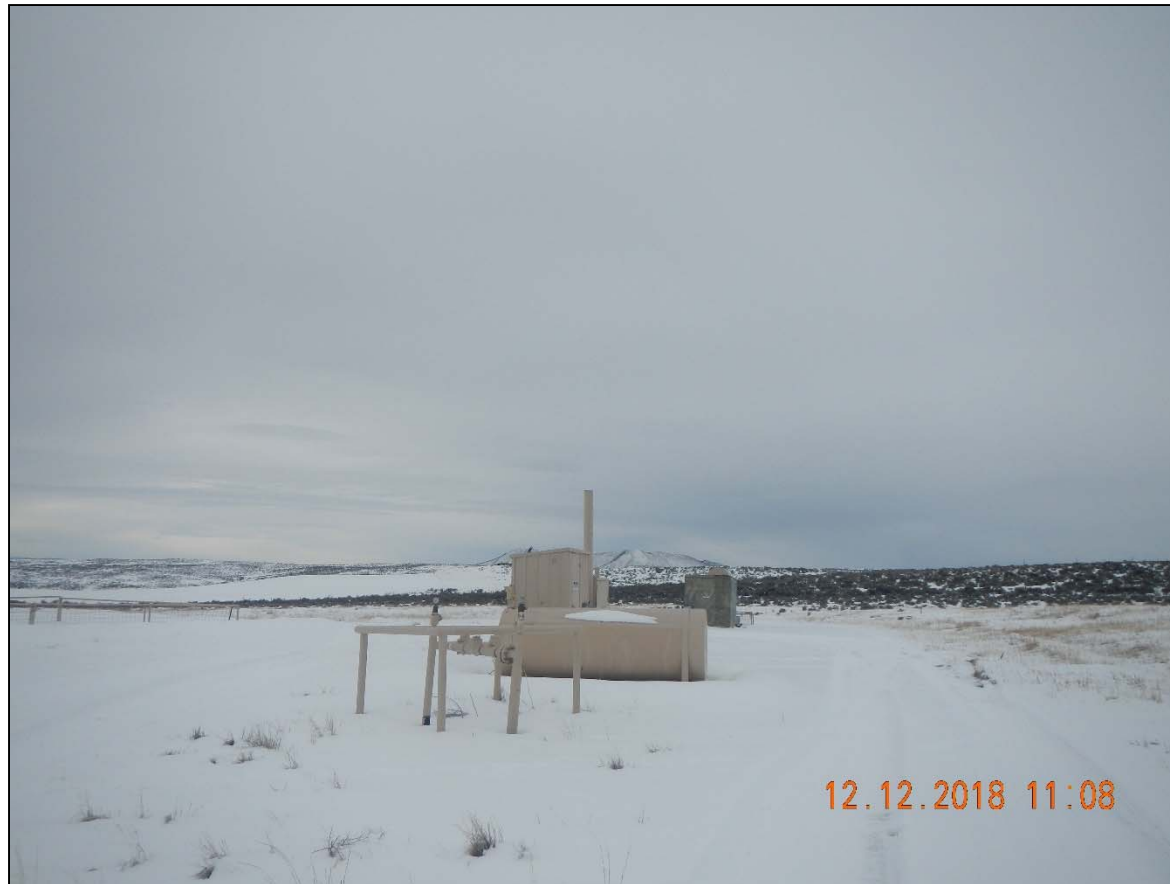
Photo 1. Overview of location taken at entrance facing south.

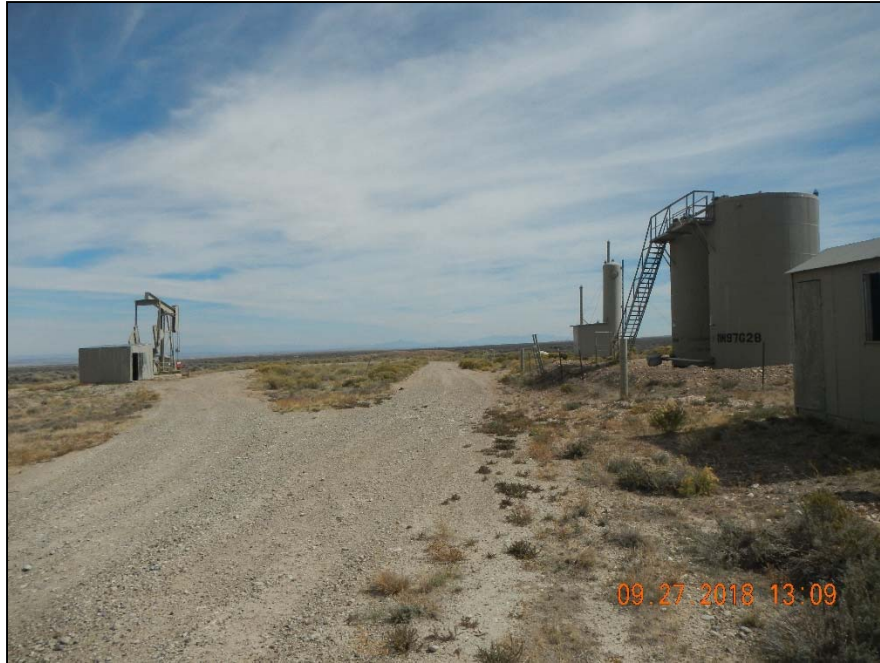
Photo 1. Overview of location taken at entrance facing east.

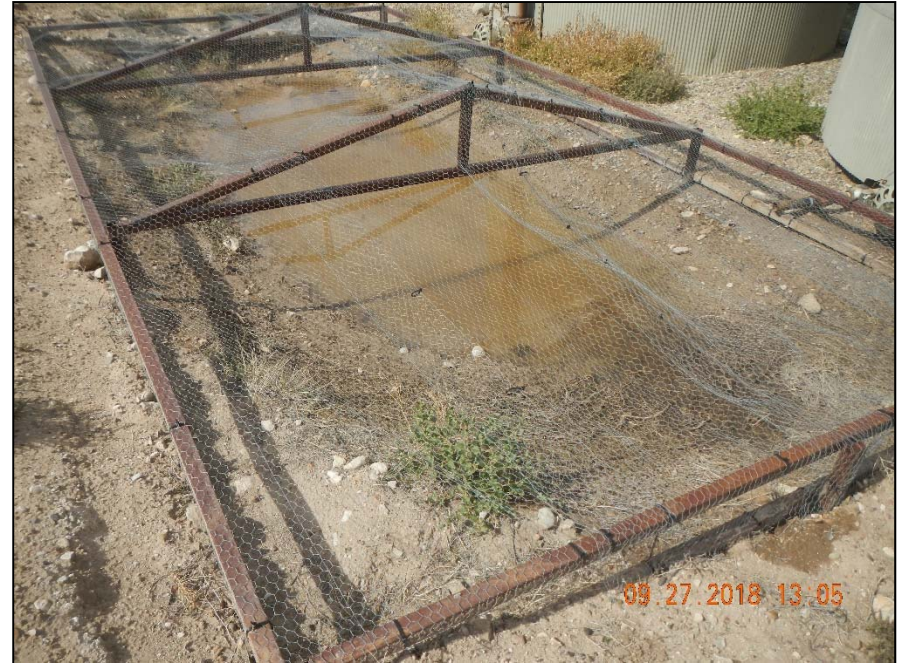
Photo 2. Pit in tank battery.

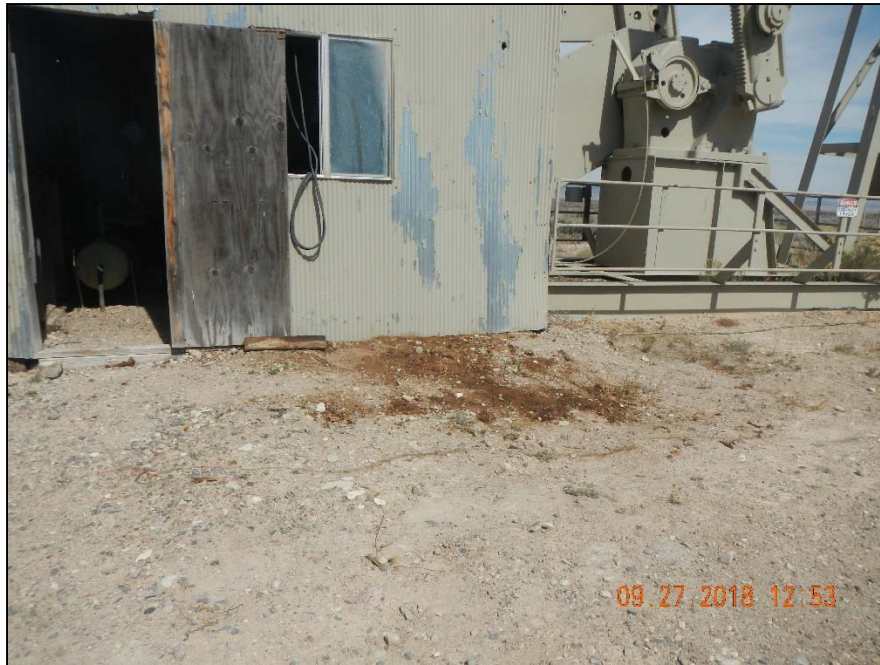
Photo 3. Stained soil at pump jack motor shed.

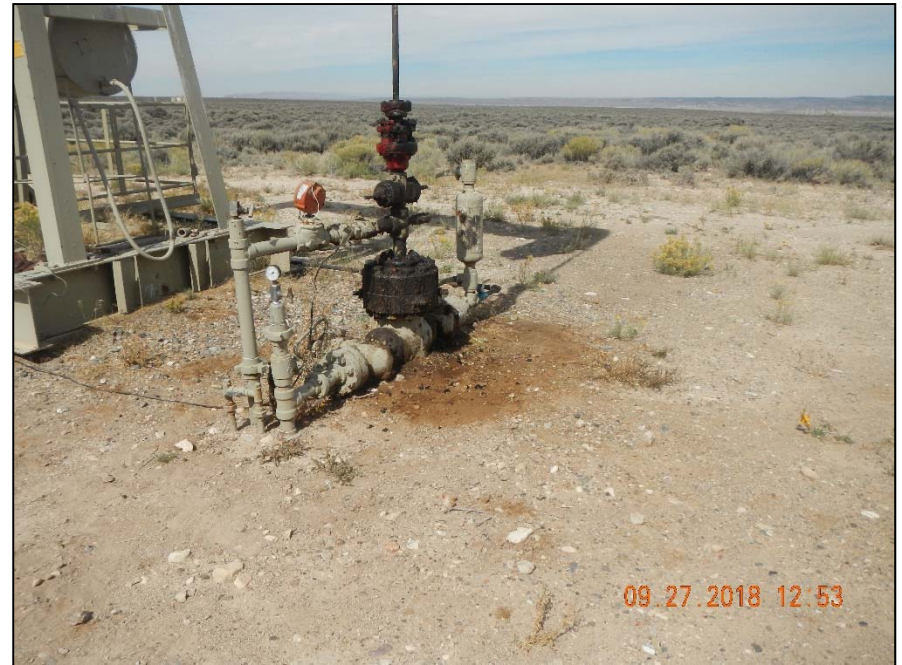
Photo 4. Stained soil at wellhead.
