Inspection Photos
Location Name: McWilliams 2-31
API: 05-081-06351

Inspection Photos
Location Name: Powder Wash Federal 28-7
API: 05-081-06605

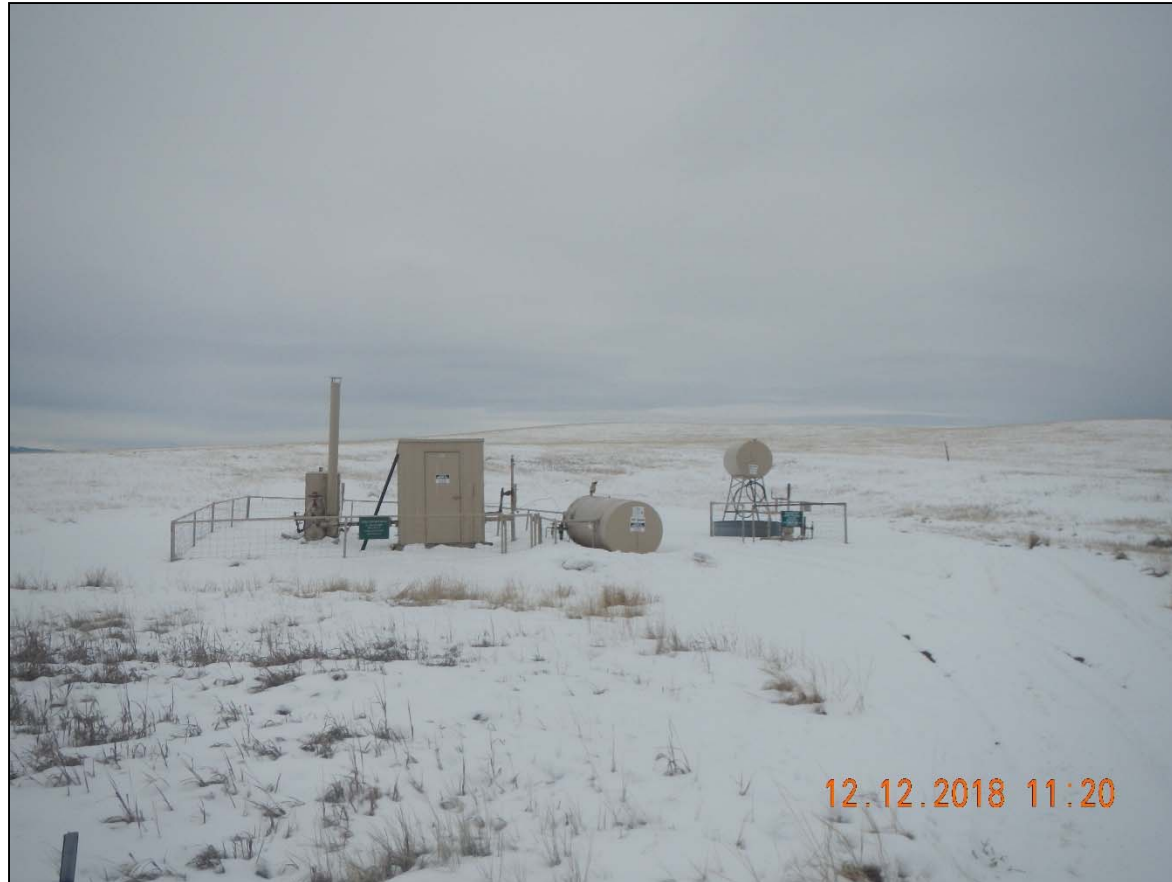
Photo 1. Overview of location taken at entrance facing southeast.
