Inspection Photos
Location Name: Schieck 11-31
API: 05-081-06530

Inspection Photos
Location Name: Powder Wash Federal 28-7
API: 05-081-06605

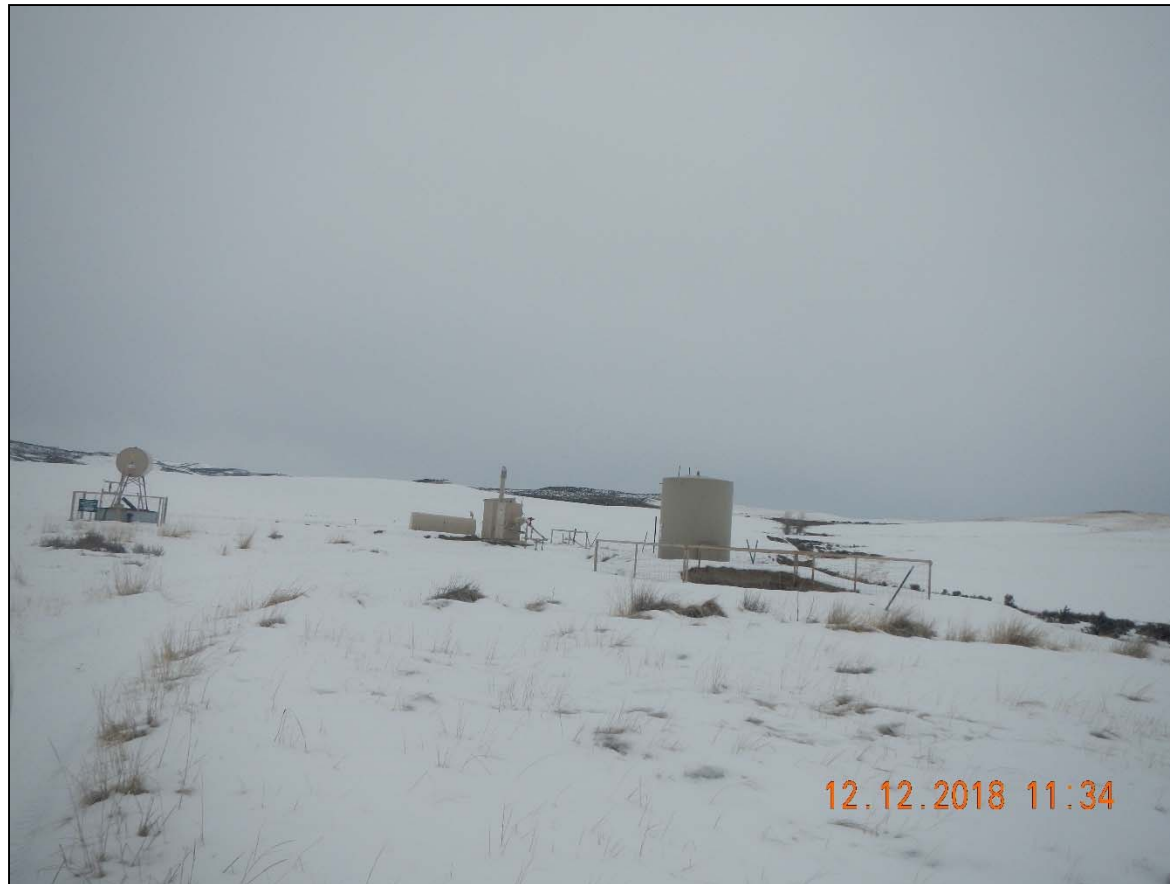
Photo 1. Overview of location taken at entrance facing north.
