Inspection Photos

Operator: BP America

API: 05-067-06816

Date: 11/14/2018

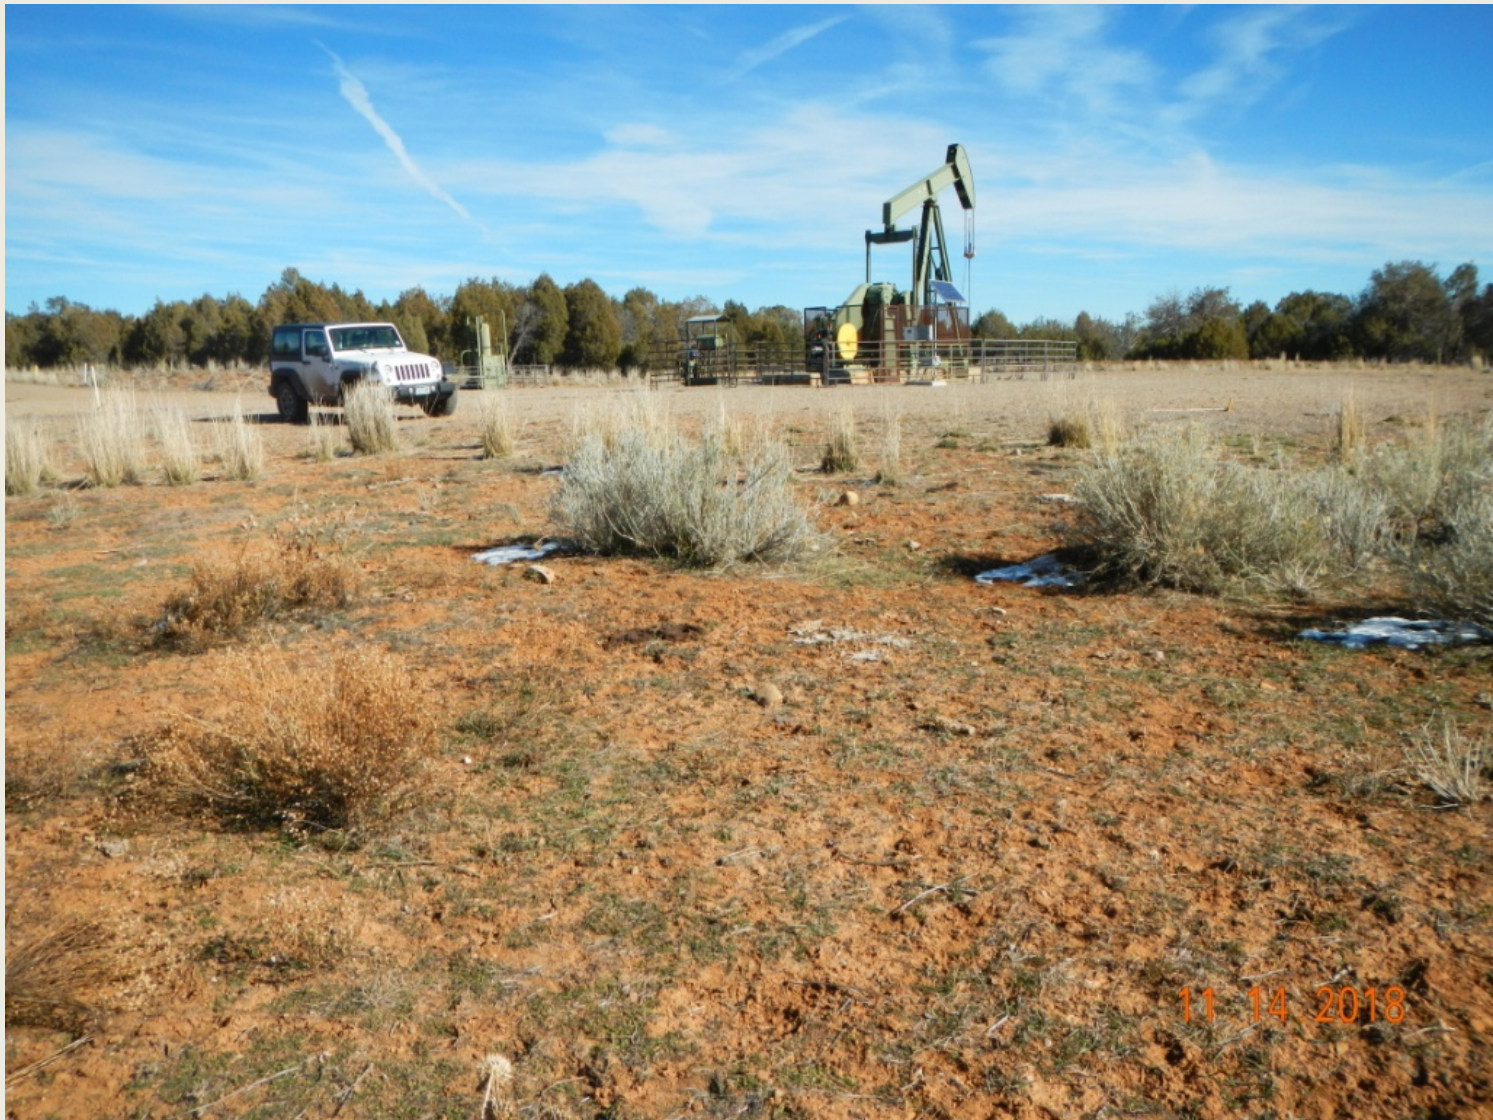
Photo 1. View of the project area from the southwestern corner facing center.

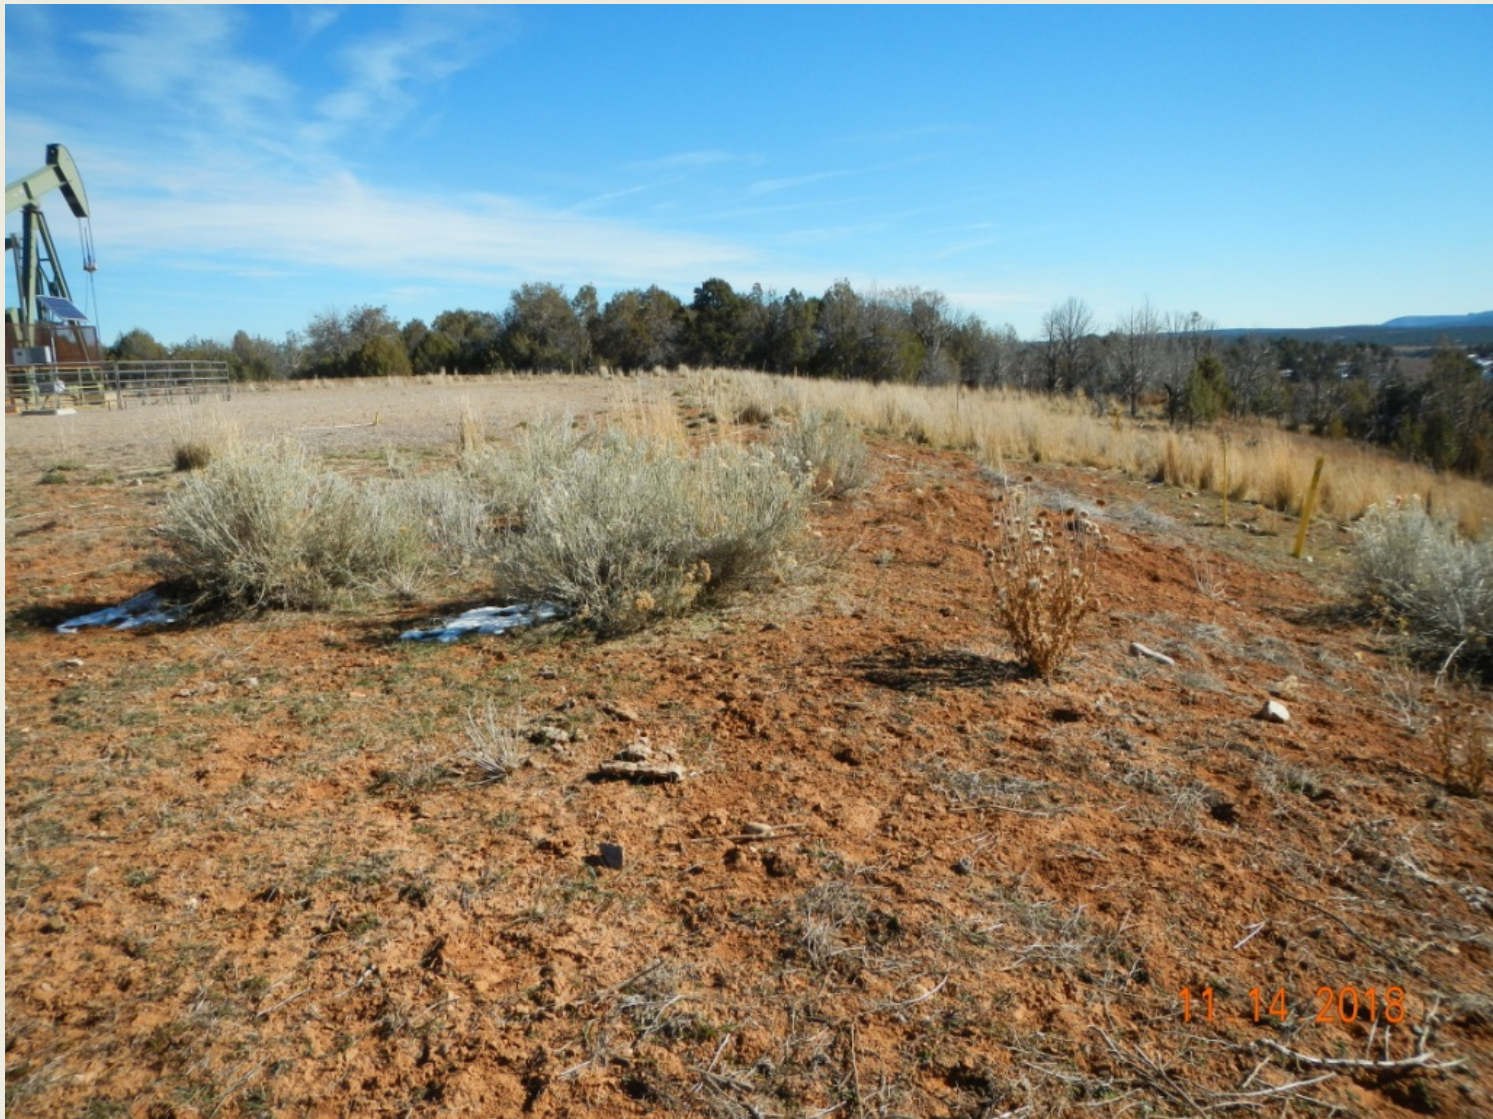
Photo 2. View of the southern project area from the southwestern corner facing southeastward. Revegetation is progressing with grasses such as intermediate wheatgrass (*Thinopyron intermedium*), as well as weeds such as cheatgrass (*Bromus tectorum*). Vegetation is sparse and heavily grazed in areas and needs to be monitored.

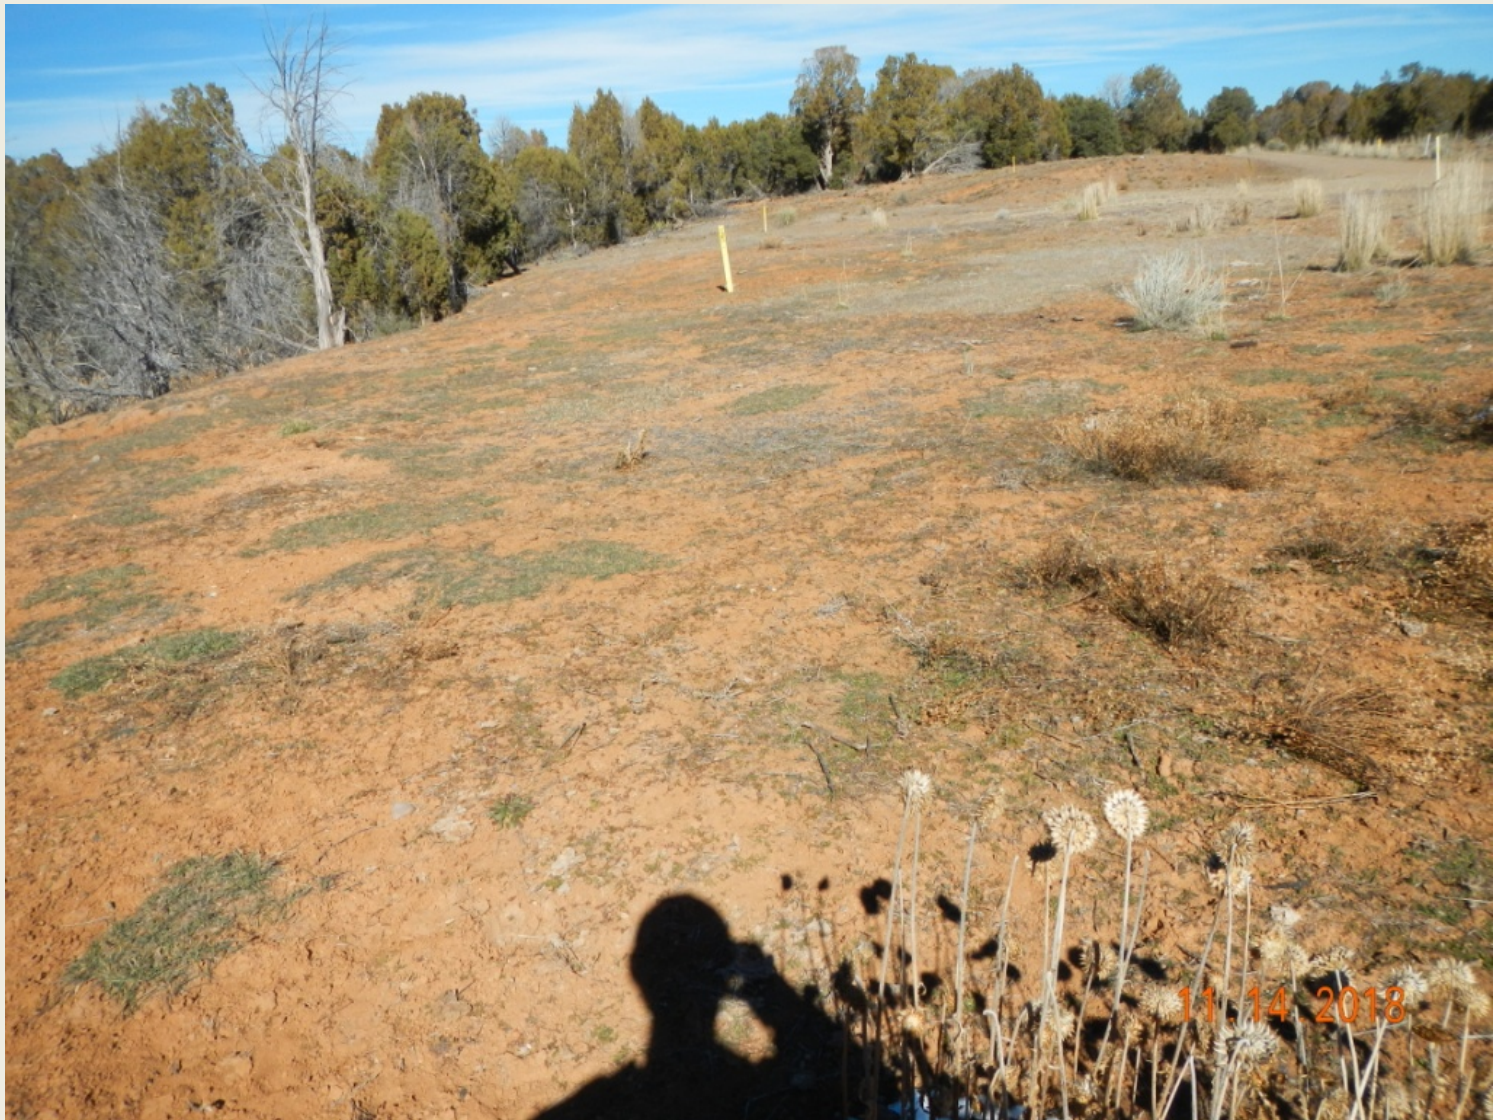
Photo 3. View of the western project area from the southwestern corner facing northward.

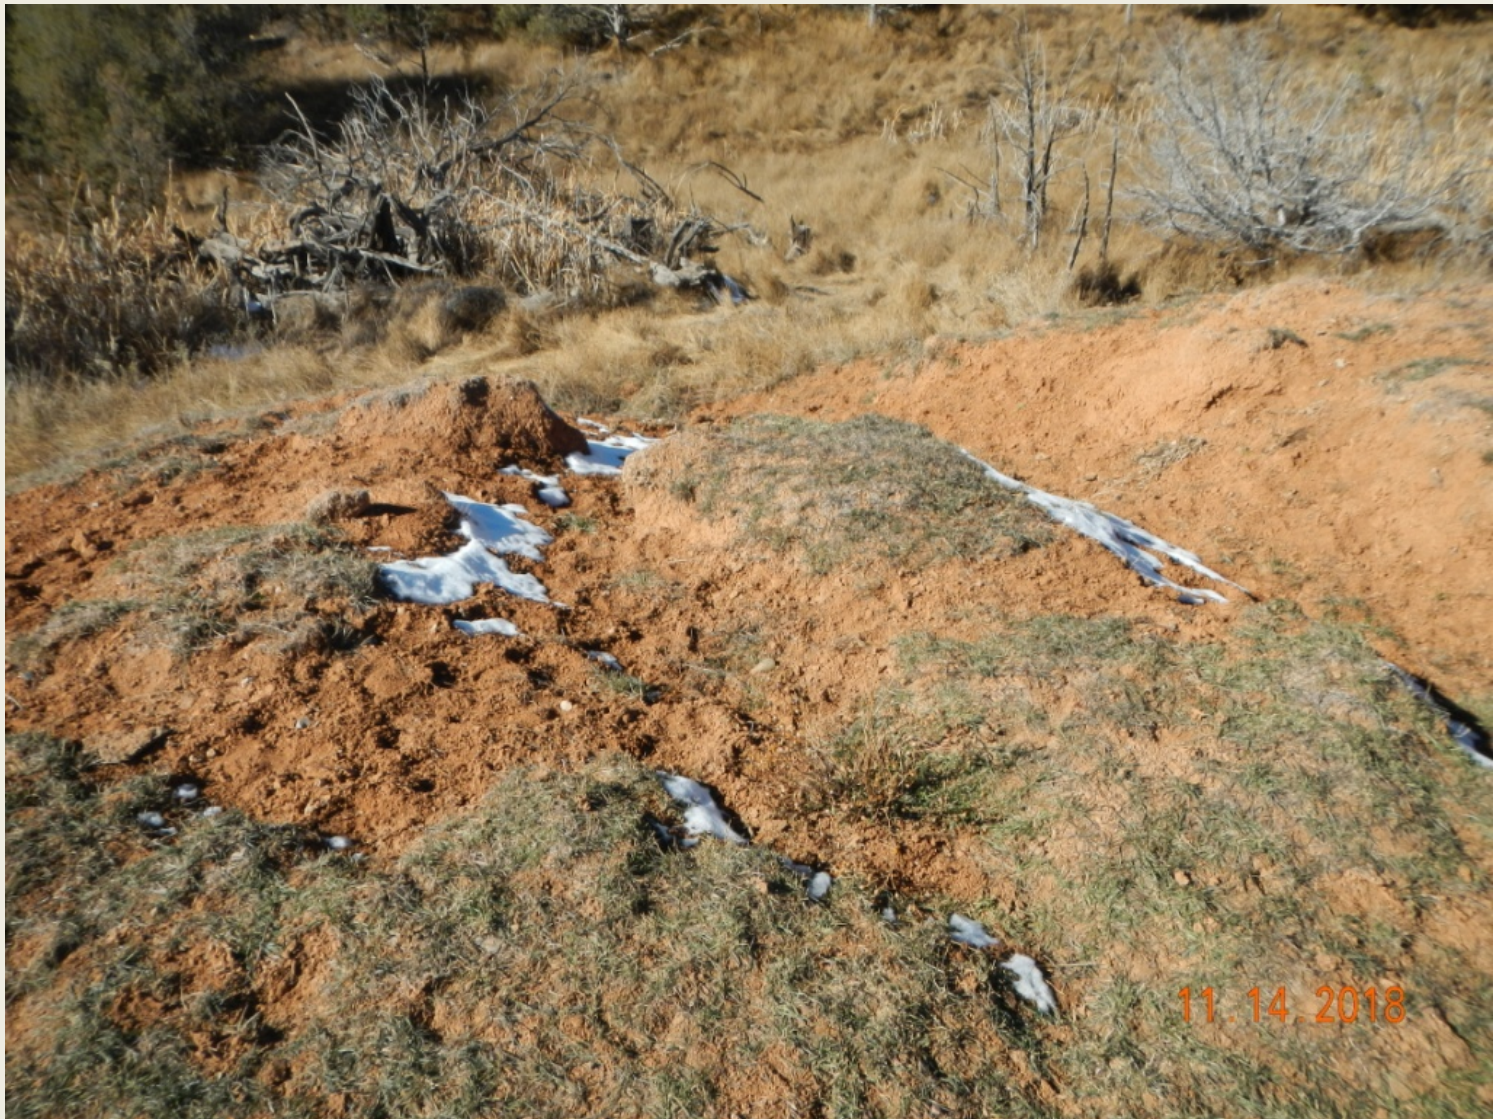
Photo 4. View of erosional channel within the western project area. Appears to be used as a cattle path.

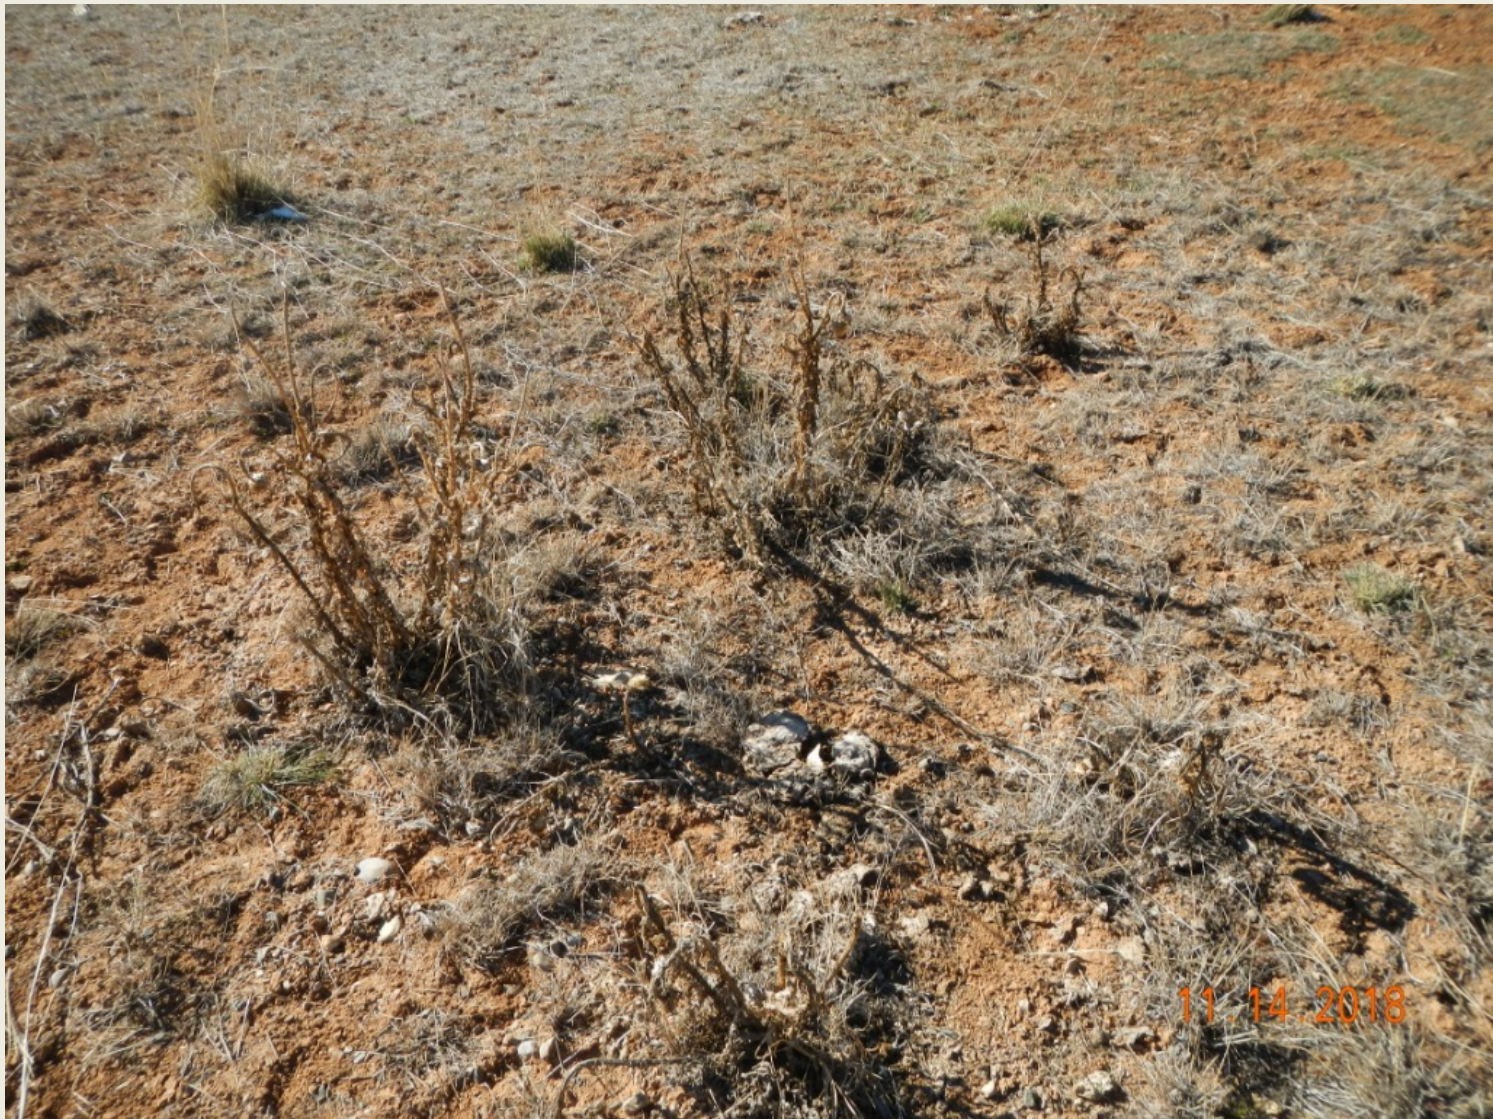
Photo 5. View of musk thistles (*Carduus nutans*) within the western project area.
