Inspection Photos
Operator: Springdale Partners LLC
Lease: Springdale Storage 2
API #05-075-05861

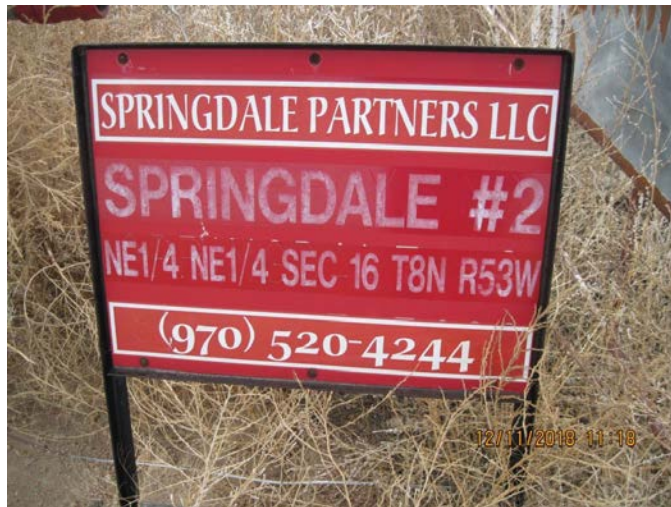
1. Lease sign, Incorrect emergency contact number

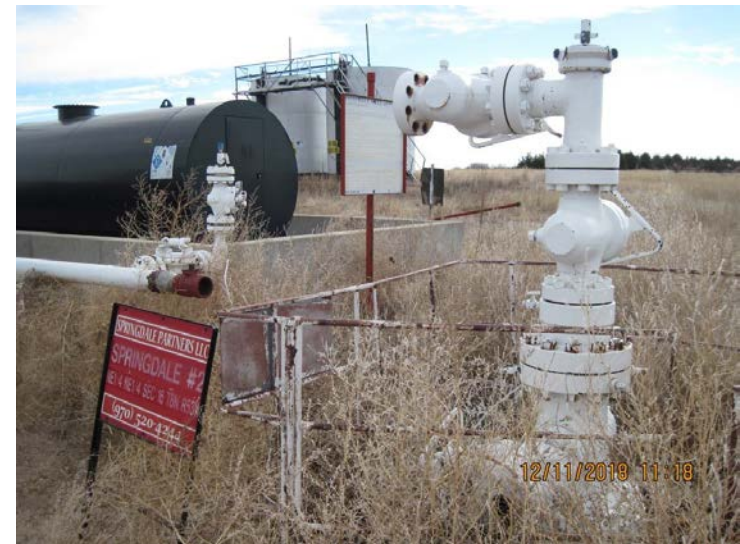
2. Wellhead disconnected, Weeds

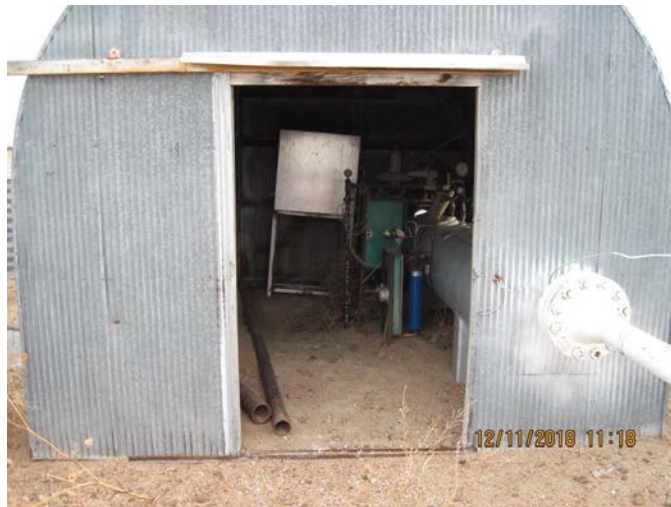
3. Separator in metal shed

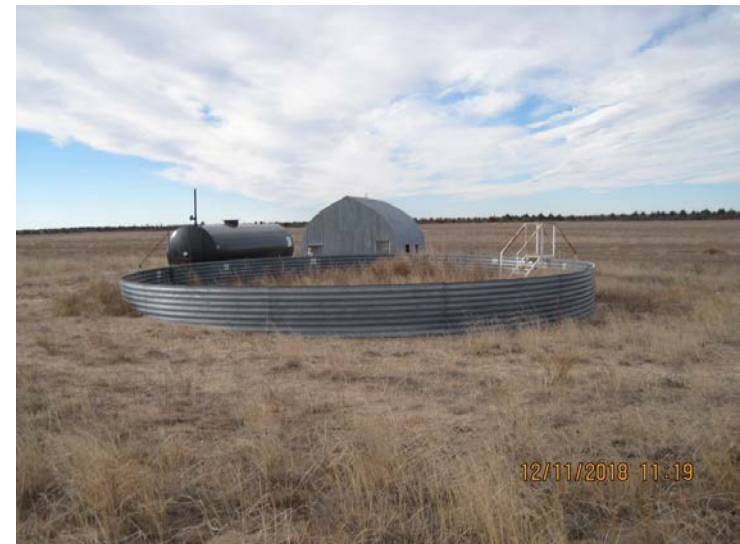
4. Steel ring containment

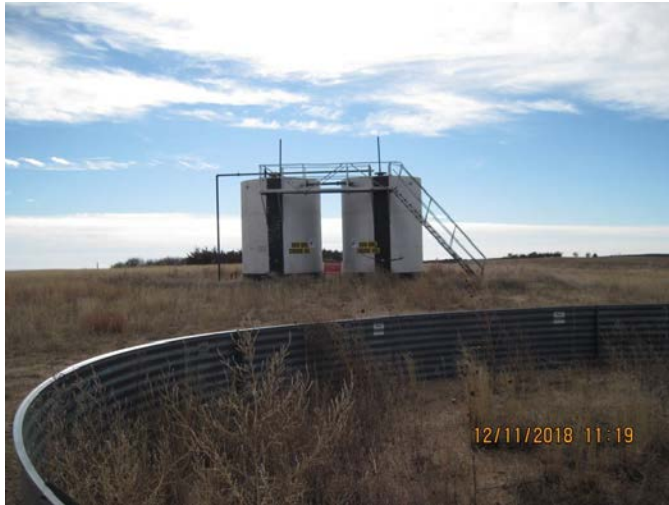
5. Tank battery

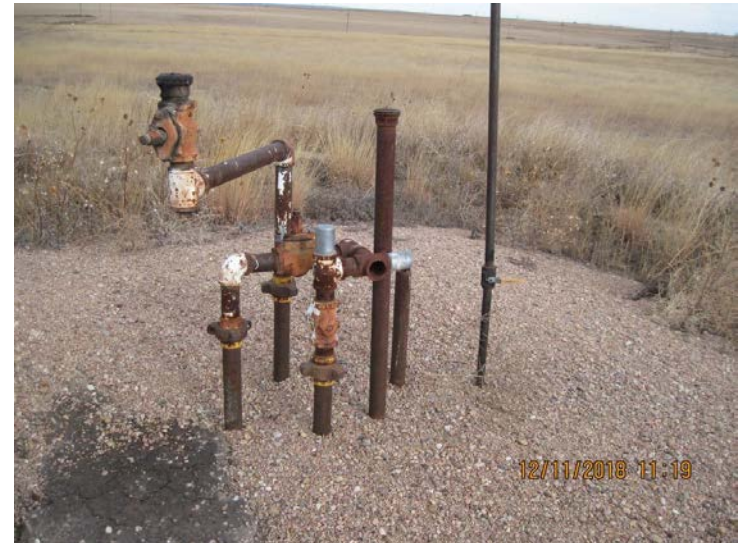
6. Abandoned/Unmarked Risers/Flowlines
