Inspection Photos

Location Name: Douglas Creek Unit-63S101W 5NWSW Pad

Location ID: #314293 Spill/Release ID: #459792

Inspection Date: December 12, 2018

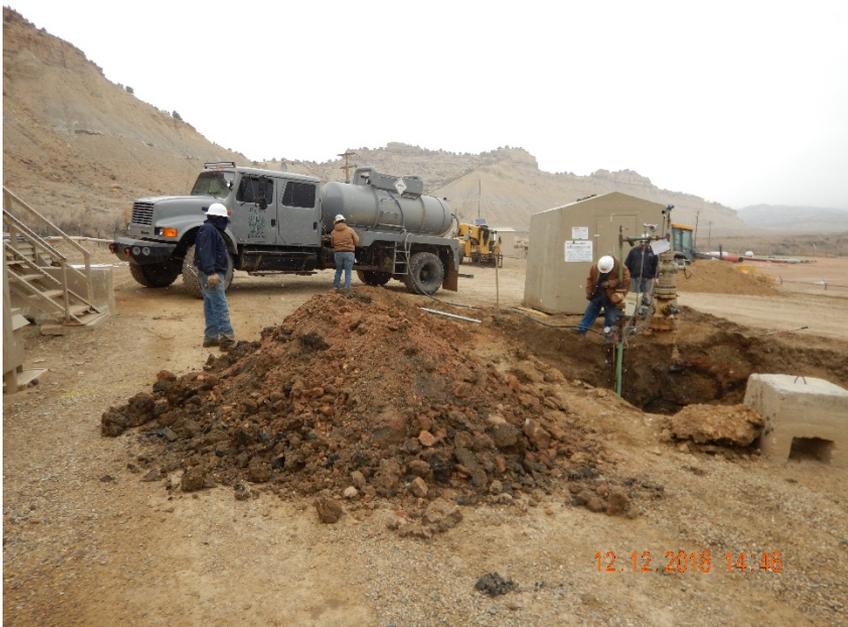
Photo #1 – Overview of flowline integrity test configuration from south of excavation. Note stockpile of excavated material in foreground.

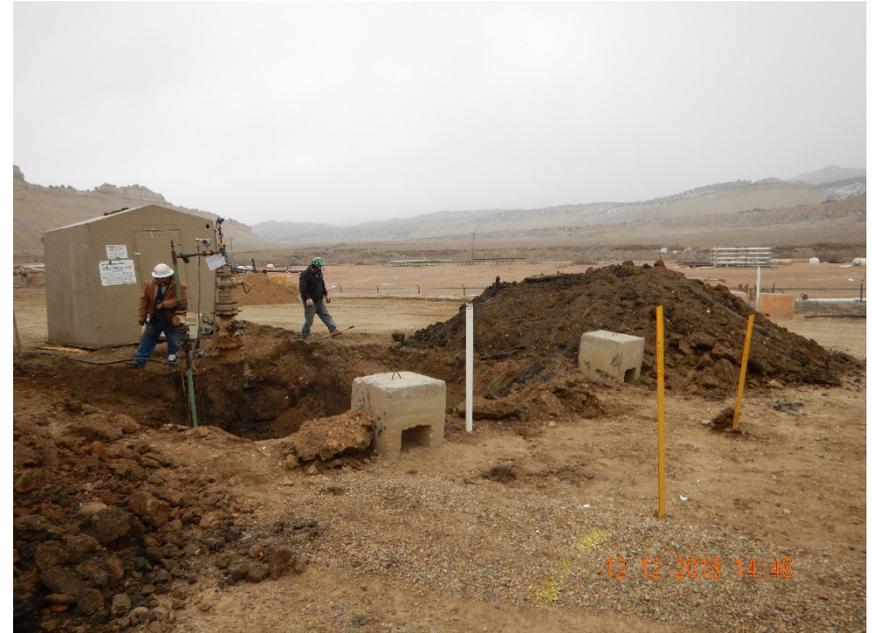
Photo #2 - View of additional excavated soil stockpile east of excavation. Note two capped PVC risers (monitoring wells) located south of excavation and east of stockpile.

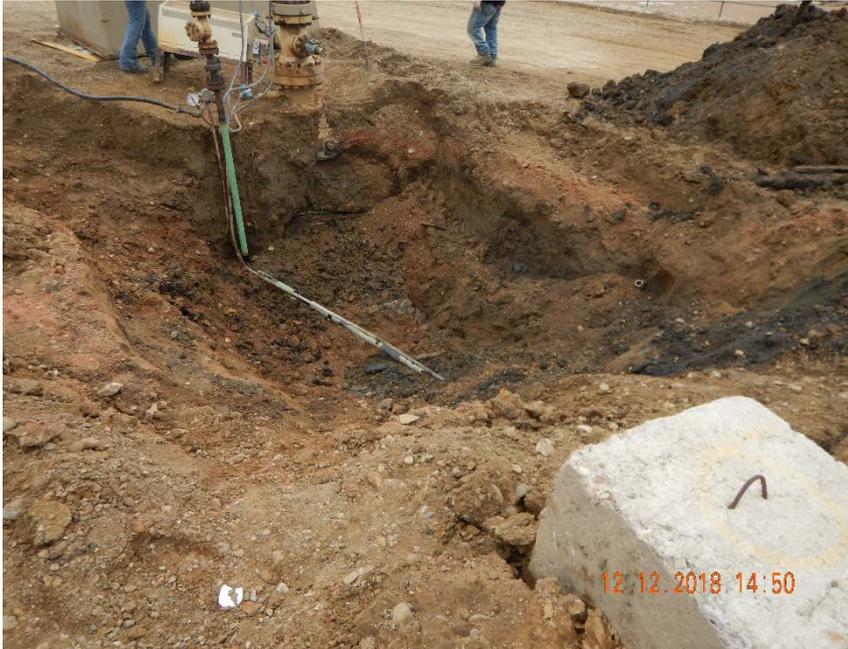
Photo #3 - View into excavation from southwest corner.

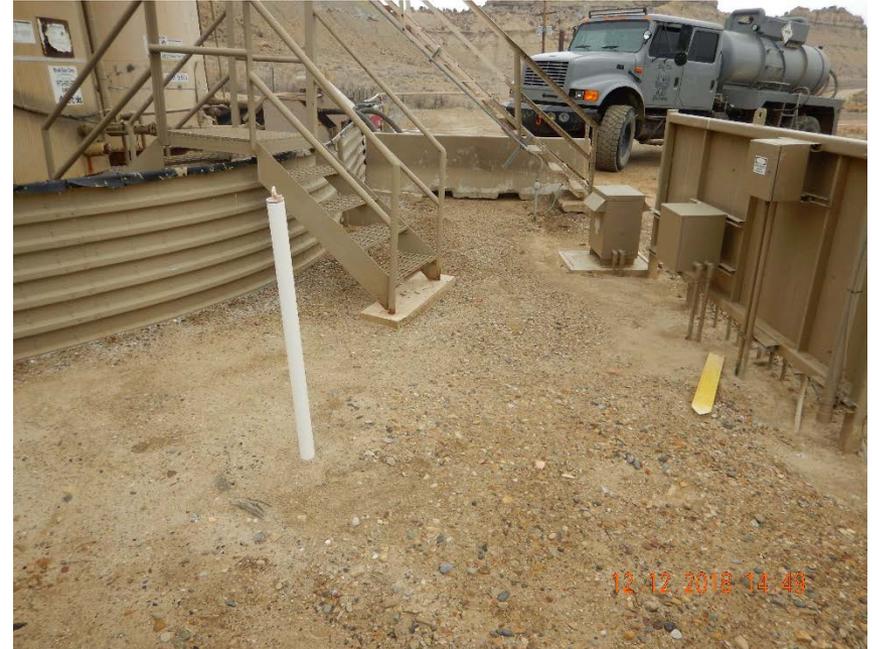
Photo #4 – Additional PVC riser (monitoring well) located between excavation and tank battery.

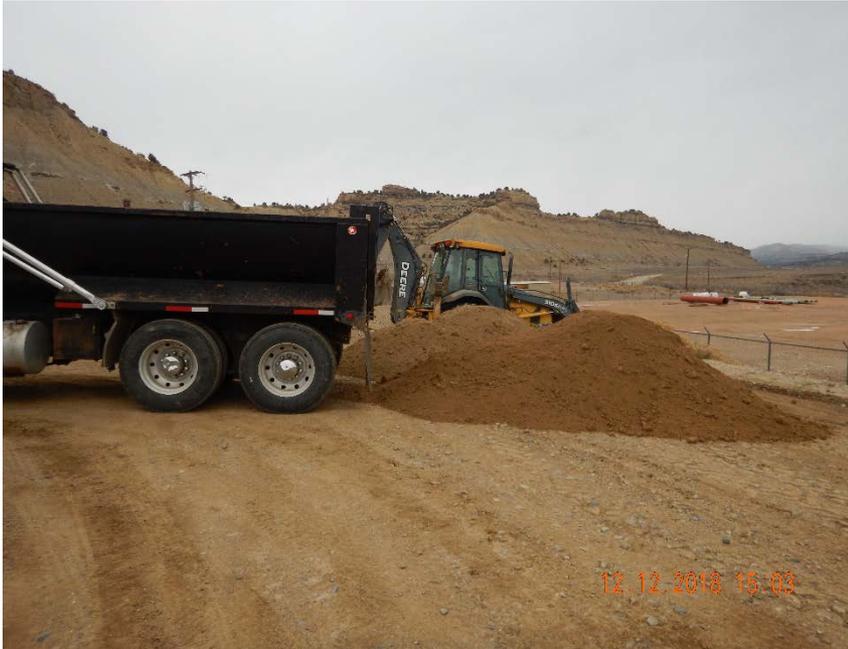
Photo #5 – Operator was trucking in clean soil to backfill excavation on inspection date.

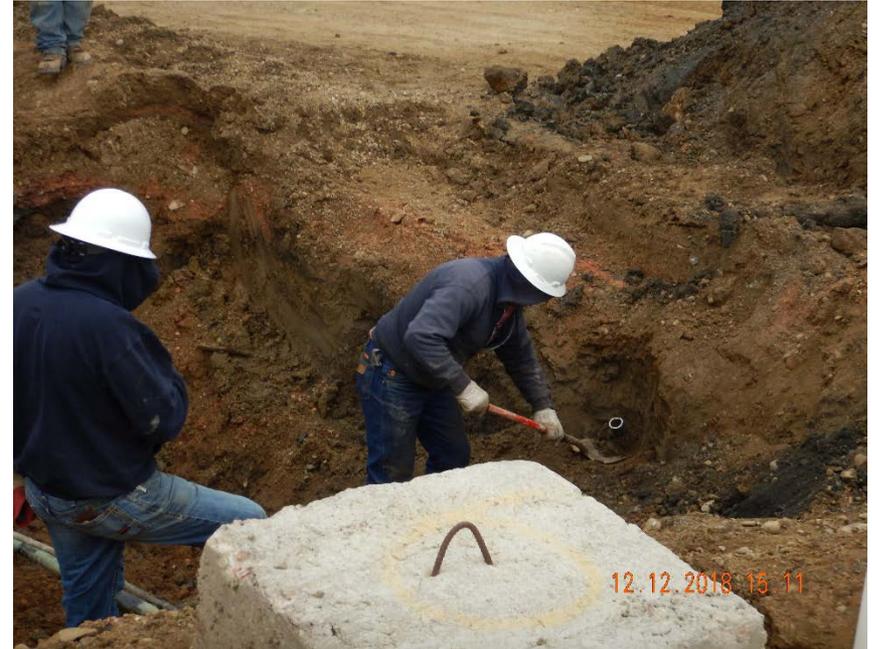
Photo #6 – Operator was instructed by COGCC Western Integrity Supervisor to cap unidentified 2" flowline that was exposed on east side of excavation.
