Inspection Photos
Location Name: Richardson G #2
Spill/Release Point ID #459307

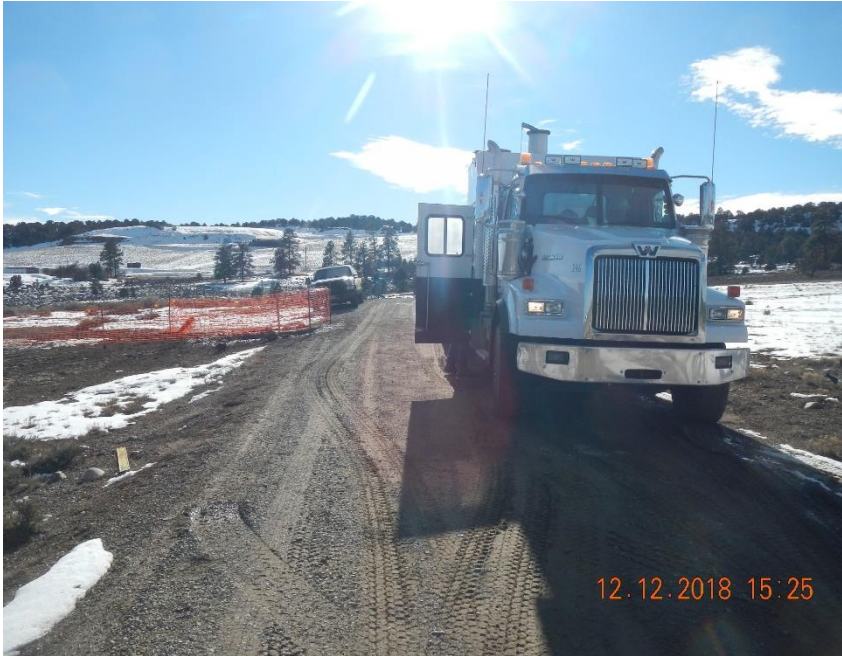
Vac truck preparing to expose pipeline along western edge of access road.

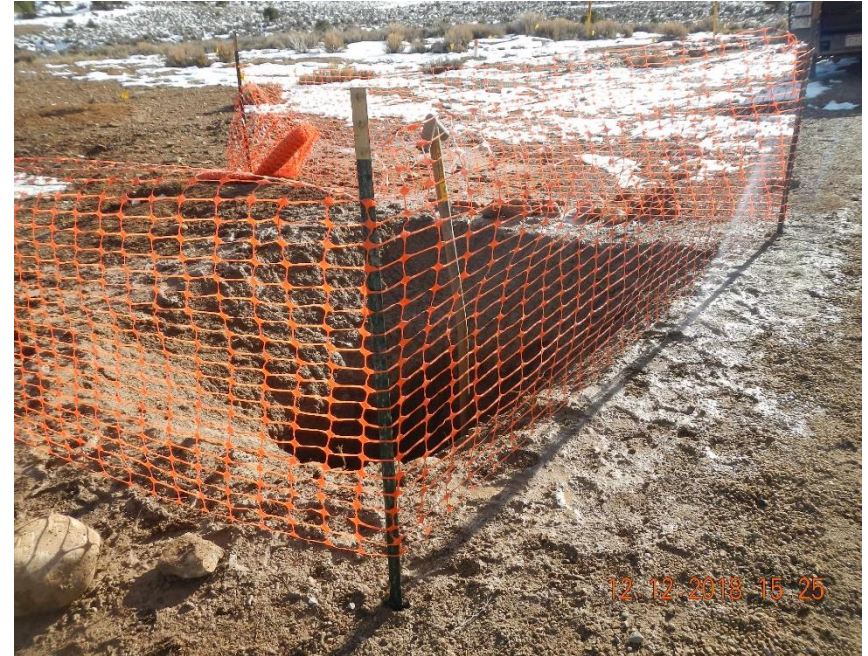
Hydro vac excavation to expose pipeline along eastern edge of access road.

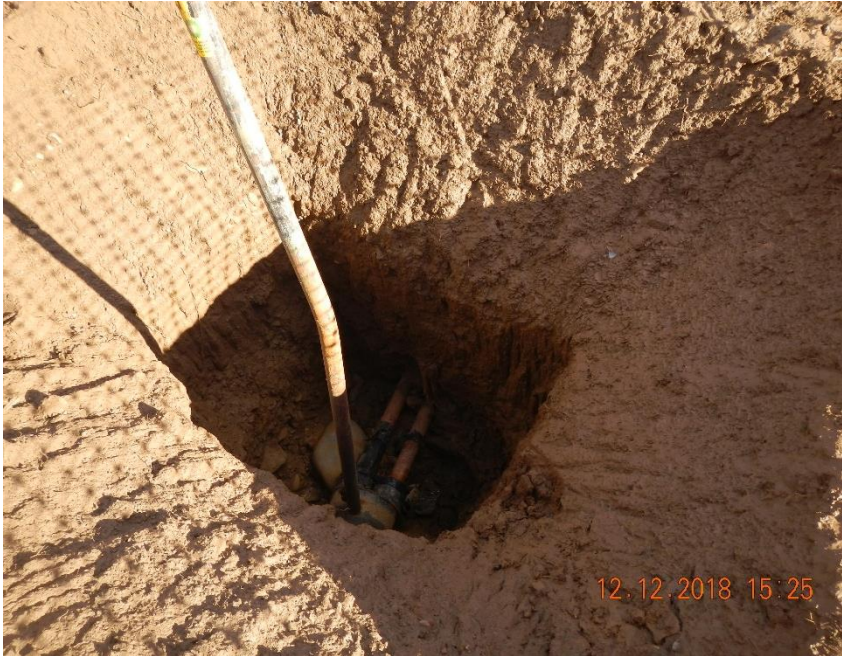
Exposed pipeline along eastern edge of access road.

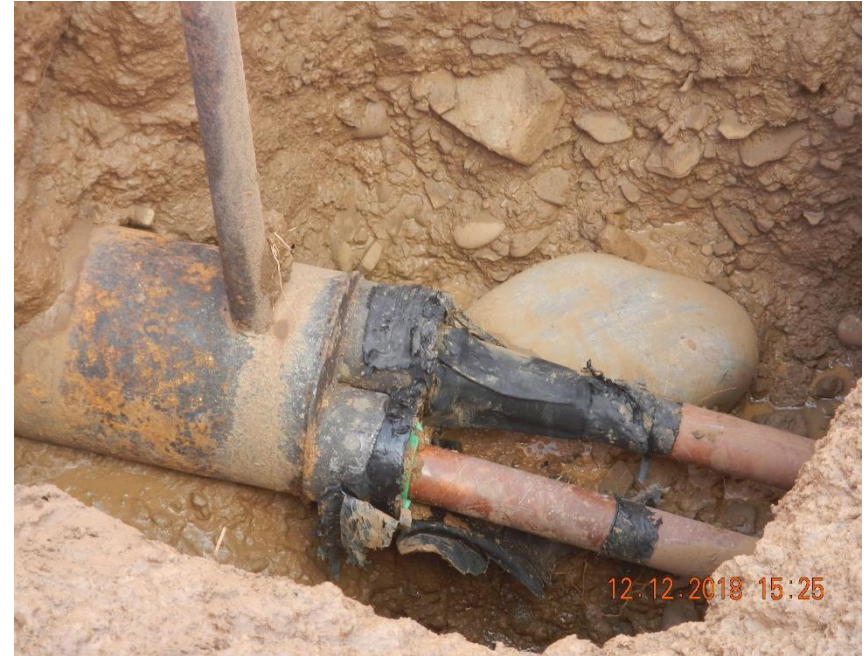
Exposed 3" fiberglass pipelines within 12" casing sleeve.

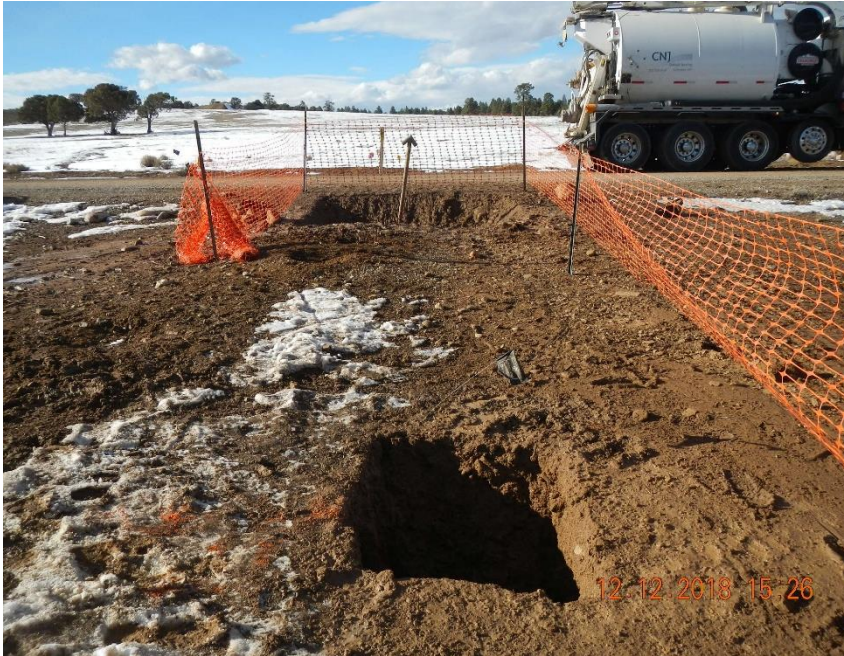
Potholed Williams pipeline in foreground.

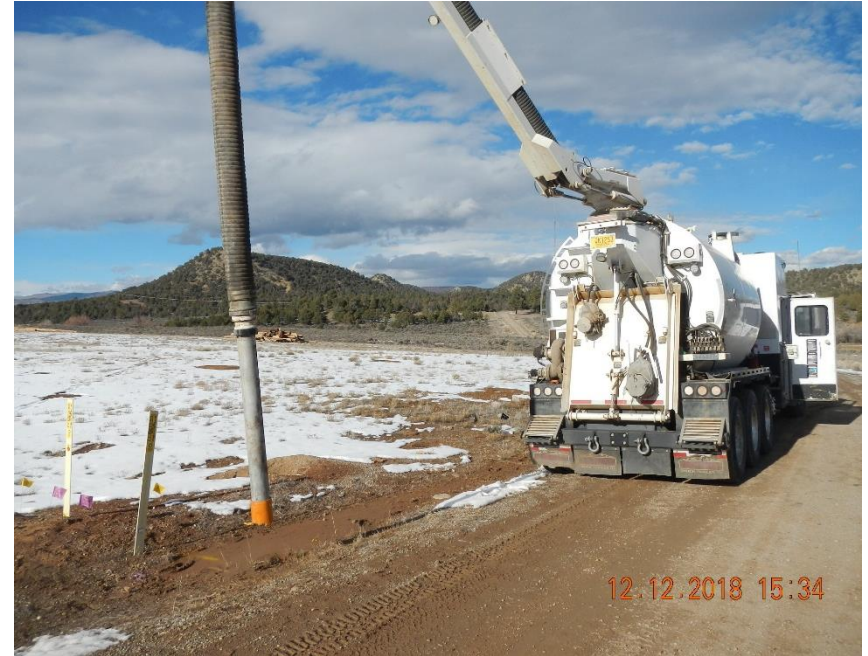
Hydro vac truck preparing to expose pipelines along western edge of roadway.
