Inspection Photos
Operator Name: UTAH GAS
Location ID: 314293

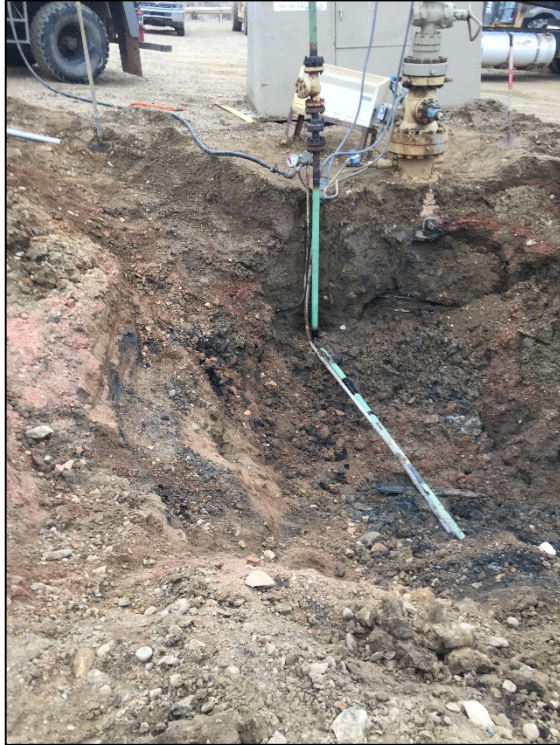
Steel Flowline from injection pump to wellhead

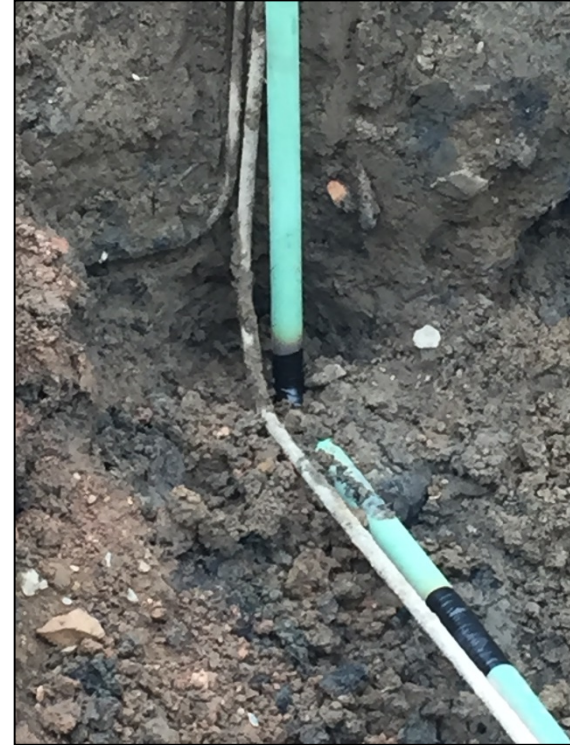
90 Degree elbow where pin hole was found. Pin hole was on inside radius of elbow

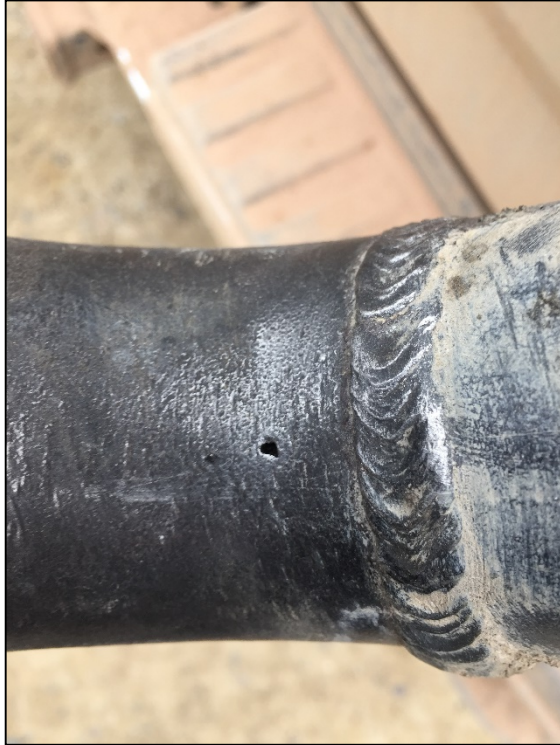
Flowline pine hole

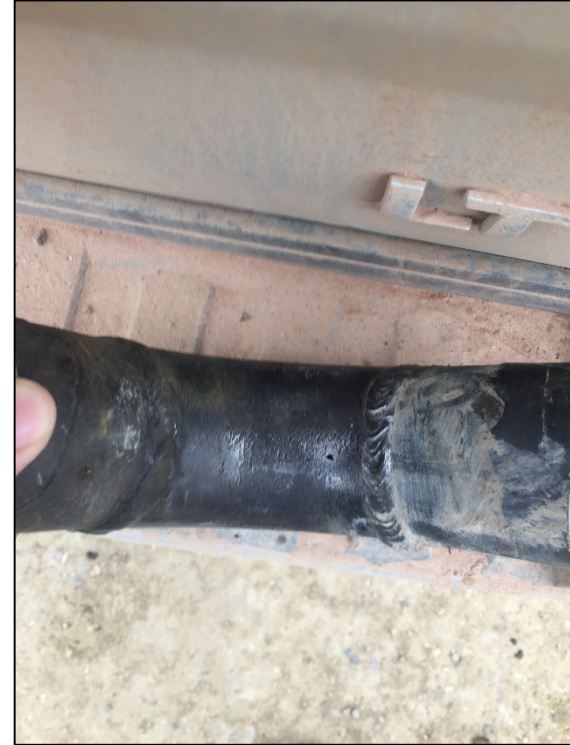
90 Degree elbow where pin hole was found. Pin hole was on inside radius of elbow

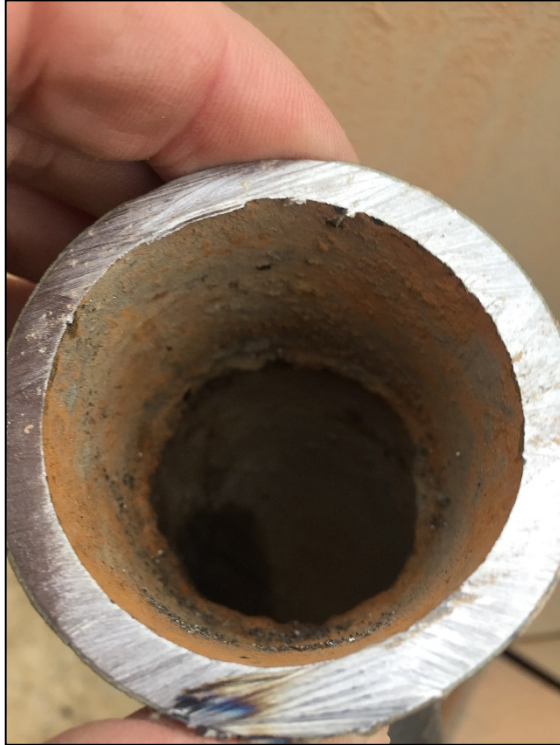
Inside picture of elbow

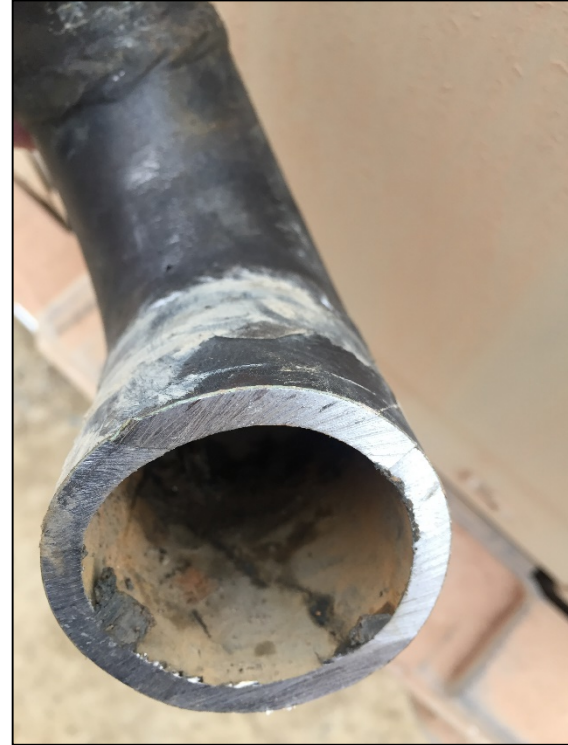
Inside picture of elbow
