Inspection Photo (s)
Couey 30-10A1
API # 05-045-07970
Inspection # 6893026039

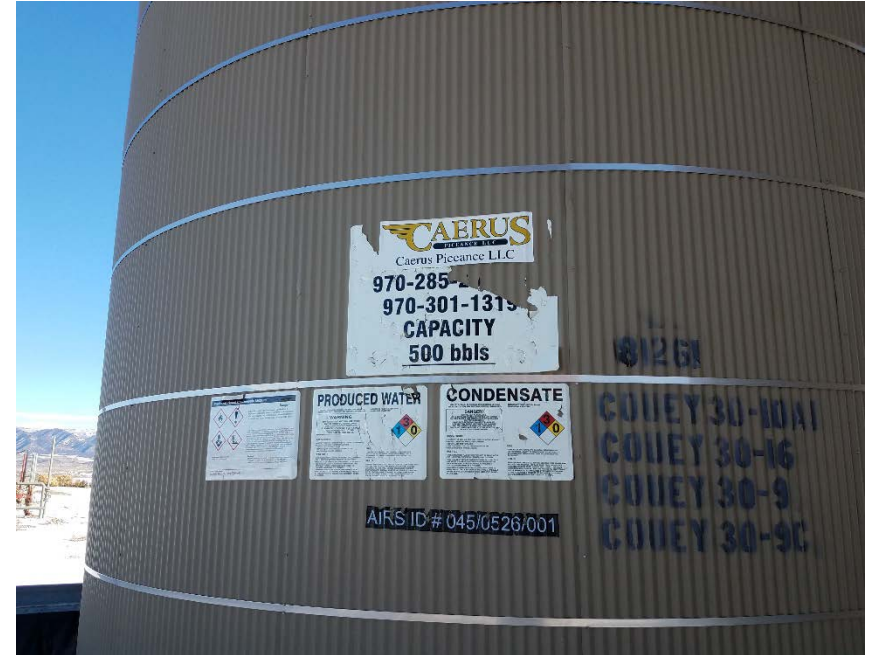
Location Photo #2, Peeling tank label.

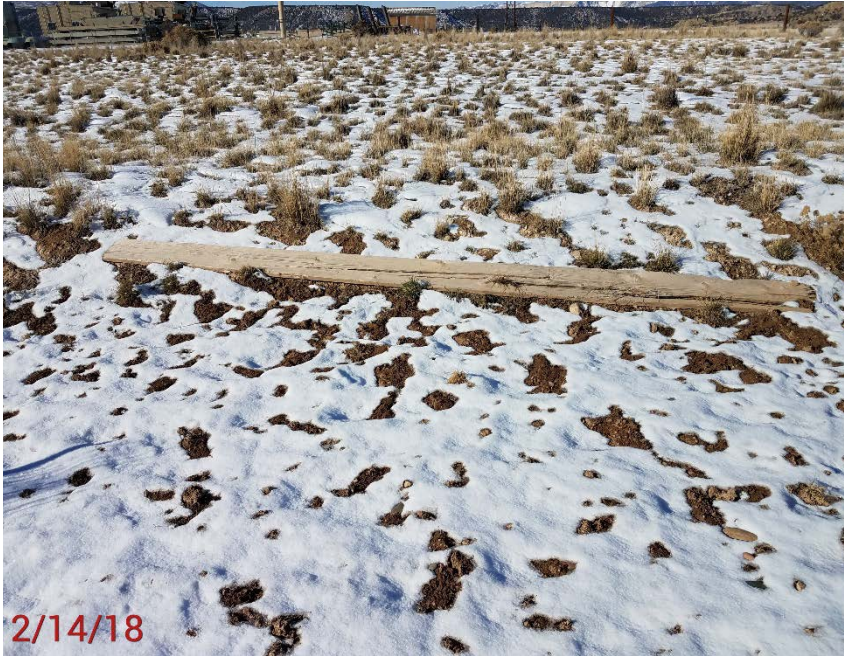
Location Photo #3, Debris on the west side of location.

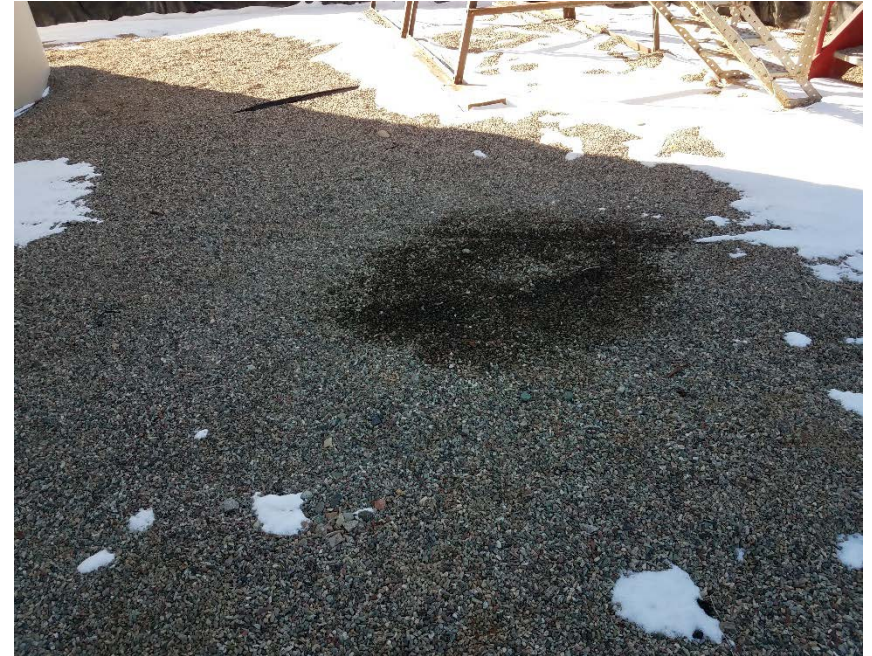
Location Photo #4, Oil stained rock in battery containment.

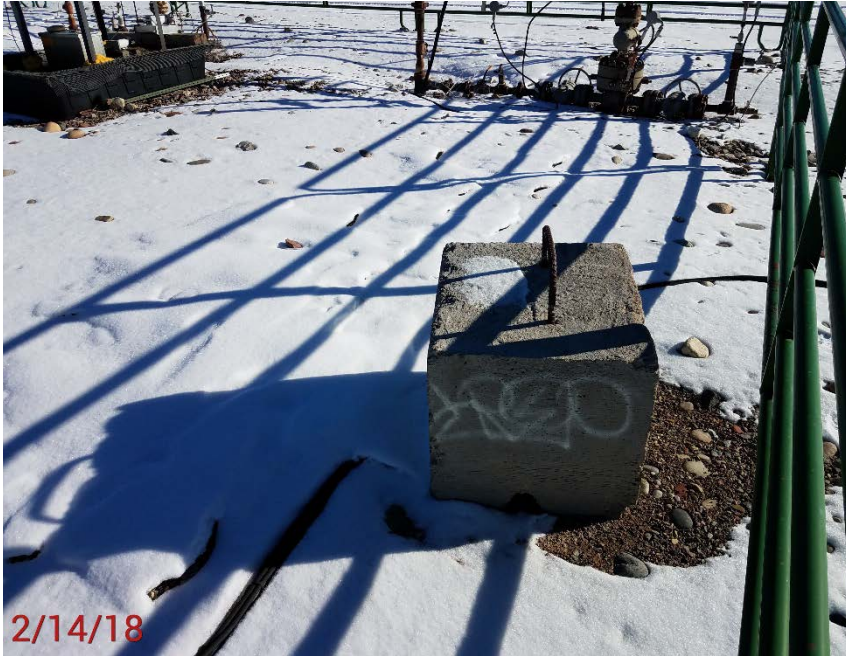
**Location Photo #5, Unused concrete block
near wellheads.**
