Inspection Photo (s)
BJM 30-14
API # 05-045-09791
Inspection # 6893026041

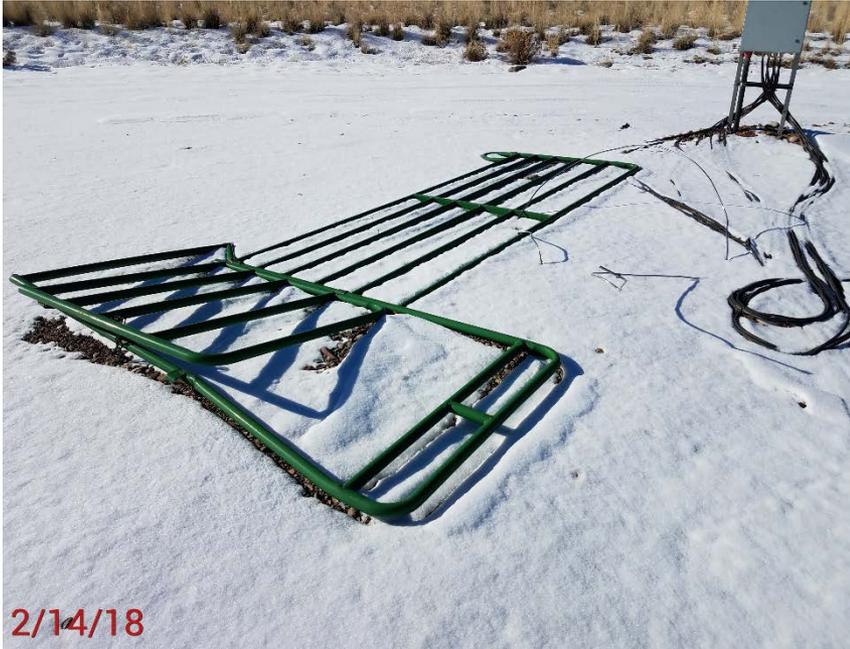
Location Photo #3, Debris near wellheads.

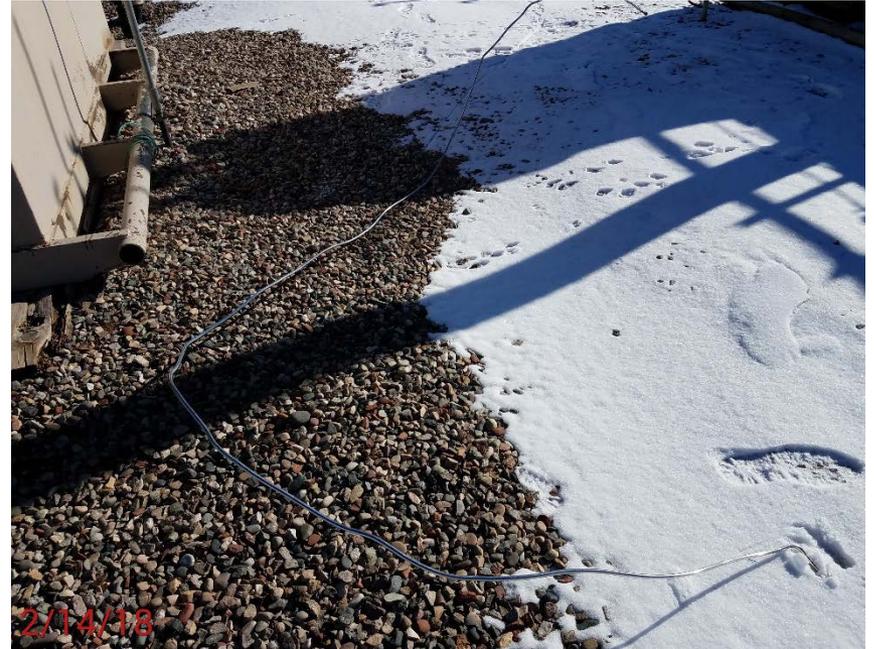
Location Photo #4, Debris near separators.

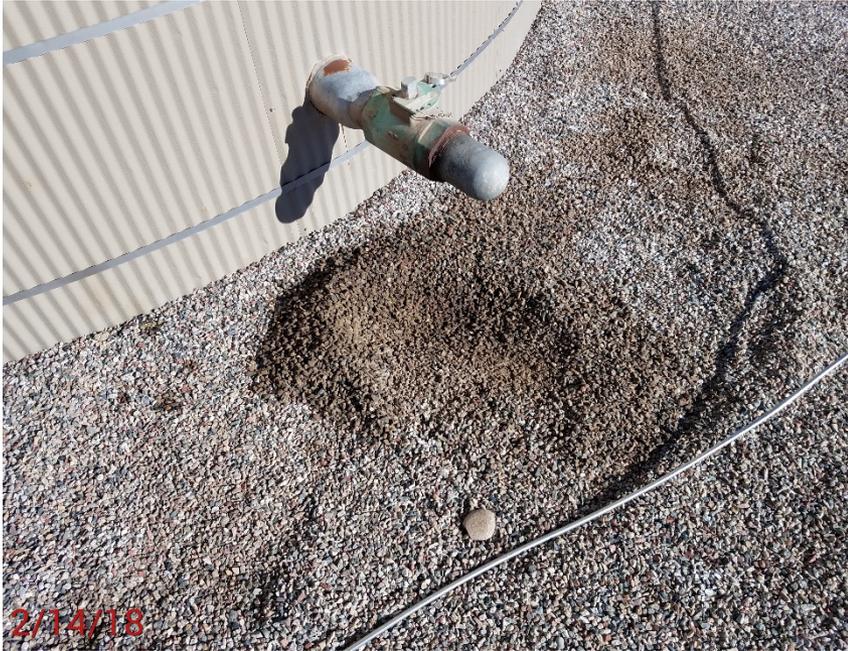
Location Photo #5, Oil stained rock in battery containment.

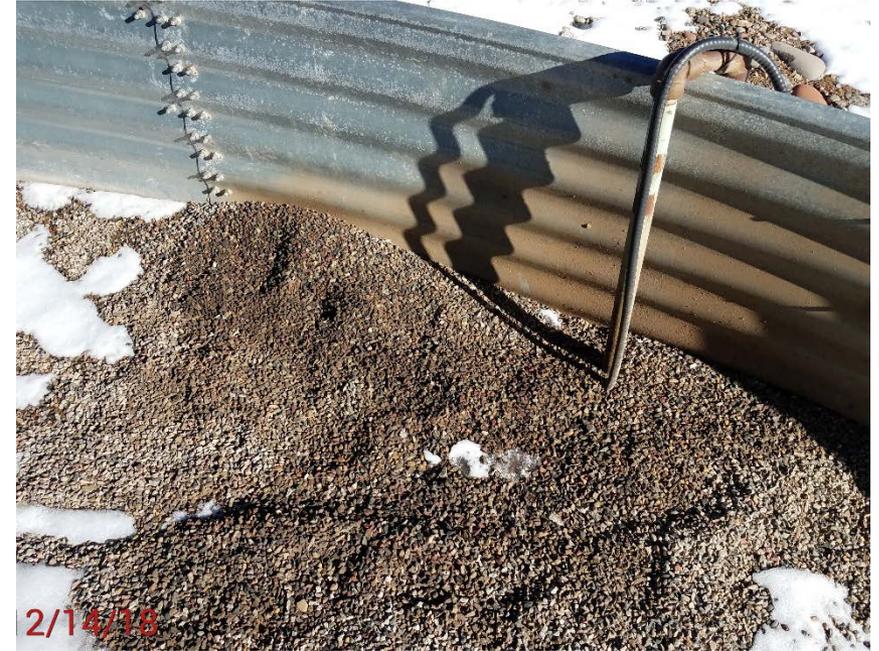
Location Photo #6, Oil stained rock in battery containment.

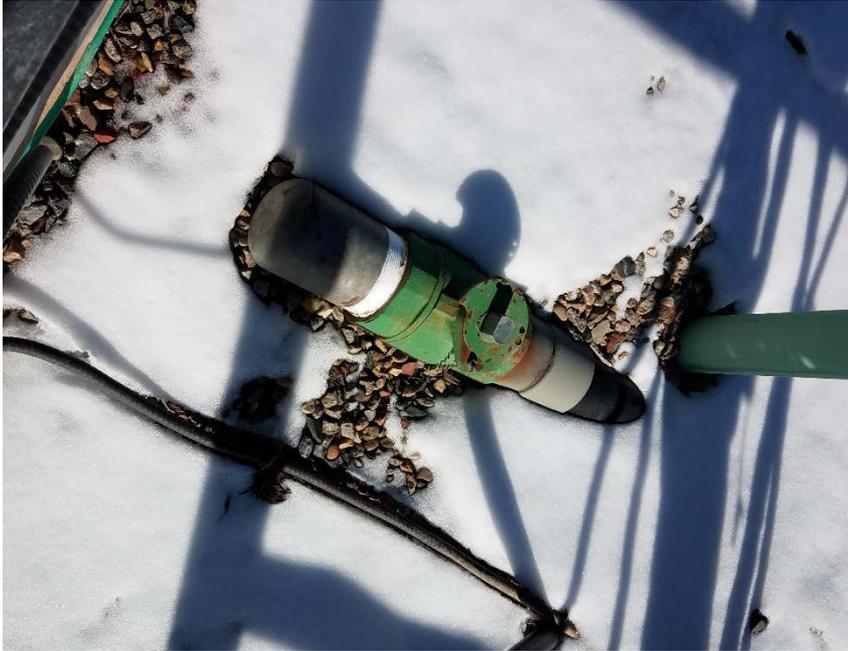
**Location Photo #7, unmarked flow line riser
on East side of the containment.**
