Inspection Photo (s)
Dever 36-11
API # 05-045-07660
Inspection # 6893026047

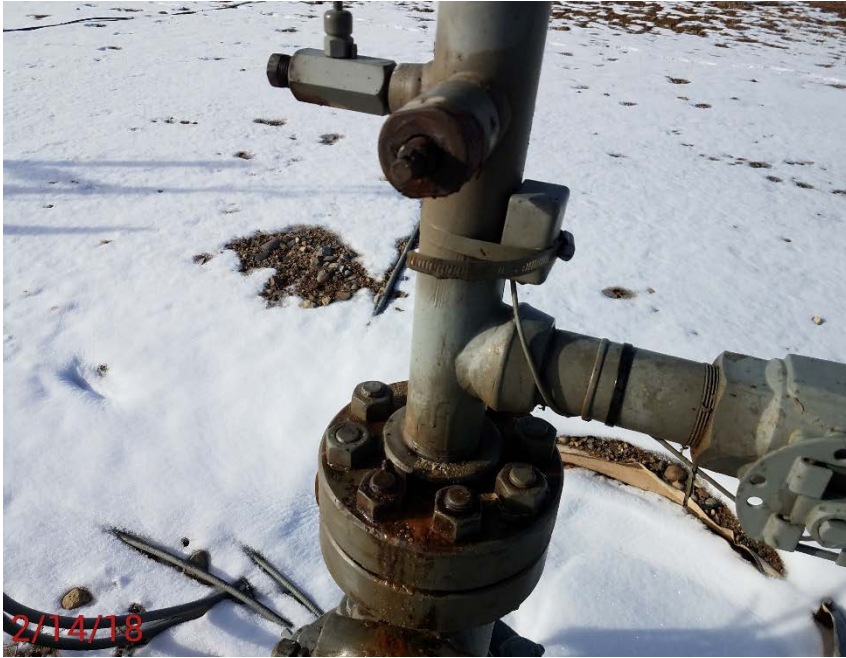
Location Photo #3, Leaking plunger catch on well 36-10

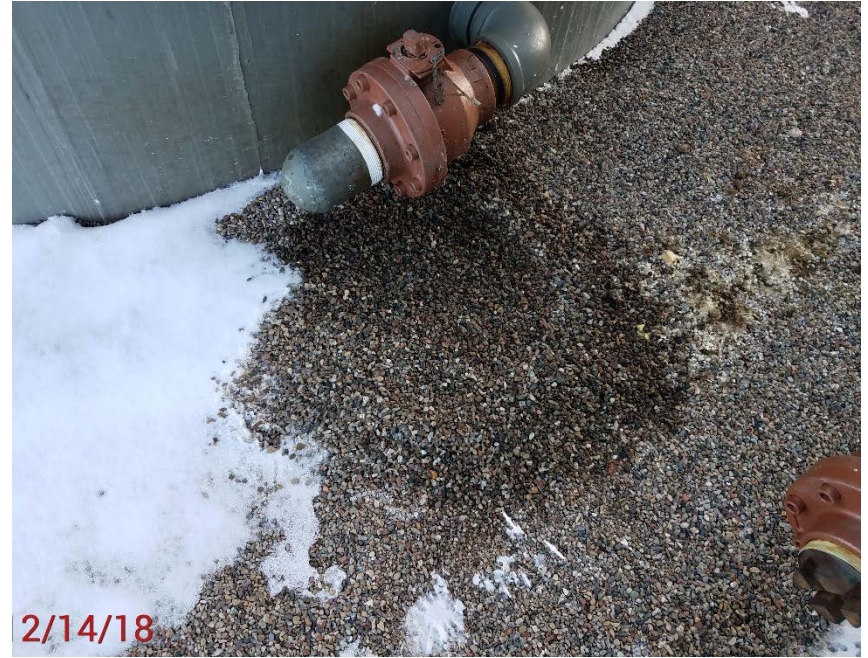
Location Photo #4, Oil stained rock in battery containment.

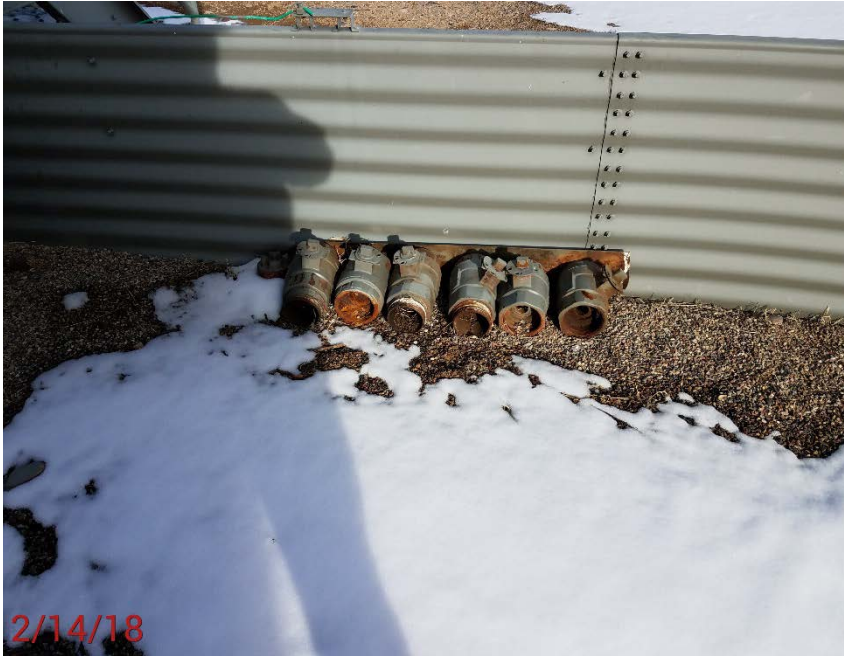
Location Photo #5, Unused valves in battery.
