# Inspection Photos

Operator: BP Production

API: 05-067-09219

Date: 11/29/2018

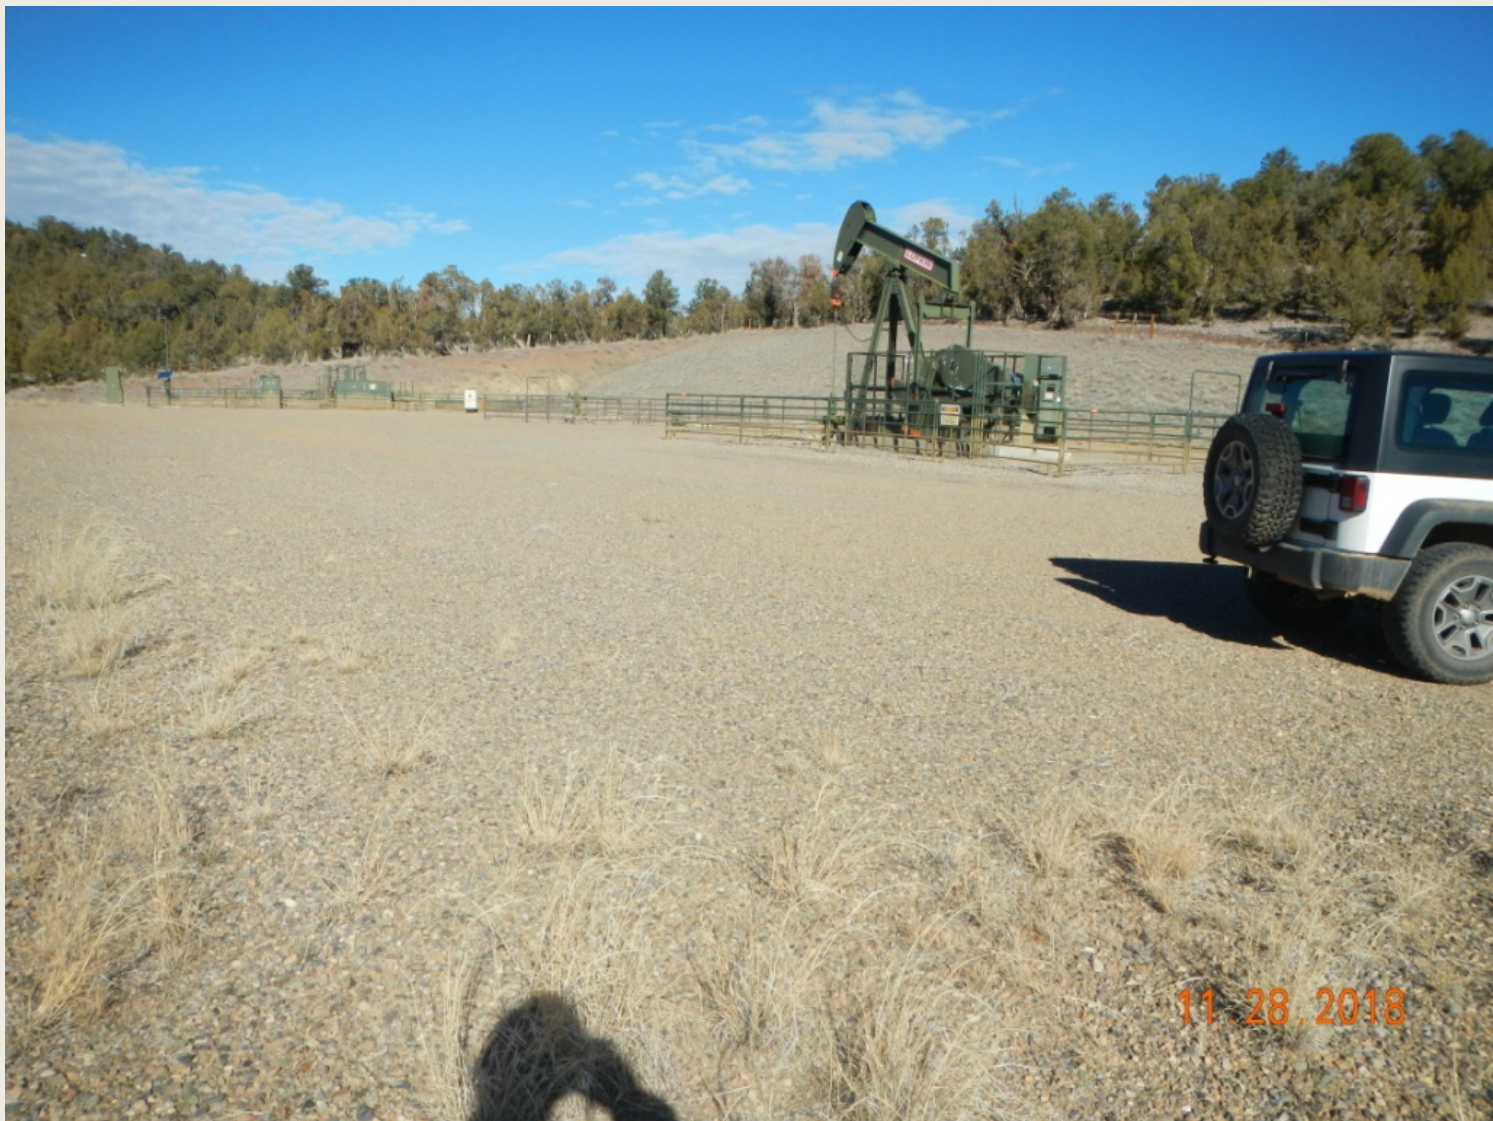
**Photo 1. View of the project area from the southern corner facing center.**

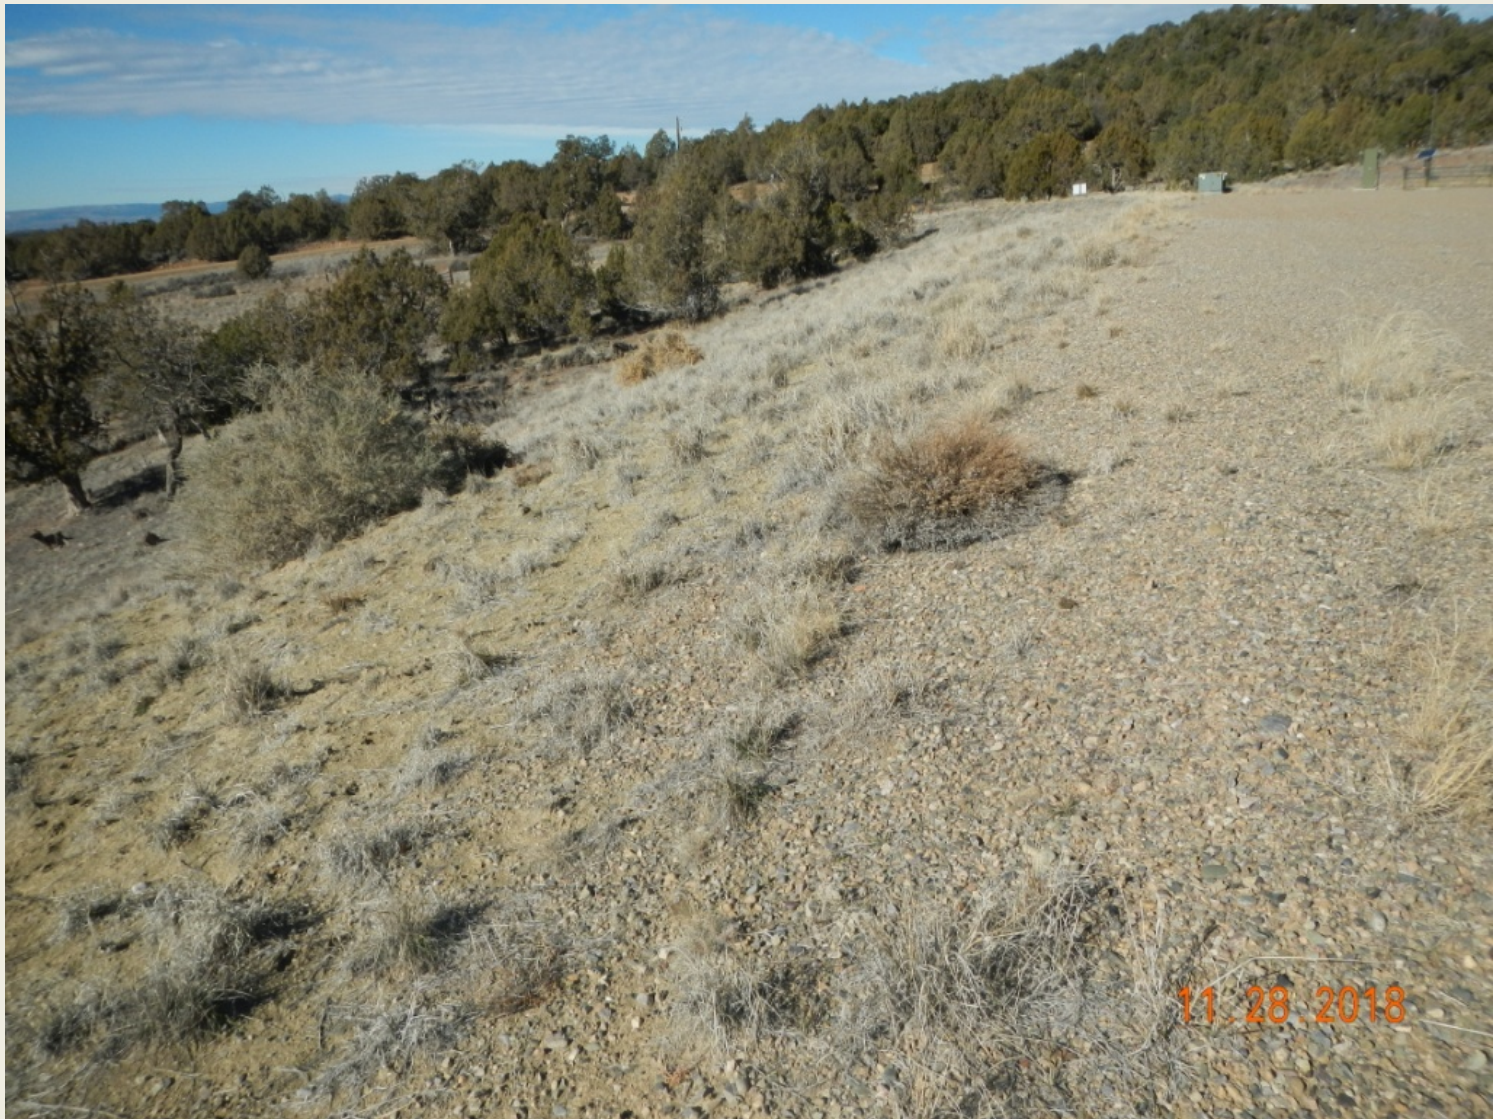
**Photo 2. View of the southwestern project area from the southern corner facing northwestward. Revegetation is largely comprised of grasses such sideoats grama (*Bouteloua curtipendula*) and crested wheatgrass (*Agropyron cristatum*).**

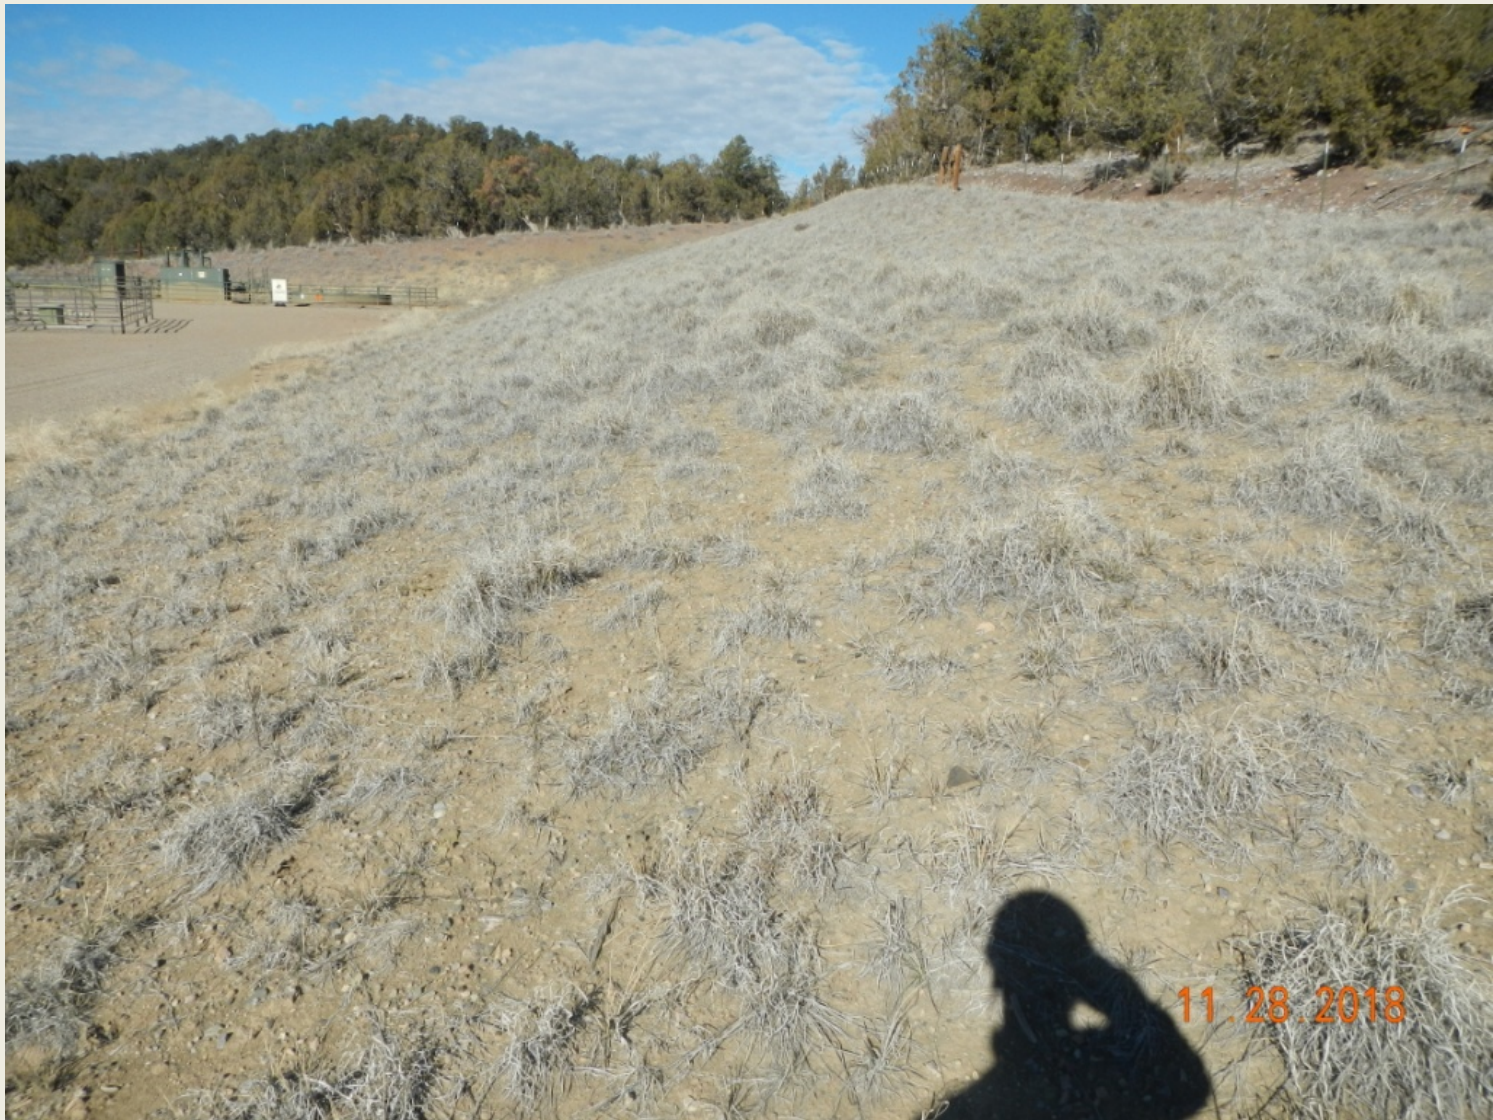
**Photo 3. View of the northeastern project area from the northeastern corner facing northwestward.**

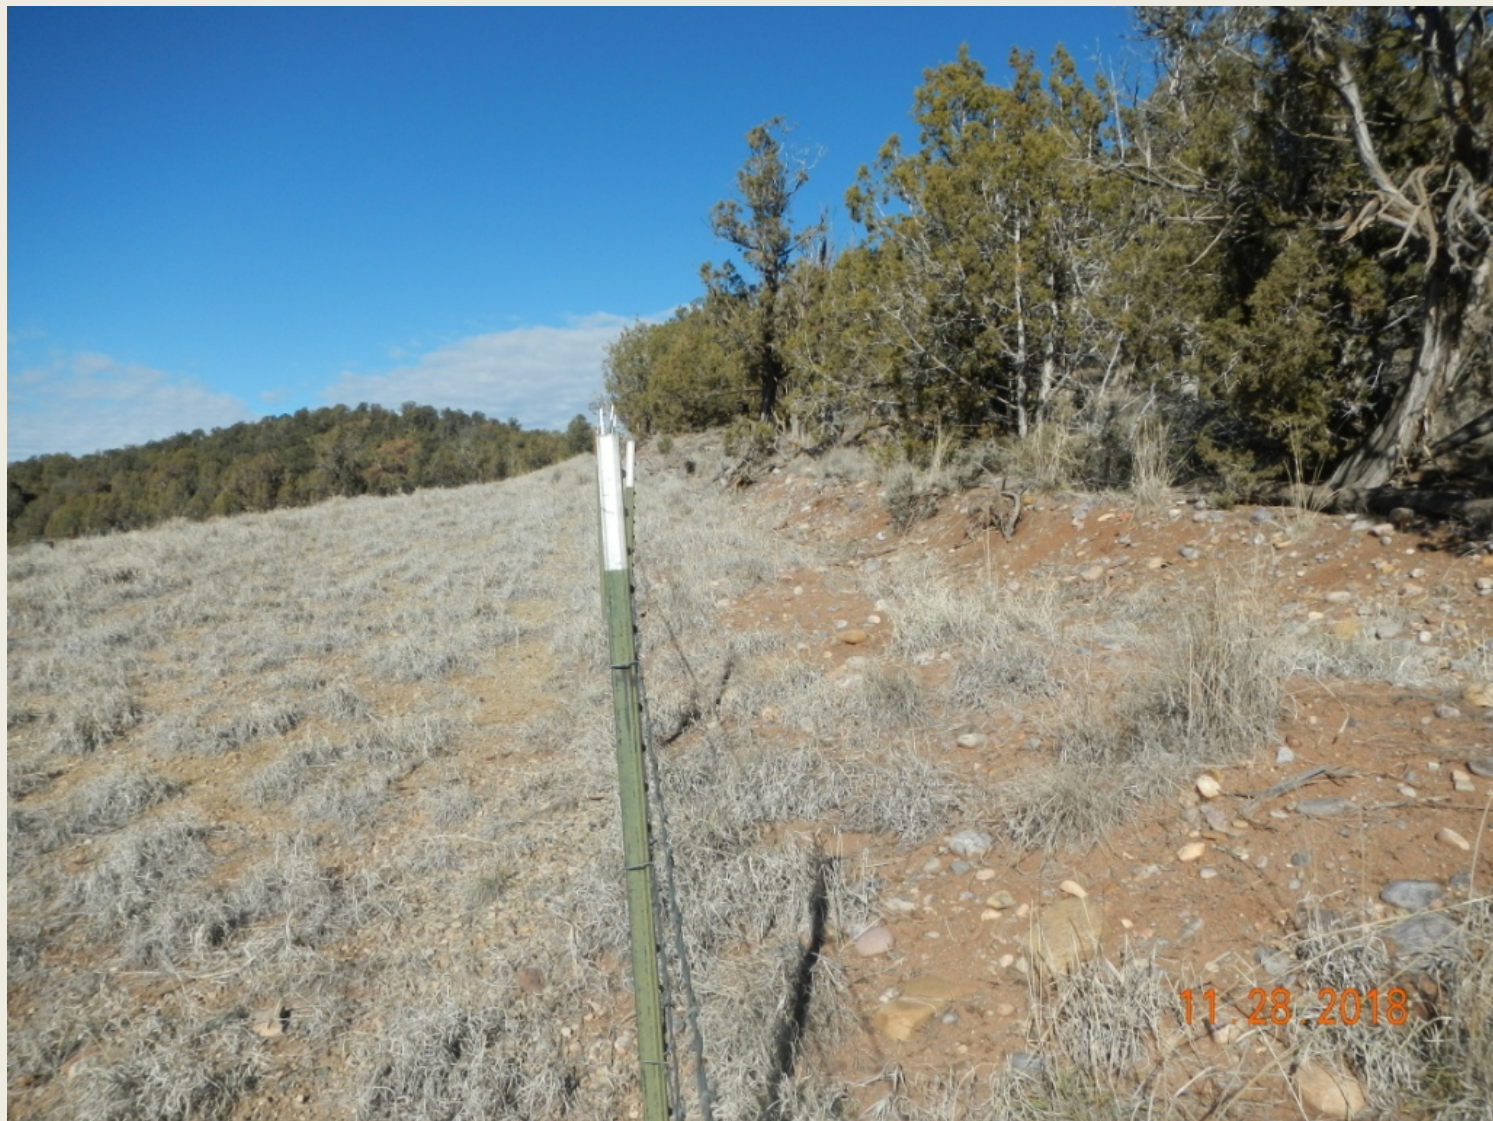
**Photo 4. View of diversion along the northeastern edge of the project area, appears to be functioning at this time.**

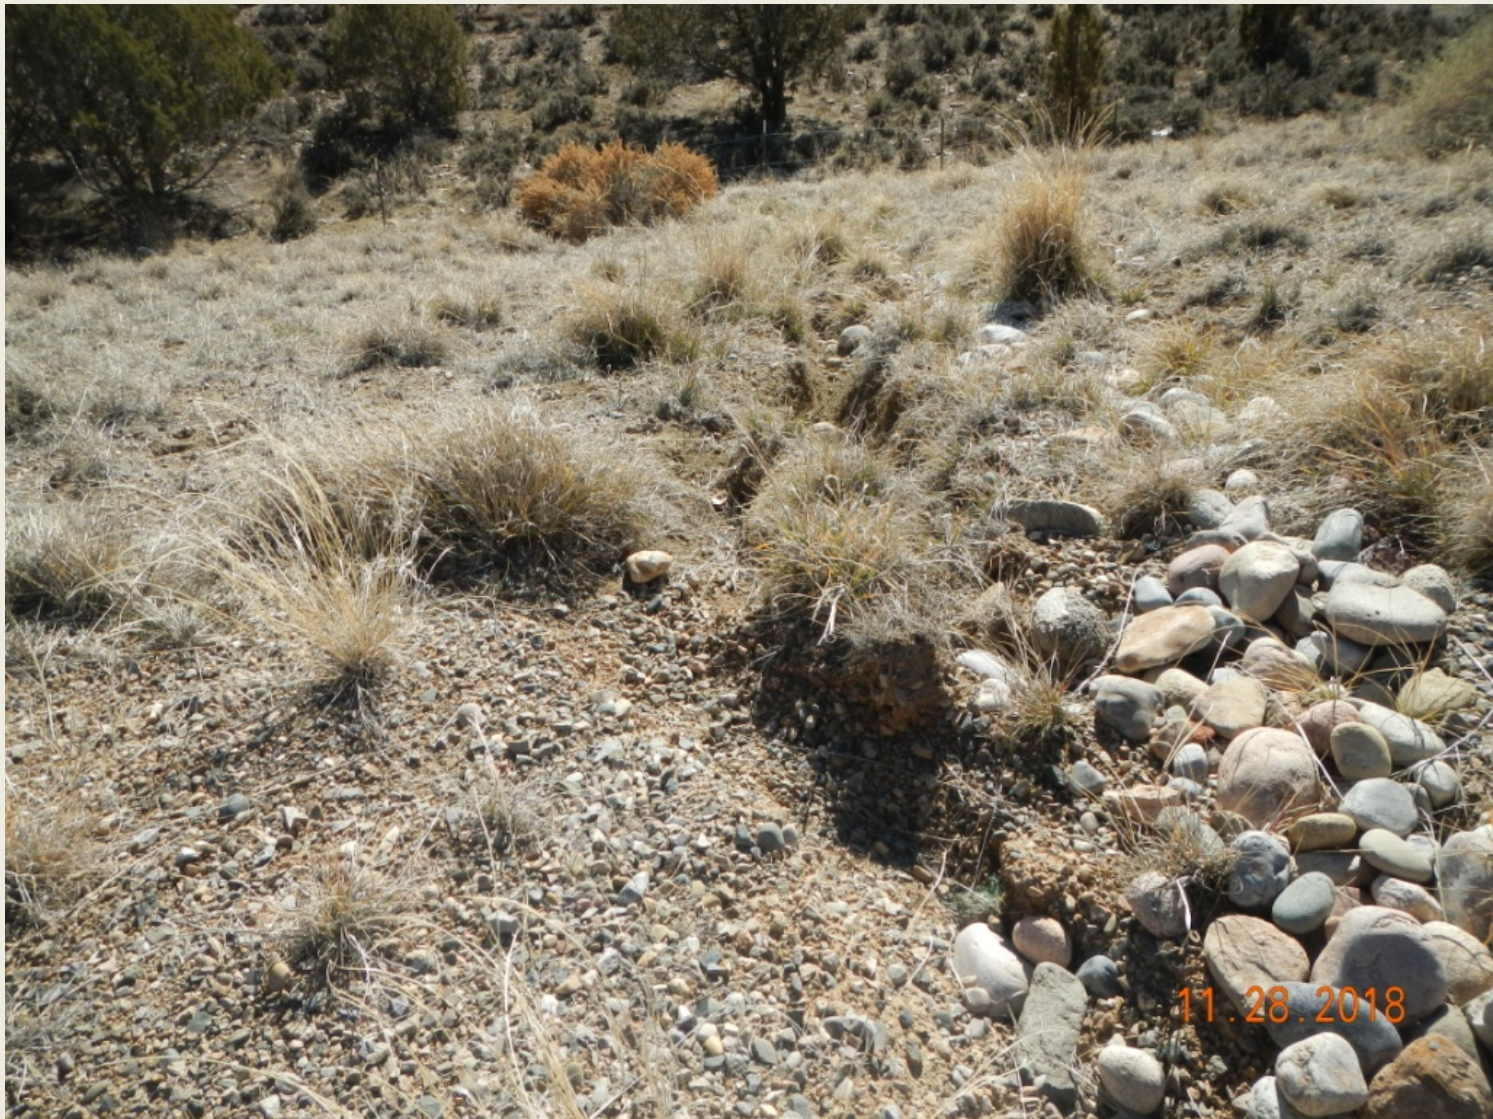
**Photo 5. View of erosional channel forming within the southeastern project area, around a cobble run-down.**
